5 **TRACK & ENGINEERING FACTUAL REPORT**

6 **DCA17FR013**

7 **Union Pacific Railroad, Derailment with Employee Fatality**

8 **Arlington, TX - September 22, 2017**

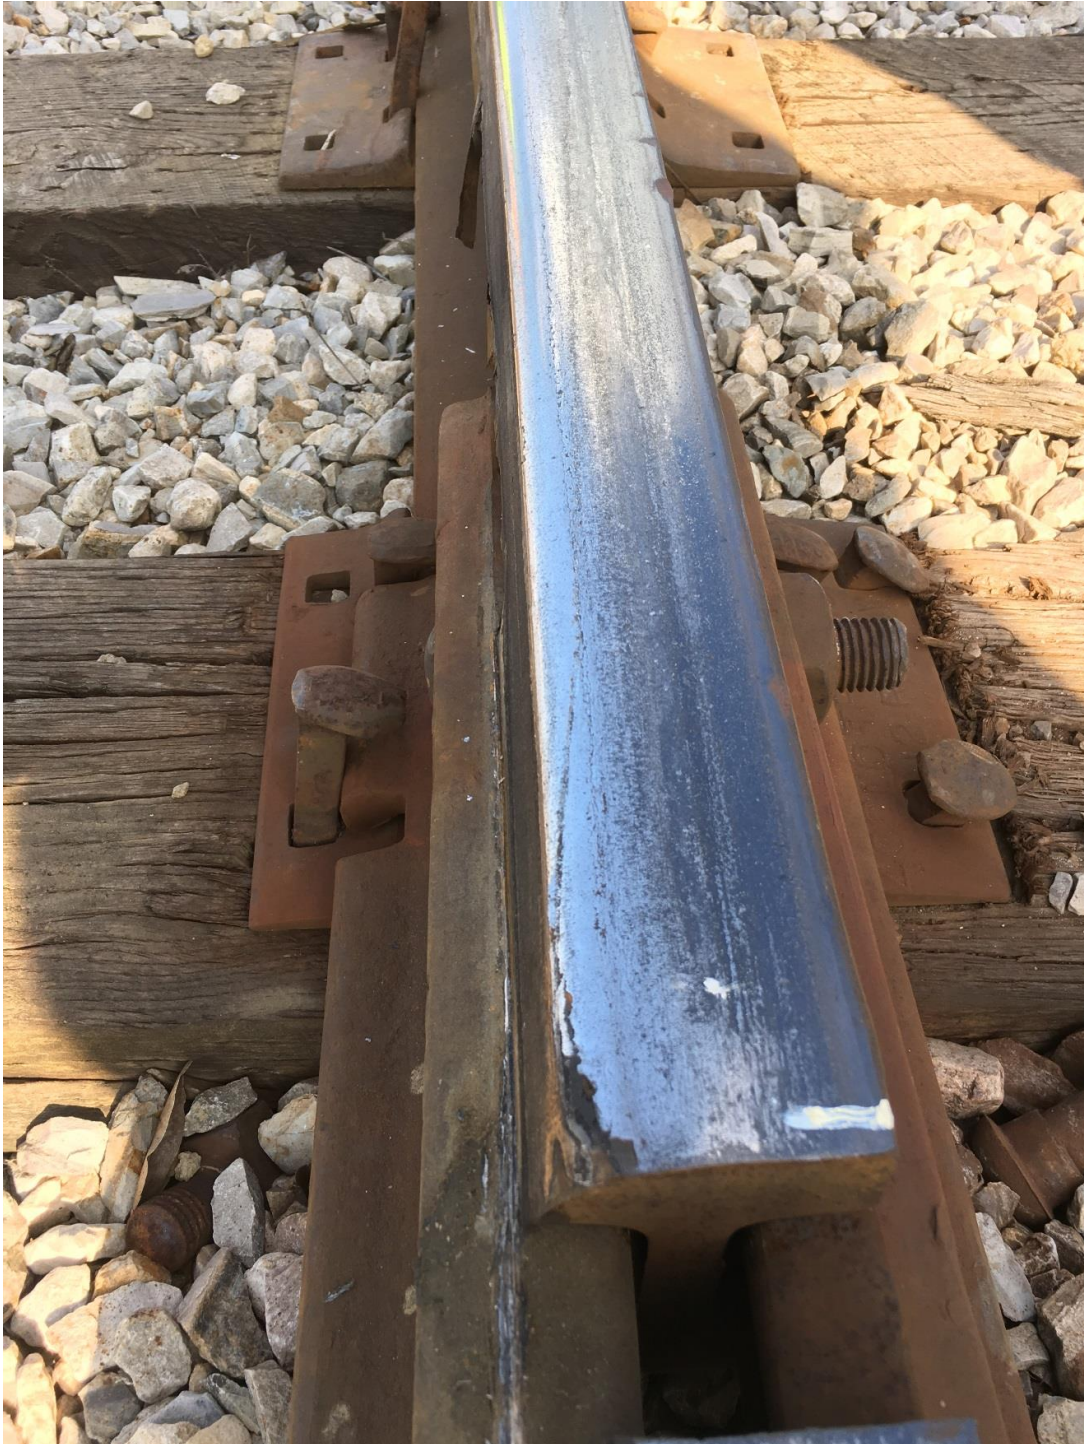
The investigation team determined that the POD (the location where the normal wheel and rail interface was disrupted) was approximately 60ft east of the west switch leading into Track 001. Investigators identified a flange mark originating at the center of a rail joint on the south rail traversing over the top of the rail head of the high rail in the curve. This flange mark was determined to be 24” in length. Corresponding wheel departure marks were identified across the top of the rail head of the low rail of the curve. Investigators also photo documented flange and tread marks from the derailed rail car wheels that were found on various track components. Evidence of the derailed car continued, in the ballast, east for 152ft from the POD to where the car came to rest.

2 Figure 2. Photo showing wheel flange departure mark at rail joint.

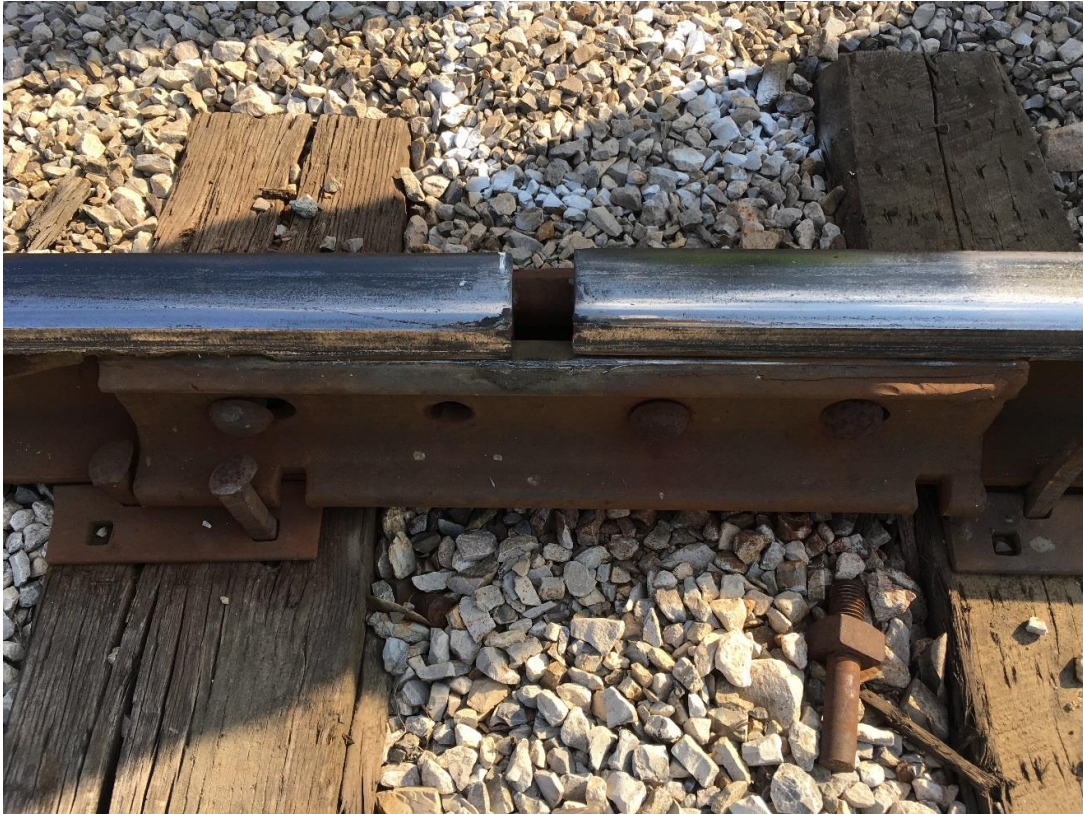
1 point of derailment. The difference cross level was 1 5/8" (low to south rail). The rail joint where
2 the wheel marks originated was loose and allowed a 1/8" gage side mismatch and 1/8" tread
3 mismatch of the rail ends. A loaded measurement of the mismatch was taken using PTLF at 4000
4 psi. At that time, the mismatch measured 3/8".

6 During the re-enactment, video recording devices were positioned to capture footage of the
7 rail joint as the cars traversed the track at the POD. Upon reviewing this video footage, it appeared
8 that the rail end mismatch was significantly greater than the previous measurement taken using the
9 PTLF. An exact measurement could not be determined.

Figure 3. Rail Joint where wheel flange marks originated (POD).

The section of rail where the derailment originated will be removed from the track and transported to UP's technical research laboratory in Omaha, NE. Lab results will be made available to NTSB and FRA for review.
