**NATIONAL TRANSPORTATION SAFETY BOARD  
OFFICE OF RAILROAD, PIPELINE AND  
HAZARDOUS MATERIALS INVESTIGATIONS  
WASHINGTON, D.C. 20594**

**Track & Engineering Group Factual Report**

Type:	Over Speed Derailment
Date and Time:	May 12, 2015 at 9:21 p.m. EDT
Location:	Philadelphia, Pennsylvania
Vehicle:	Amtrak train 188
NTSB Accident#:	DCA15MR010

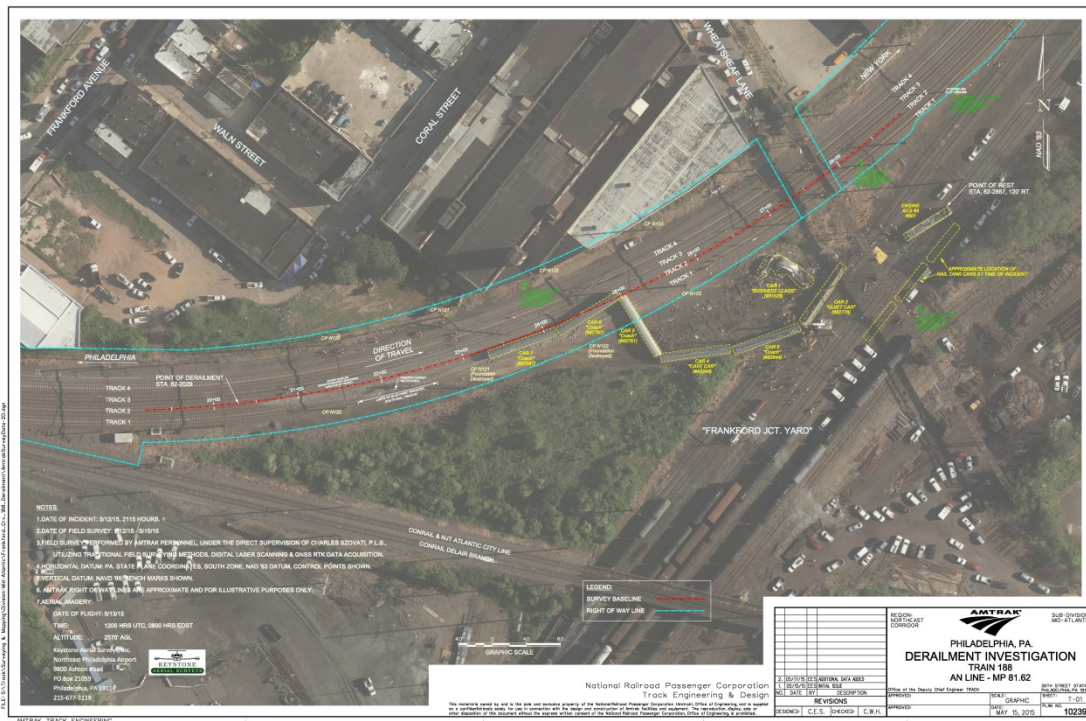
**Figure 1**  
**Survey of Derailment Site with Derailed Car Positions, Car Component Locations, Right of Way Boundaries, Noted Structure Damages, Track & Evidence Locations, Direction of Travel, and Point of Derailment Identified**

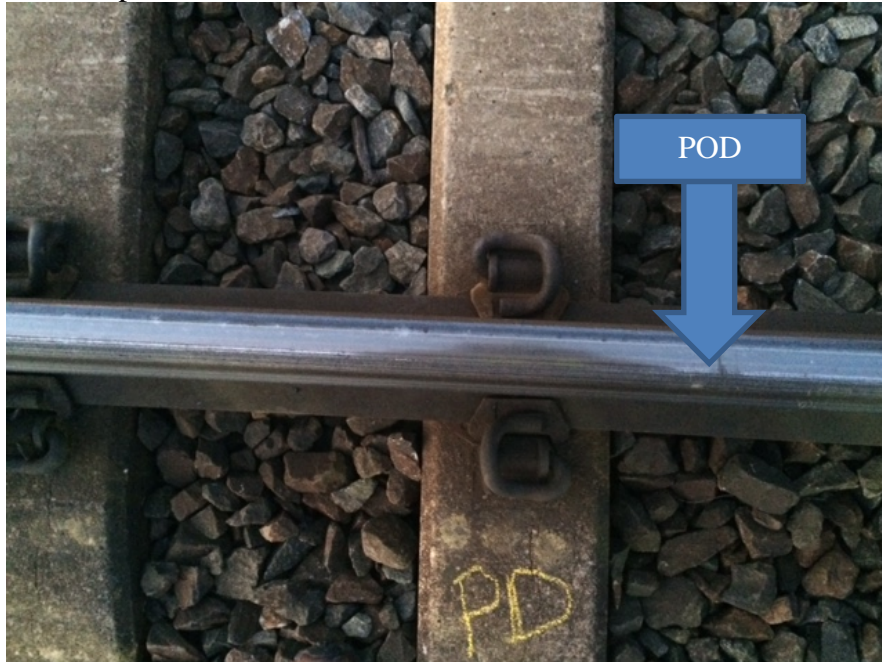
In the area of the derailment there are 4 main tracks that are numbered 1 through 4 from south to north respectively, and are parallel to each other. The point of derailment (POD) was determined to occur in the full body of curve #298, at MP 81.62 (GPS 40° 0'

**Figure 2**  
**View of the POD on the south rail**

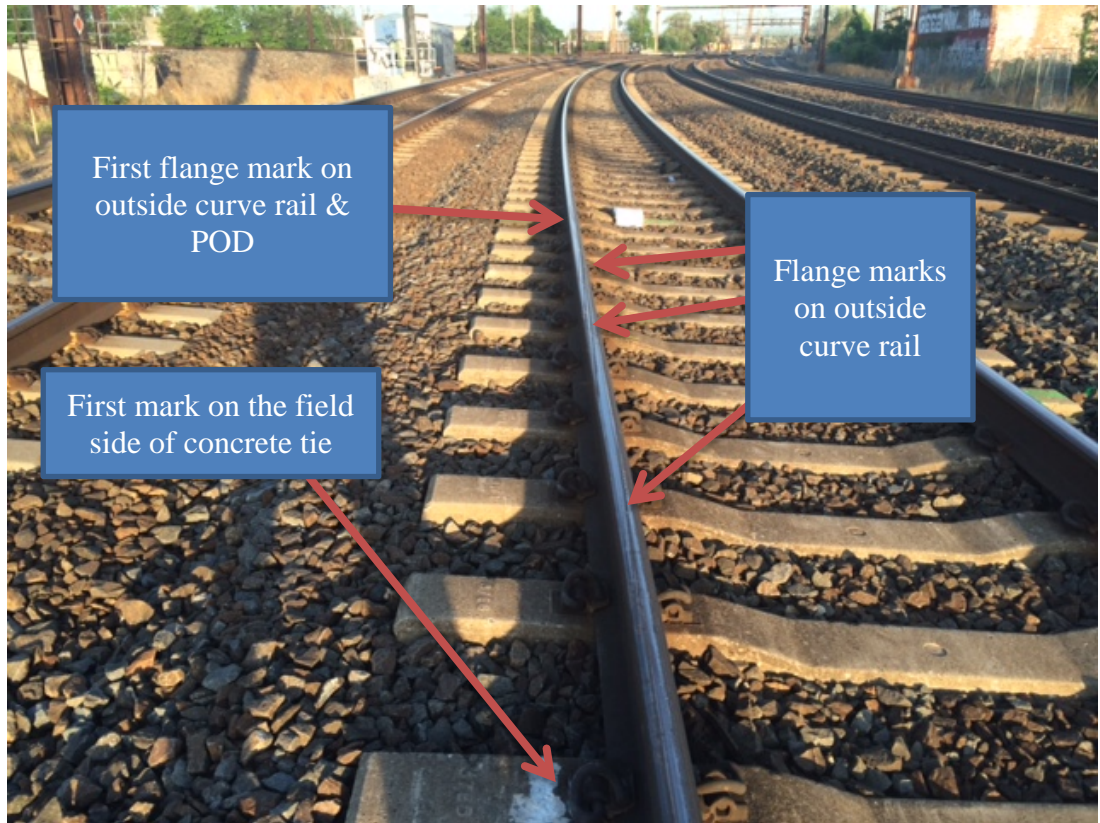
Observation of main track #2 revealed that there were marks on the outside curve rail at the west end of curve #298. It appears that a wheel flange climbed the gage face of high rail, traveled approximately 22 feet, and dropped onto the concrete ties on the field side of the outside rail as the train began or rolled over. See figure 3. There was no evidence at the POD where the wheels on the inside of the curve contacted the ties within the gage. However, there was sand and arching marks on the inside rail just west of the POD which is evident of wheel lift and grounding of electricity from the overhead catenary propulsion system. See figure 4. About 155 feet east and across from the POD

Figure 3-Wheel marks

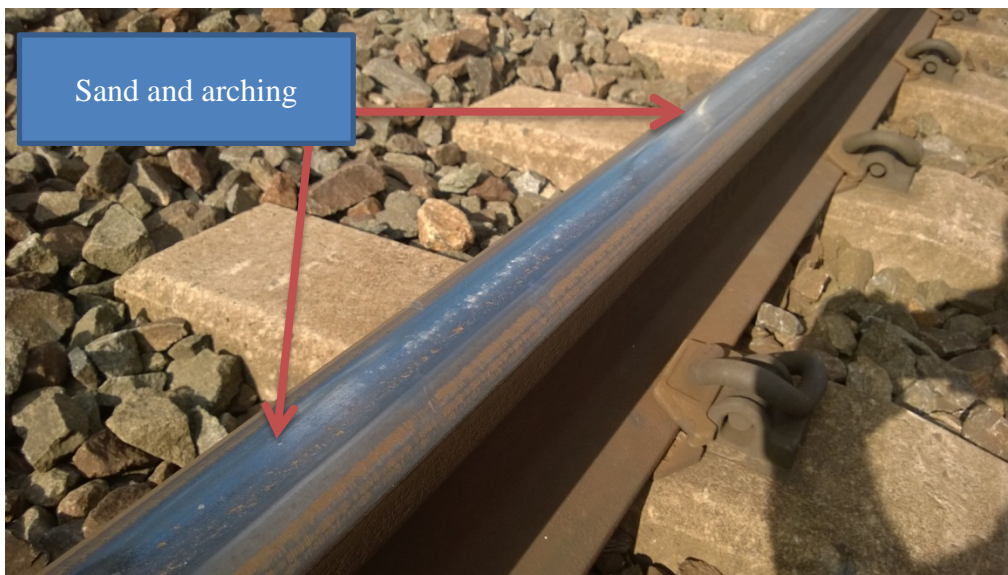
Figure 4-sand and arching on inside curve rail - west of POD

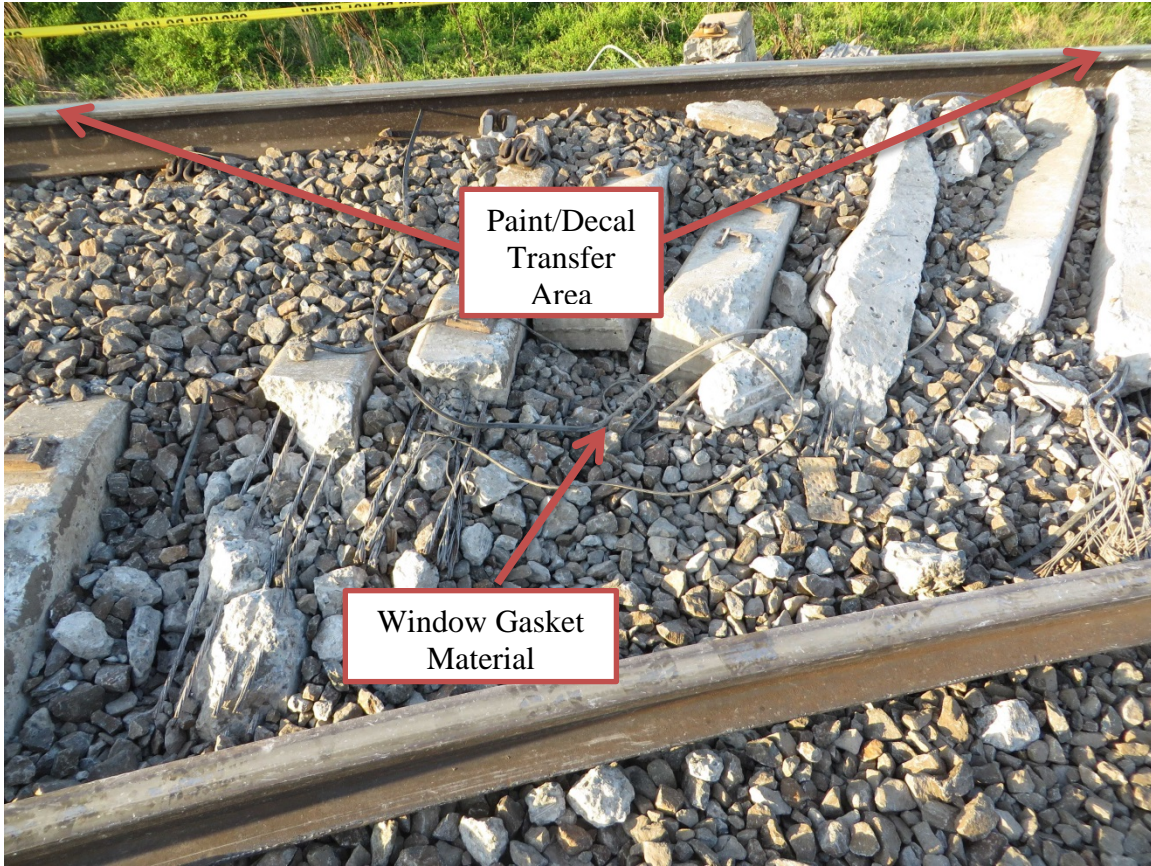
on main track #1, there was evidence of blue paint or decal transfer on the rail head that extended eastward for about 155 feet. About midway in that transfer location was passenger car window gasket materials. See figure 1 and figure 5.

**Figure 5 – Window Gasket Material and Blue Paint/Decal Transfer**
