5  
6 **TRACK & ENGINEERING FACTUAL REPORT**

7  
8 **DCA17FR013**

9  
10 **Union Pacific Railroad, Derailment with Employee Fatality**

11  
12 **Arlington, TX - September 22, 2017**

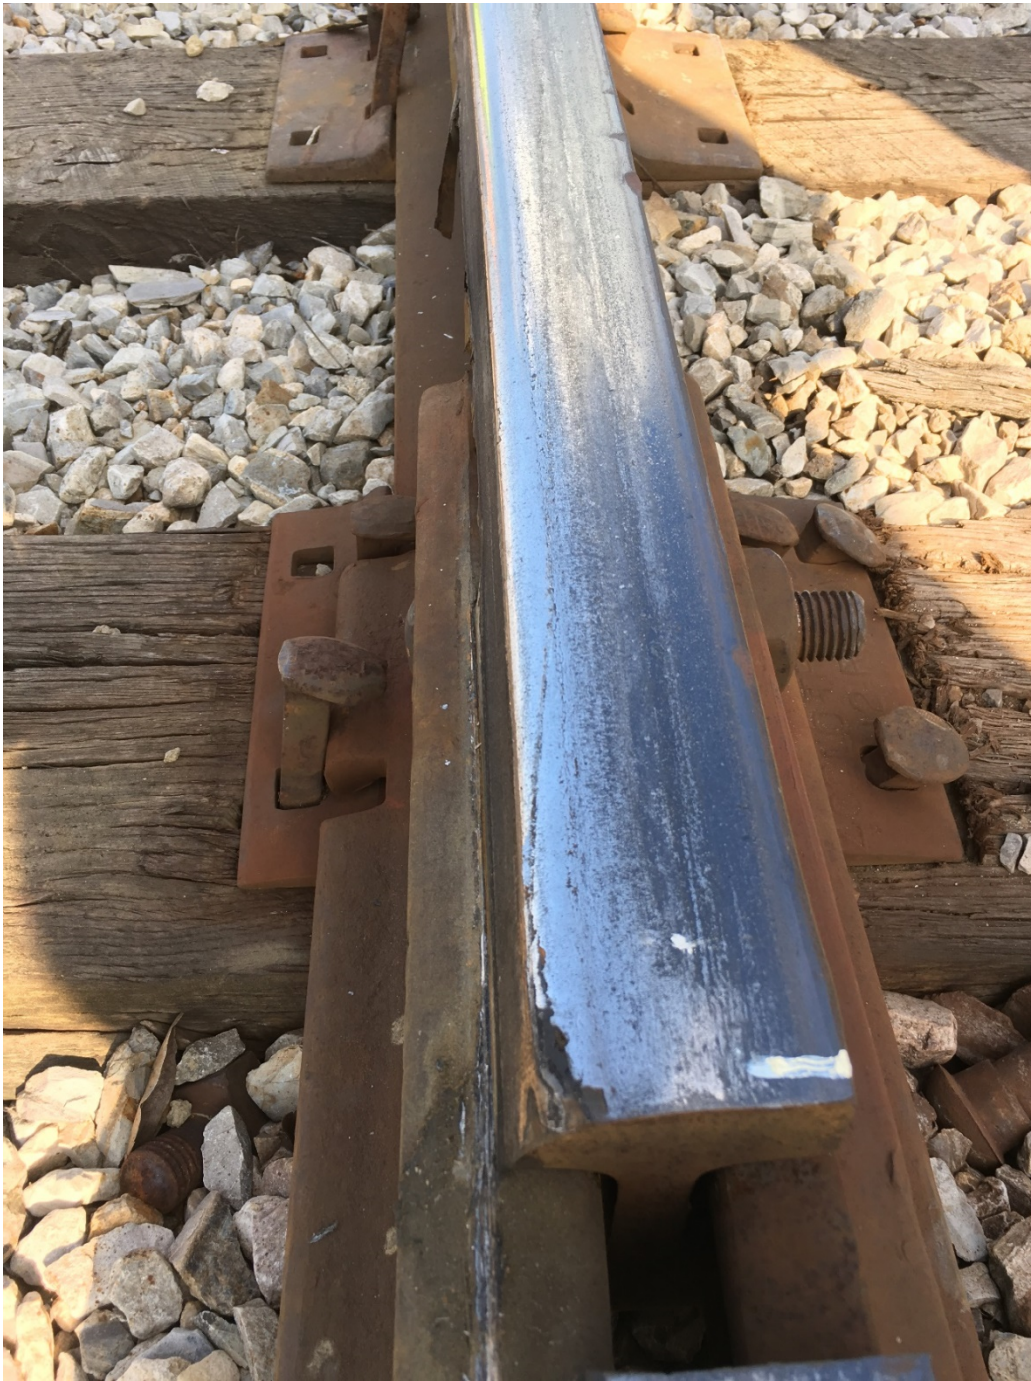
2  
3 The investigation team determined that the POD (the location where the normal wheel and  
4 rail interface was disrupted) was approximately 60ft east of the west switch leading into Track  
5 001. Investigators identified a flange mark originating at the center of a rail joint on the south rail  
6 traversing over the top of the rail head of the high rail in the curve. This flange mark was  
7 determined to be 24” in length. Corresponding wheel departure marks were identified across the  
8 top of the rail head of the low rail of the curve. Investigators also photo documented flange and  
9 tread marks from the derailed rail car wheels that were found on various track components.  
10 Evidence of the derailed car continued, in the ballast, east for 152ft from the POD to where the car  
11 came to rest.

**Figure 2. Photo showing wheel flange departure mark at rail joint.**

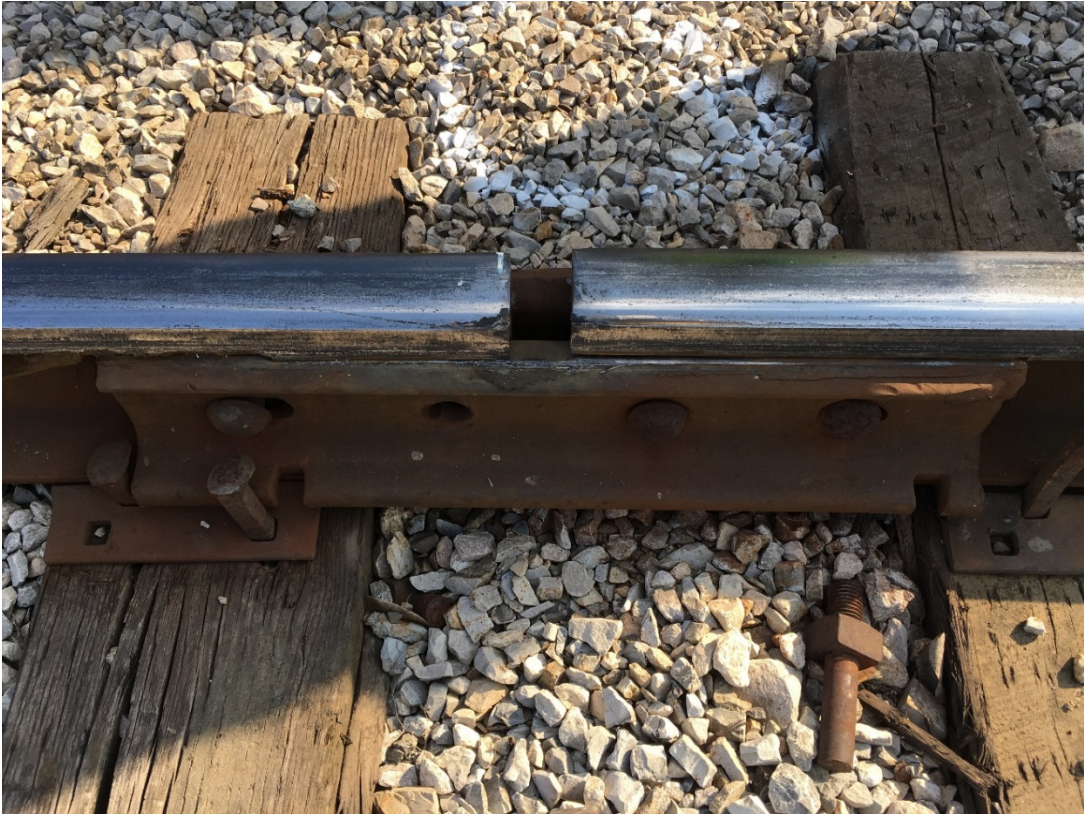
12  
13 Track note measurements taken in curve that the derailment occurred, revealed an average  
14 degree of curvature of 12 degree 6 minutes. The gage measured 57-5/8 inches under load at the  
15 point of derailment. The difference cross level was 1 5/8” (low to south rail). The rail joint where  
16 the wheel marks originated was loose and allowed a 1/8” gage side mismatch and 1/8” tread  
17 mismatch of the rail ends. A loaded measurement of the mismatch was taken using PTLF at 4000  
18 psi. At that time, the mismatch measured 3/8”.

19  
20 During the re-enactment, video recording devices were positioned to capture footage of the  
21 rail joint as the cars traversed the track at the POD. Upon reviewing this video footage, it appeared  
22 that the rail end mismatch was significantly greater than the previous measurement taken using the  
23 PTLF. An exact measurement could not be determined.  
24

**Figure 3. Rail Joint where wheel flange marks originated (POD).**

- 14• Gage: 57 ½" Static / 57 5/8" underload
- 15• Warp: 1 3/8" Static / 1 5/8" underload (High Side)
- 16• 3/8" gage side mismatch loaded, using PTLF at 4000 psi
- 17• Crosstie conditions meet requirements
- 18• Rail fasteners were raised on gage side of south rail at the joint
- 19• Ballast and drainage conditions were acceptable
- 20• Curve wear was noted on the high rail in the accident curve
- 21• Rail joint at POD had one bolt per rail end on the outermost bolt holes, one bolt on the  
22 inner bolt hole of the west rail end was broken.  
23

28             The section of rail where the derailment originated will be removed from the track and  
29 transported to UP's technical research laboratory in Omaha, NE. Lab results will be made  
30 available to NTSB and FRA for review.  
31
