**NATIONAL TRANSPORTATION SAFETY BOARD**

**Track Image Recorder Factual Report**

**Specialist's Factual Report  
By Sean Payne**

Location: Chaffee, Missouri  
Date: May 25, 2013, 02:30 A.M. CDT (Central Daylight Time)  
Company: BNSF Railway Company (BNSF) and Union Pacific Railroad (UP)  
Train: UP Train 2-ASMAR-25 & BNSF Train U-KCKHKMO-05T  
NTSB Number: DCA13MR004

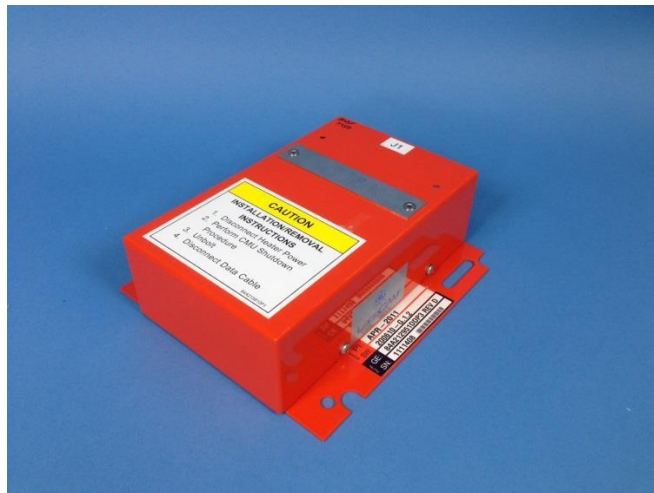
The hard drive was recovered undamaged. A photo of a GE LocoCAM hard drive is shown in Figure 1.

Figure 1. GE LocoCAM Hard Drive from BNSF Locomotive 7750.

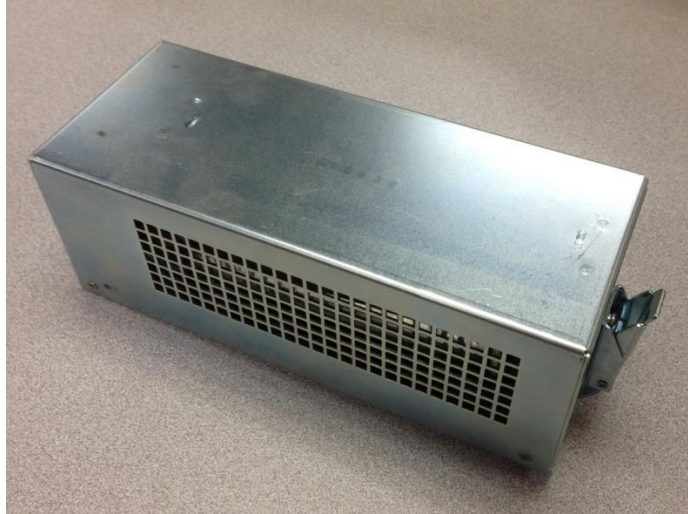
The hard drive was recovered undamaged. Figure 9 shows the condition of the Wabtec VideoTrax recorder.

**Figure 9. The undamaged Wabtec VideoTrax recorder from UP locomotive 5668.**

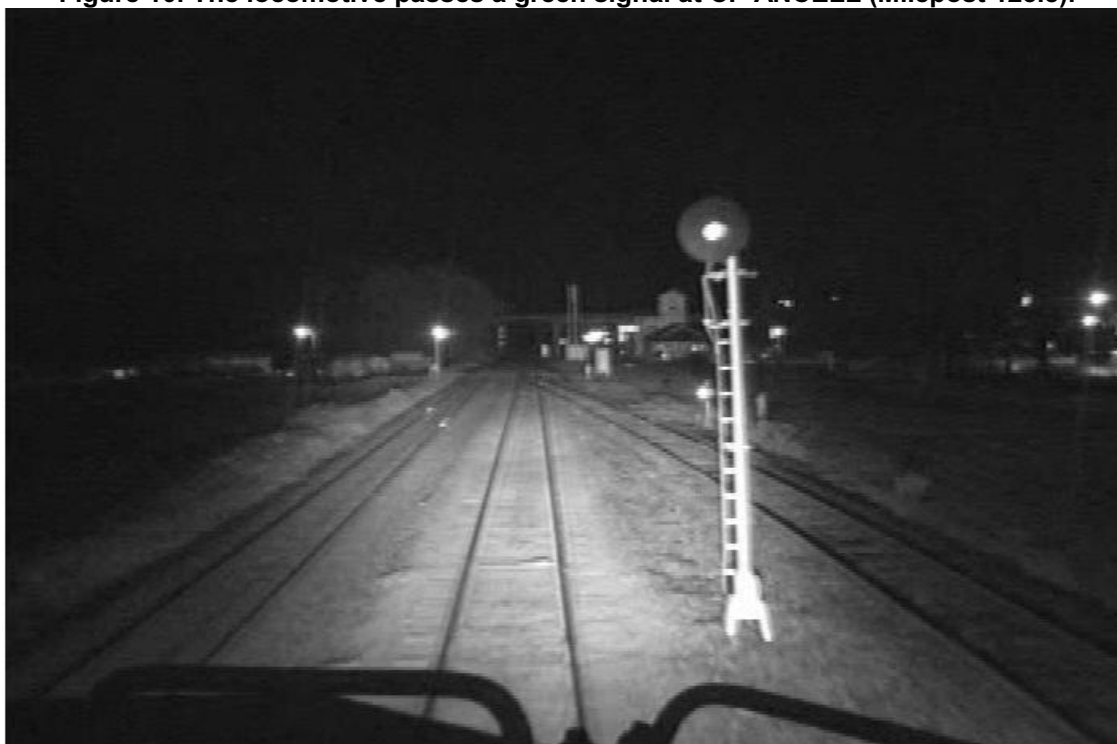
**Figure 10. The locomotive passes a green signal at CP ANCELL (Milepost 125.8).**

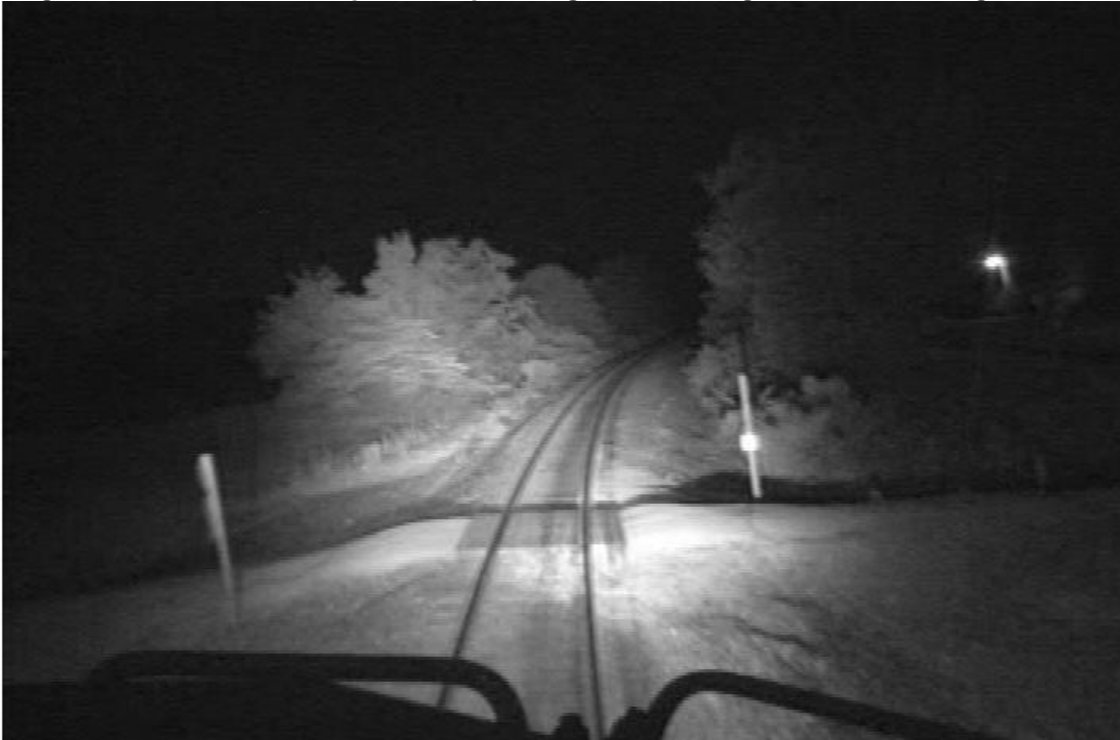
**Figure 11. The locomotive passes a private grade crossing without activating the horn.**

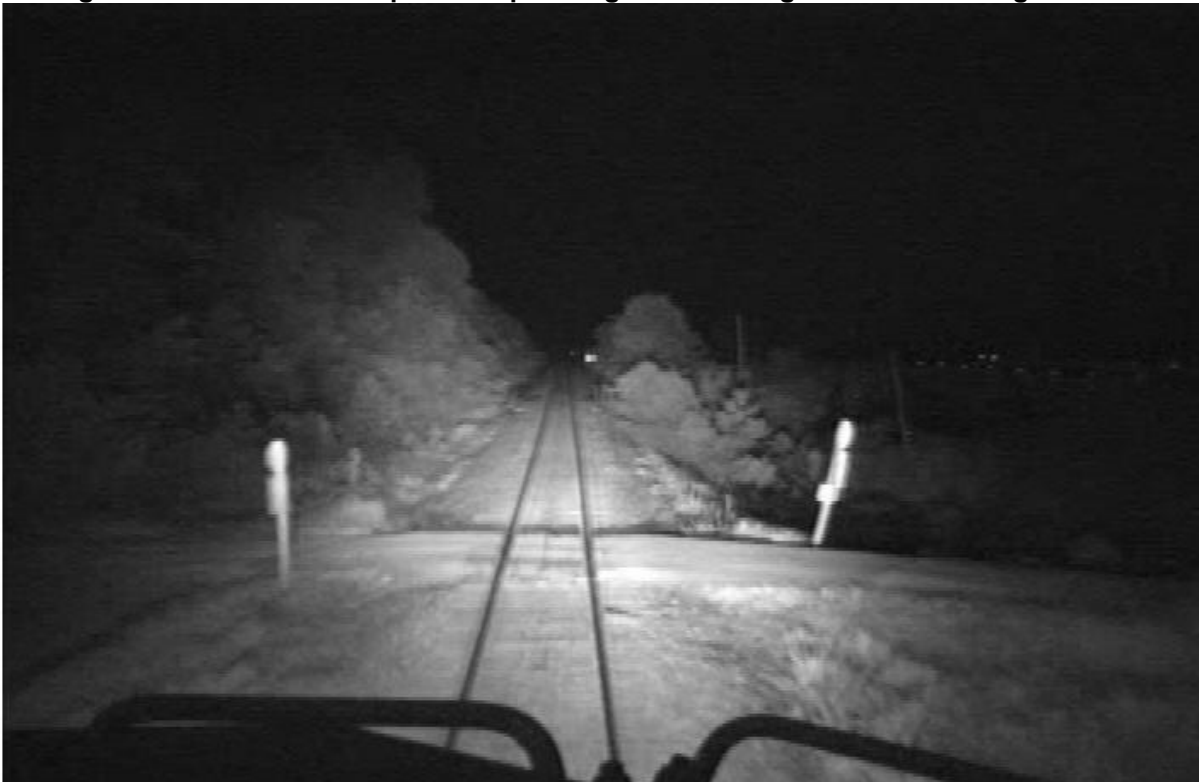
**Figure 12. The locomotive passes a private grade crossing without activating the horn.**

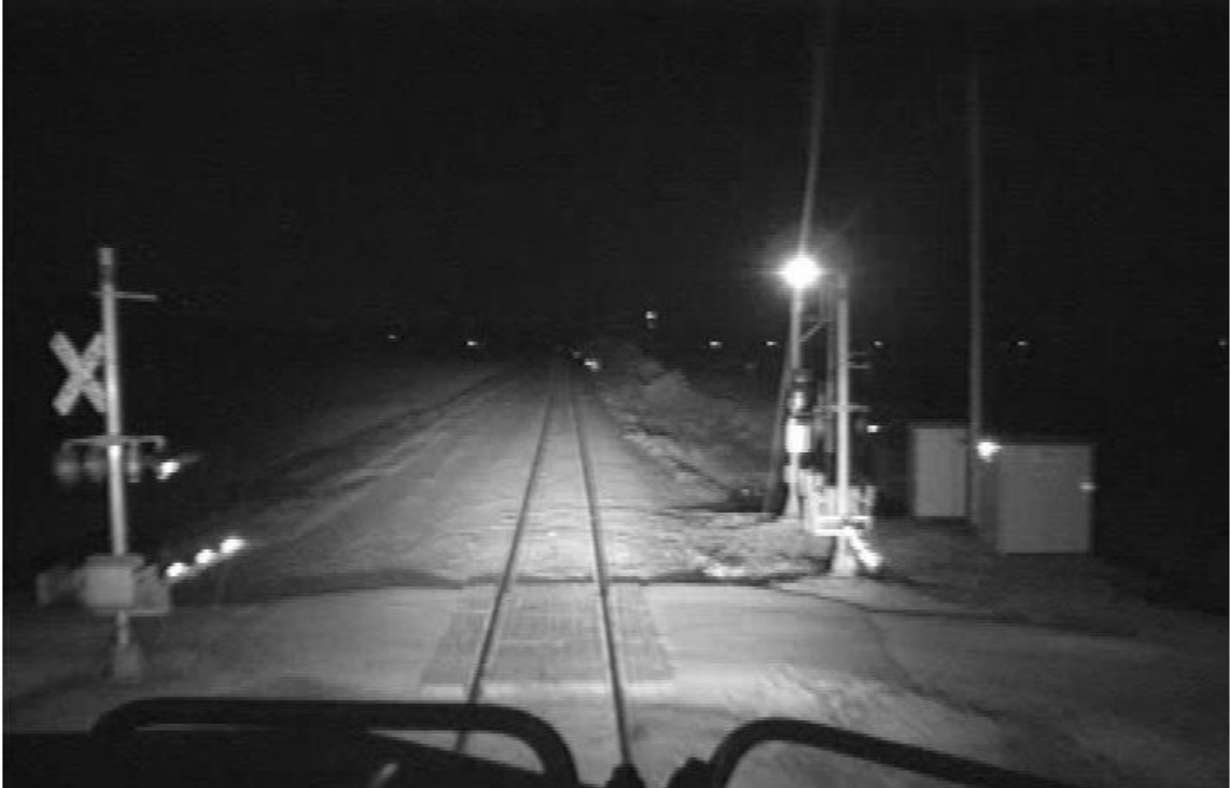
**Figure 13. A horn is heard as the locomotive passes a private grade crossing at a flashing yellow Intermediate Signal (Milepost 127.7).**

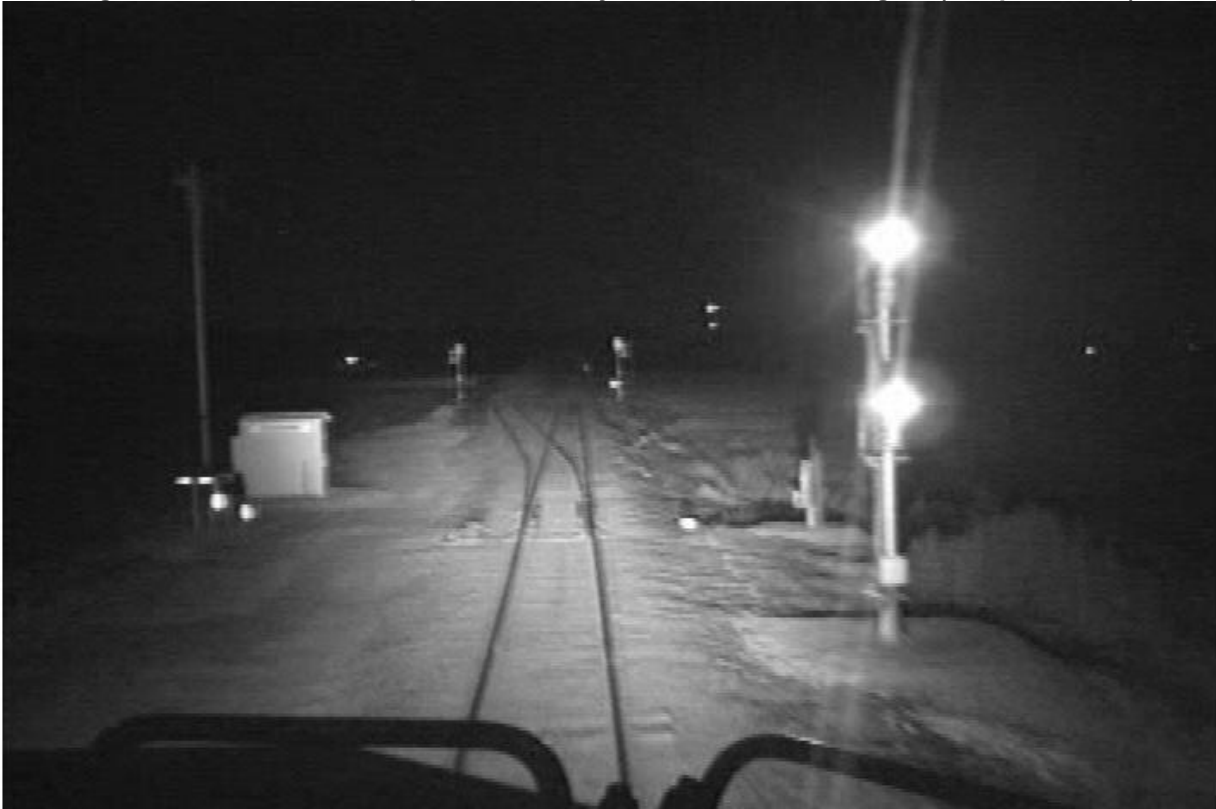
**Figure 14. The locomotive passes a solid yellow intermediate signal (Milepost 129.1).**

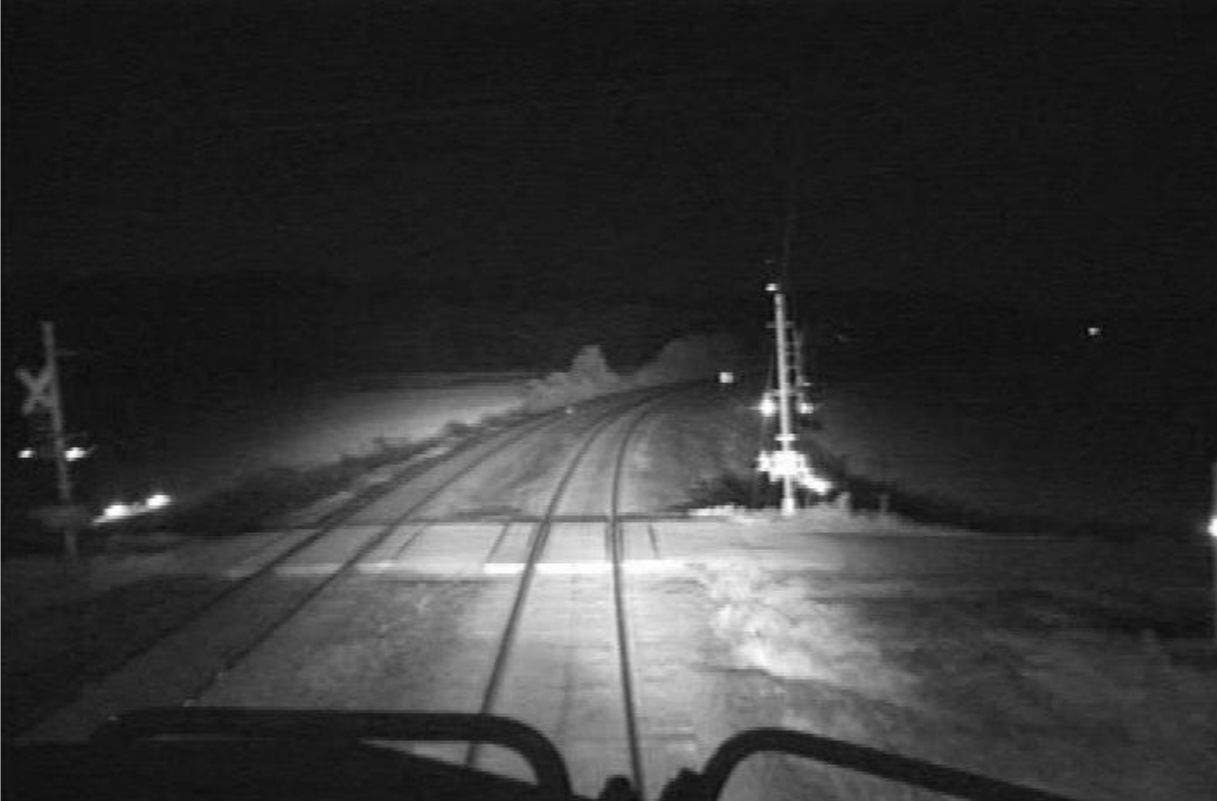
**Figure 15. A horn is heard as the locomotive passes a grade crossing.**

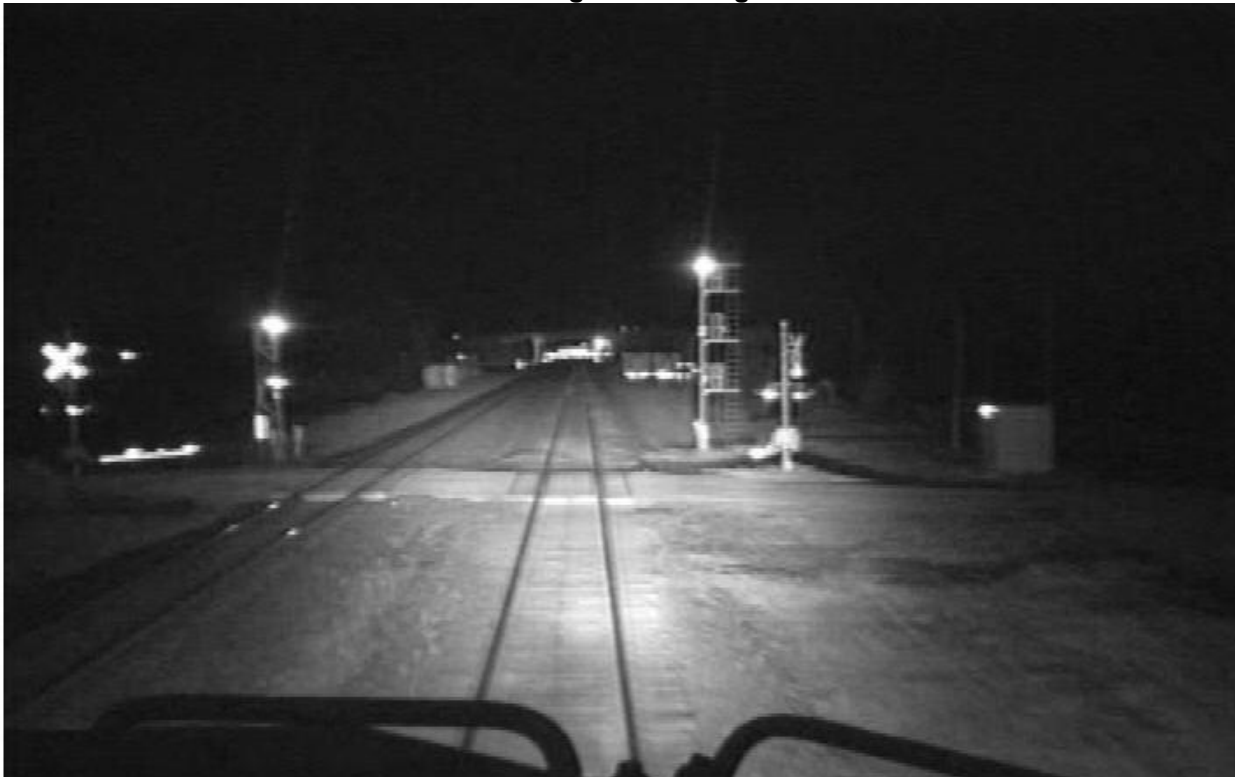
**Figure 16. The struck BNSF locomotive is visible as the locomotive passes a flashing red intermediate signal. Only one short horn blast was detected 22 seconds prior to the locomotive meeting the crossing.**

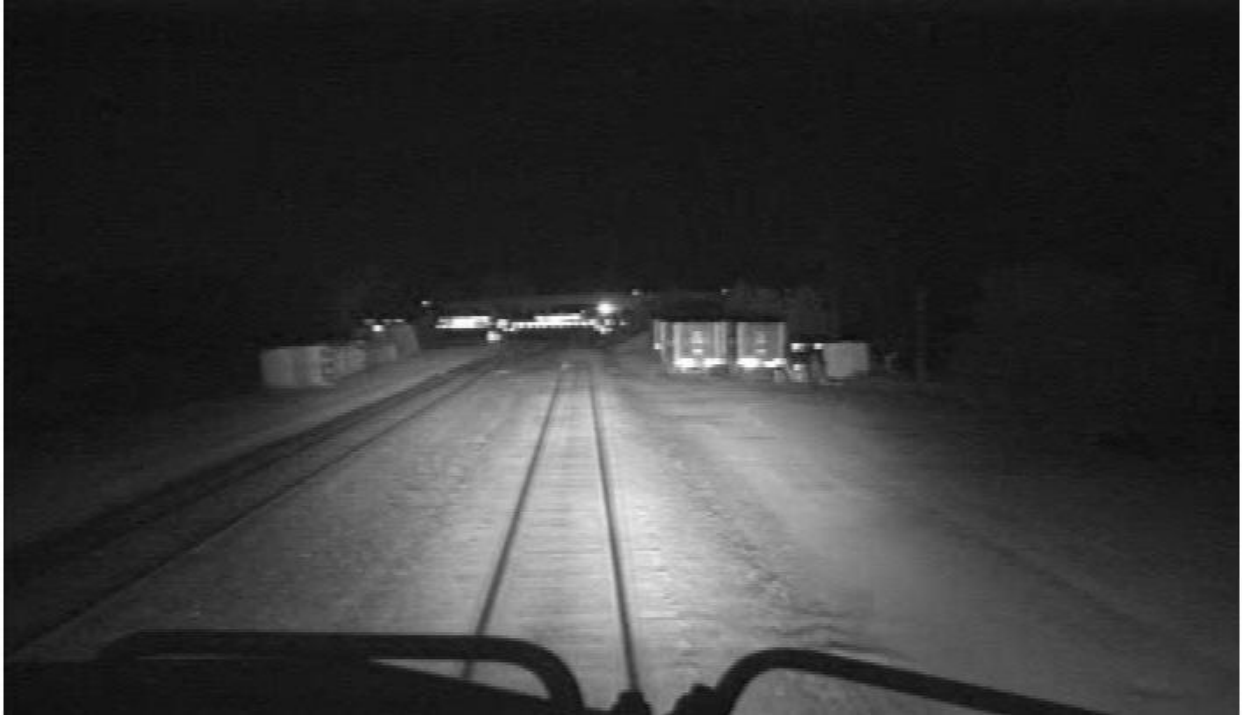
**Figure 17. The struck BNSF locomotive is seen ahead of the striking UP locomotive.**

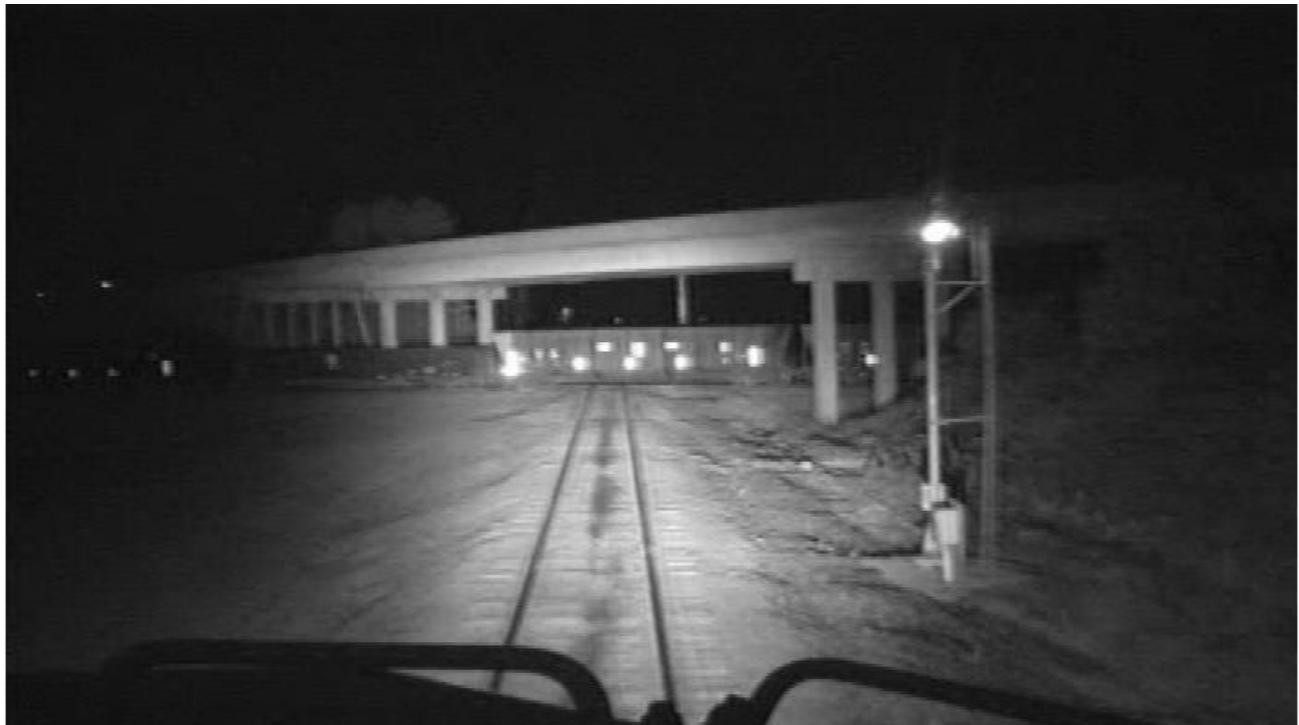
**Figure 18. The locomotive passes a solid red signal at CP Rockview. The struck BNSF locomotive is visible.**

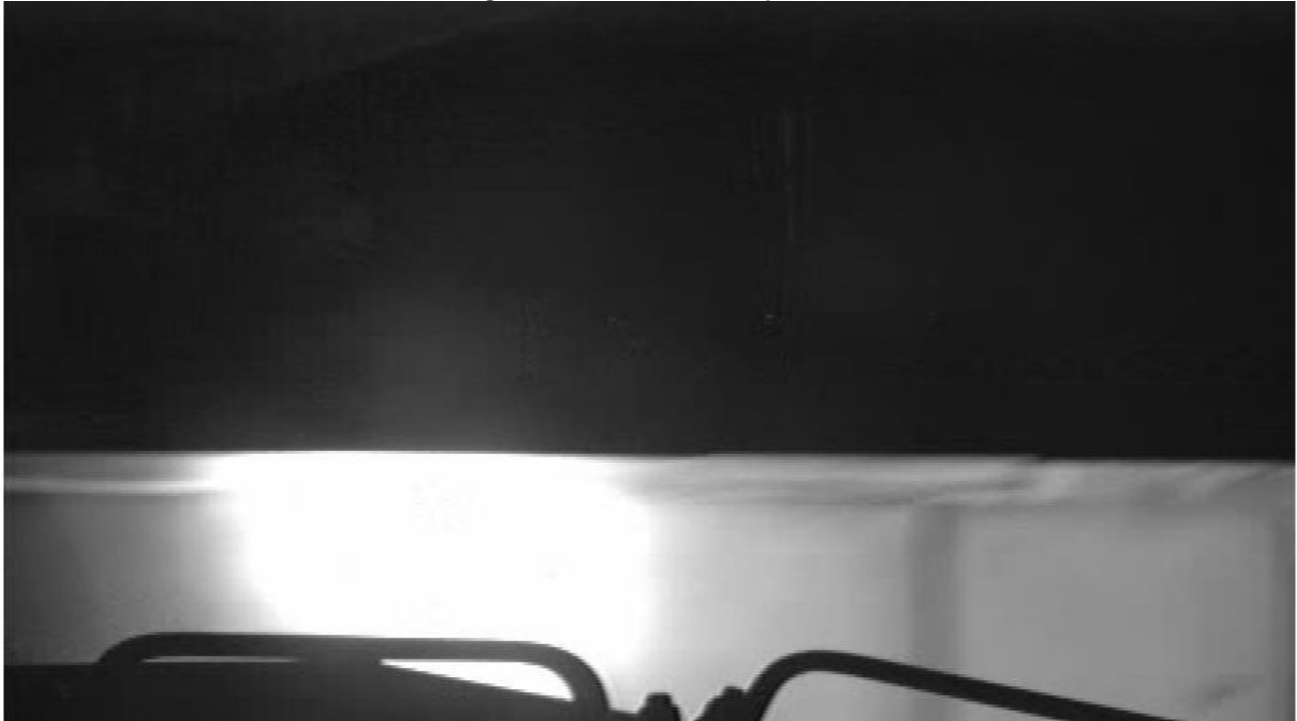
**Figure 19. Moment of Impact.**

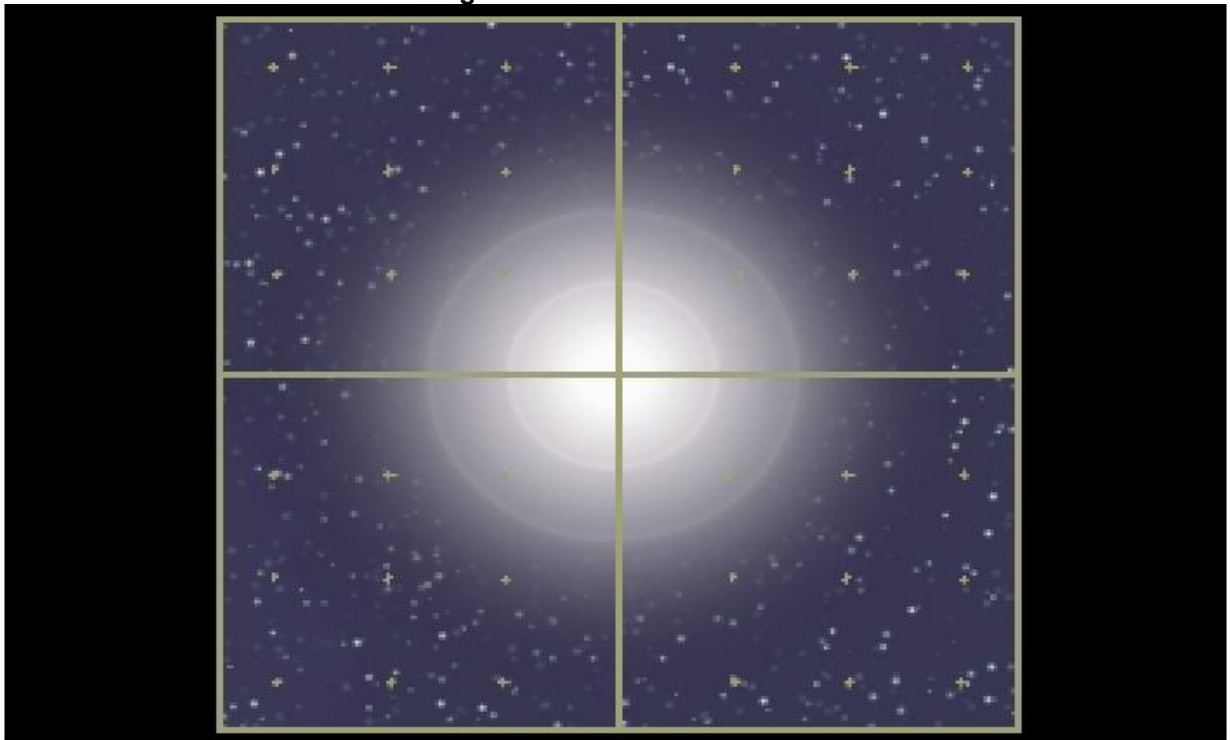
**Figure 20. Video feed is lost.**

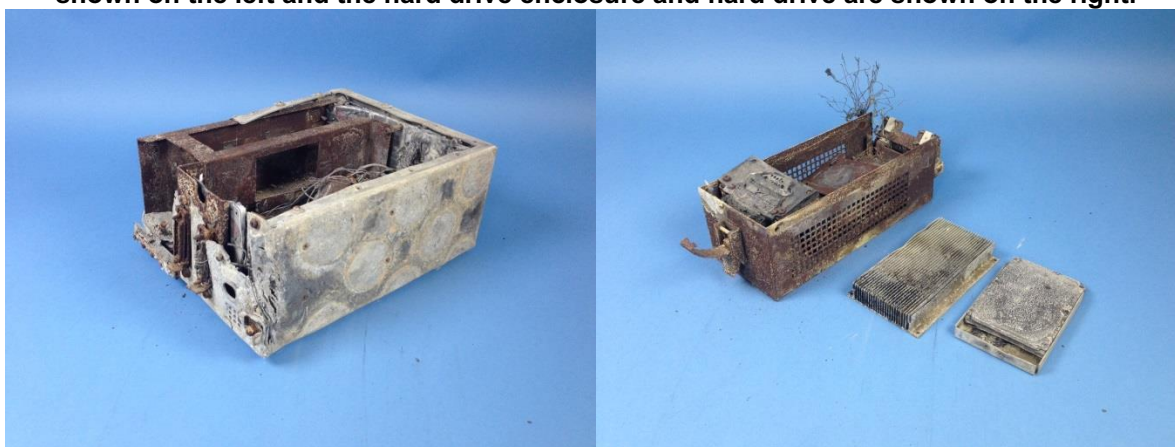
The recorder arrived at the laboratory heavily damaged. The recorder's chassis, the recorder's enclosure and the hard drive were severely damaged in the post-accident fire. Due to the damage, recovery was not possible. Figure 21 shows the arrival condition of the recorder to the laboratory.

**Figure 21. The arrival state of UP locomotive 7421's image recorder. The recorder chassis is shown on the left and the hard drive enclosure and hard drive are shown on the right.**
