FACTUAL REPORT

DCA16MR004

**Derailment of Amtrak's Southwest Chief Train No. 4
With Injuries at Milepost 373.07 on BNSF's La Junta Subdivision**

**Cimarron, Kansas
March 14, 2016**

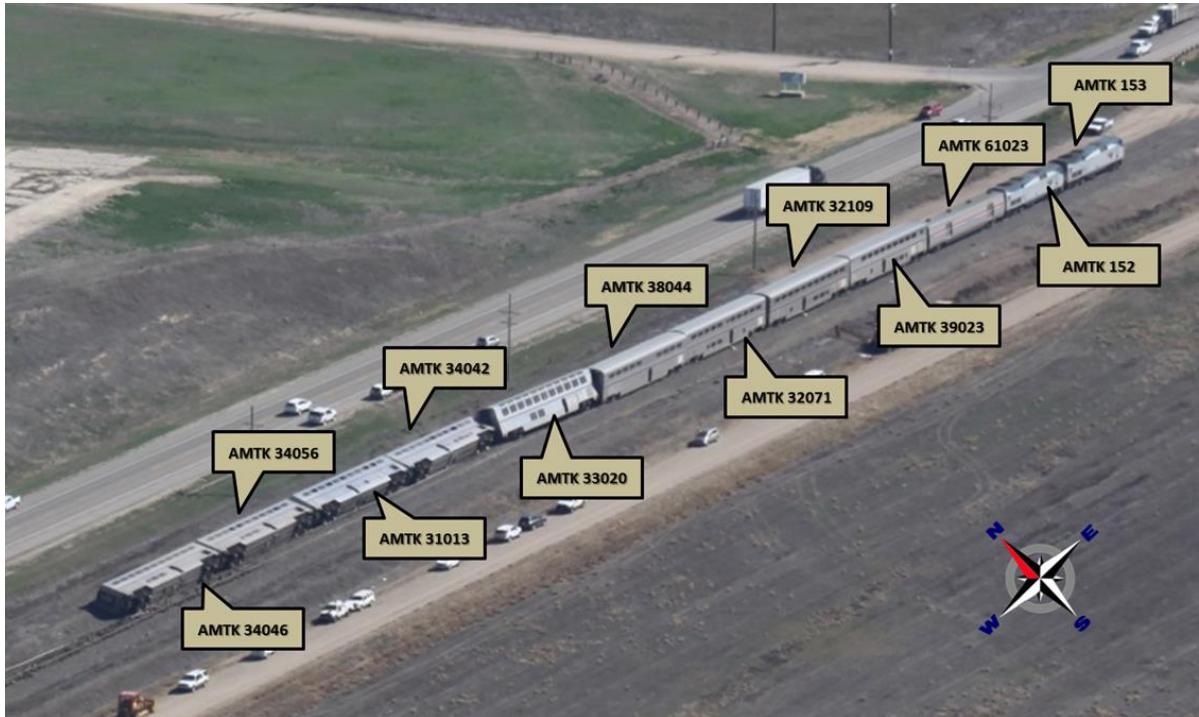
Figure 1. Aerial view of derailed Amtrak train 554. The point of impact and point of derailment is to the left of the rear car of the train appearing in the lower left hand portion of the photo.

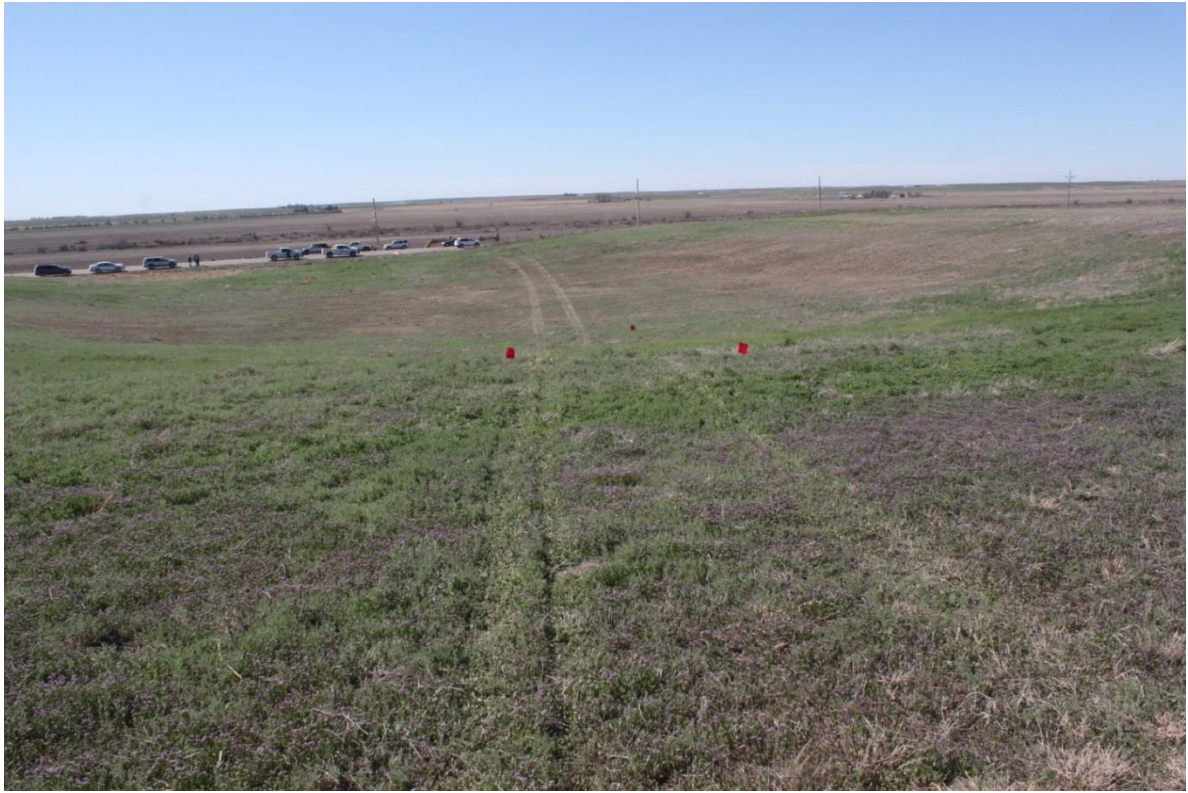
According to an interview of an employee of the nearby feed lot industry supplier; on Sunday, March 13, 2016, the interviewed employee was assisting another employee with loading a truck; when his unattended truck began to roll away from its position under the loading chute. The truck continued to roll south down a hill towards the highway gaining speed. The truck crossed the highway continuing towards the railroad right-of-way and struck the ballast shoulder of the track structure.¹ Investigators and local police agencies documented the continuous set of wheel marks and path of the truck from the feed lot silos to the track. The employee said ~~that~~ he tried to catch up to the truck but failed to stop it. The employee said he drove another vehicle to the south side of the railroad track, ~~and~~ walked over to the truck that was stopped and drove the truck off of and away from the railroad right-of-way. He stated ~~that~~ he later reported the incident to his supervisors.

Figure 2. This photo looking south towards the highway with vehicles in the background. The photo shows the imprints of tire marks on the hillside marked by red flags in the center of the photo.

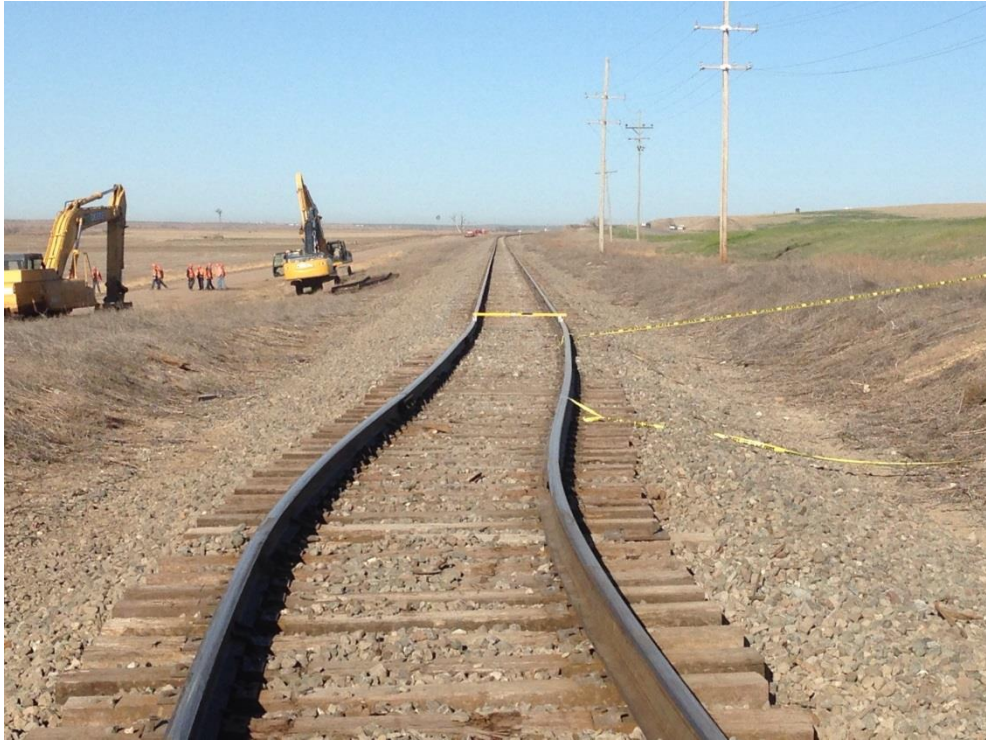
A review of Amtrak Train #4's forward facing digital video recorder data indicates that as the train approached milepost 373.07, an image of track misalignment (lateral shift in the track structure) was visible. Initial event recorder data indicates that the engineer placed the train into emergency. The lead portion of the train traversed the misalignment; however, cars of the rear portion of the train derailed to the north of the track east of the misalignment. When the train came to a stop, the engineer radioed the dispatcher with an emergency notification and eventually emergency responders arrived.

Figure 3. This is a view in daylight hours looking west from the point of derailment at the misalignment or lateral shift in its' "as found" condition after the train moved over the shifted track.

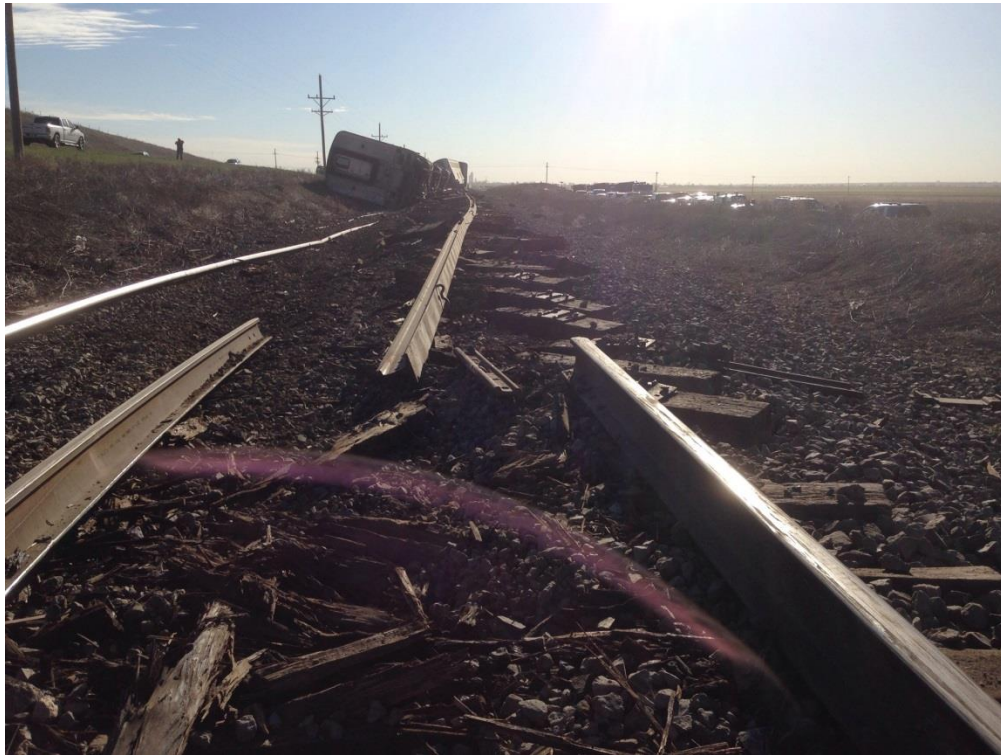
BNSF determined there was about \$336,000 in damage to the track and surrounding structure.

Figure 4. A view looking east at the derailed equipment cars and damaged track.

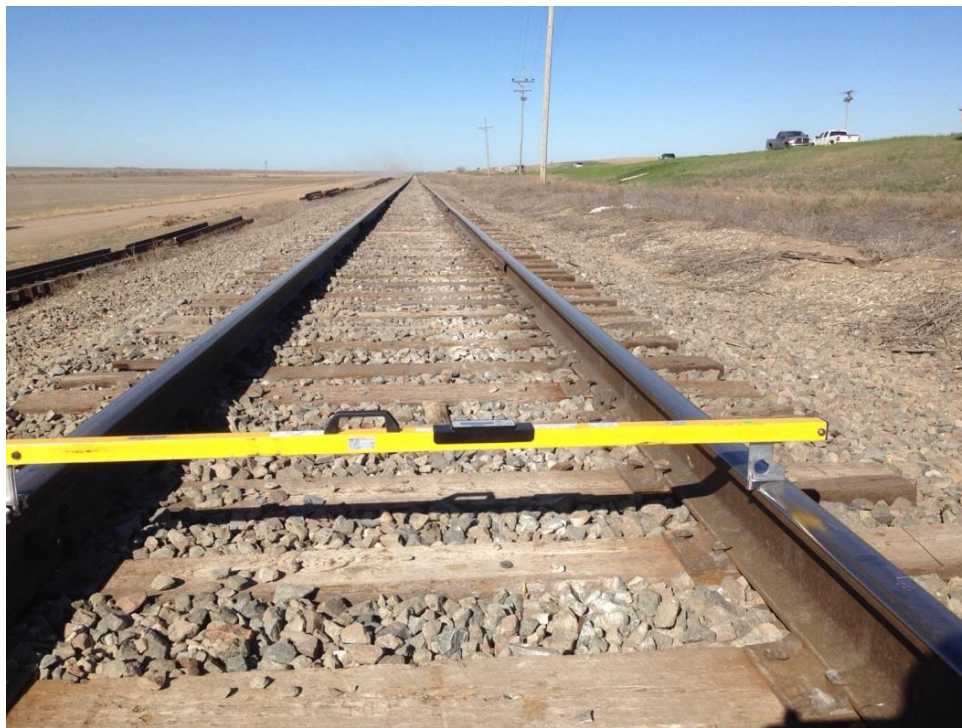
On March 14, 2016, investigators inspected, measured and photographically documented the area of the single main track preceding the derailment footprint. The track field notes measurements were within FRA TSS for the assigned class of track.

Figure 5. Photograph of the area of track where field notes measurements were taken.

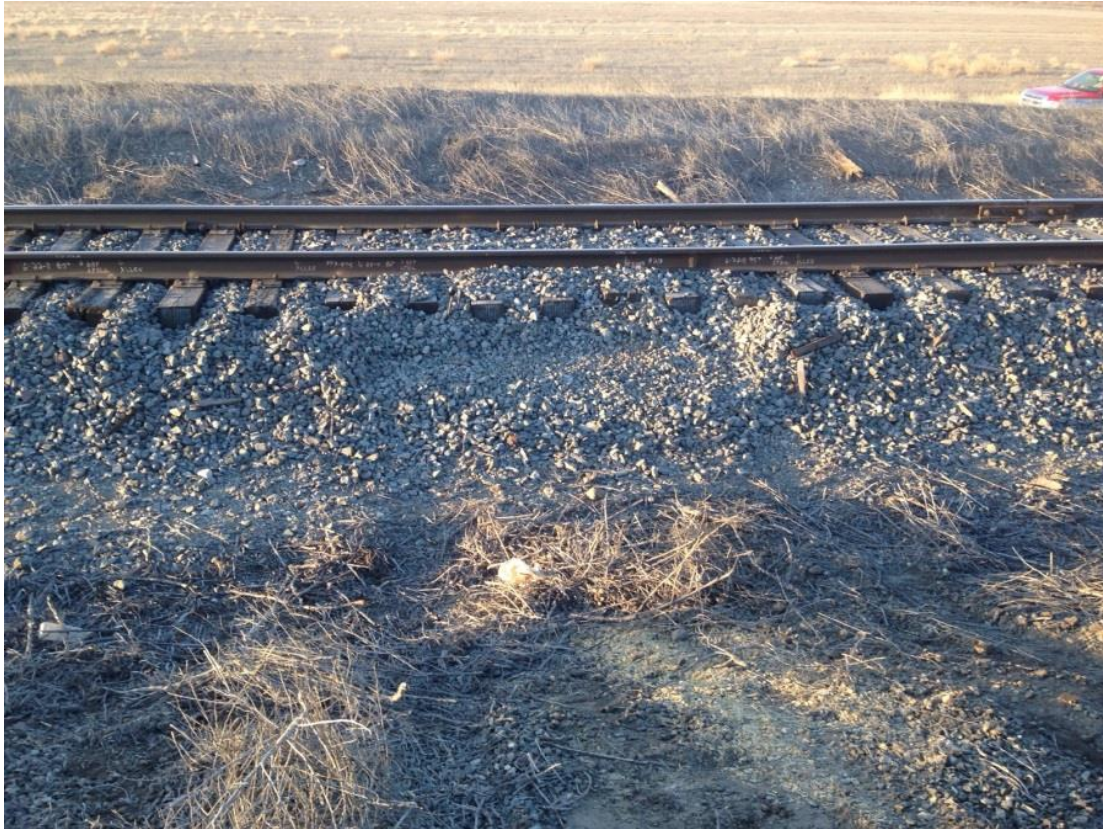
The investigators photographed and measured the “as found” condition of the track structure and lateral shift or misalignment. The amount of misalignment measured 7 inches. Investigators have termed this area as the point of impact (POI) or intrusion from an outside force acting upon the track structure.

Figure 6. This is a view looking south at the track structure. Notice the disrupted ballast shoulder section and track structure movement (see Figure 3 for different perspective).

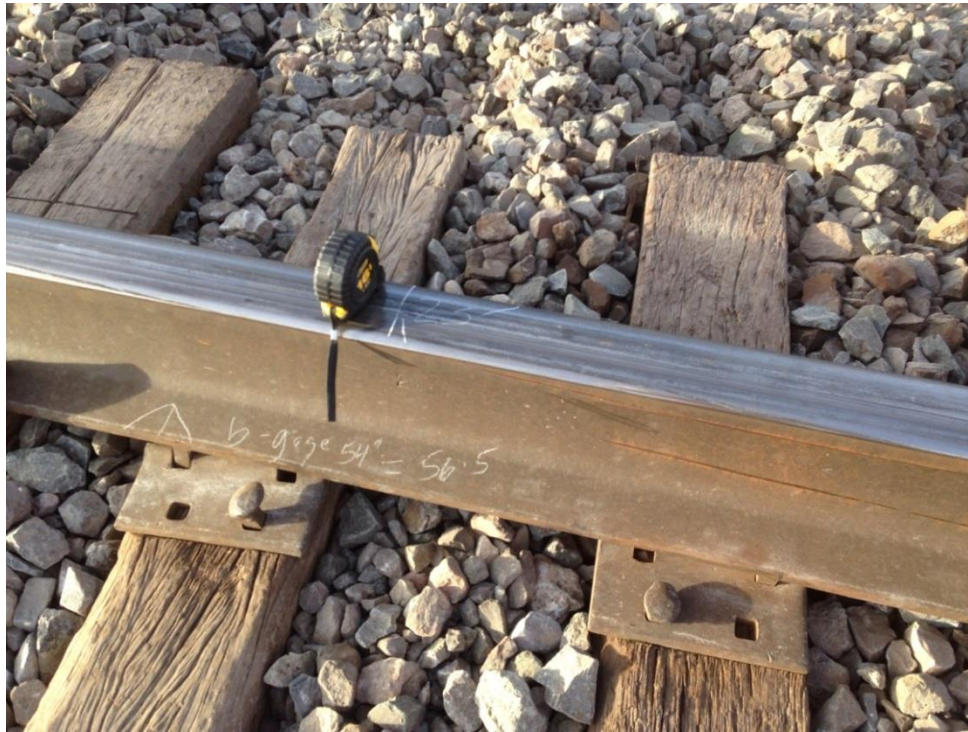
Investigators documented where they observed the first markings at MP 373.07 on the inside gage face of the north rail approximately twenty-five feet after the POI and determined this was the point of derailment (POD).

Figure 7. This is a view of the point of derailment.
