**BNSF Roadway Worker Fatalities
Edgemont, South Dakota
January 17, 2017**

DCA17FR004

TRACK AND ENGINEERING GROUP FACTUAL REPORT

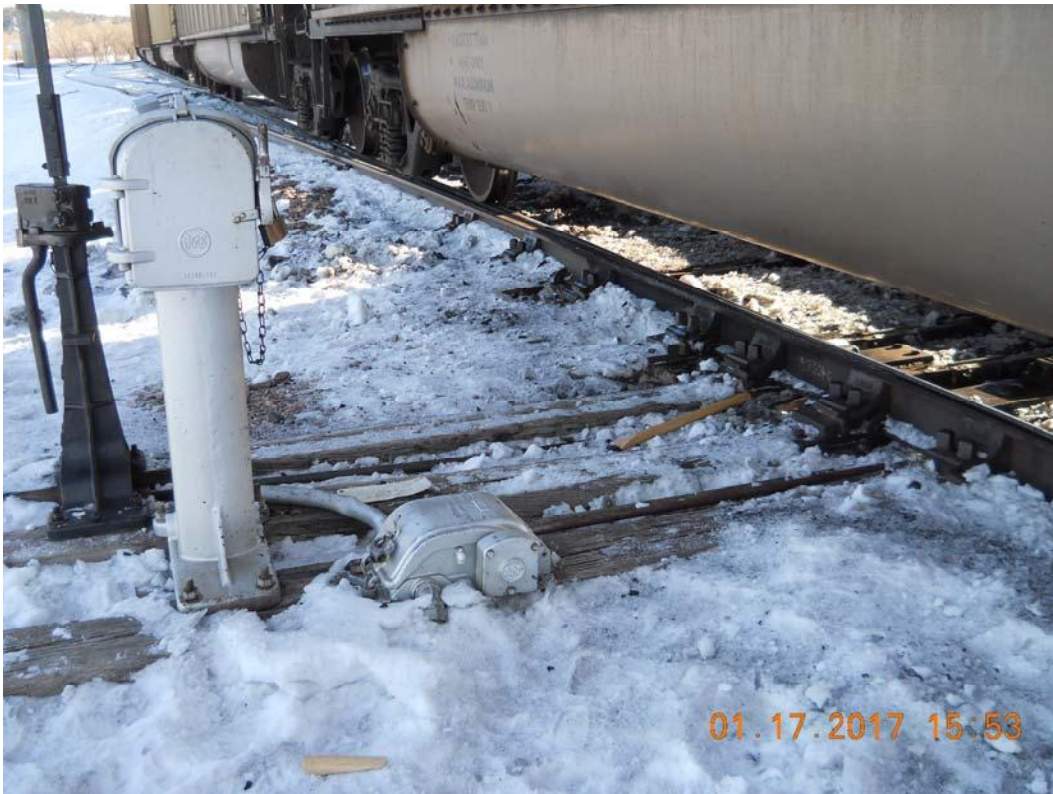
13 The section crew walked from the crew truck in the snow/ice conditions to the west leg of
14 the wye switch, and started cleaning the snow and ice from the switch points. The crew truck was
15 approximately 191 feet away from the west leg of the wye switch. While doing this task, the truck
16 driver (watchman/lookout) held a long handle tool in both hands, the section foreman used a
17 Tanaka Model TBL7800R backpack blower, and the trackman had a short handled tool.¹ At the
18 time of the accident, the watchman/lookout was positioned near the north rail between the running

9
10 Figure 1. Switch at west leg of Deadwood Wye.

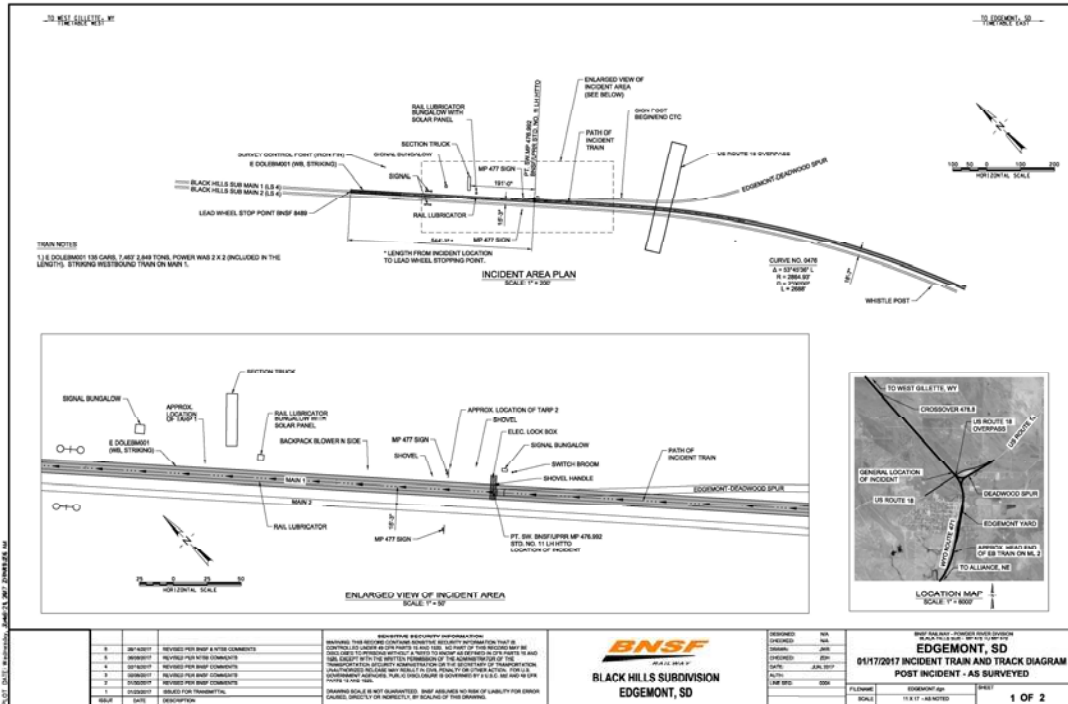
2 A survey team documented and measured data points of the tracks and other pertinent
3 features and fixtures. The track and engineering group supervised the BNSF contractor surveyors
4 who used the data to complete a plan view drawing. See Attachment 1 for the drawing of the track
5 configuration.

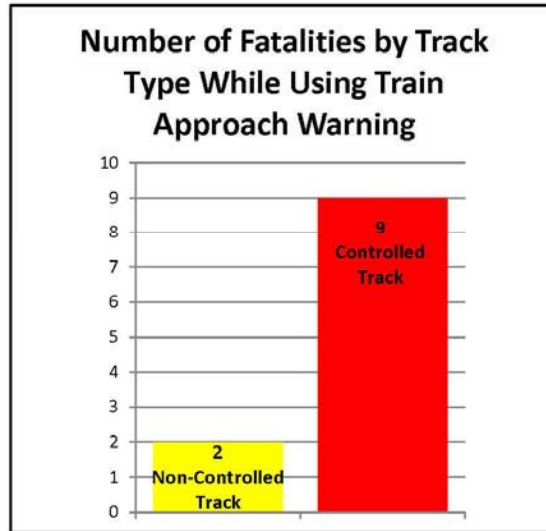
In 4 of the 10 fatal accidents, the Watchmen/Lookouts were not using prescribed warning devices, such as a whistle, air horn, white disk, red flag, lantern, or fusee. In one fatal accident under TAW, FAMES was unable to determine if the Watchman/Lookout was equipped with such devices. In the other five fatal accidents, the Watchmen/Lookouts were equipped with the prescribed warning devices.

- Whenever environmental or working conditions change that could interfere with a Watchman/Lookout's ability to detect the approach of a train or provide appropriate warning, the Watchman/Lookout must immediately clear Roadway Workers from the tracks until proper protection can be established.
