1
2
3
4 **NATIONAL TRANSPORTATION SAFETY BOARD**

10
11
12 **TRACK & ENGINEERING GROUP FACTUAL REPORT**
13

14
15 **DCA16MR011**
16

17
18 **New Jersey Transit Passenger Train Accident, Hoboken Station**
19

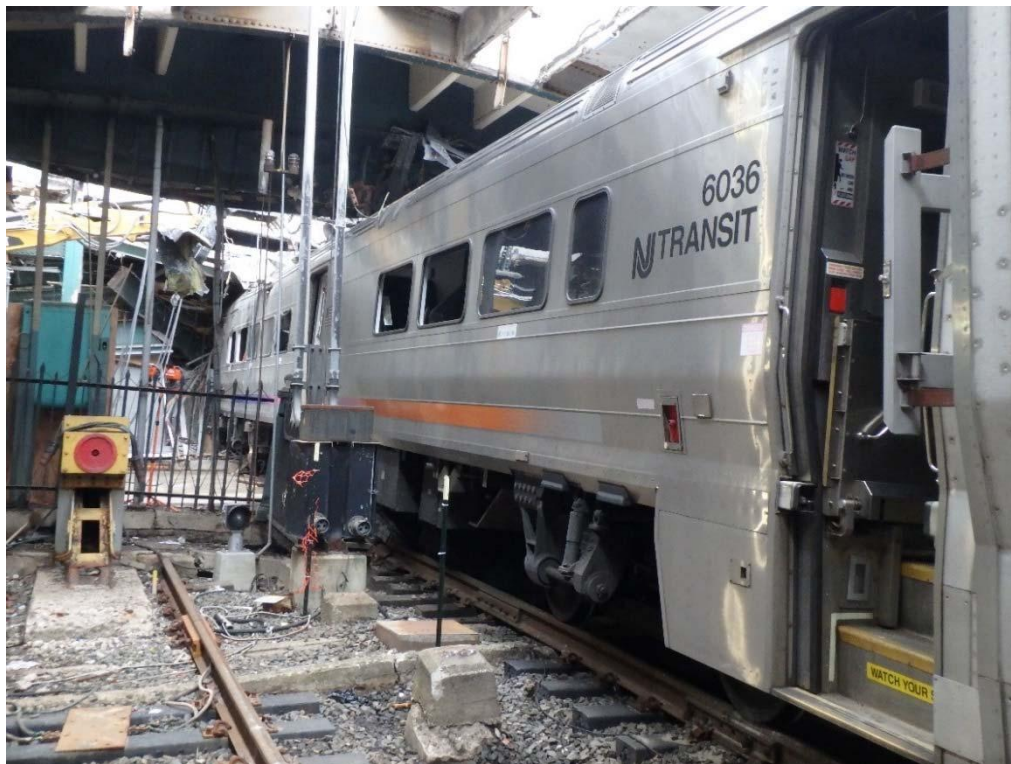
10 **Figure 1. Controlling cab car of accident train shown beyond the end of the track and at rest against**
11 **the station wall. Damage to the station structure also shown, with a portion of the canopy resting on**
12 **the accident train (Photo NTSB)**

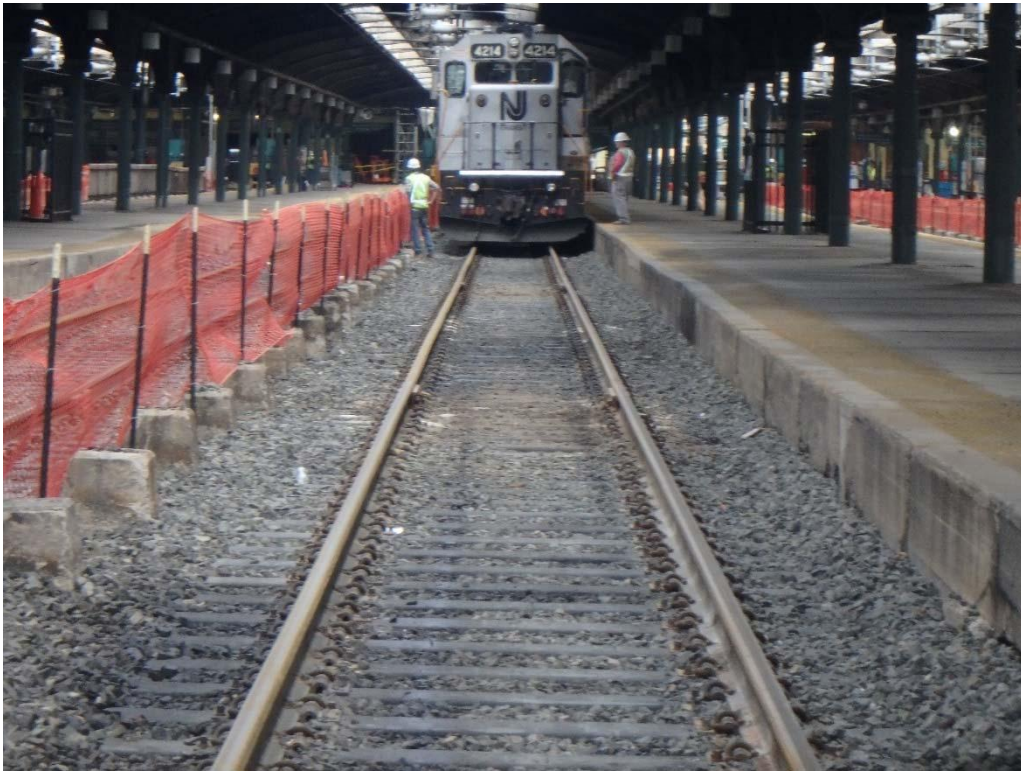
2 **Figure 3. Track Five leading into accident area, rear end locomotive of accident train shown (Photo**
3 **NTSB)**

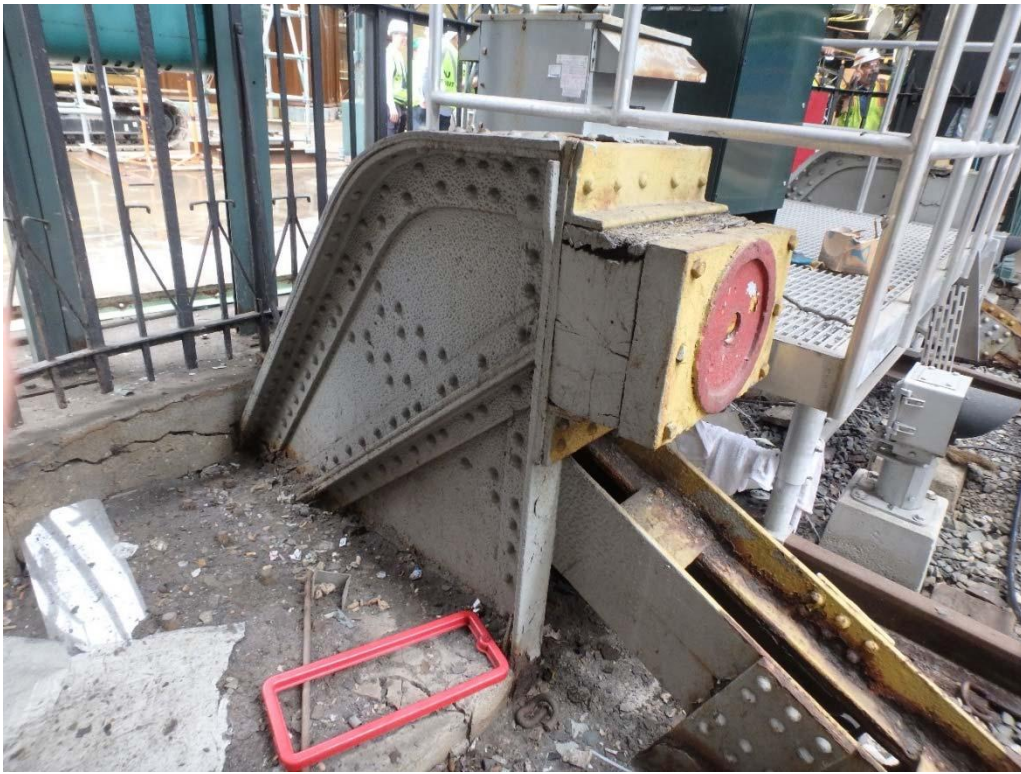
1 controlling cab car of the accident train safely and without further damage to the station
2 structure, crews would need to disassemble the struck bumping post. The adjacent track 4
3 bumping post was measured as an exemplar. The terminal bumping posts are constructed
4 of steel with thickness ranging from ½ inch to ¾ inch. The base portion of the bumping
5 post is set in concrete. Generally, the visible portion of the bumping post measured 60
6 inches high, 24 inches wide, and the depth was tapered starting at 22 inches and angling
7 down to 60 inches at the top of the concrete slab. A 24 inch by 16-inch striking plate was
8 mounted at about 42 inches above the running surface of the rail.

Figure 4. Exemplar bumping post from Hoboken station (Photo NTSB)

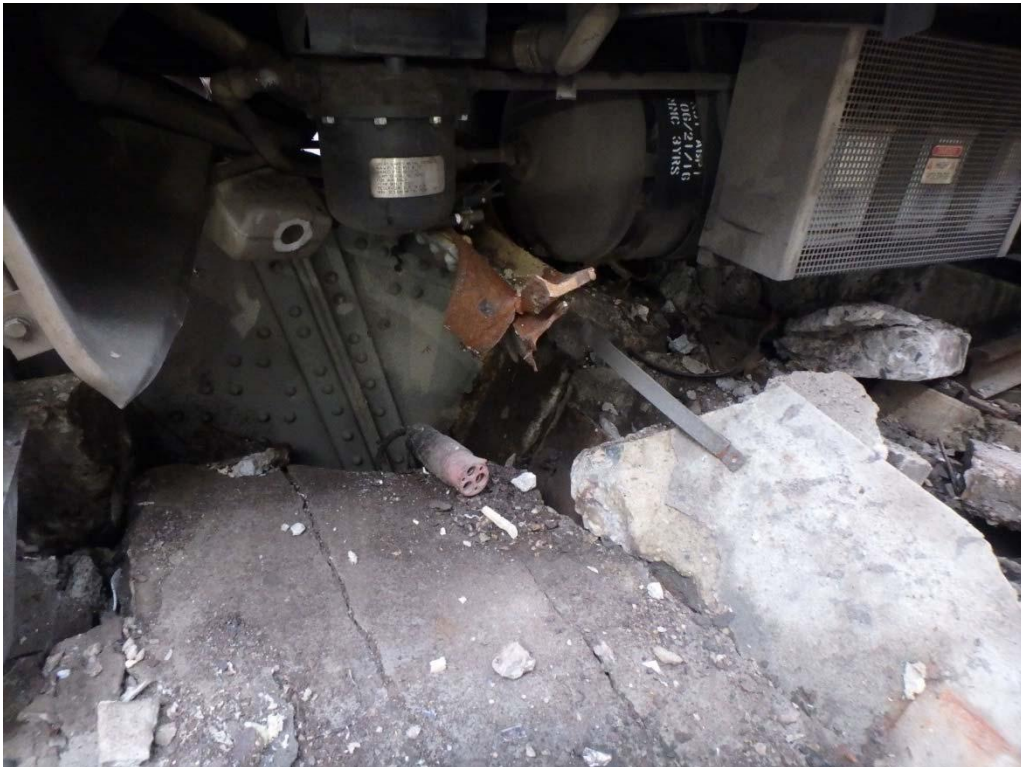
1 Investigators measured and photo documented the damage and displacement of
2 the struck bumping post. After the collision, the track 5 bumping post was displaced a
3 total of 65 inches. The concrete slab that the post superstructure was set moved 40 inches
4 to the east. The base of the bumping post tore from the portion incased in the concrete
5 slab, and canted eastward about 55° and an additional 25 inches. The strike plate and
6 portion of the post to which the strike plate was affixed were found near the front truck of
7 the accident controlling cab car.

8
9 **Figure 5. Photo of track Five bumping post under the controlling cab car. The displaced bumping**
10 **post and cracked/broken station floor are shown. (Photo NTSB)**

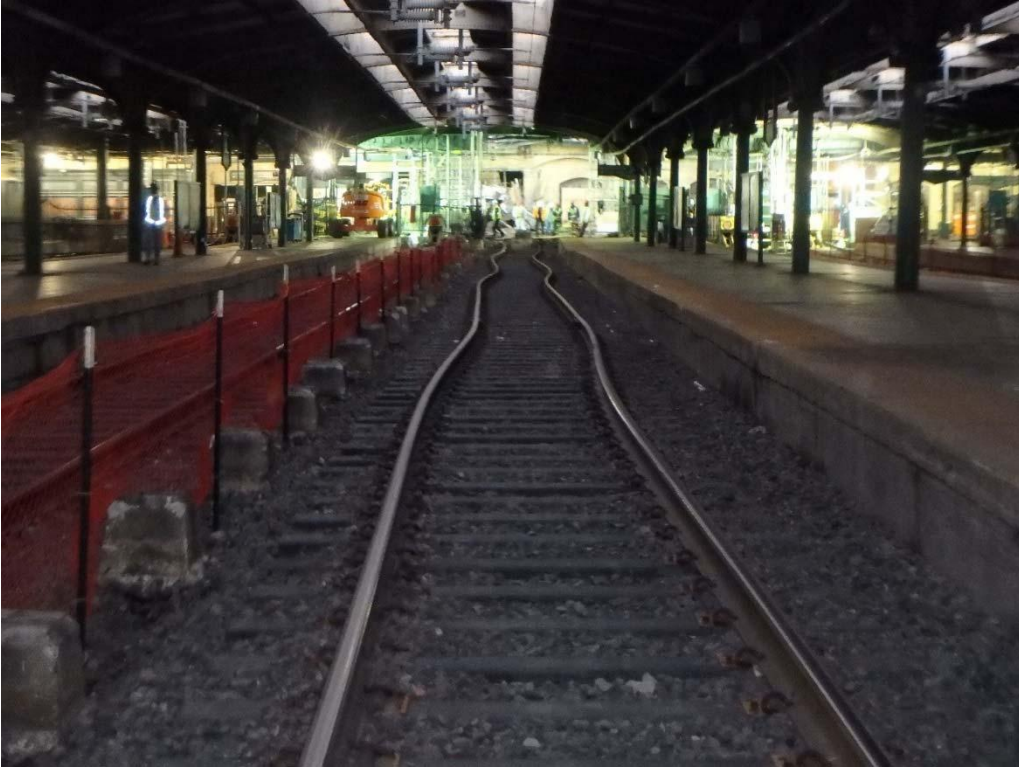
17 After the accident train was removed, investigators walked track 5 from the
18 bumping post to the end of the passenger platform. Investigators noted that the track was
19 severely misaligned consistent with track moved by train induced forces resulting from
20 an emergency stop. Investigators did not detect the presence of any rail lubrication
21 leading into track 5.

3 **Figure 6. Photo showing Track 5 misalignment with accident train removed. The track that was**
4 **laying straight prior to the accident is wavy, with several misaligned areas. (Photo NTSB)**
