## **NATIONAL TRANSPORTATION SAFETY BOARD**

**Train 2817 Collision at the End of Track**

**NTSB Accident Number DCA17FR002**

### **TRACK & ENGINEERING FACTUAL REPORT**

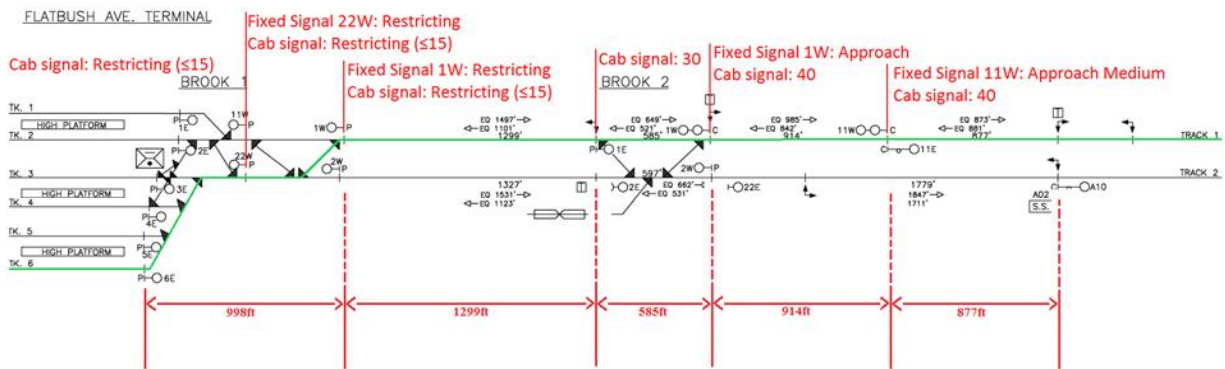
12           From Brook 2 Interlocking to Brook 1 Interlocking, the train traversed tangent track. See  
13 Figure 1 for a schematic drawing of Brook 2 and Brook 1 with the route of train #2817 into station  
14 track #6 traced in green. Figure 2 is a schematic drawing of Brook 1. Immediately after entering  
15 Brook 1 Interlocking, the train crossed over to from main track Atlantic #1 to main track Atlantic  
16 #2 over the #21 crossover switch, which are No. 10 turnouts. The train then traversed tangent track  
17 for a short distance until it traversed a left hand curve at the 33E switch (first interlocking switch).

11  
 12 **Figure 1.** Route of train #2817 into Atlantic Terminal

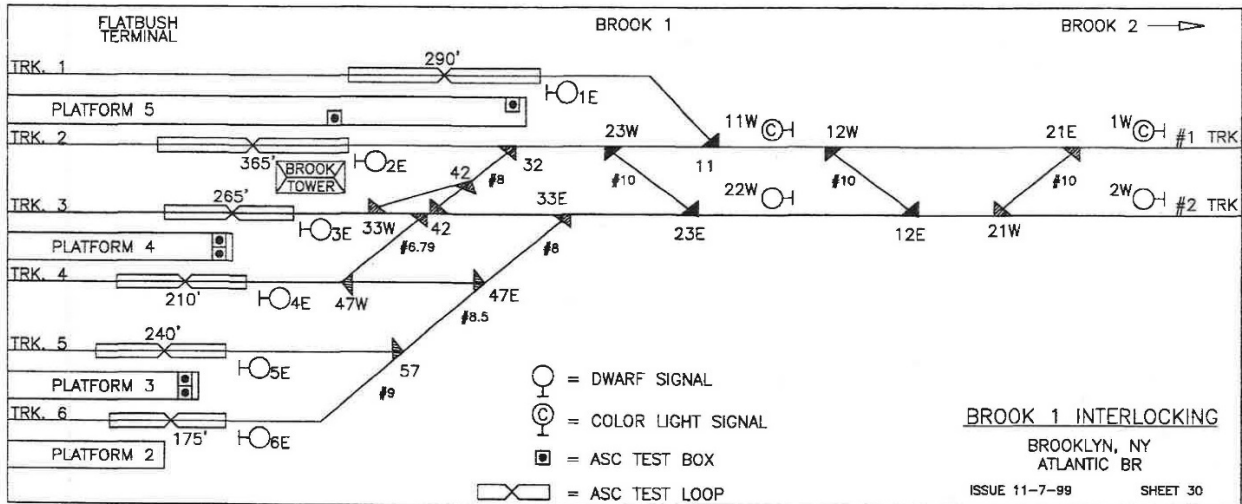
**Figure 2.** Brook 1 Interlocking.

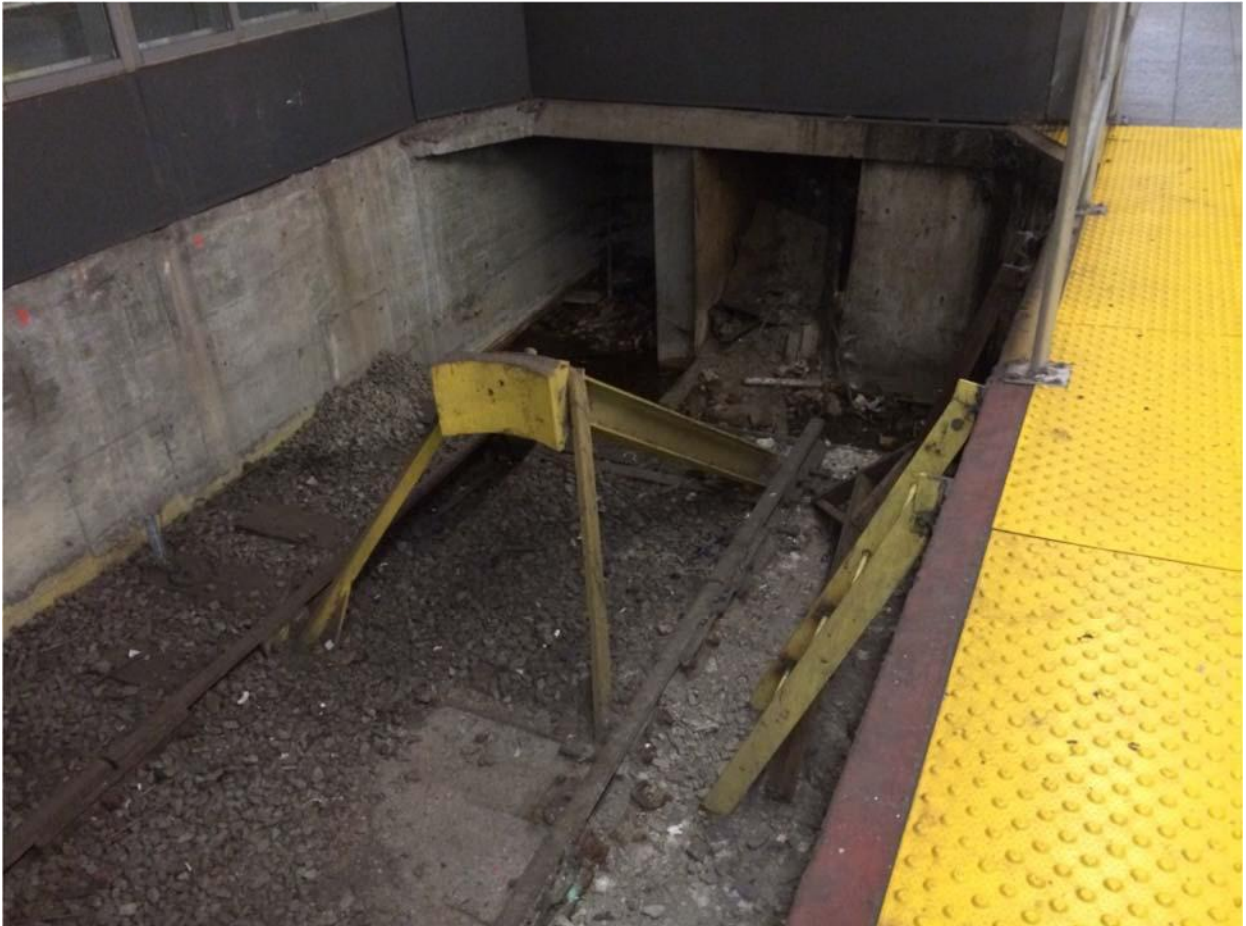
4 Train #2817 impacted the bumping post at the west end of the station track #6 at 12 mph.  
 5 See Figure 3 for a picture of the bumping post that was on station track #6. Upon impact, the lead  
 6 car #7553 destroyed the bumping post, slid onto the concrete flooring and entered and destroyed  
 7 a secure hallway area that is used only by employees, and apparently stopped as it struck two  
 8 vertical steel columns.<sup>5</sup> The lead car went 13 feet 6 inches past the bumping post faceplate, and a  
 9 segment of the running rail attached to the bumping post pitched upward and pierced the floor of  
 10 car #7553 and entered the electrical closet directly behind the engineers control cab.

8            In 2015, the LIRR engineering management asset group inventoried all bumping posts in  
9 passenger yard tracks, including Atlantic Terminal. The bumping post at the west end of station  
10 track #6 was a Western Cullen Hays, Inc., model WDC. Figure 3 shows the actual bumping post  
11 that was located at the end of station track #6. Calculations provided by the manufacturer show  
12 that the bumping post had a maximum impact capacity of 415,000 pounds. This force equaled six  
13 partially loaded M7 class multiple unit passenger cars moving at approximately one mph.

2 **Figure 3.** Bumping Post on Station Track #6.

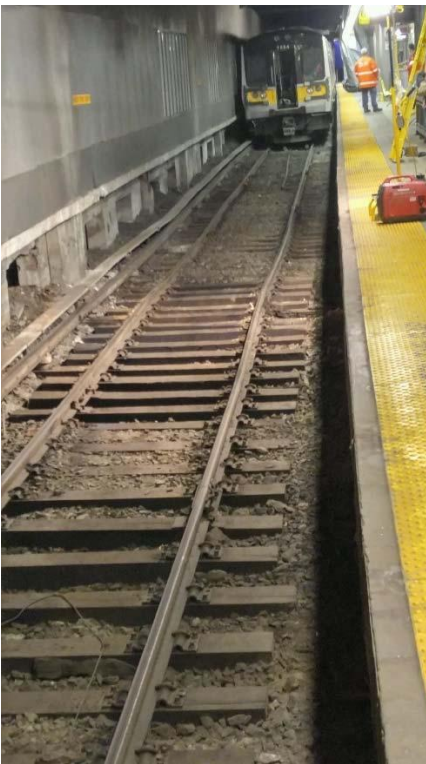
3 After pulling the rear four cars away from the train, investigators noted that station track  
4 #6 was misaligned consistent with track moved by train induced forces resulting from sudden  
5 impact at the end of track. See Figure 4 for a picture of the track misalignment.

7 **Figure 4.** Track 6 misalignment with accident train removed.
