NATIONAL TRANSPORTATION SAFETY BOARD

TRACK & ENGINEERING FACTUAL REPORT

DCA17MR007

**Union Pacific Railroad, Derailment with Hazardous Materials Release and
Fire**

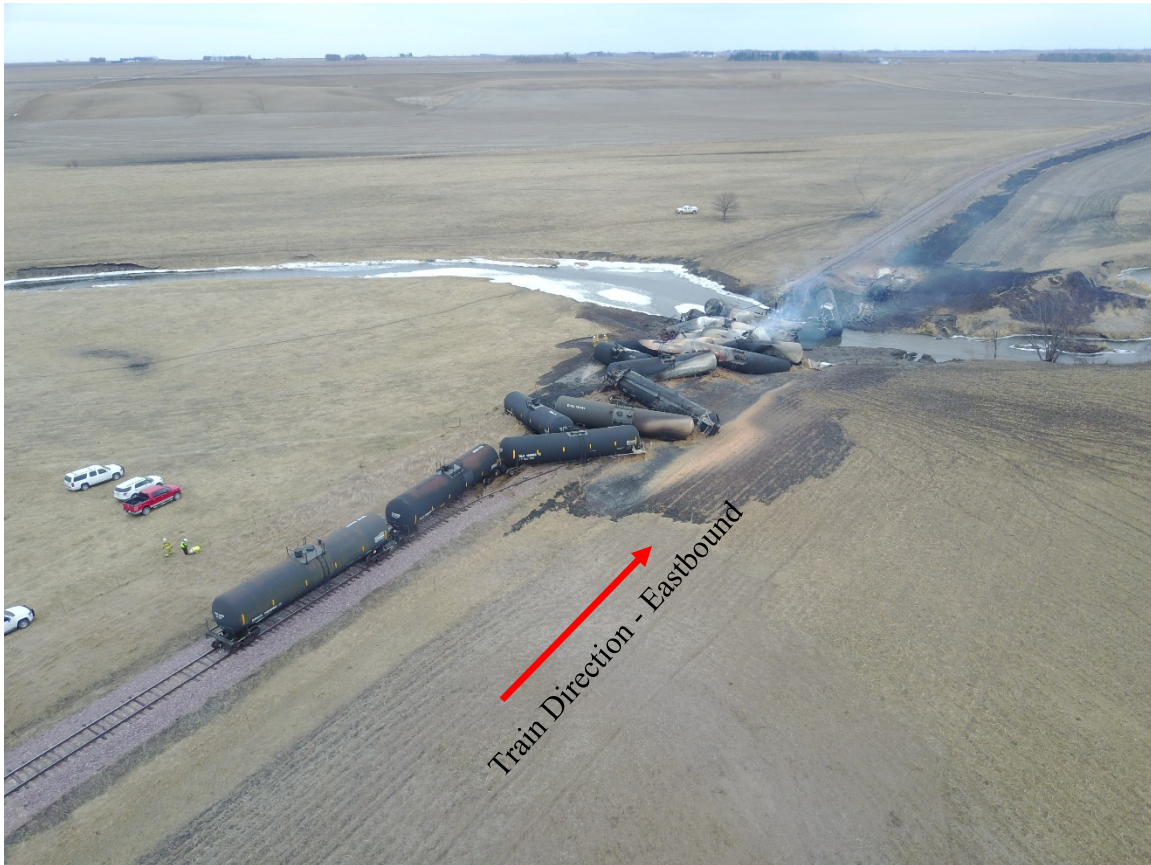
Figure 1. Aerial view of accident site. (NTSB Photo)

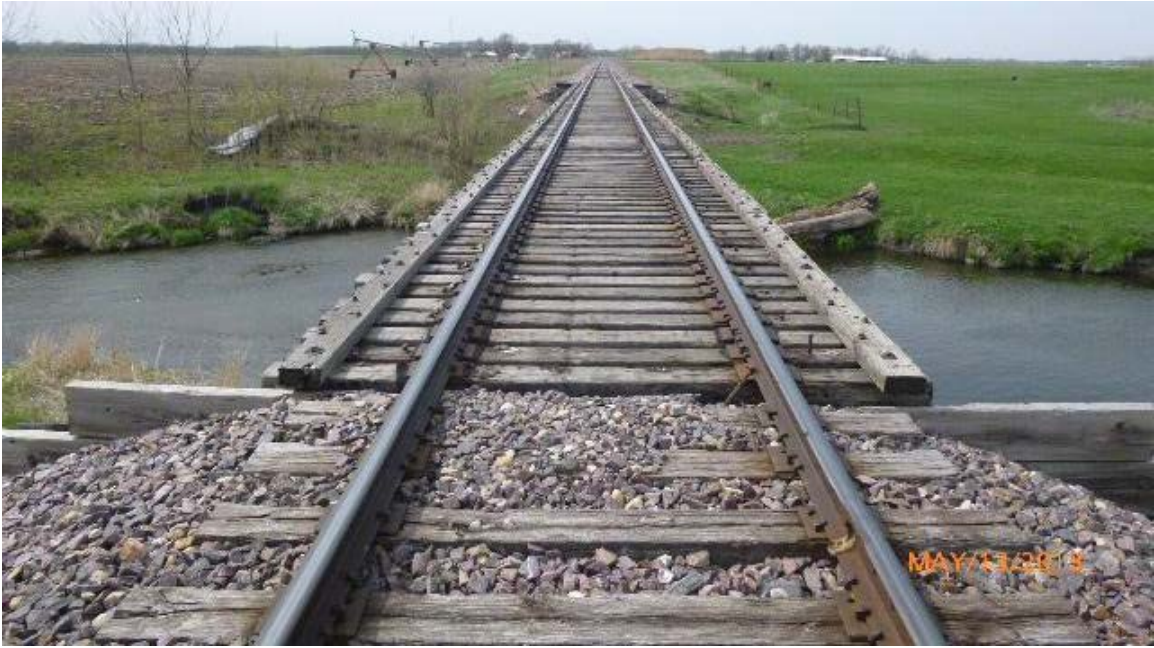
Figure 2. Bridge 56.72, spanning Jack Creek. Photo shows the bridge deck of the open deck bridge (UP Historical Photo)

According to UP documentation this bridge was last inspected on October 11, 2016. The inspection record shows that the bridge was built in 1937, the bridge deck ties were replaced in 1970. No exceptions were noted during this inspection. The UP bridge inspector did provide a comment on the report noting insufficient ballast on the approach to the bridge as follows: high end, first tie off of bridge hanging 2 ½”.⁶

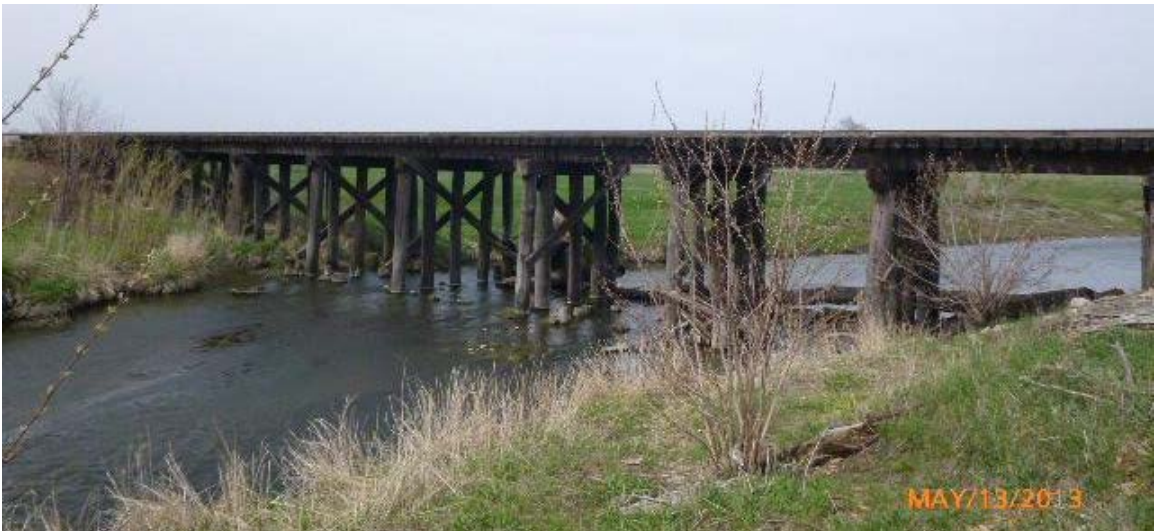
Figure 3. Bridge 56.72, spanning Jack Creek. View of the open deck bridge substructure (UP Historical Photo)

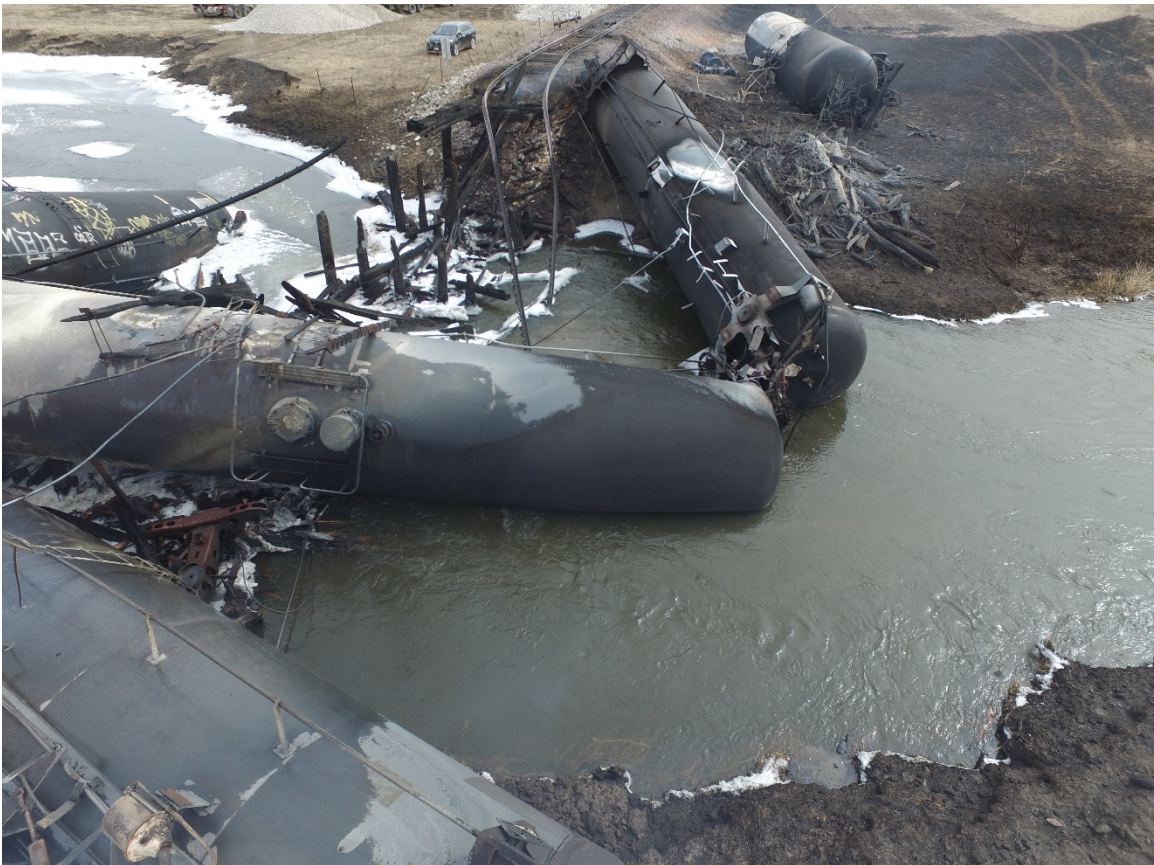
Spanning Jack Creek was an eleven span, timber, open deck bridge that measured 152 feet long. The bridge was destroyed by the derailment and ensuing fire.

Figure 4. Jack Creek bridge destroyed as a result of the derailment and ensuing fire.

replacement of the bridge structure spanning Jack Creek.⁹ The UP opted to replace the destroyed 152' bridge with a bridge measuring 180'. This estimate does not include additional costs associated with train equipment and environmental remediation efforts.

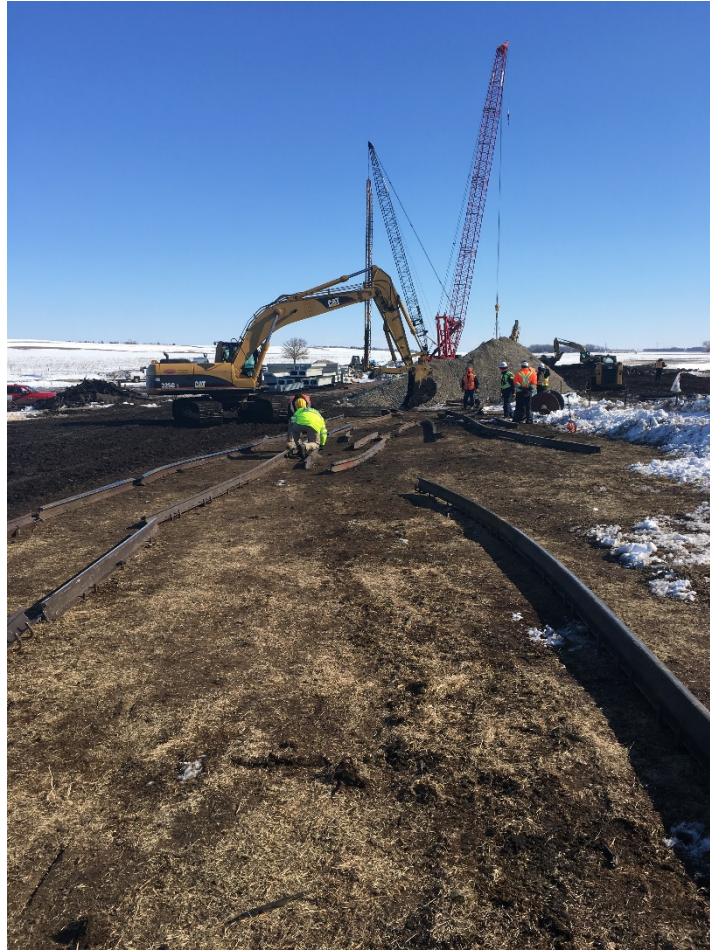
Figure 5-Photograph of rail rebuild.

The rail piece 10S measured 3 feet, 4 inches. This piece exhibited a fracture surface on the west side of the rail consisting of transverse and vertical components. Head batter was also present on this fracture.

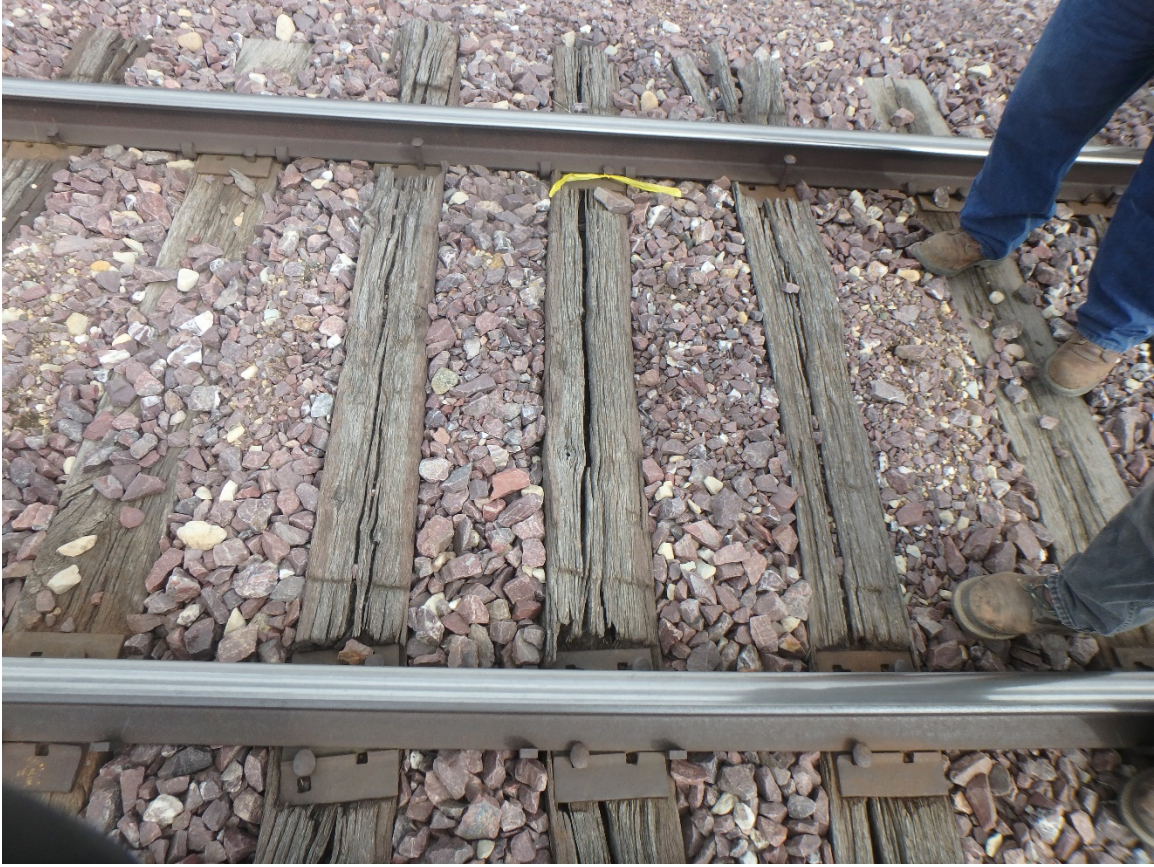
In the area of the derailment, the track structure was misaligned as a result of derailment forces. Investigators took gage measurements, observed track alignment, and measured track surface leading into the disturbed track. No exceptions were taken to the track geometry in the track segment from MP 57.10 into the derailment area. Investigators noted profile conditions ranging from $\frac{3}{4}$ inch to 1- $\frac{1}{4}$ inches in the areas with defective crossties.

Figure 6. Split, broken cross-ties not holding fasteners in the track immediately west of the accident area near MP 56.9. (NTSB Photo)

- UP has put on a divisional tie gang to correct the defects identified by FRA inspectors and added an additional 150 ties per mile under the 90 pound rail. As of November 2017, the UP regional gang has installed 8,605 cross ties since the derailment in March 2017. (4,415 on the Estherville Sub, 2,195 on the Ft. Dodge Sub, and 1,995 on the Tara Sub).

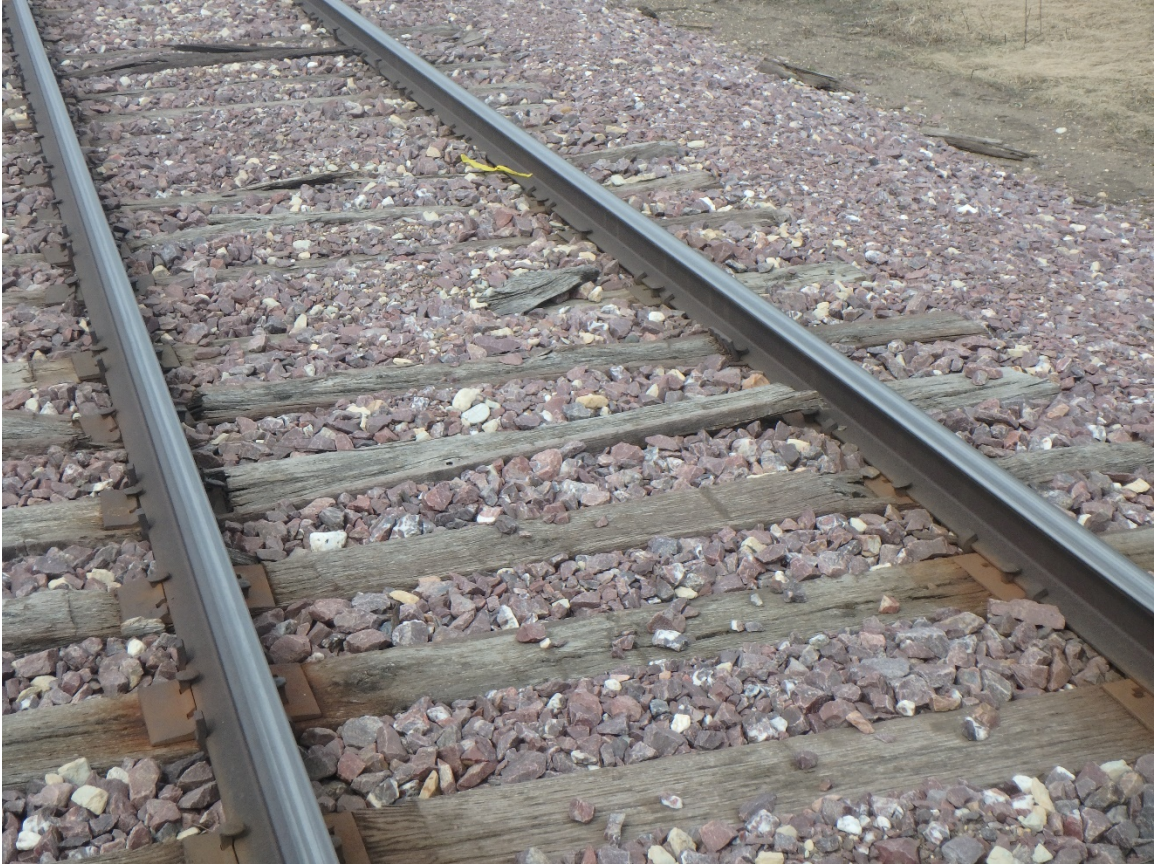
Figure 7. Split, broken cross-ties not holding fasteners in the track west of the accident area near MP 56.9. (NTSB Photo)
