NATIONAL TRANSPORTATION SAFETY BOARD

TRACK & ENGINEERING GROUP CHAIRMAN FACTUAL REPORT

DCA-12-MR-009

**CSX Transportation Derailment with
Non-Railroad Fatalities**

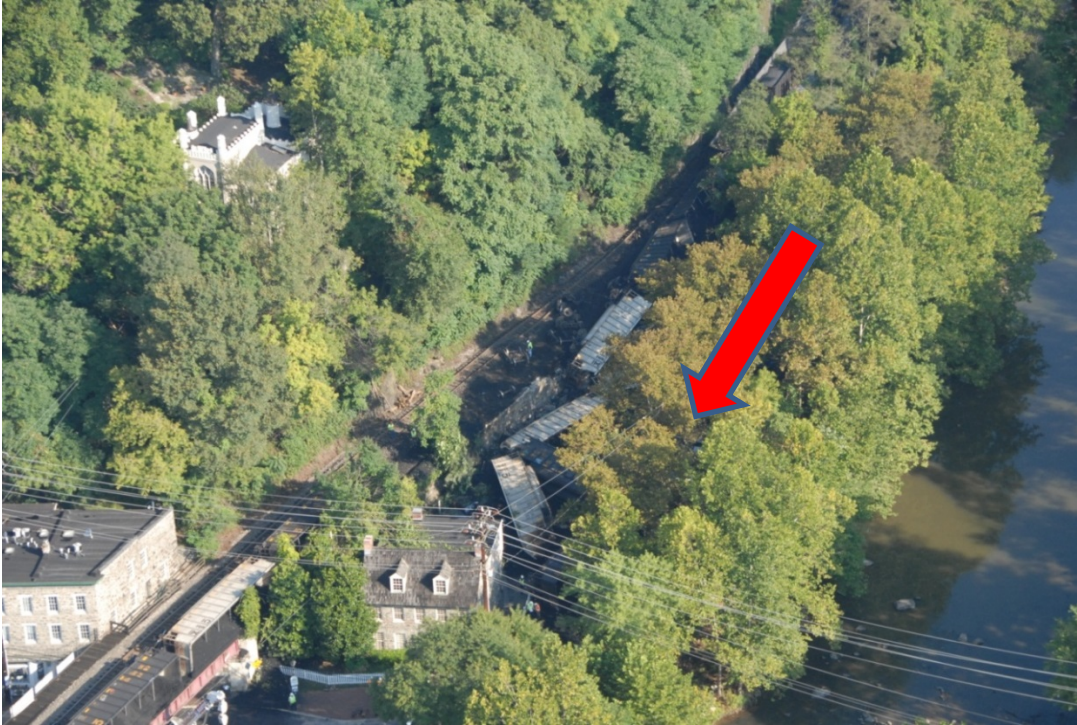
Figure 1. This is an aerial view looking west at derailed coal hoppers along side a railroad track. In the lower left hand corner, one can see the bridge over Main Street in Ellicott City.

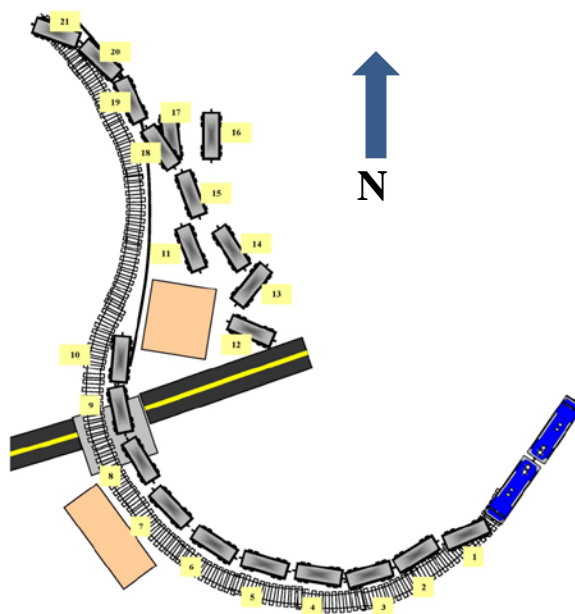
The head ten loaded coal hoppers rolled over to the north side of the track and did not significantly damage the track. The 11th through the 18th cars came to rest significantly farther from the center of the track. Several of the cars were found in a parking area adjacent to and below the right-of-way. The 19th to 21st cars were derailed north of the track towards the west end of the derailment footprint as shown in the diagram below.

Figure 4. This diagram is a depiction of the resting position of derailed equipment in Ellicott City. (Drawing is not to scale.)

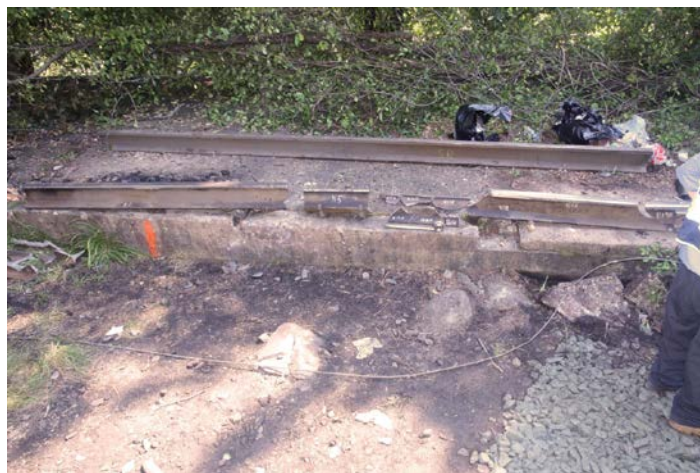
The south rail was found unbroken and upright on the crossties for the vast majority of the derailment footprint. The only piece used in the rail re-build was a section of the south rail with marking indicating a loss of normal wheel/rail relationship that was directly opposite of the north rail re-build location. This section of the south rail was under the last car derailed (the 21st head car). A set of joint bars on the north rail under the same car and directly opposite the south rail was cut from that joint location to serve as a coordinated set of reference points for the rail re-build. Investigators examined, recovered and achieved total continuity of the south rail. In reconstructing the west portion of the north rail, investigators pieced together all of it, save for about 5 inches of rail missing from the west portion of a 17' 1" section of rail. (See rail inventory photos and details in this report or NTSB's Materials Laboratory Factual Report. Note: During the laboratory examination, investigators confirmed the 5 inch figure for the missing piece of rail).

Figure No. 5. View of rail re-build.

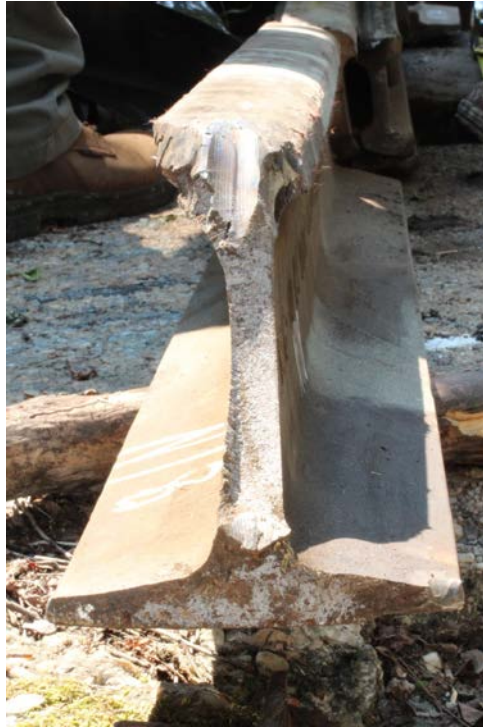
Figure No. 6. A view of a severe wheel flange strike mark on piece No. “N 18”.

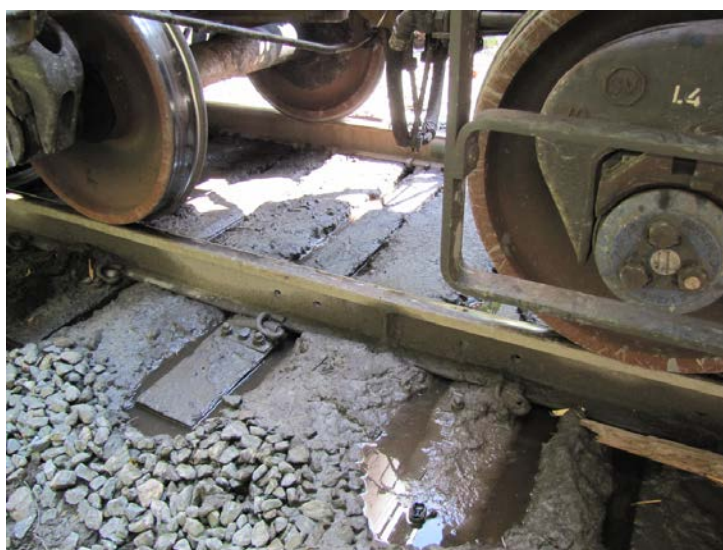
This is the last segment of track CSX train No U813-18 traveled over prior to the August 20, 2012, derailment. Investigator's post-accident inspection from the west end of the derailment walking west from the end of the undisturbed track toward the west found there were no visual exceptions to MP 13.0. The investigators did observe locations of the track where fouled ballast was present.

Figure No. 7. View of water and mud condition under derailed car.

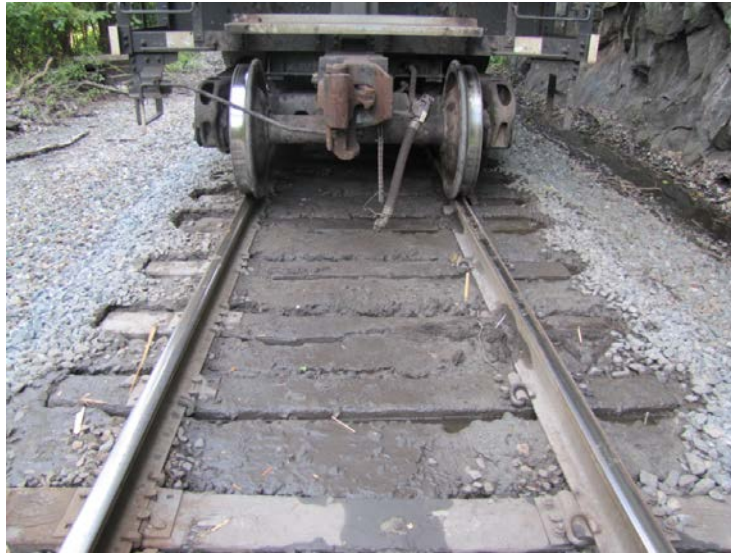
Investigators noted that several locations prior to and at the point of derailment exhibited fouled ballast conditions or saturation of the subgrade. Investigators observed that the south ditch line was wet and there was evidence of water flow along the ditch line (See Post Accident Inspection/Testing of Track section of this report).

Figure No. 8. View of a fouled ballast condition
Preceding the derailment footprint.

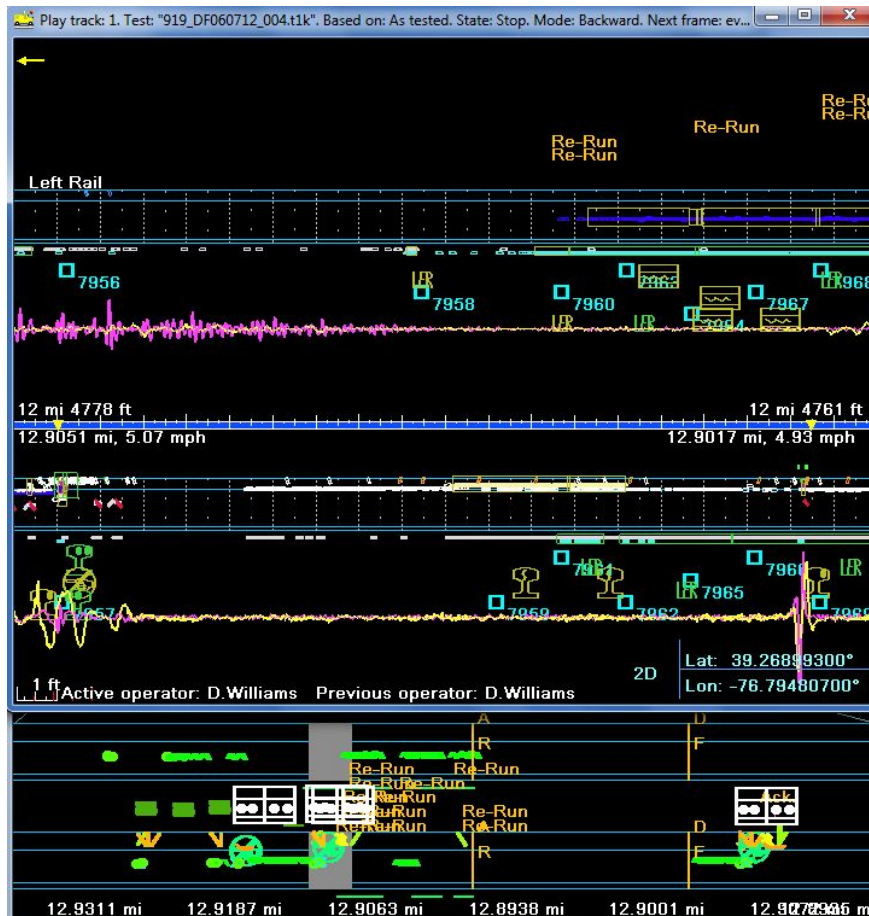
- The July test was conducted by a “relief” operator.
- Each of the three test were conducted going the same direction—from the west going east or descending mileposts;
- The length of the “rail plug” was validated as 17’ 1” (plus or minus 3/16”);
- The July test identified a rail defect at milepost 9.908, north rail, defect number 593 (screen shot file requested);
- Rail identification labeled from perspective of test truck moving forward—eastbound, thus left rail is north rail, right is south rail.

Figure No. 11. Sperry Rail Flaw Test July 6, 2012, Screen Shot of MP. 12.9311 to 12.9001.

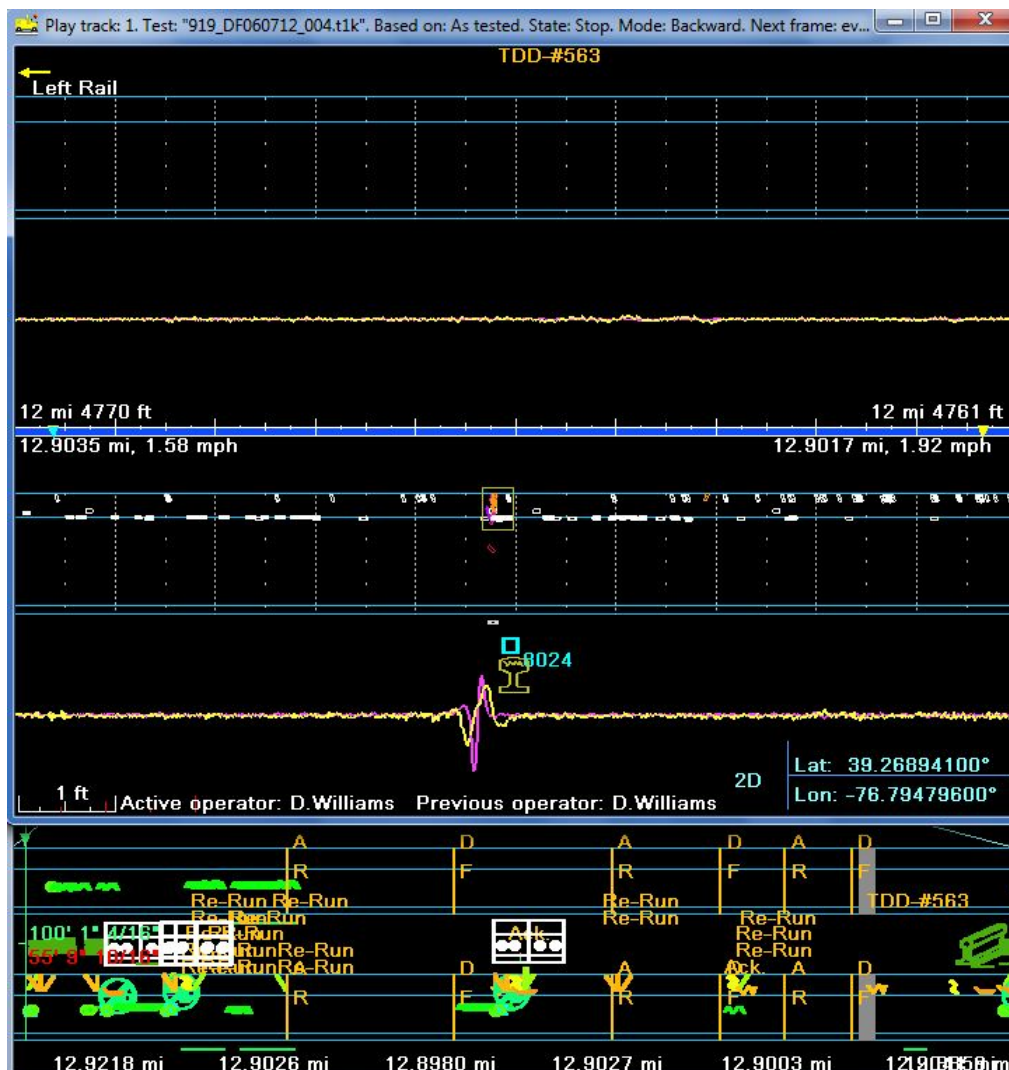
- The screen shot data in the lower limits of the data indicates a stop after a TDD was identified; an AR (ascending milepost location/ reverse) to a west location followed by a DF (descending milepost location/forward) to a stop point after a “re-run” over the “rail plug”. The data indicates this process was repeated once again, the third run—original and two repeats. The data also indicates a final fourth run that continued beyond the location of the previous three stop indications—a total of four runs.
- The final run was the valid test for that area—each run indicated the presence of the TDD, first identified during the first run;
- The final run had no loss of bottom¹⁹ indication but did contain “intermittent positive zero (head of rail).

Figure No. 12. July Test Car Re-runs and defect location.

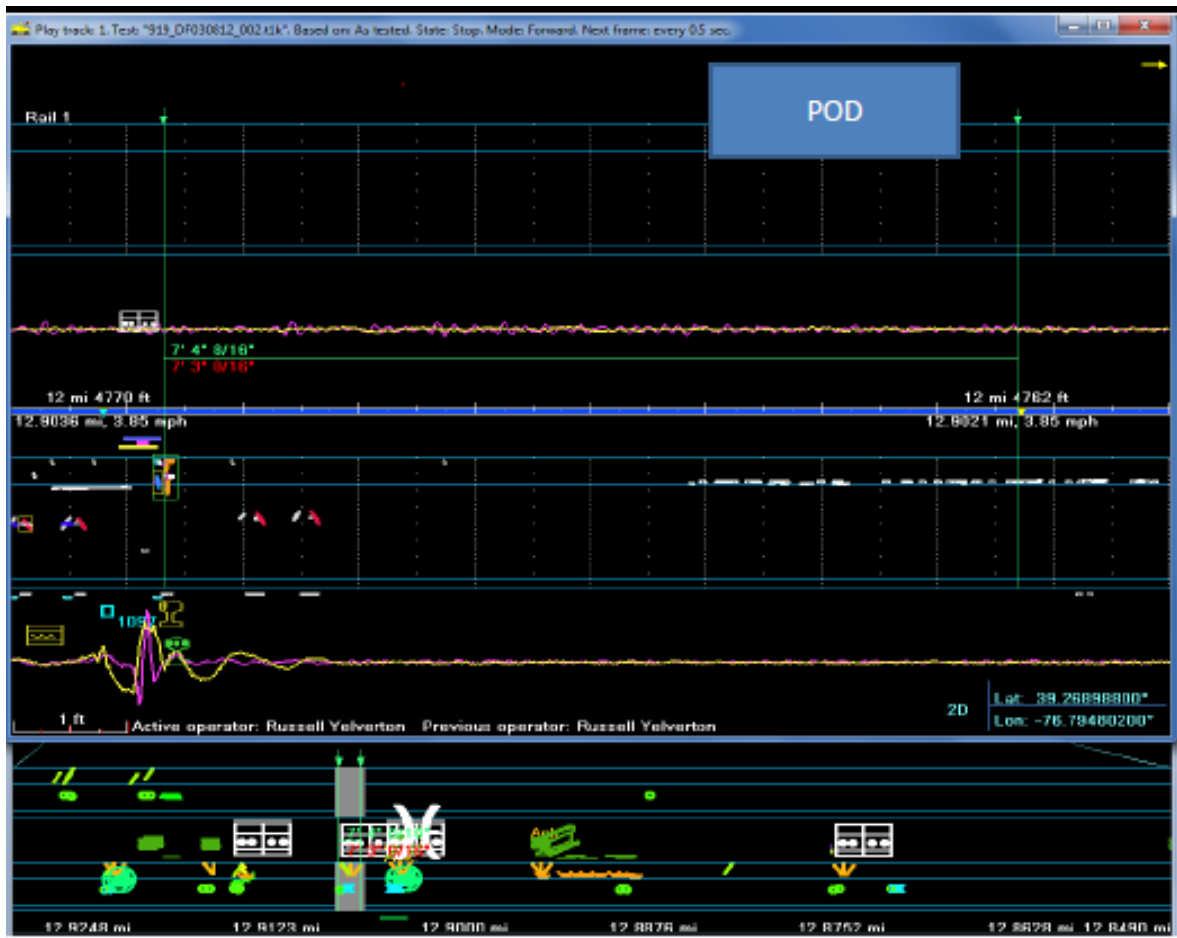
Figure 13. August 3, 2012, Sperry Screen Shot.

During the investigator's panel interview with Sperry, a Sperry representative provided the following observations about the August 3, 2012 screen provided to the investigation.

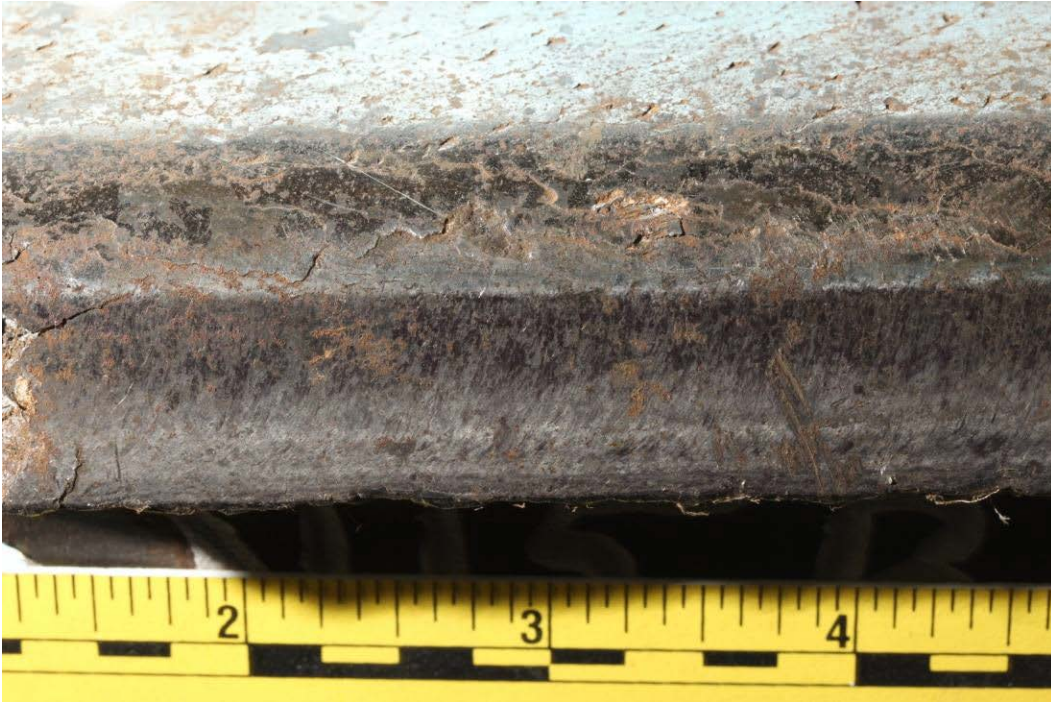
Figure 15. Views of the rail surface on two of the pieces showing rail surface conditions observed on the rail pieces. Unlabeled arrows in the upper image point to some of the cracks associated with surface rolling contact deformation as observed on the running surface near the gage corner.

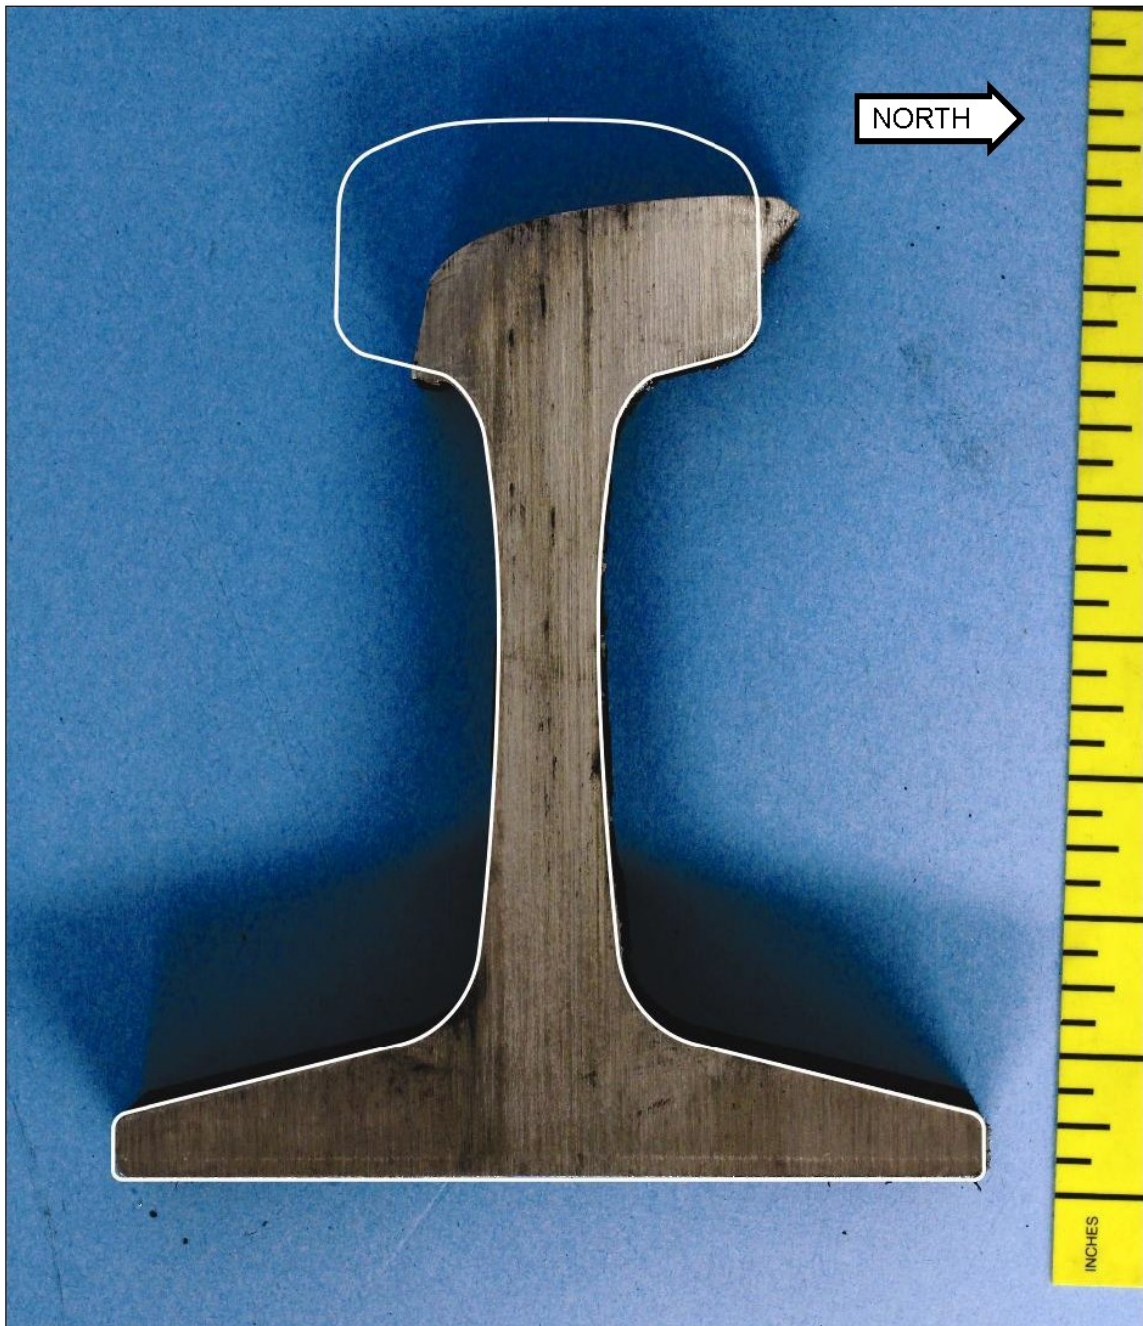
Figure 16. View of the rail cross-section (as-cut surface) near the west end of piece N5. The outline represents the cross-section of a new 136 pound rail.
