1  
2  
3  
4  
5  
6 **NATIONAL TRANSPORTATION SAFETY BOARD**

12  
13  
14  
15 **TRACK & ENGINEERING GROUP CHAIRMAN**  
16 **FACTUAL REPORT**

17  
18  
19 **DCA-14-MR-004**

20  
21  
22  
23 **Collision and Derailment with Hazardous Materials Release**  
24 **Eastbound BNSF U FYNHAY4-05 (Petroleum Train) with Westbound BNSF**  
25 **Train G RYLRGT9-26 (Grain Train) at Casselton, North Dakota**

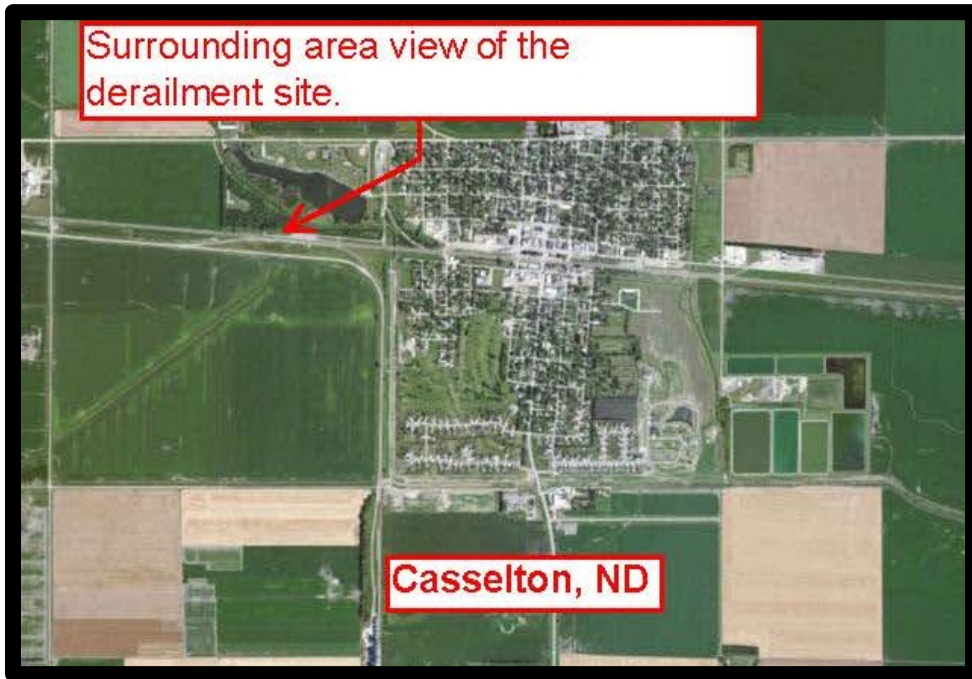
41 **Figure 1. Global view of derailment area.**

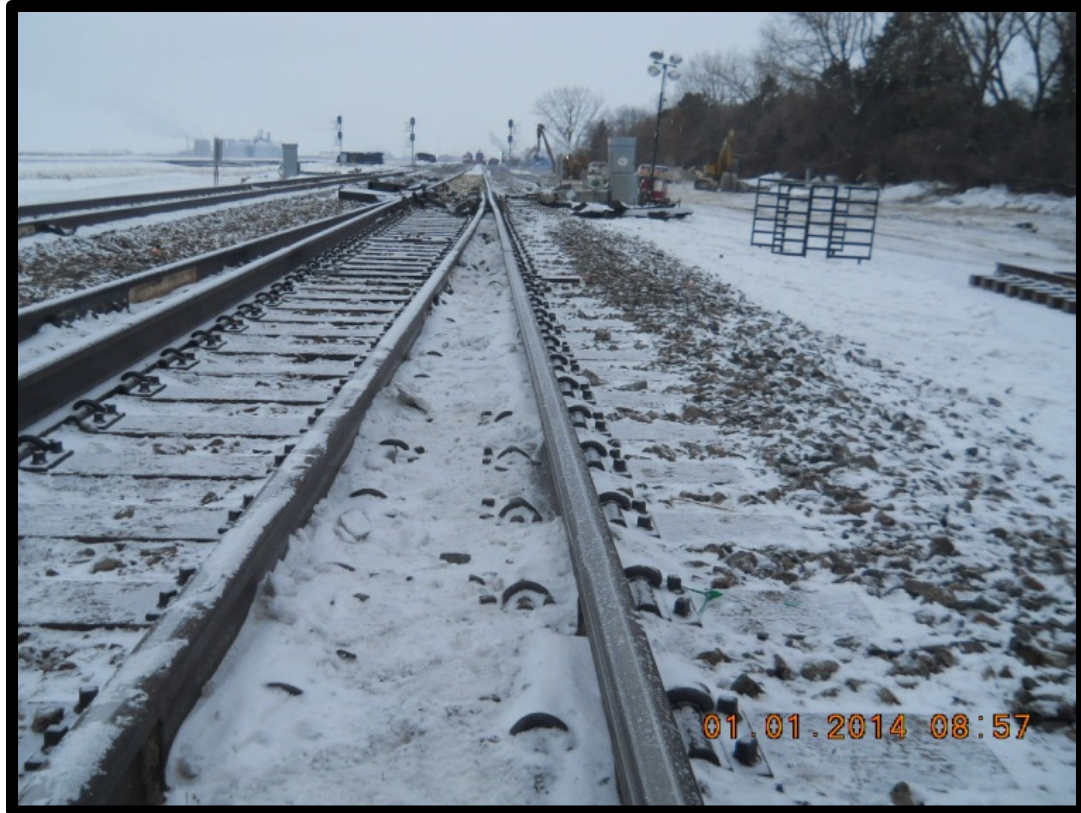
1  
2 **Figure 2.** View looking west (direction the train was travelling) from near the point of derailment.

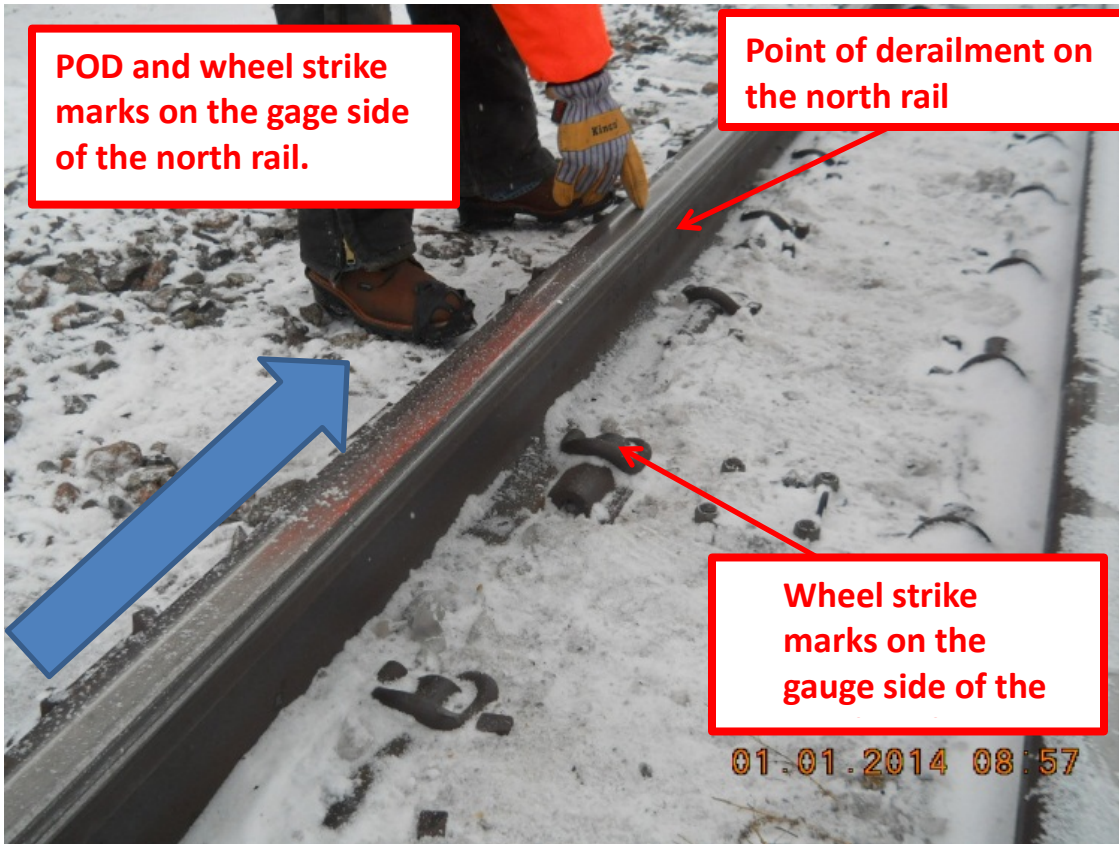
27 Investigators observed marks at the frog area and on top of the closure rail extending  
28 from the switch point area to the frog. The rail exhibited several marks but there were no wheel  
29 flange marks departing the rail head.  
30

Figure 3. View of derailment marks; blue arrow indicates direction of train travel.

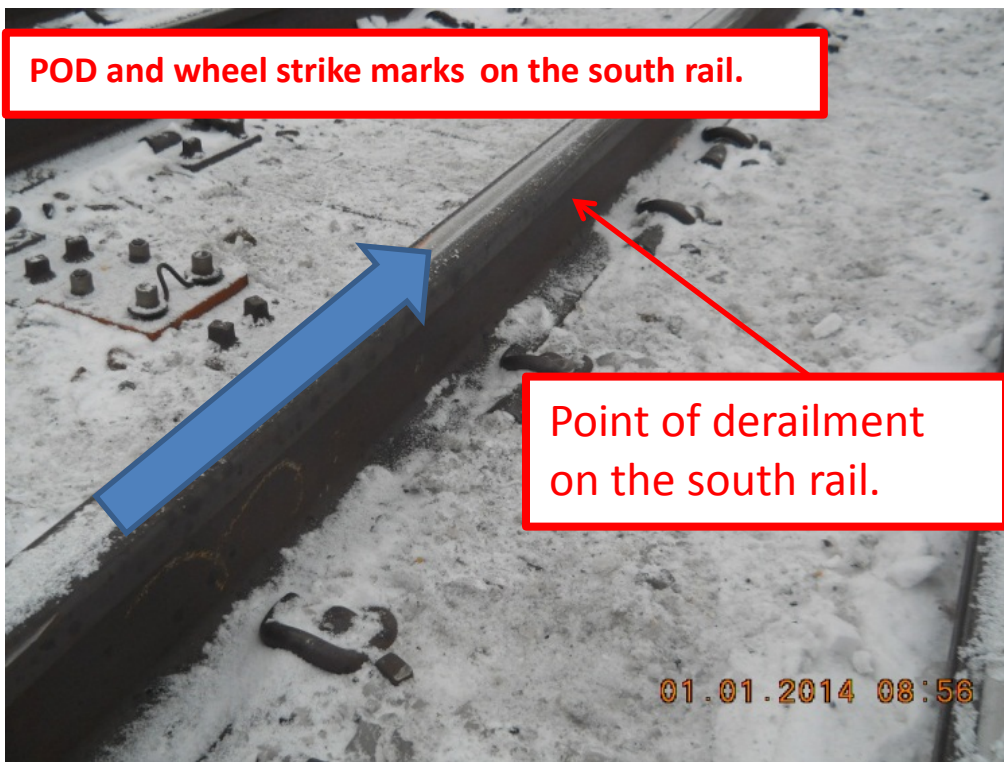
31 Investigators identified the point of derailment (POC) at a location where the outside  
32 edge (field side) of the south rail showed an indication of wheel flange trailing off to the field  
33 side and continuously marking the field side OTM in a westerly direction. The initial mark was  
34 located 60 feet 3 inches from the frog point and 96 feet 6 inches from the switch point. On the  
35 opposite rail, marks indicated a wheel flange trailing to the inside of the rail head and downward  
36 onto the track and OTM marking elastic clips and proceeding in a continuous manner to the heel  
37 block location. Investigators observed and documented a deep strike mark at the heel block.  
38 The switch crossties supporting the switch point area were damaged and the track west of the  
39 switch was destroyed.  
40  
41  
42  
43

Figure 4. View of south rail derailment marks; blue arrow indicates direction of train travel.

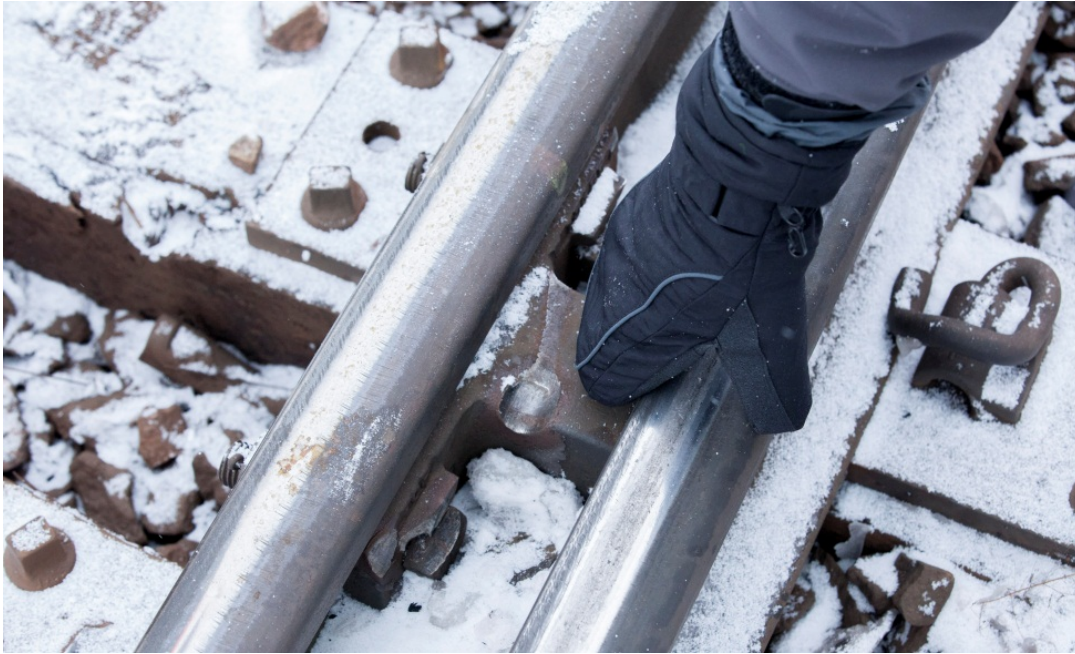
**Figure 5. Strike mark located at left hand switch point heel block**
