NATIONAL TRANSPORTATION SAFETY BOARD

TRACK & ENGINEERING GROUP CHAIRMAN FACTUAL REPORT

DCA16FR005

Union Pacific Railroad Head-on Collision/Derailment with Injuries

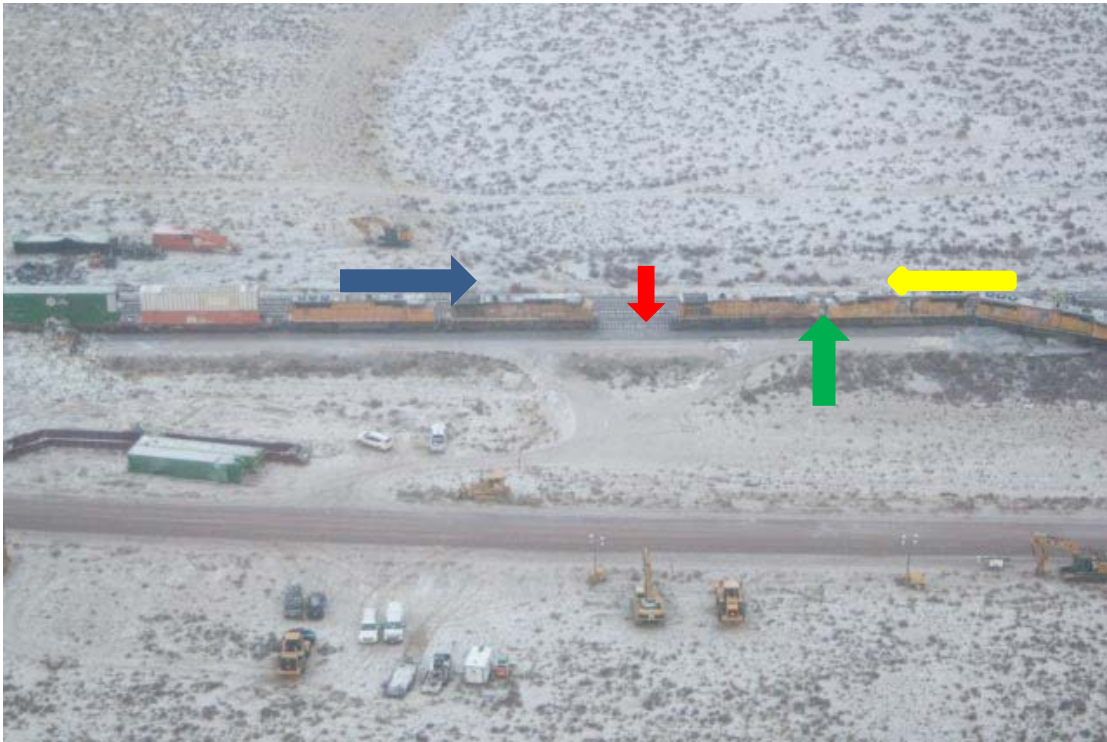
Figure 1. This is an aerial view on March 15, 2016, looking south at the derailment area. The red downward arrow identifies the point of collision (impact); the yellow arrow shows the position and EB direction of travel of the stopped local train, LCK41; the blue arrow identifies the WB direction of travel of the striking train; the green upward arrow identifies the “as found” position of the locomotives. Note: the striking train moved the stopped train about 246’ west.

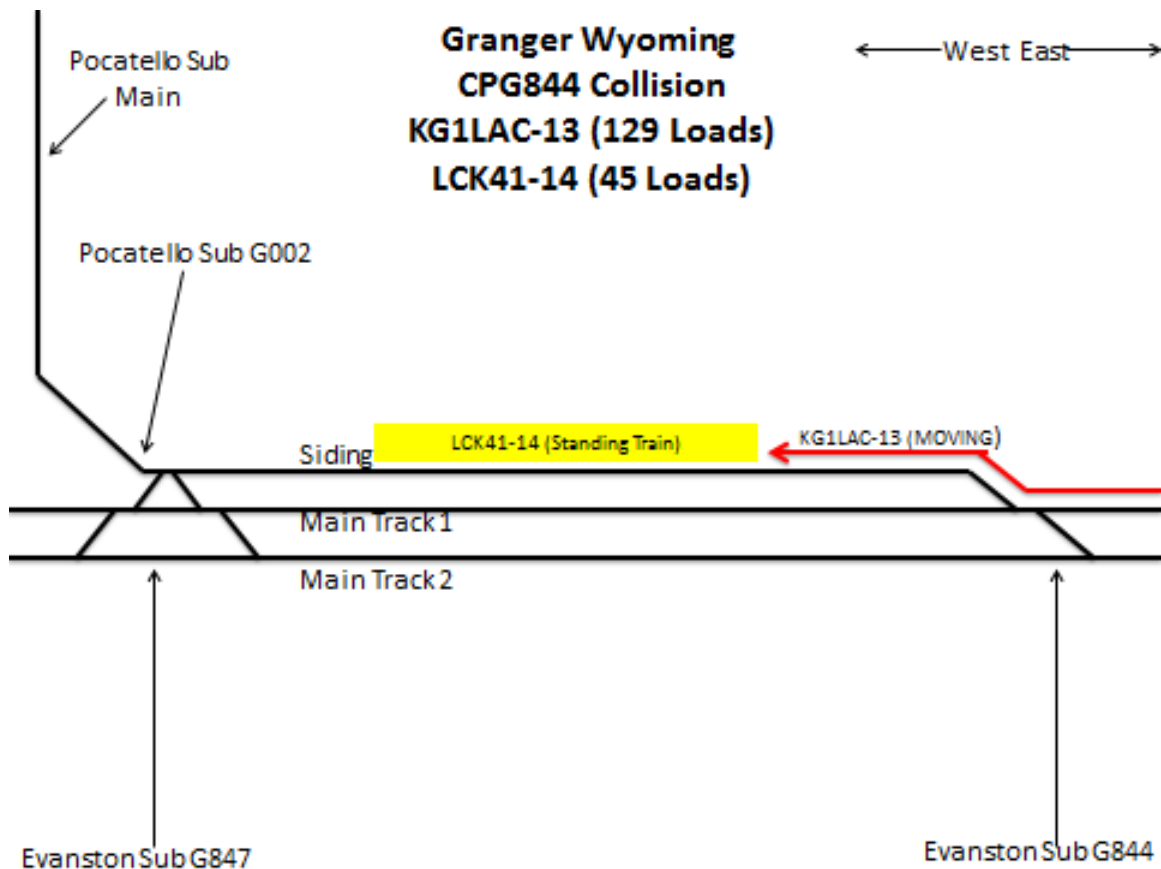
Diagram No. 1. Track layout in the Granger vicinity. The yellow highlighted area represents the track occupation of the local train. The red highlight represents the direction of travel the westbound train and its routing.

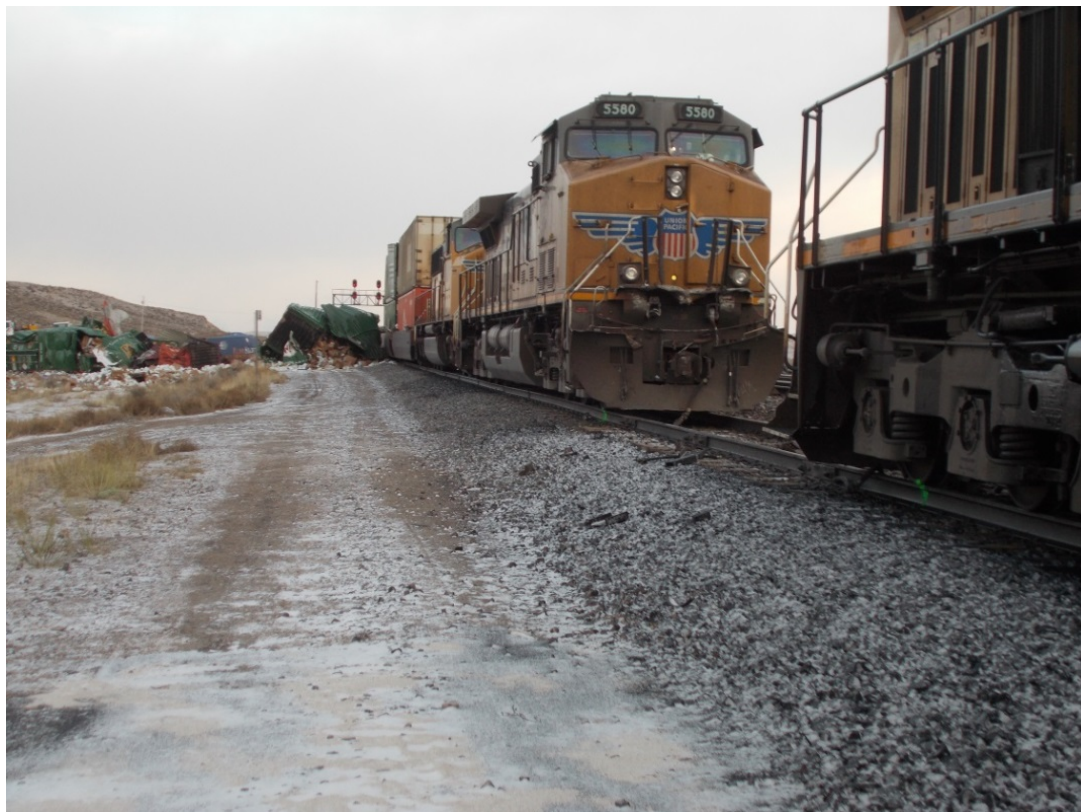
There was track structure damage in the immediate area of the impact (collision) and derailed equipment. Derailed cars and lading prevented initial detailed inspection for the immediate area of impact. Post accident observations by investigators disclosed that the track construction consisted of 133 pound RE, continuously welded rail³ (CWR). The rails were predominantly 133 pound RE controlled cooled rail manufactured by Colorado Fuel and Iron (CF&I) in the 1970's (1973). The CWR that was installed was seated in 14 by 8 inch double shoulder tie plates that lay between the bottom surface of the rail and the top surface of timber crossties. The rail was fastened through the tie plates to standard wooden crossties with conventional six inch cut track spikes. The present day spiking pattern used by UP prior to the derailment consisted of two rail-holding spikes on the gage side of the rail with an additional anchor spike; one rail holding and one anchor spike on the field side.

Figure 2. This is a view looking east at the intermodal train derailed cars.

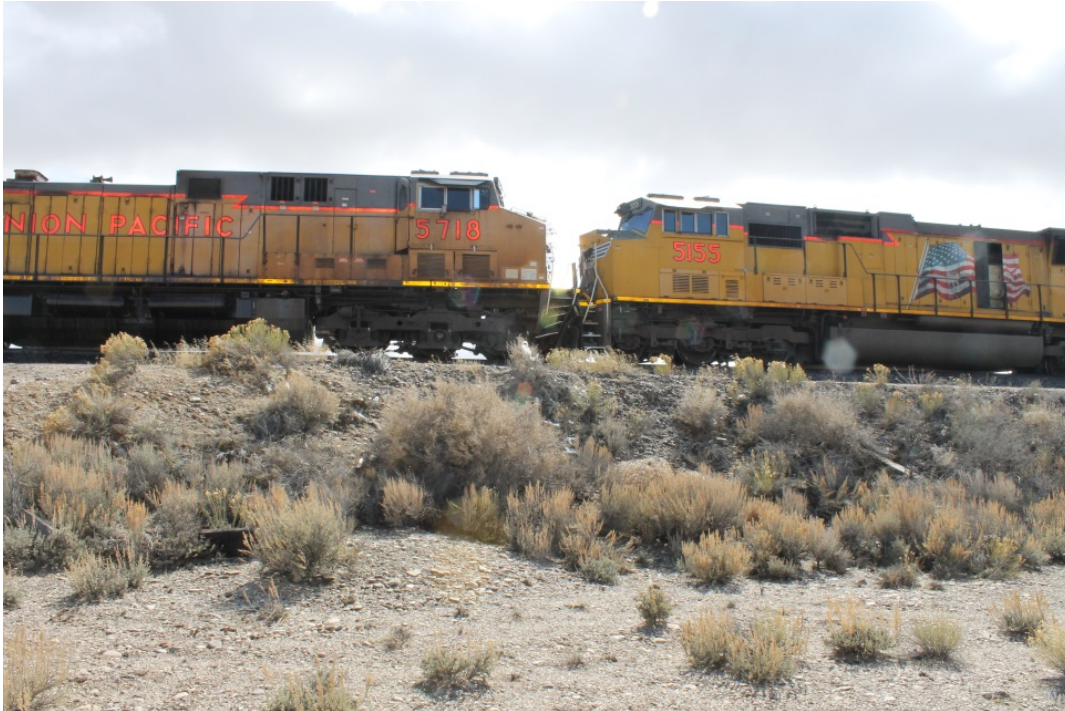
Investigators observed and photographed an area where locomotive debris from the locomotives impact area was present in the gage of the siding. Investigators formed a consensus that this location indicated the point of impact (POI)⁴. Investigators also determined that the POI was at MP 844.25, which is about 1,463' from the east end of the entrance to the siding or about 1,122' from the clearance point of the siding at the east end.⁵

Figure 3. This is a view looking south at collision of two locomotives.

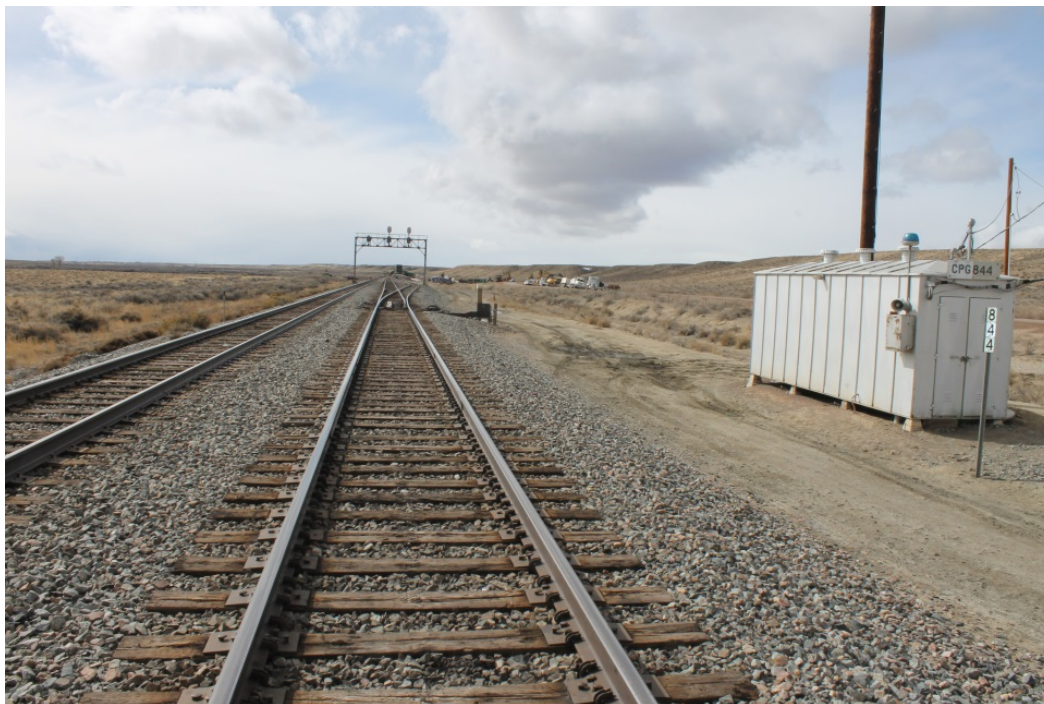
On March 17, 2016, investigators inspected and photographically documented the No. 20 turnout (a right hand switch⁶) switch point area located at MP 844.02 on the main track that provides access to the siding. No exceptions were noted.

Figure 4. This is a view looking west at CP 844 and the east switch or entrance into Granger Siding.

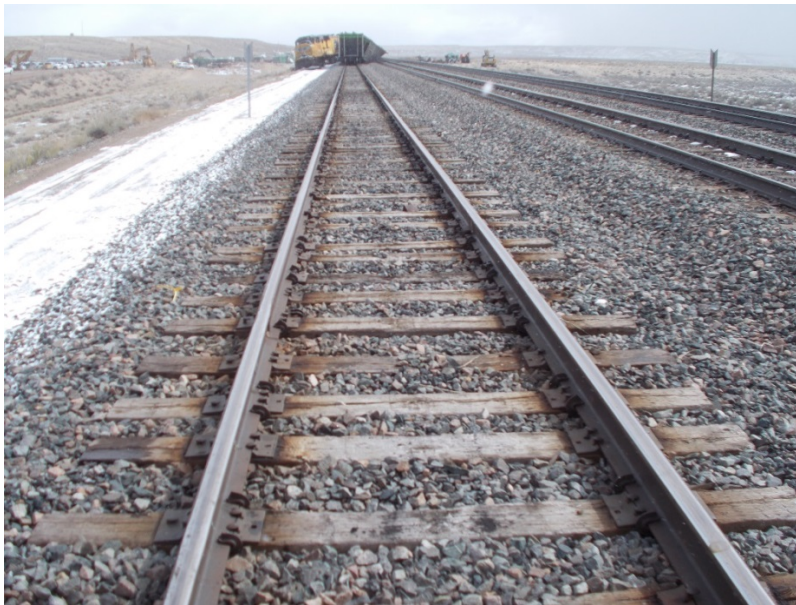
Figure 5. This is a view looking east at the area where the track field measurements were taken.

- The maximum measurement allowed for gage in FRA Class 3 track, which allows for a maximum authorized speed of 40 mph for freight and 60 for passenger trains, is 57 $\frac{3}{4}$ inches. Track notes recorded that the widest gage was 56 $\frac{3}{8}$ inches; or 1 $\frac{3}{8}$ of an inch under the FRA maximum allowable limit on the west side of the derailment. Track notes recorded that the widest gage was 56 $\frac{1}{2}$ inches; or 1 $\frac{1}{4}$ of an inch under the FRA maximum allowable limit on the east side of the derailment.

- The maximum measurement allowable for crosslevel in FRA Class 3 track is 1 $\frac{3}{4}$ inches. Track measurements for the west side of the derailment found that the highest crosslevel measurement was $\frac{3}{8}$ of an inch, or 1 $\frac{3}{8}$ inches under the maximum allowable. The highest value of crosslevel for the track measurements on the west side of the derailment was $\frac{1}{2}$ of an inch or 1 $\frac{1}{4}$ inches under the maximum allowable.
