**NATIONAL TRANSPORTATION SAFETY BOARD**

**TRACK & ENGINEERING GROUP CHAIRMAN PRELIMINARY FACTUAL  
REPORT**

**DCA-14-FR-008**

**CSX Transportation Crude Oil Train Derailment with  
Hazardous Materials Release**

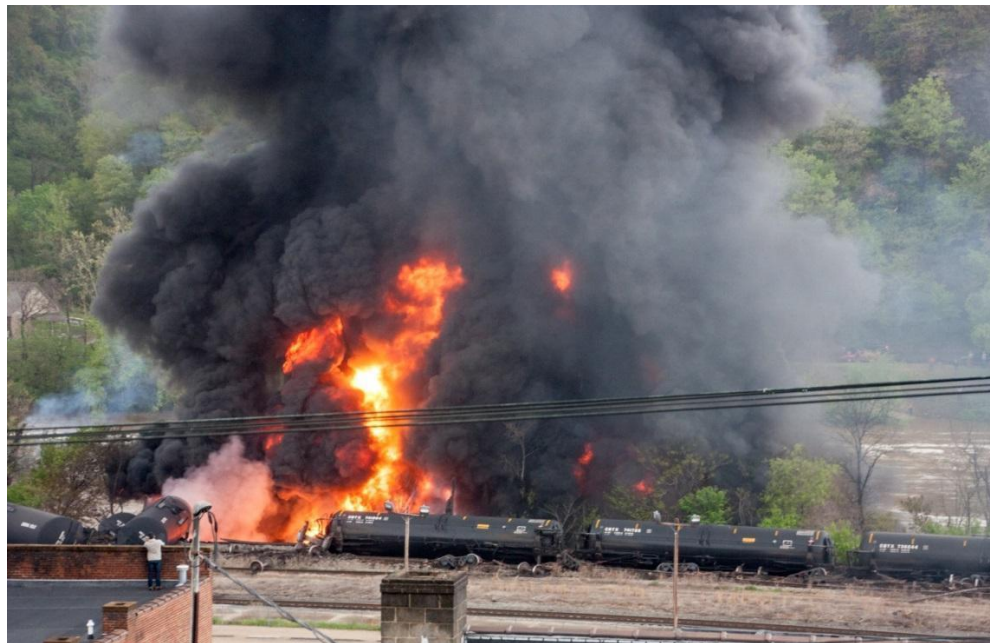
Figure 1. This is a view looking east at tank car on fire in the James River.

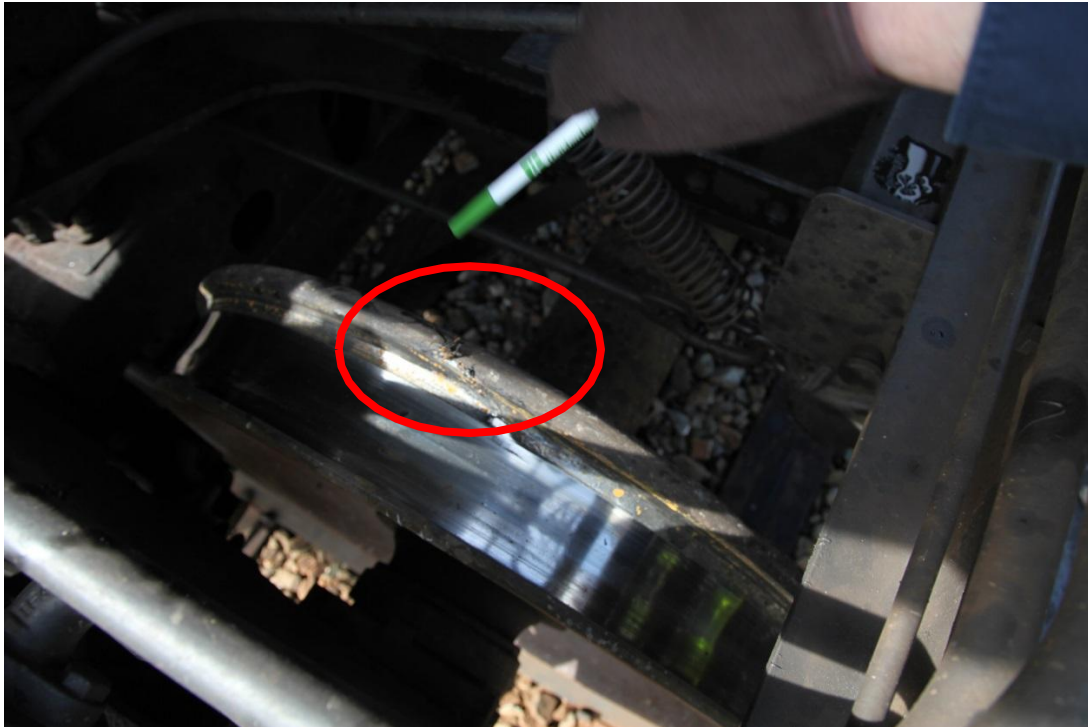
Figure 2. A close-up view of the wheel flange strike mark observed on the 34<sup>th</sup> car's rear truck, rear axle, the L1 wheel.

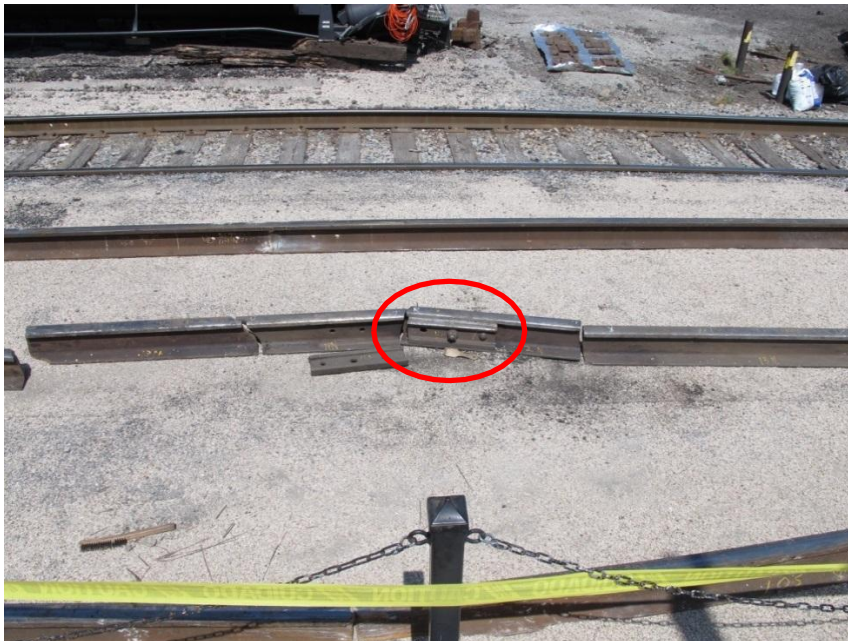
The rail break immediately east of the joint bar location exhibited slight rail end batter on the trailing fracture edge and slight rail end batter on the receiving rail fracture edge. Several rail pieces from this area of rail were tagged and marked as evidence and sent to NTSB Materials Laboratory in Washington DC.

Figure 3. A view looking east at the rail service failure repair—rail joint bars and broken rail to the right of the intact one half joint bar. The defect, tested on April 29<sup>th</sup>, is located about three feet from the rail end in the rail joint.

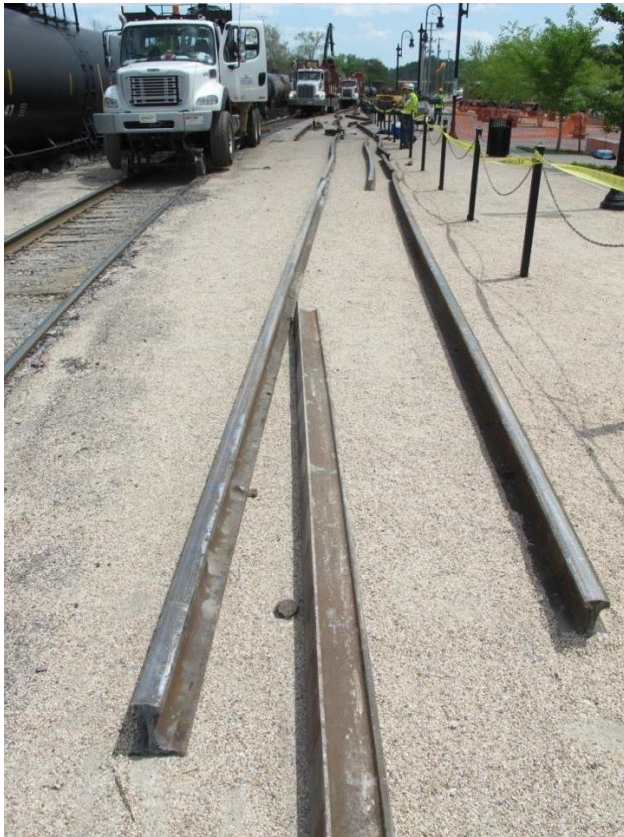
Figure 4. A view looking east at portions of the rail re-build project. The high rail is on the left and the low rail on the right.

- James River Subdivision POD at CAB 146.45 No. 2 track;
- Rail rebuild began and ended on 5/1/2014 – 5/4/2014;
- 1990 132 RE Nippon rail;
- In the focus area, investigators pieced together 353' of rail on the low side and 222' on the high side;
- Investigators determined there was about 1' missing on the high side 6' west of barred service failure;
- Investigators determined there was about 3' missing on the low side ;approximately 25' east of the barred service failure;
- The barred rail service failure on the high side of the curve at or near POD;

- Marked 20% transverse detail defect (a fracture coded as TDD) by Sperry SRS931 rail test car was 3' east of barred service failure. The paint and mark was not present;
- A <5% reverse TDD fracture<sup>7</sup> was found where we expected the 20% TDD was marked;
- A 20% defective field weld was discovered in the weld 8'10" from the barred service failure.

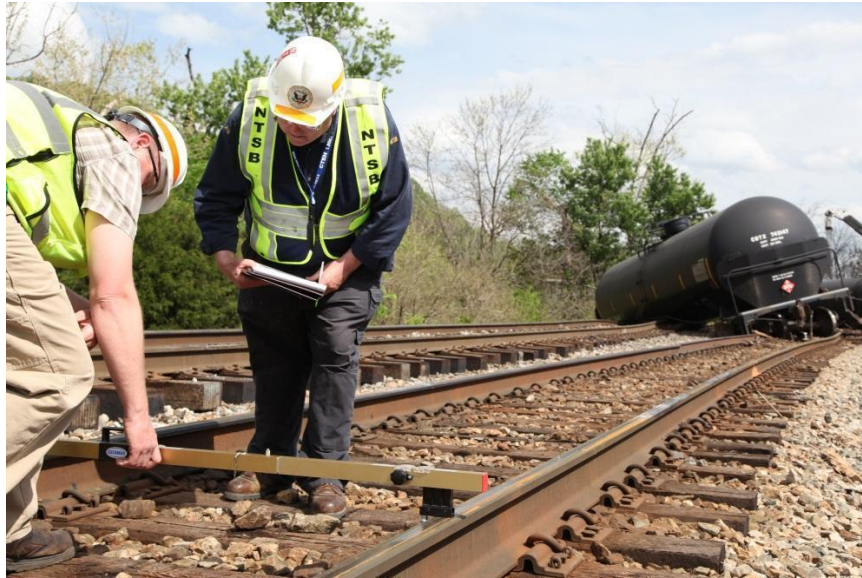
Figure 5. A view looking east at the last car derailed in the background while investigators are taking measurements of the track geometry.

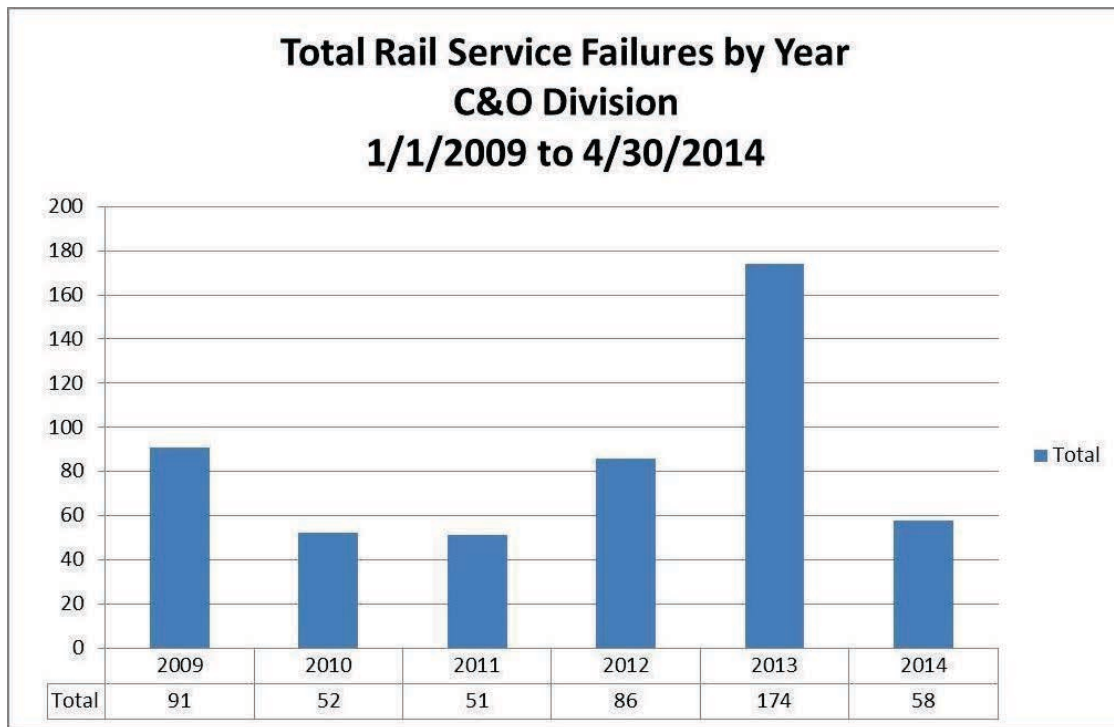
Figure 6. Rail service failure data by year for CSX’s C&O Division—1/1/09 to 4/30/14.

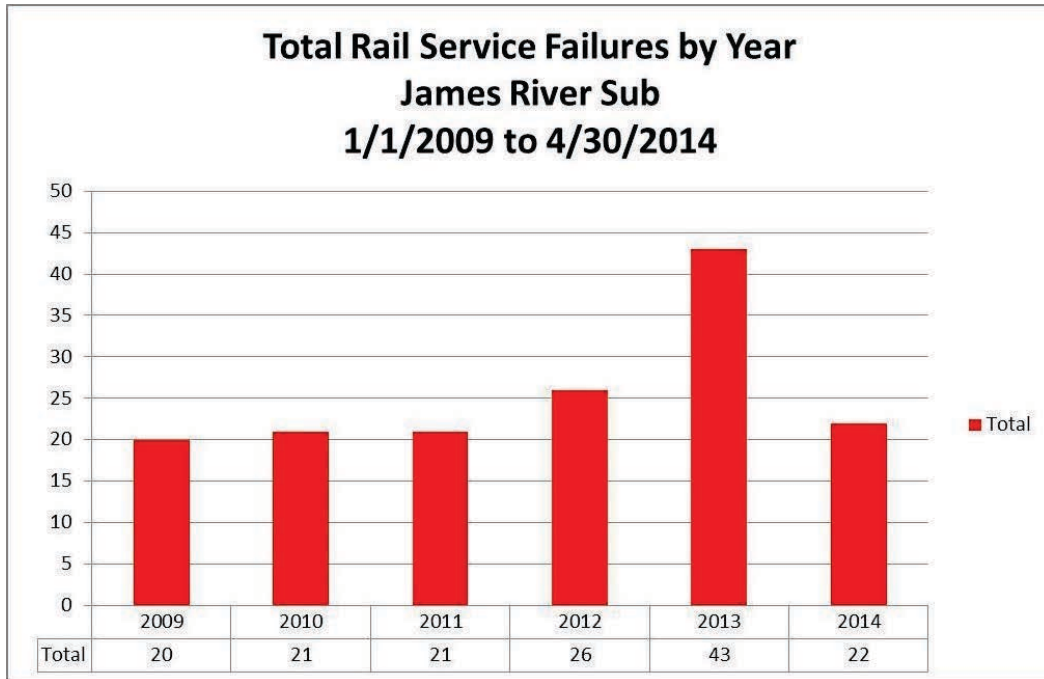
Figure 7. Rail service failure data by the year from 2009 to April 30, 2014.

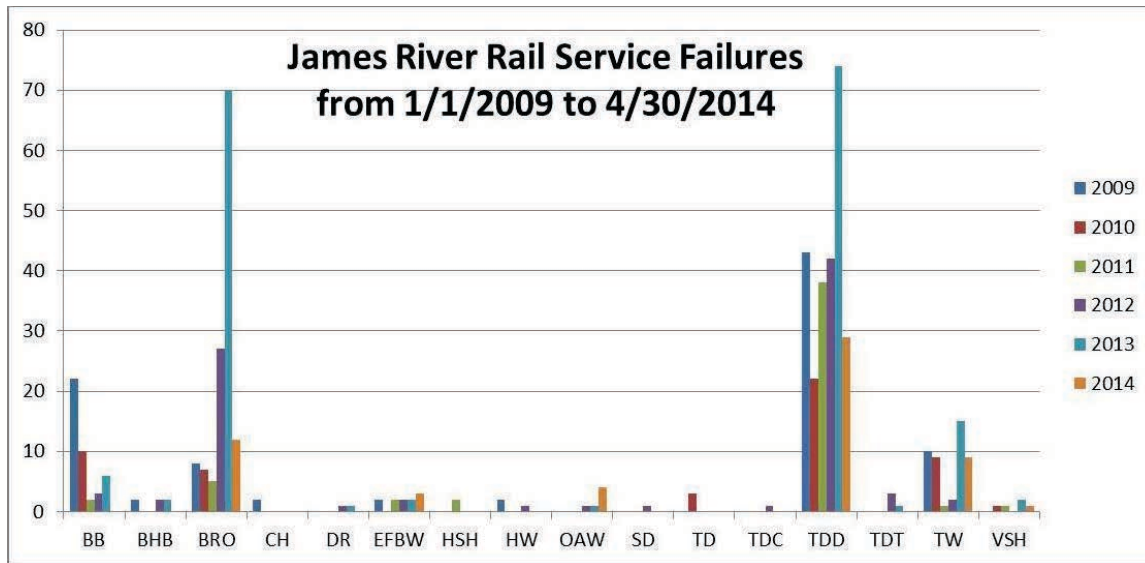
Figure 8. James River Subdivision rail service failure data from 2009 to April 30, 2014. The TDD coding represents the number of transverse detail fractures.

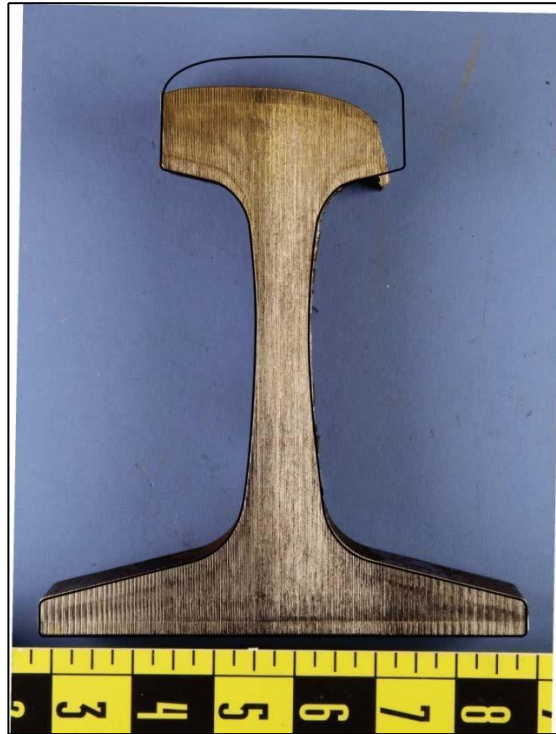
Investigators sent evidence rail pieces to NTSB to determine exact measurements of the rail head and side wear, as well to characterize the size and type of rail defects. NTSB conducted its formal examination of the rails at the POD on September 10<sup>th</sup> and 11<sup>th</sup>, 2014 in Washington, DC in NTSB’s Materials Laboratory. Rail pieces were measured and photographed. NTSB measured 0.42 of an inch vertical wear and 0.28 of an inch side wear. During the rail examination, a CSX representative provided NTSB with rail measurements: 7/16 of an inch vertical wear and 5/16 of an inch side wear.

Figure 10. Photo of cross section of rail near 12N. Outline shows loss (wear) of rail hear.

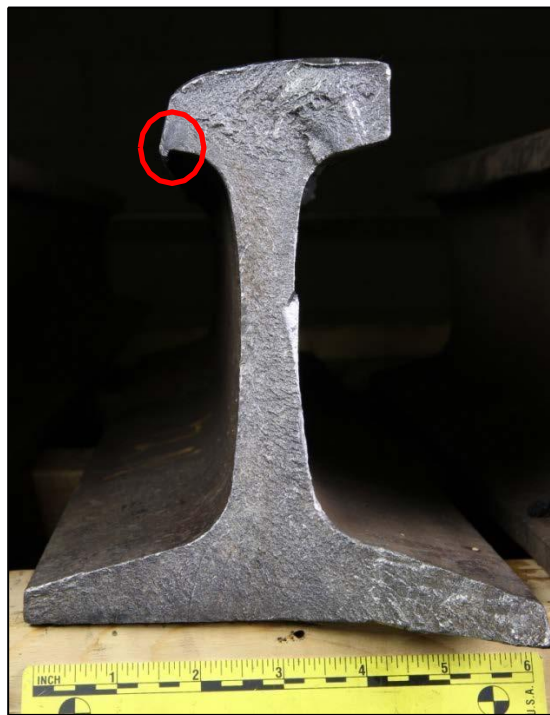
Figure 11. Reverse detail fracture at east end of piece 12N.

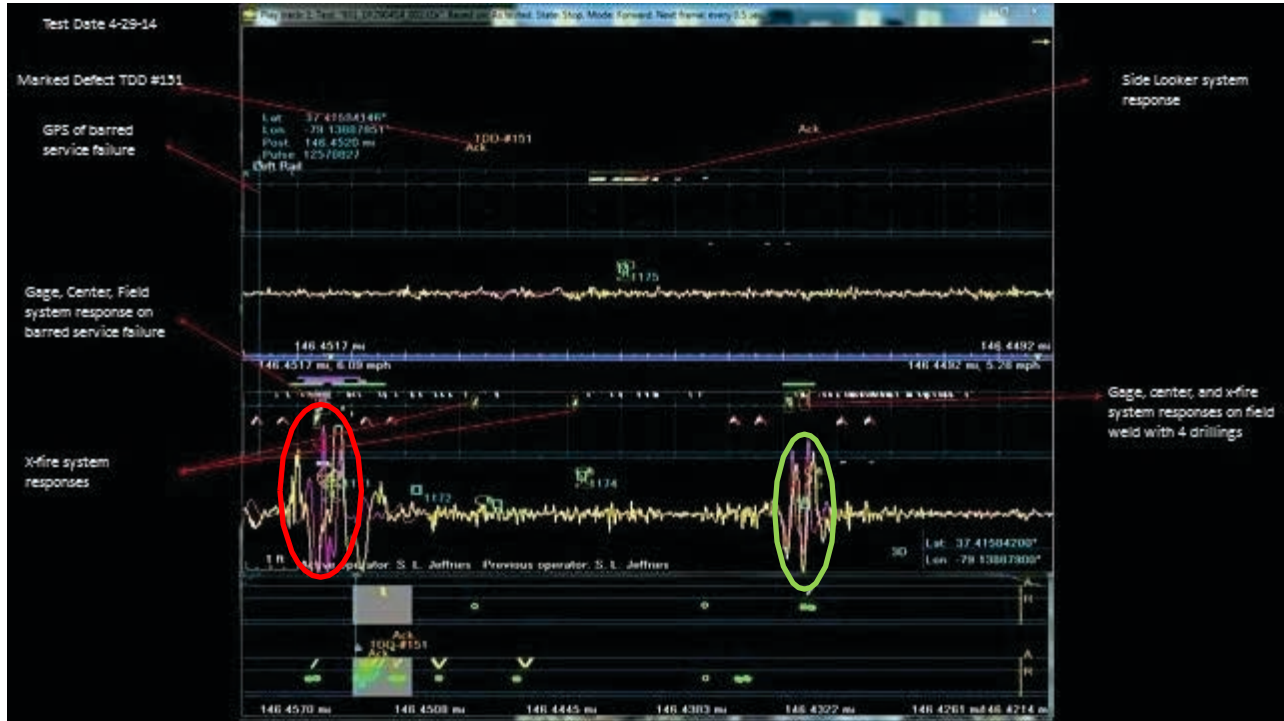
Figure 12. Screen image of the rail test data for MP 146.45.

From the April 29<sup>th</sup> test, the above image is 10 foot track section screen shot including the rail joint area at MP 146.45. The screen shot data notes a marked defect No. 151, the GPS data for a barred service failure, and the multiple channels responses for two separate defects: 1) about three feet east of joint bar (in the image to the right of the joint bar) and 2) a second defect at a field weld about eight feet east (to the right) of the joint bar location.

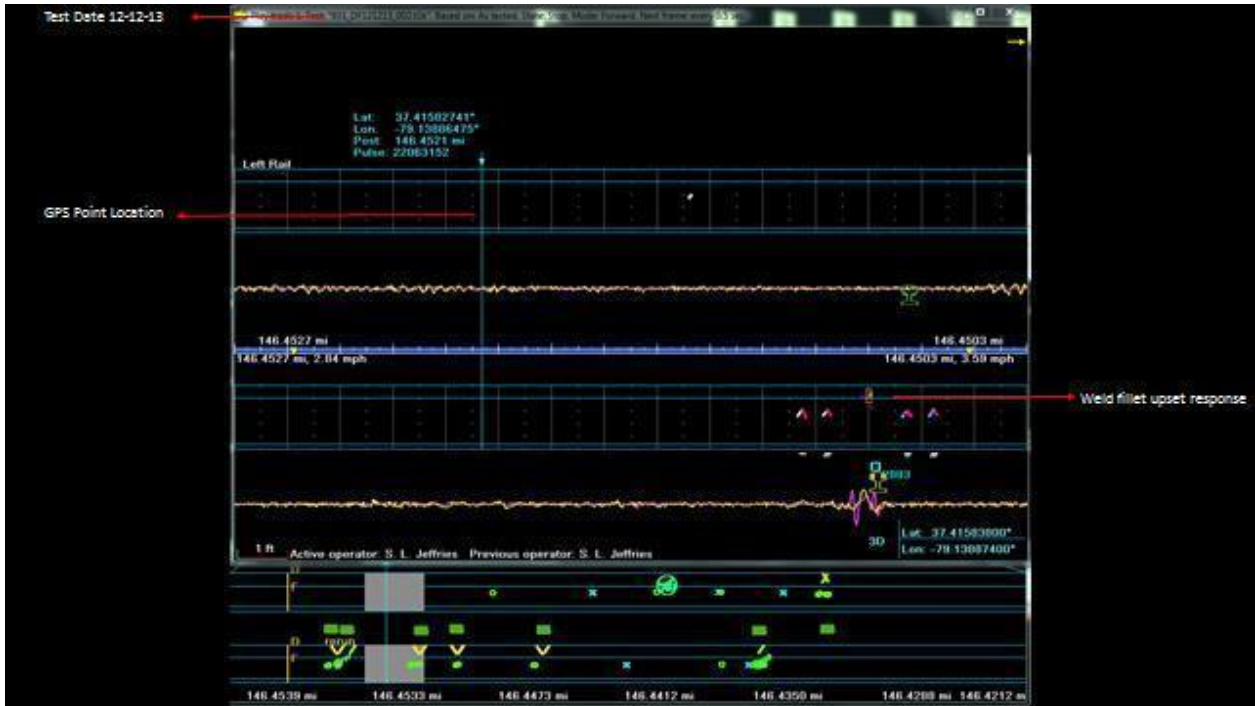
December rail test—10 foot screen shot, no presence of a rail joint bar at MP 146.45.

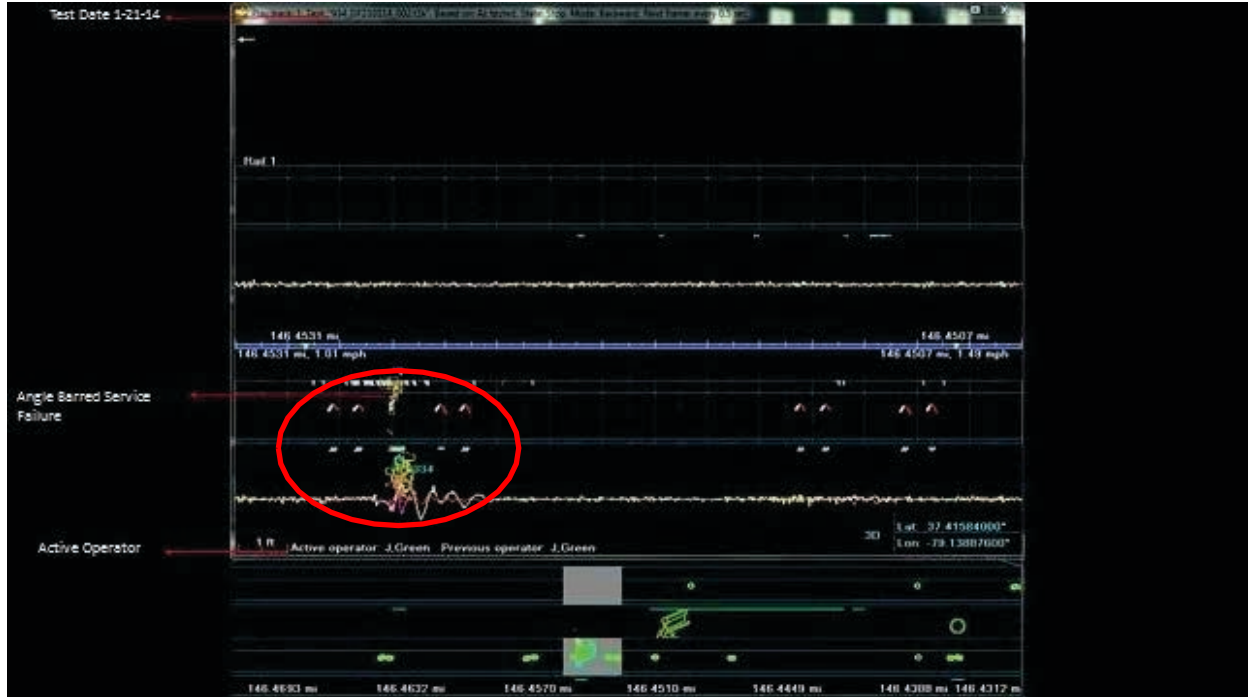
January rail test—10 foot screen shot, shows presence of a rail joint bar at MP 146.45. CSX maintenance personnel described a service rail failure that was repaired in early January of 2014.

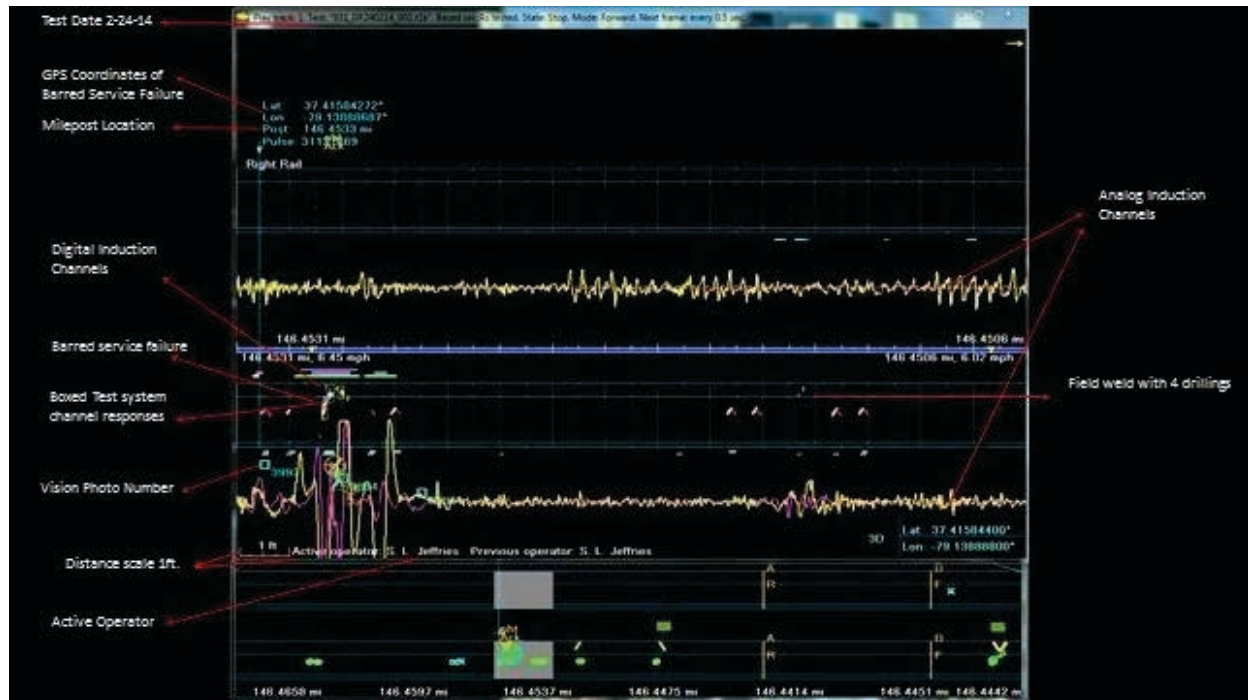
February rail test—10 foot screen shot, rail joint bar at MP 146.46, no rail defects.

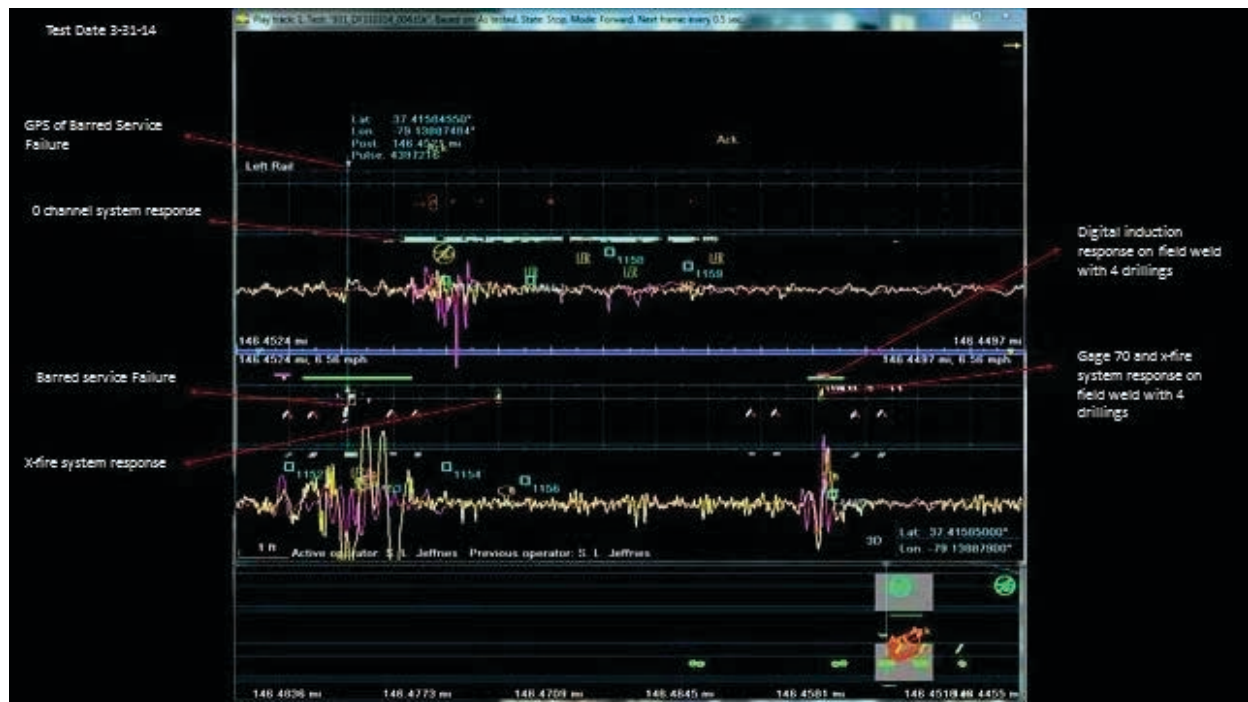
March rail test---10 foot screen shot, rail joint bar location at MP 146.45. No rail defects.
