1
2
3
4 **NATIONAL TRANSPORTATION SAFETY BOARD**

10
11
12 **TRACK & ENGINEERING GROUP FACTUAL REPORT**

13
14
15 **DCA16FR008**

16
17
18 **BNSF Railway Head-on Collision/Derailment with Fire**

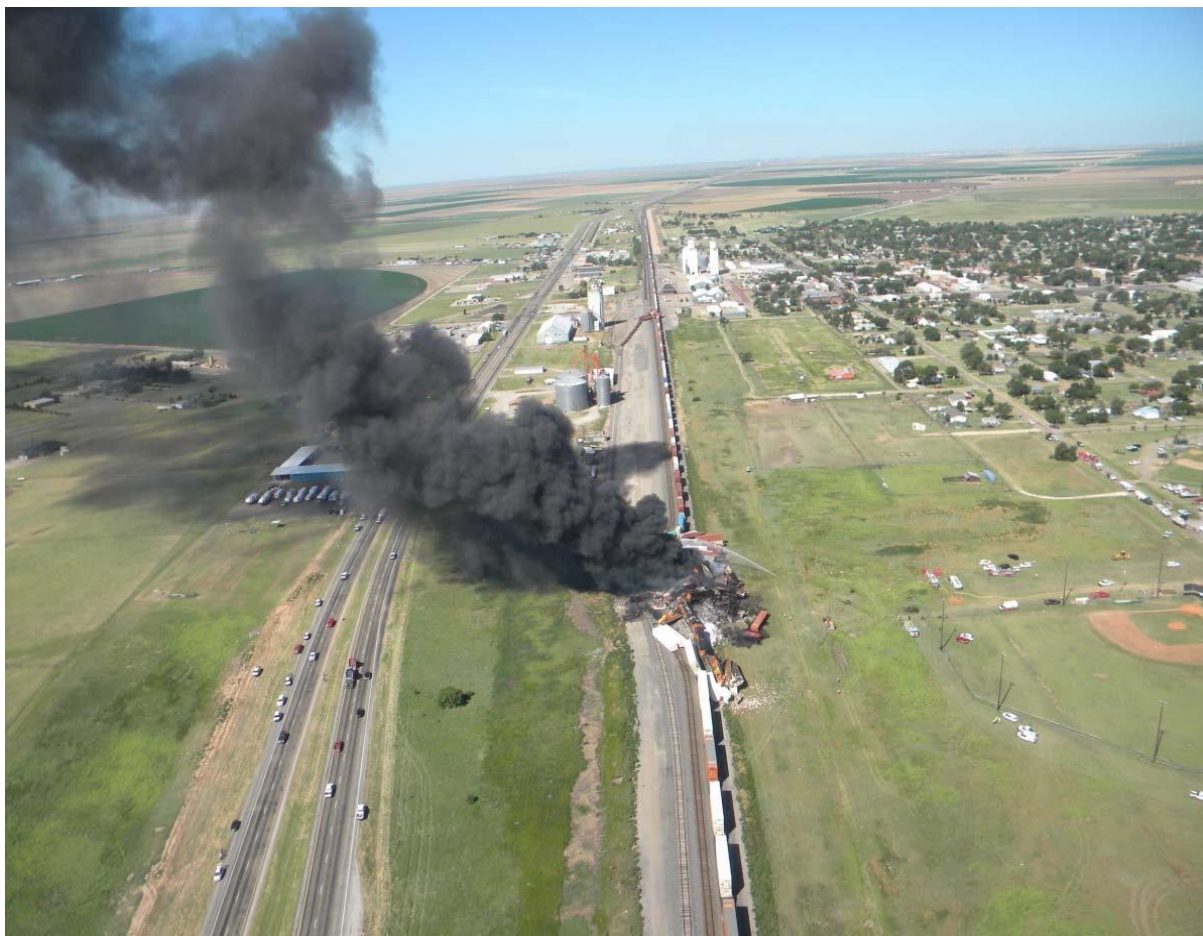
8 **Figure 1.** Aerial view of derailment site, geographical direction west toward the top of the photo. Photo
9 shows damaged and displaced rail equipment and smoke rising from the wreckage. (Photo BNSF)

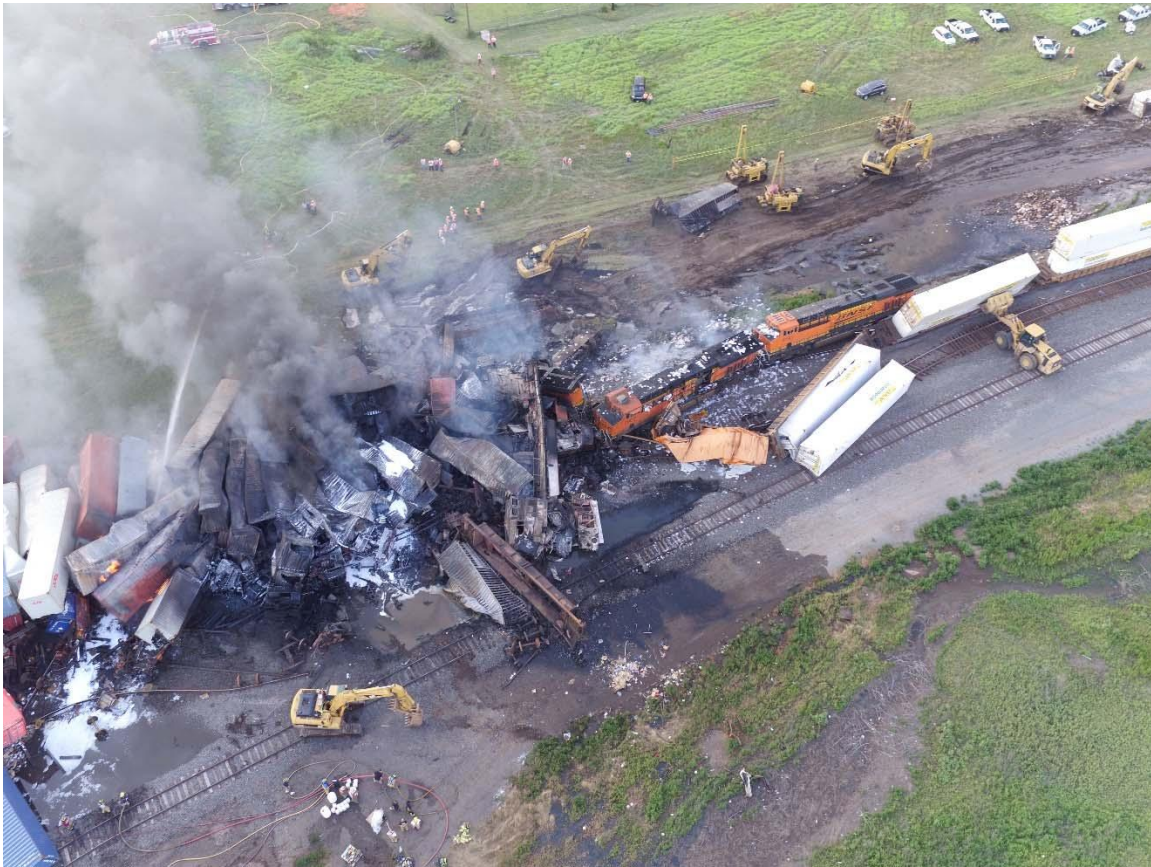
2 **Figure 2.** Aerial view of railroad equipment at the POC. Photo shows damaged and displaced rail
3 equipment and smoke rising from the wreckage (Photo BNSF)

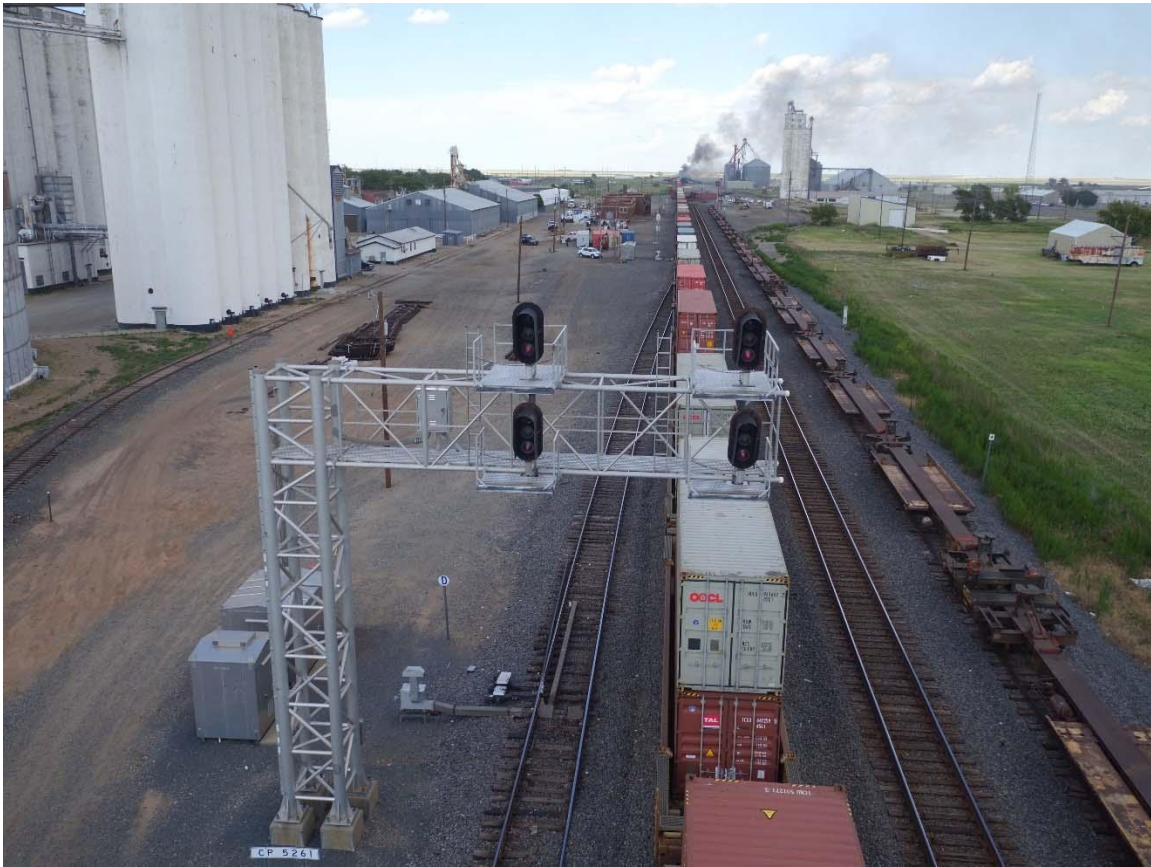
5 BNSF installed 15 track panels at the POC on main one track and 14 track panels
6 on main two near the POC, where the track damages required total renewal. The
7 consensus point of collision was mile post 525.4. This determination was supported by
8 aerial photography and associated landmarks. The POC was about 4,000 feet east of the
9 east switch of Panhandle siding and 4,187 feet east of the eastward absolute signal at the
10 east end of Panhandle Siding. As a result of the collision and train induced forces, there
11 was a secondary derailment of one car in the eastbound train consist. The derailed car
12 was the twenty-first car from the head end of the east bound train. This secondary
13 derailment damaged the track structure of main tracks one and two as well as one
14 intermediate signal mast at mile post 525.9.

2 **Figure 3.** Aerial view showing signal mast at damaged switch and smoke from POC east of the switch
3 location. (Photo BNSF)

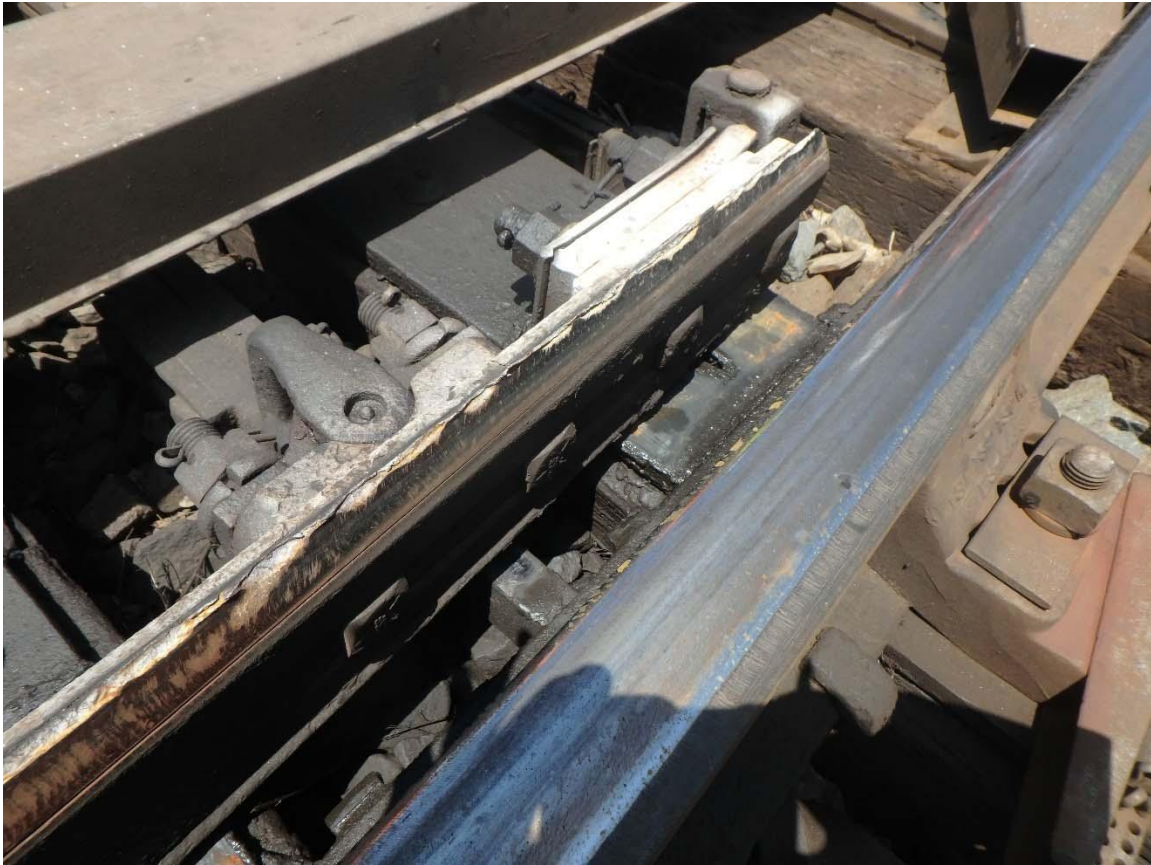
5 On June 29 and 30, 2016, investigators inspected and photographically
6 documented the No. 20 (right hand turnout) switch point area located at milepost 526.15
7 main one track that provides access to the Panhandle siding. During these inspections,
8 investigators observed contact marks on the field side of the turnout's left hand switch
9 point, the side that fits up against the stock rail. Investigators noted that when the switch
10 was operated by hand into a reverse position; the switch points were not up against either
11 stock rail. Investigators observed the operating rod that controls the throw of the switch
12 was bent. The left-hand switch point's tip showed fresh signs of contact. According to

1 dispatcher log data, the switch had been reversed for the westbound train to take the
2 siding, while the eastbound train was to stop on main track one west of the switch.

5 **Figure 4.** Metal flow chipped from back side of left hand switch point indicating a run through switch
6 condition. Photo shows railroad switch components. (Photo NTSB)

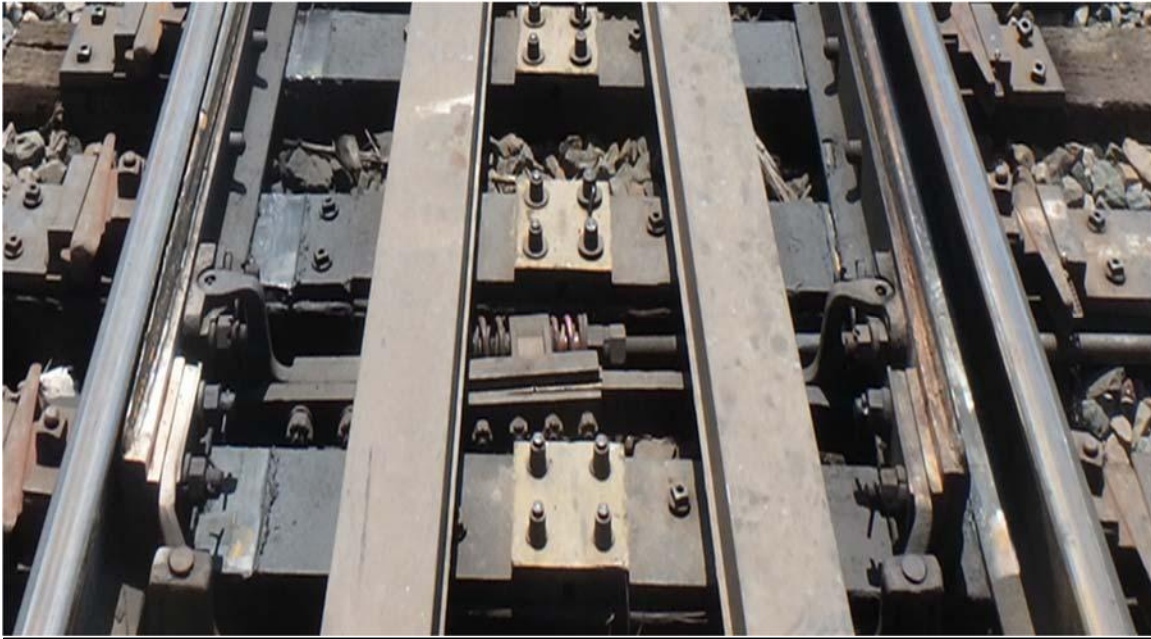
2 **Figure 5.** Gap shown on left hand switch point when switch was hand thrown for entry into siding track,
3 East End of Panhandle Siding. Photo shows railroad switch components. (Photo NTSB)
