Figure 1. Overall view of the examined lock pieces relatively arranged as if on the bridge.

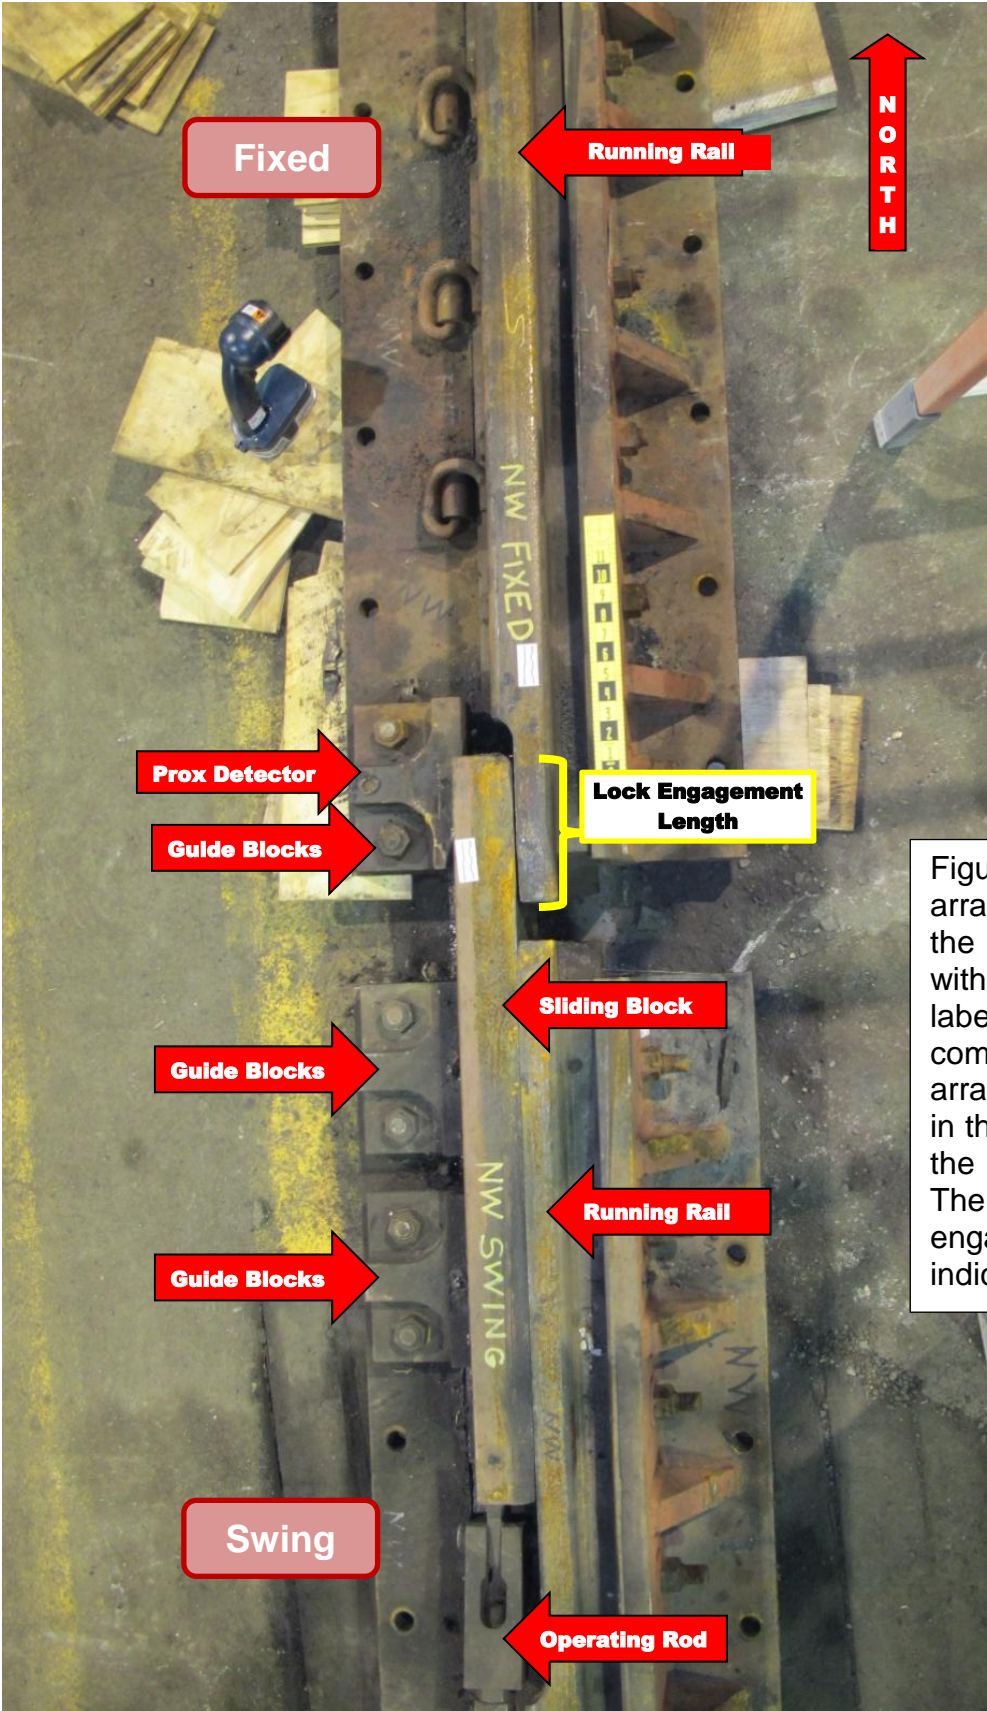
Figure 3. Image showing the arrangement of components at the north side of the bridge with many of the components labeled. West rail shown. The components have been arranged with the sliding block in the locked position engaging the fixed side components. The approximate lock engagement length is also indicated.

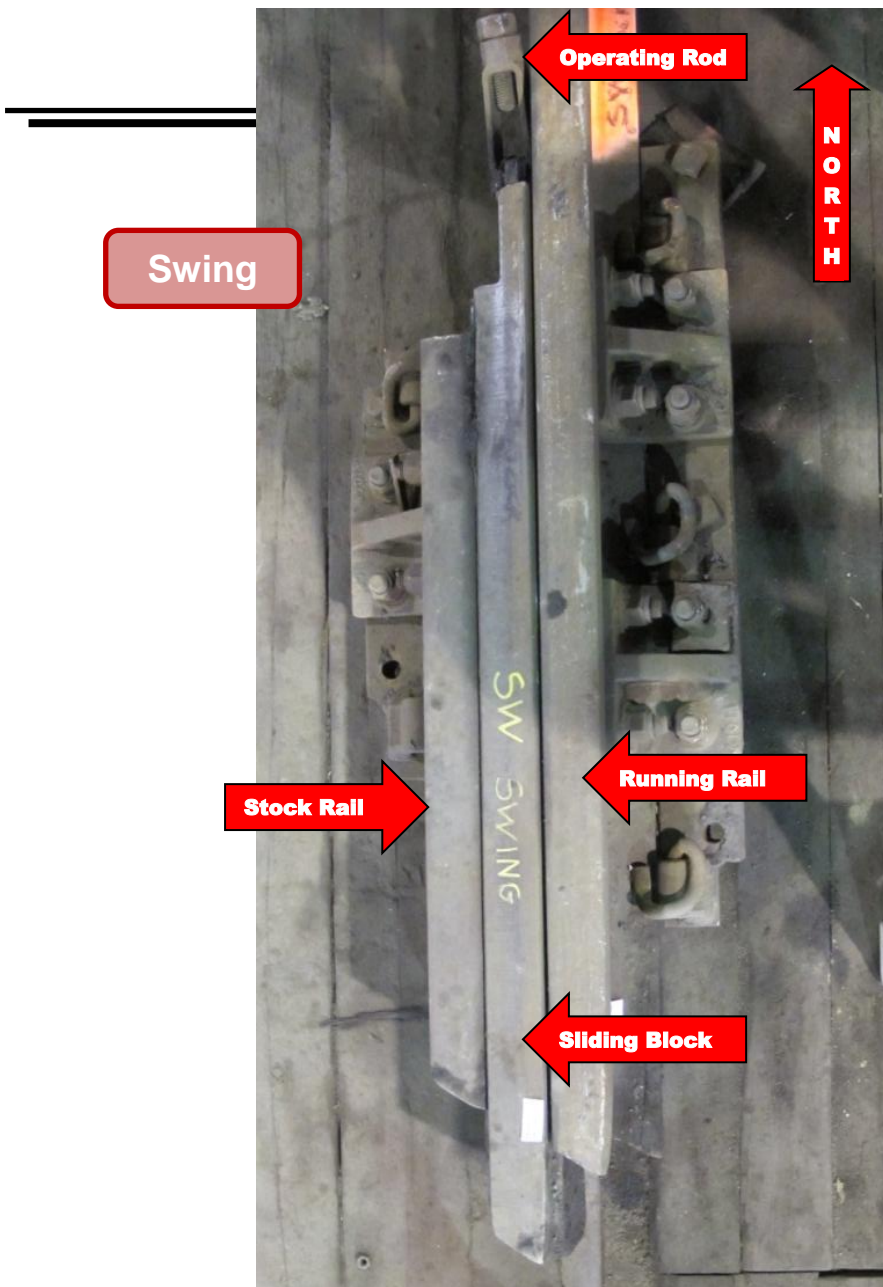
Figure 4. Images showing the arrangement of components at the south side of the bridge with many of the components labeled. West rail shown. The swing side components have been arranged with the sliding block in the extended locked position but not engaging the fixed side components (shown below). The approximate lock engagement length is also indicated.

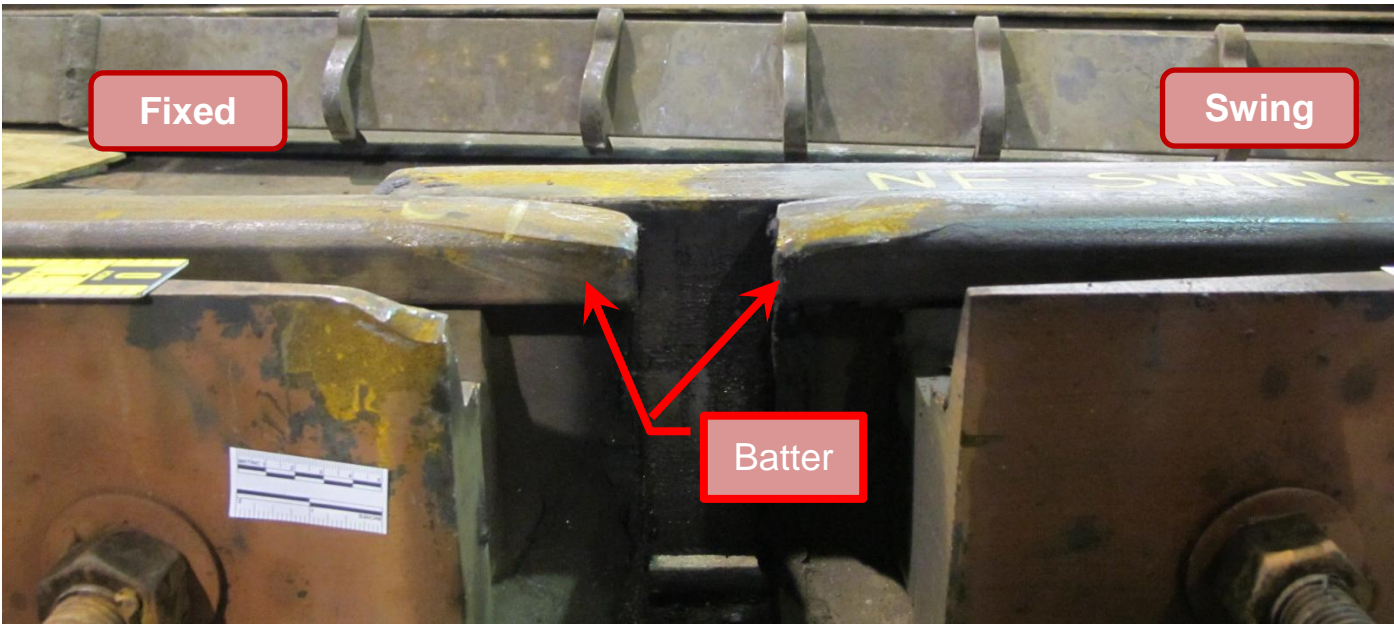
Figure 5. Side view looking east at the rail end battering on the running rail at the at the north bridge end gap. East rail shown, also typical of the west rail.

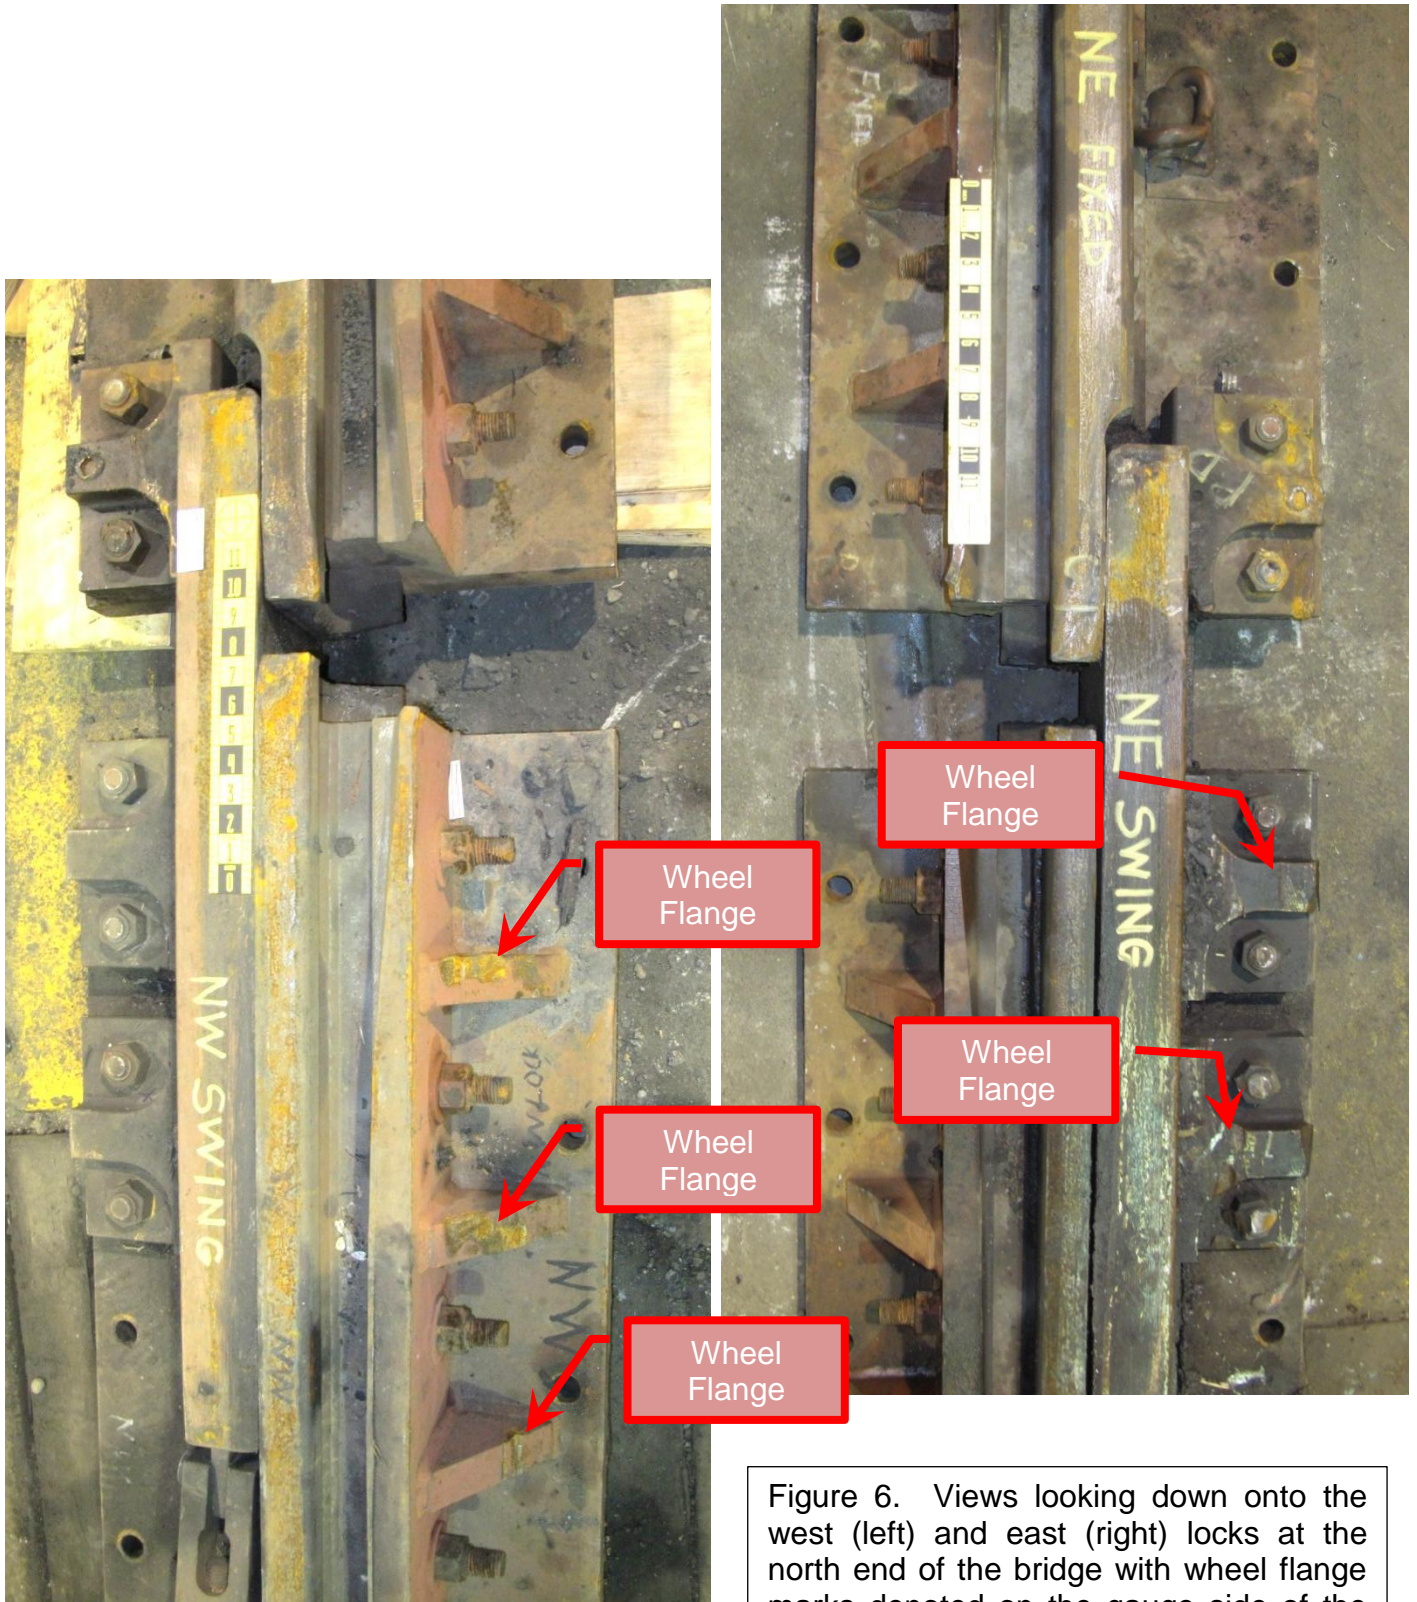
Figure 6. Views looking down onto the west (left) and east (right) locks at the north end of the bridge with wheel flange marks denoted on the gauge side of the west rail and field side of the east rail.

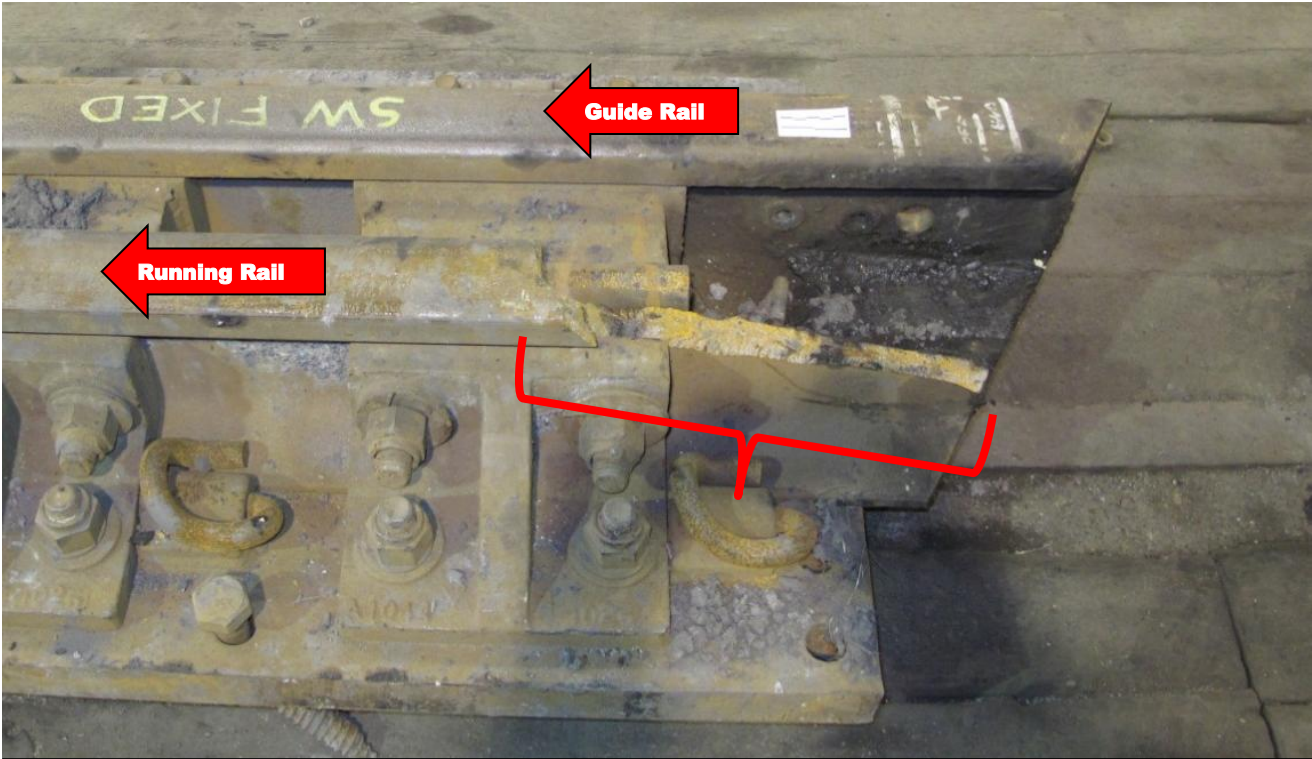
Figure 7. View of the fractured end of the running rail on the fixed south side west rail. View looking west.

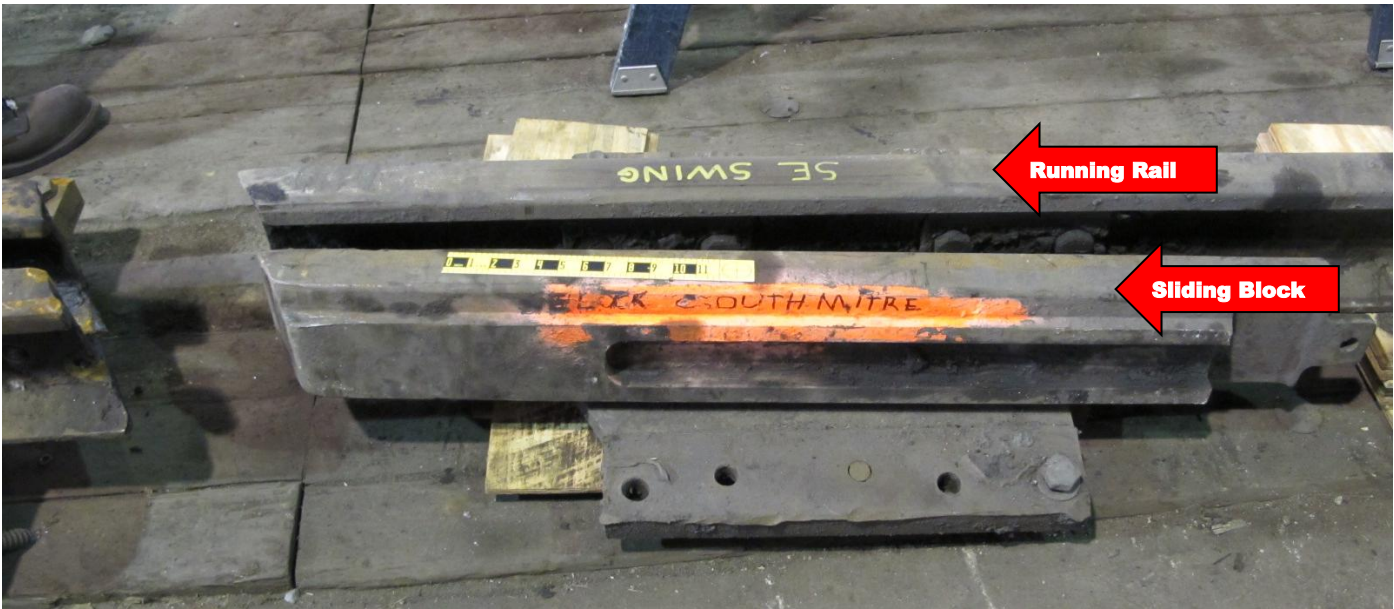
Figure 8. View of the south side east rail lock showing extensive damage to the bridge side components including; separation of the guide rail section with fracturing of the attaching bolts and release of the sliding block. View looking west.

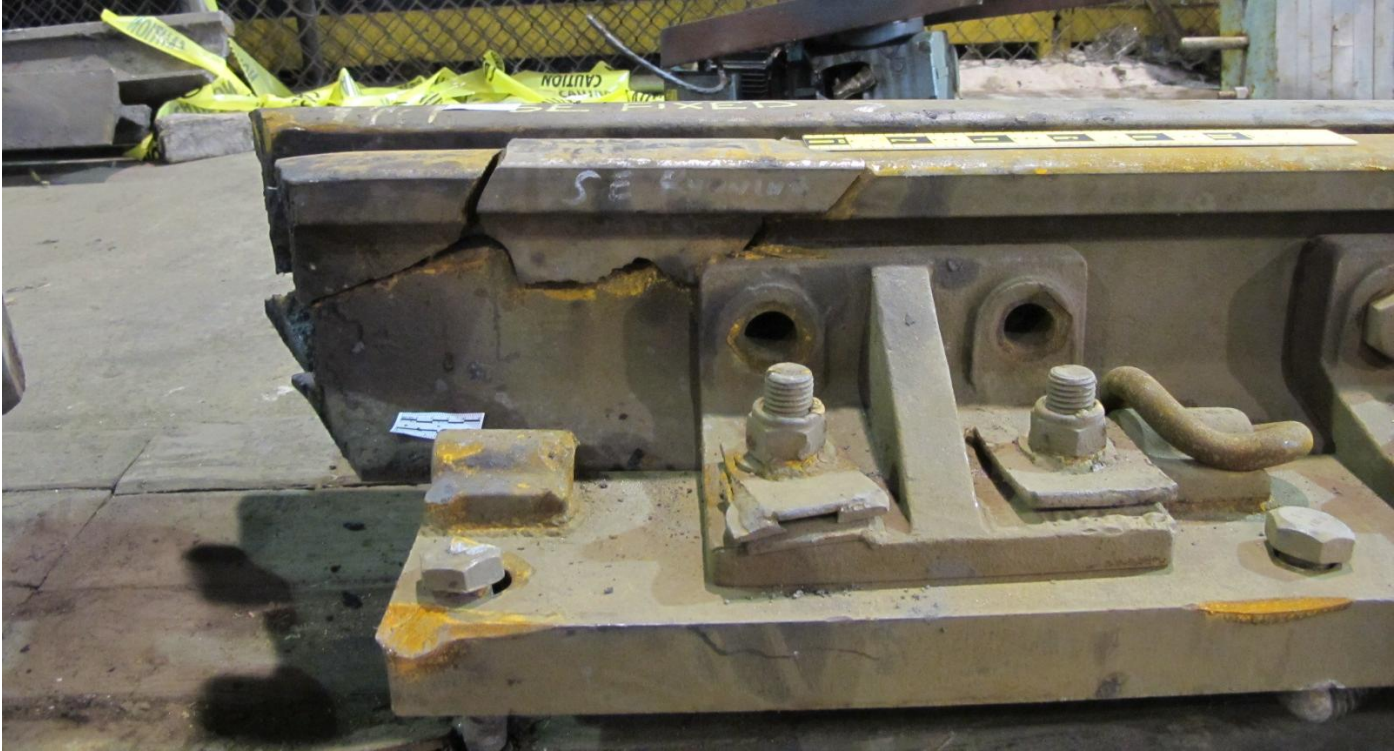
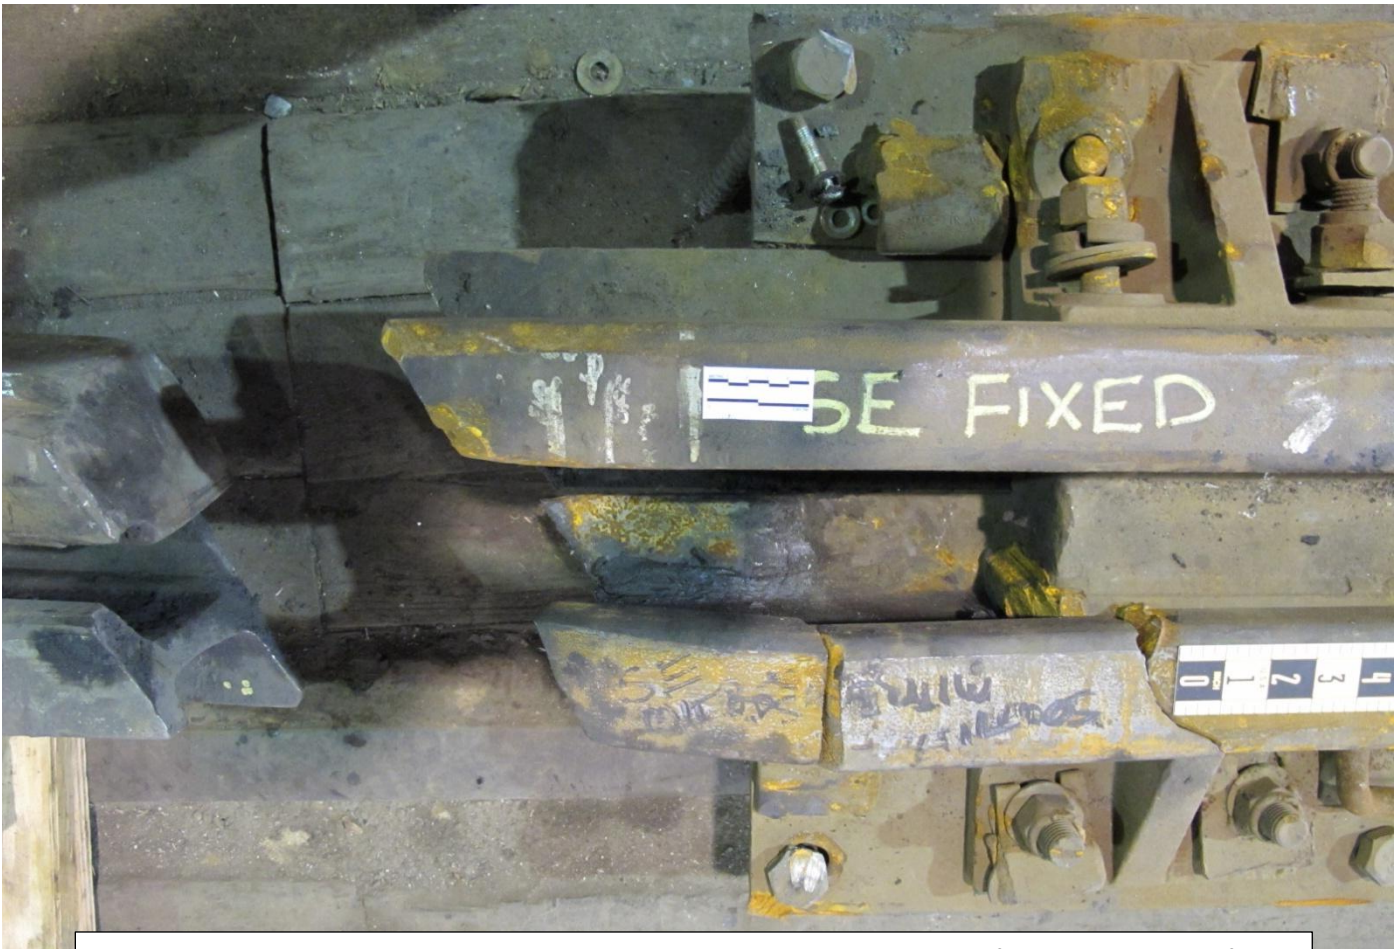
Figure 9. Upper view shows a side view looking east at the fractures in the fixed east running rail, south side adjacent to the gap. Lower view shows the same fractures from above relative to the grease line in the locking slot.

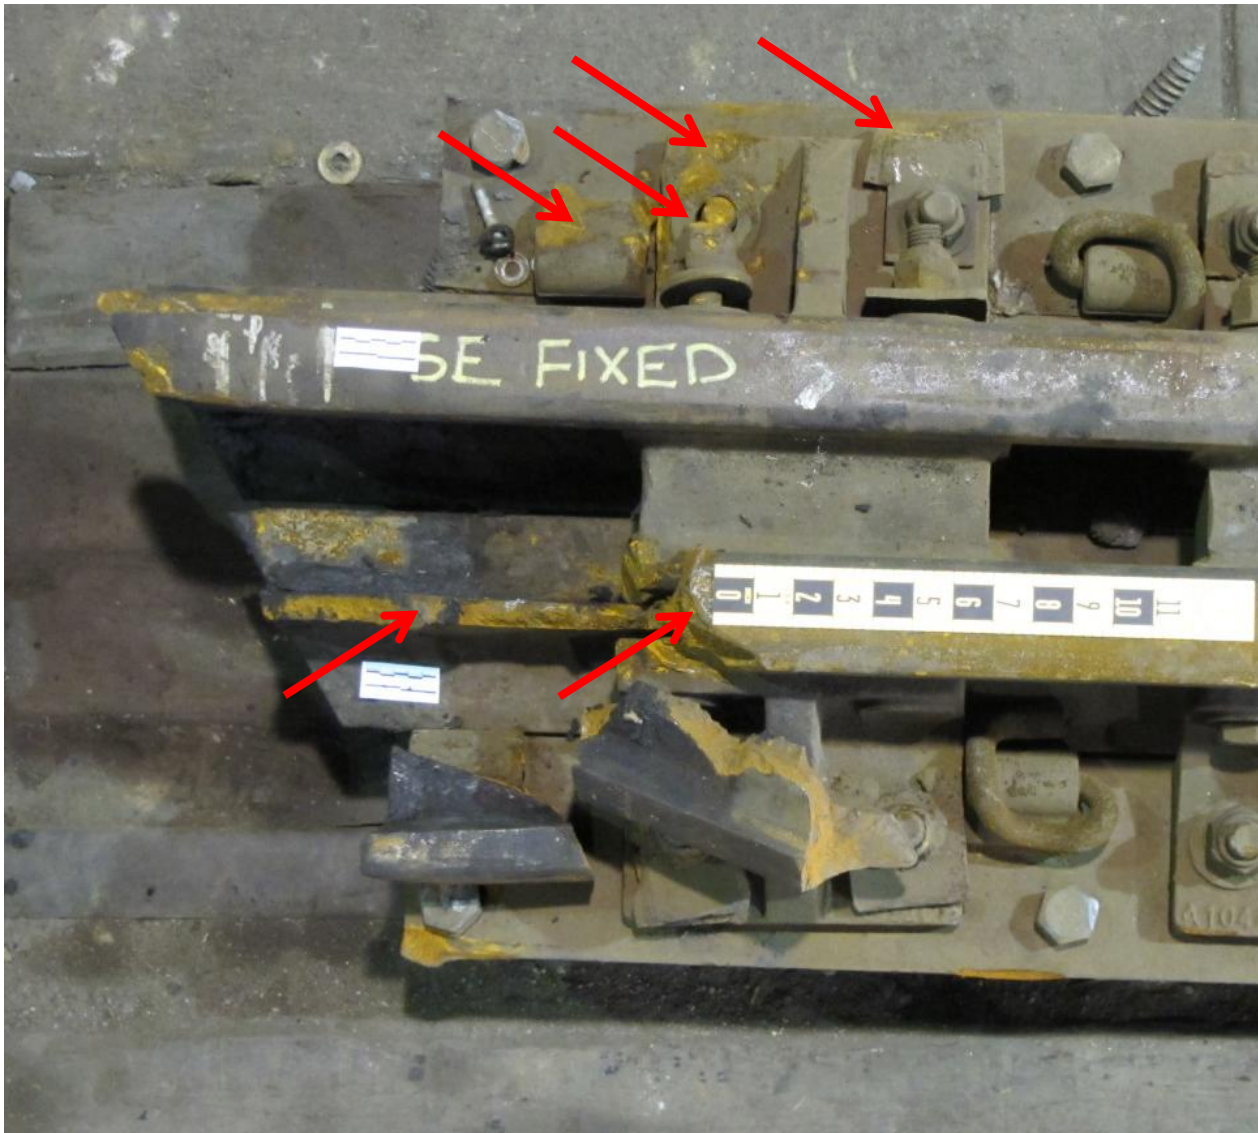
Figure 10. The fractured south side, east running rail with areas of wheel impact damaged denoted by arrows.

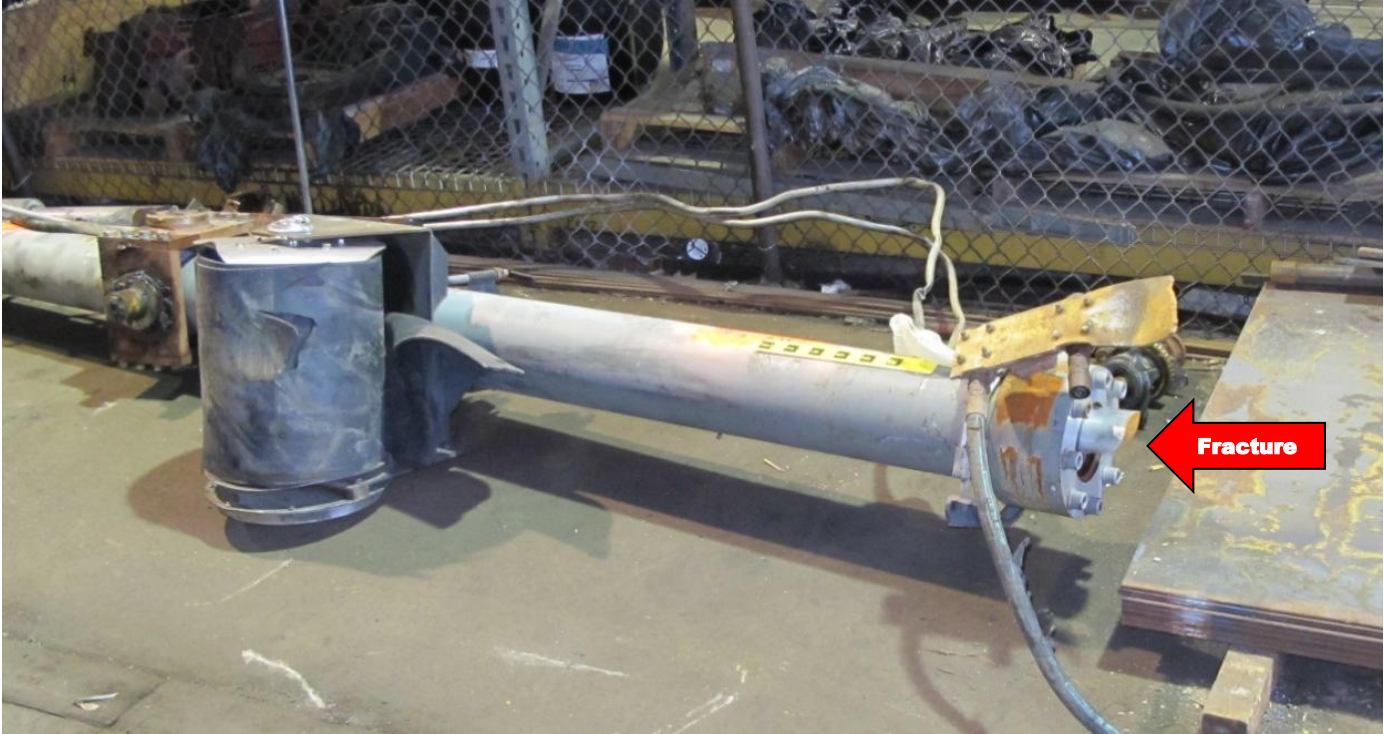
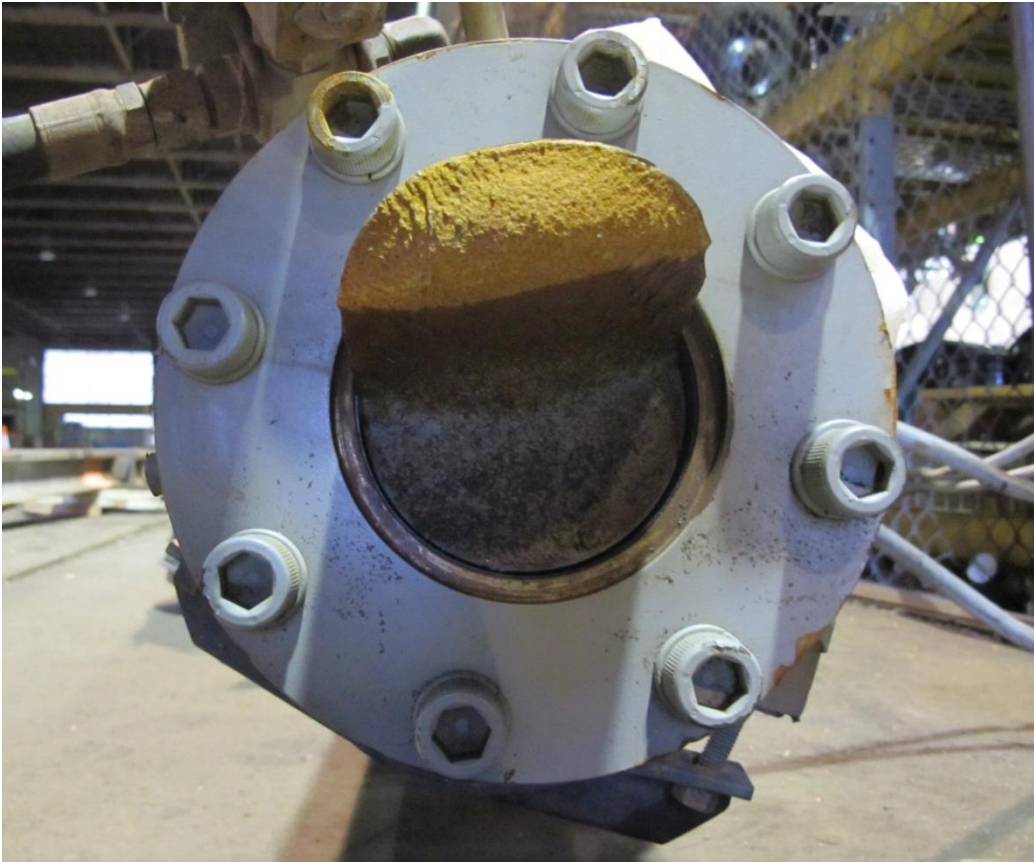
Figure 11. Overall view of the swing actuating hydraulic cylinder above with a closer view of the fracture below.
