**NATIONAL TRANSPORTATION SAFETY BOARD**  
**OFFICE OF RAILROAD, PIPELINE & HAZARDOUS MATERIAL**  
**INVESTIGATIONS**

**Track & Structures**

**FACTUAL ACCIDENT REPORT**

**Accident No.:** DCA-13-MR-002  
**Location:** Paulsboro, New Jersey  
**Date:** November 30, 2012  
**Time:** 06:59 a.m., Eastern Daylight Time  
**Railroad** Consolidated Rail Corporation  
**Property Damage:** \$450,654.00  
**Injuries:** None  
**Type of Accident:** Train Derailment and Hazardous Materials Release

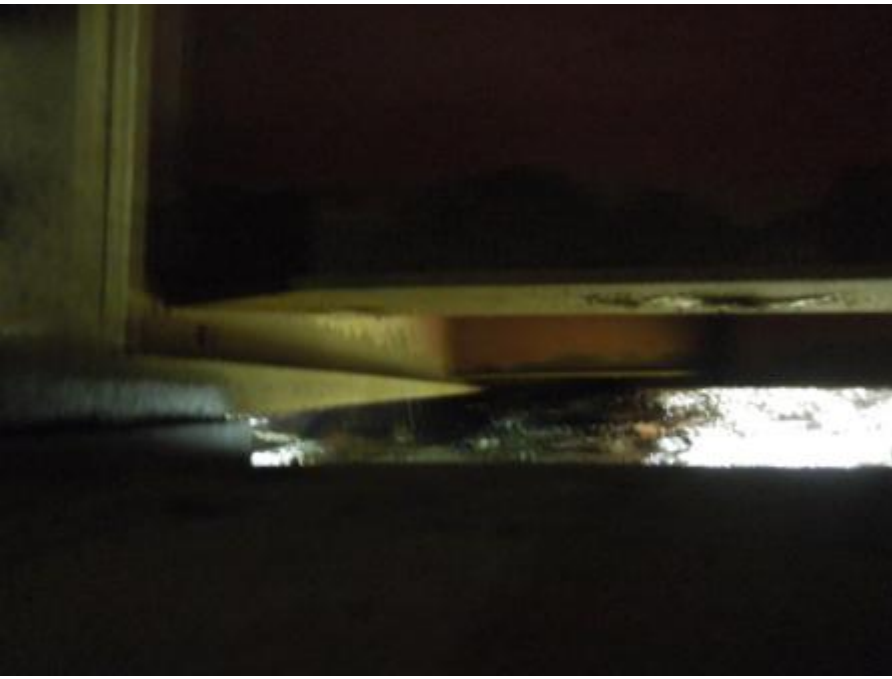
Photo 1. East girder bottom flange, span 1

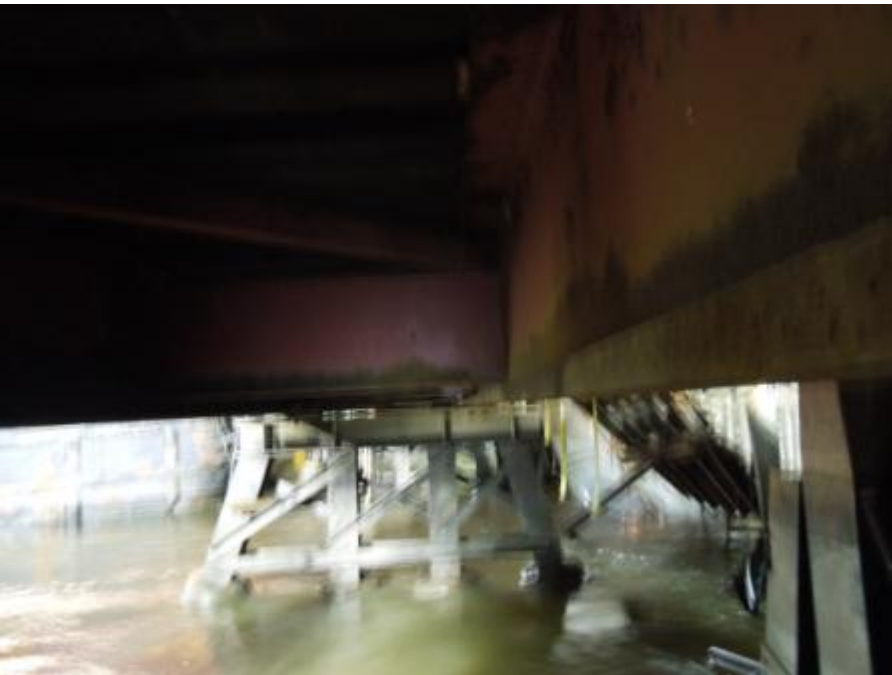
Photo 2. East girder, span 2

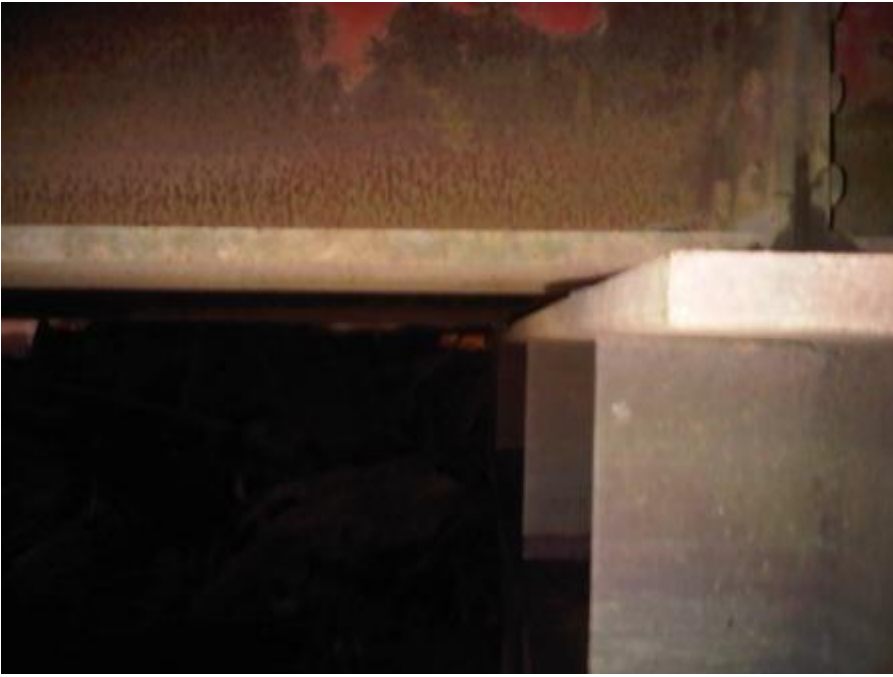
Photo B1. Bent 1 cap top flange looking east

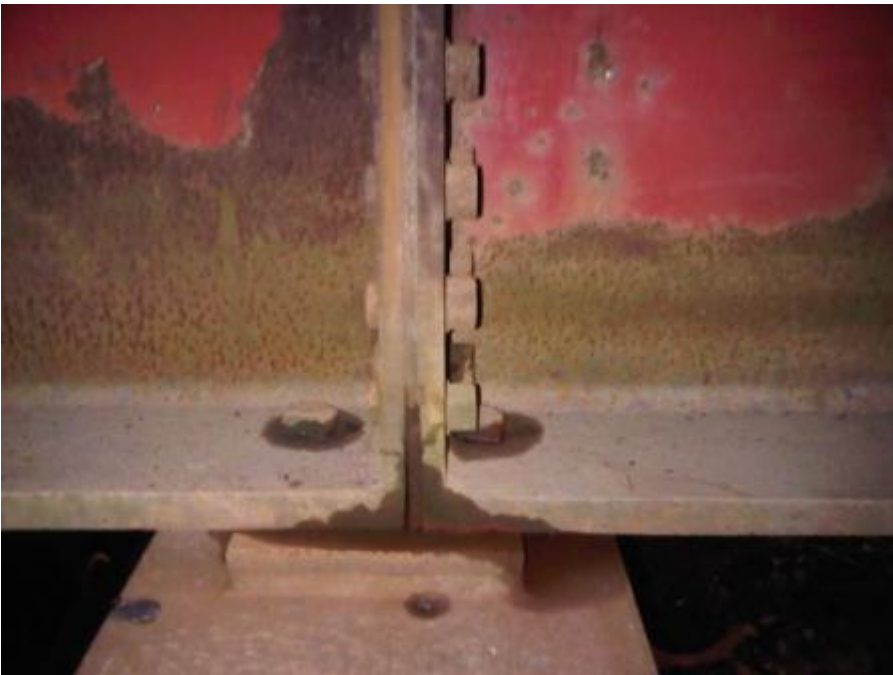
- The expansion bearing on Bent 1 is at the limit of movement (Photo B4). The girders are pushed south so the bearing bolt is bearing on the north side of the slotted hole. The bearing bolts are pushed out of plumb and girder movement to south is restricted. The USACE said that this condition would not contribute to a train derailment, but should be evaluated in the future.
- A dent exists in the bottom east flange of the east girder about mid-length of the swing span. The USACE said that this appears to have existed for some time and is of no concern.
- The northwest bearing stiffener of the east girder in Span 3 is distorted (Photo B6; bottom portion is pushed to the south). The USACE said that this condition is not considered to have contributed to the train derailment, but the condition should be evaluated in the future.

Photo B4. West expansion bearing on Bent 1

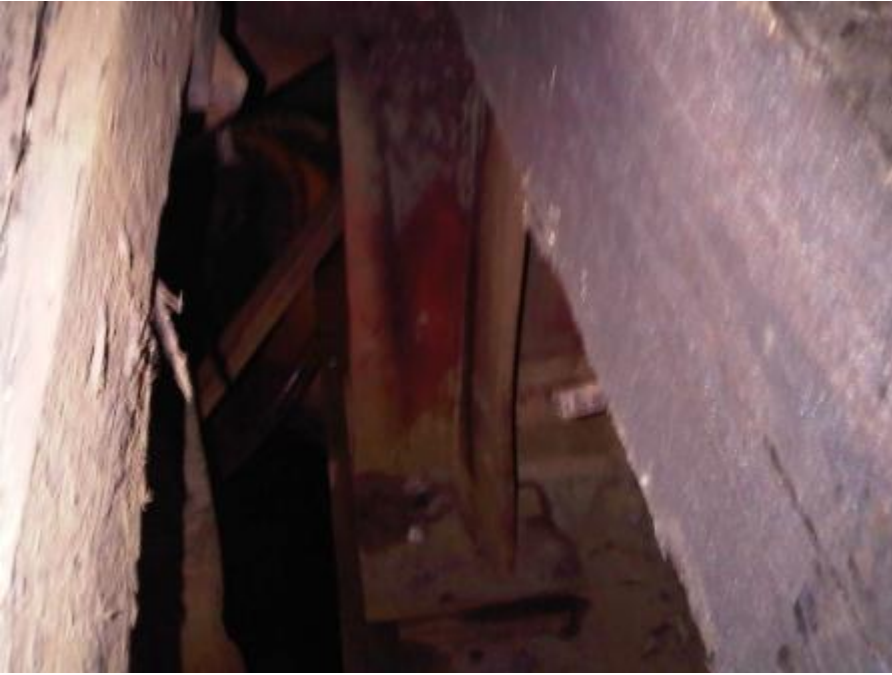
Photo B6. NW bearing stiffener, E girder, Span 3

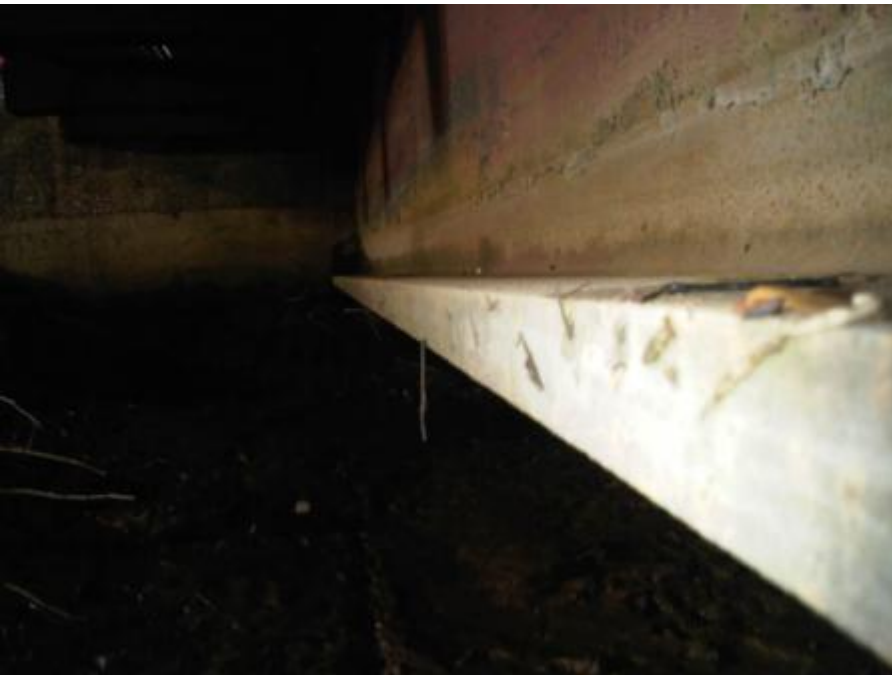
Photo B7. West girder bottom flange, span 4

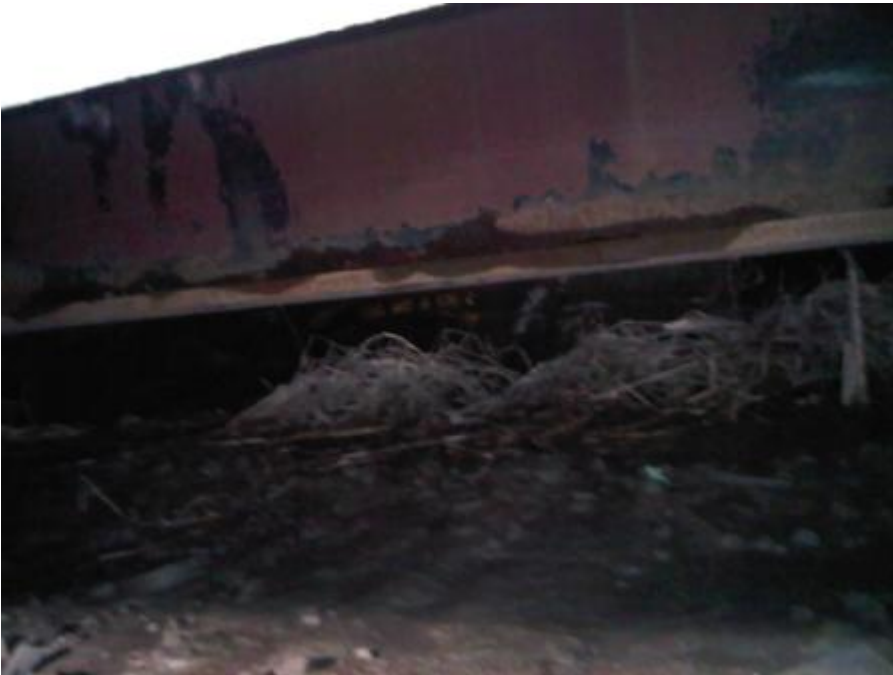
Photo B8. West flange of east girder, span 4

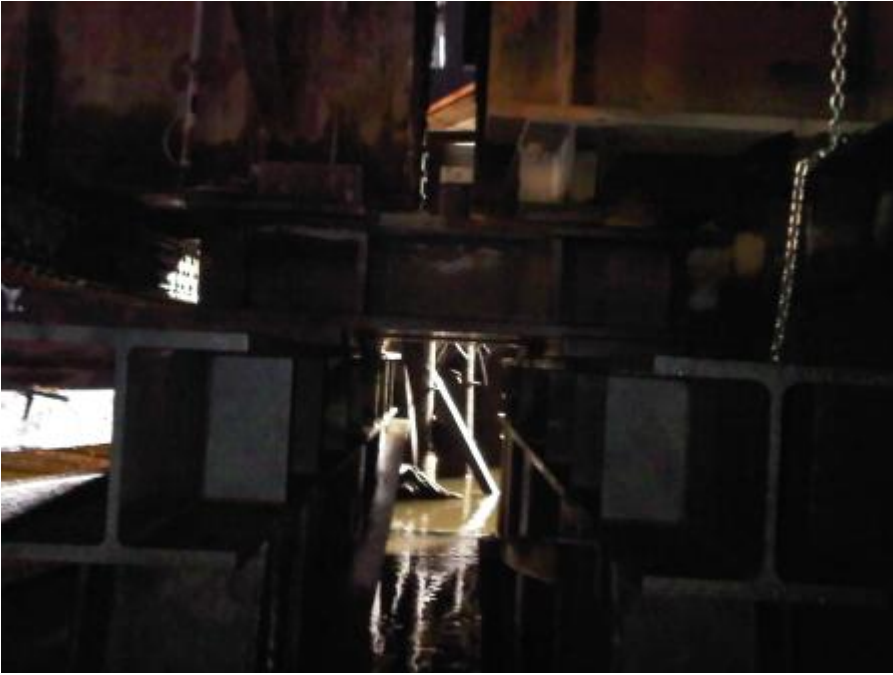
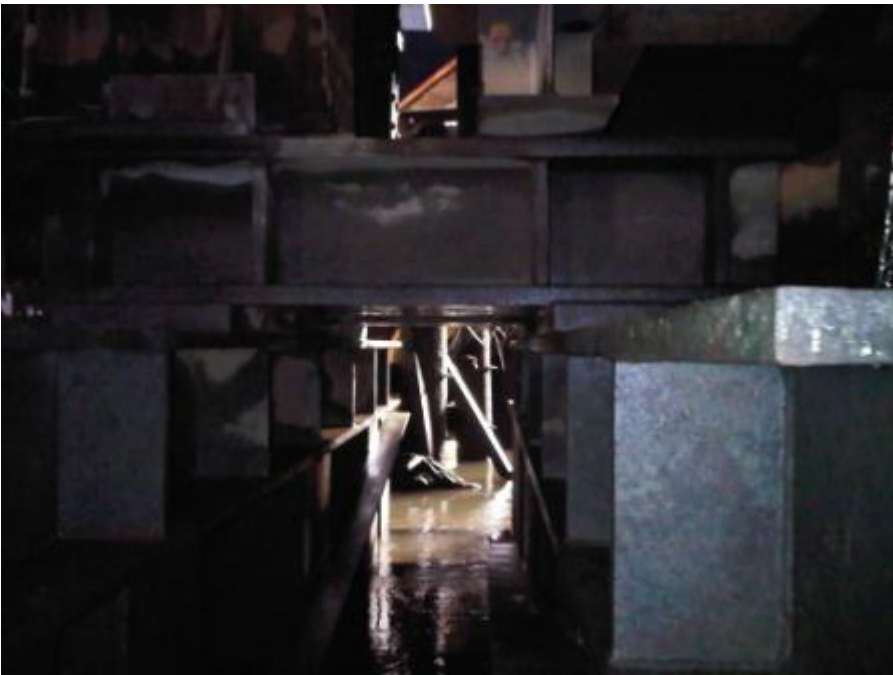
Photo B10. Double bent (toe bent and bent 4) looking west

Photo B11. Double bent (toe bent and bent 4) looking west

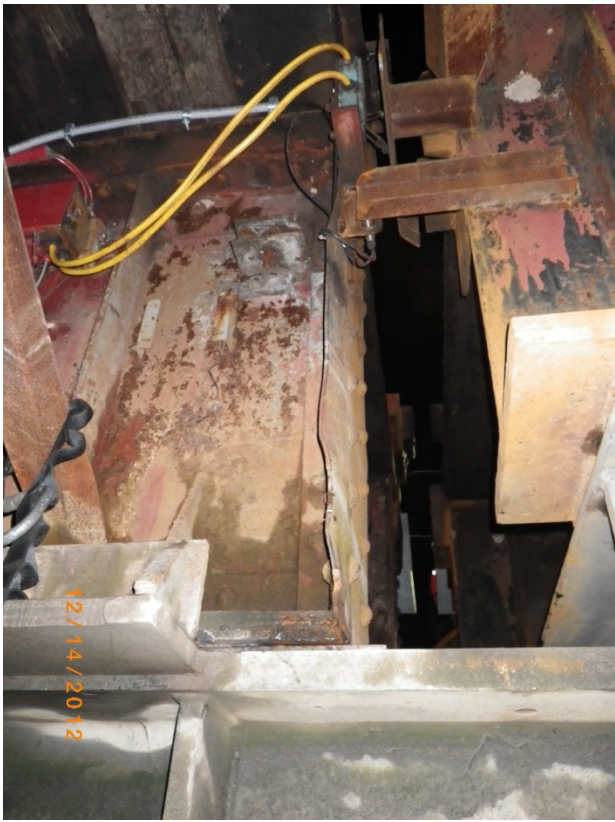
Photo B12. Northeast bearing bent – swing span, east girder

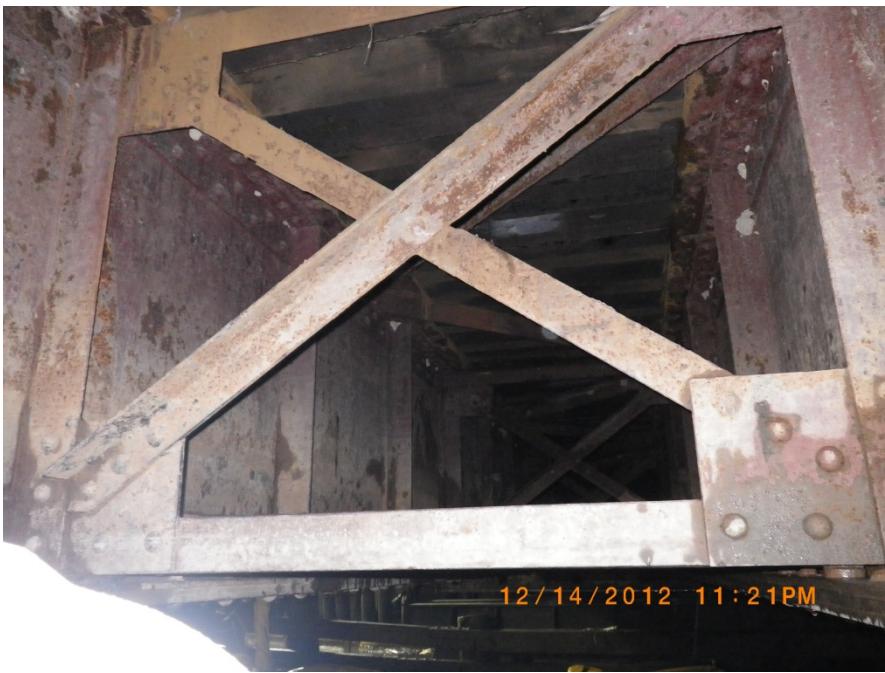
Photo B13. Internal bracing – swing span looking north

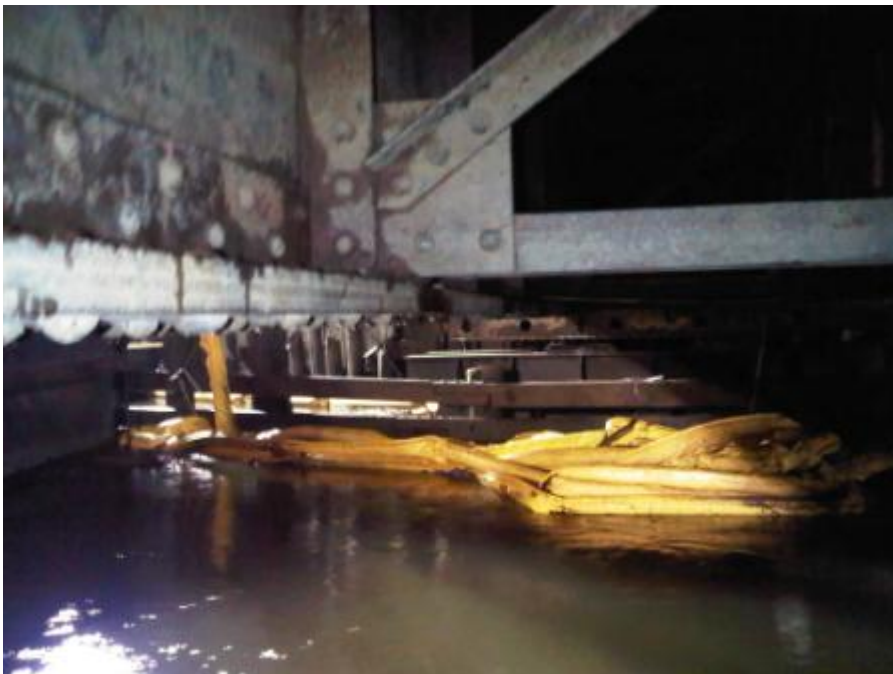
Photo B14. Swing span west girder bottom flange

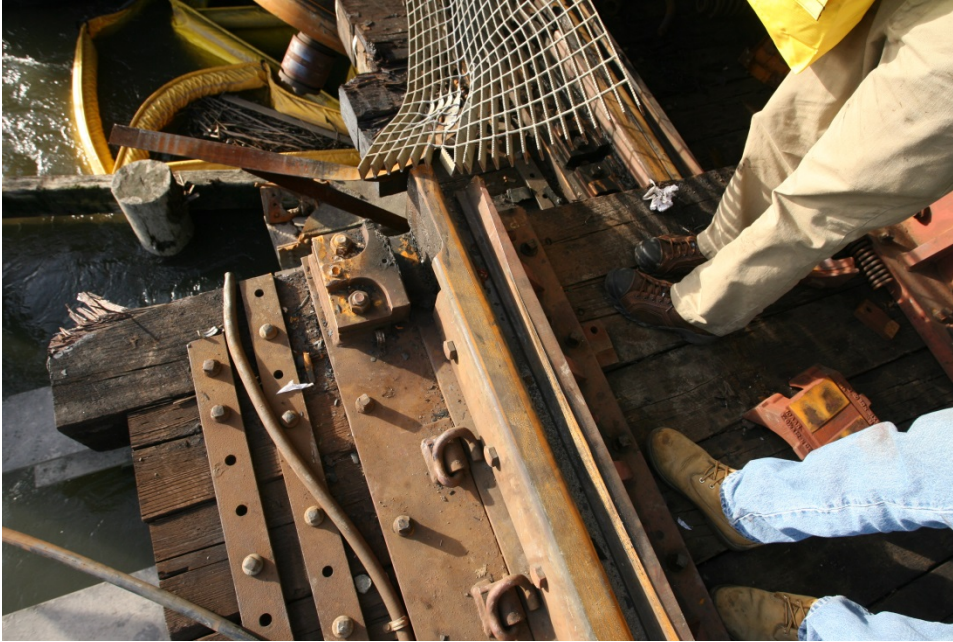
Figure 1A  
Northeast Slide Lock Assembly on the North Approach Span and POD

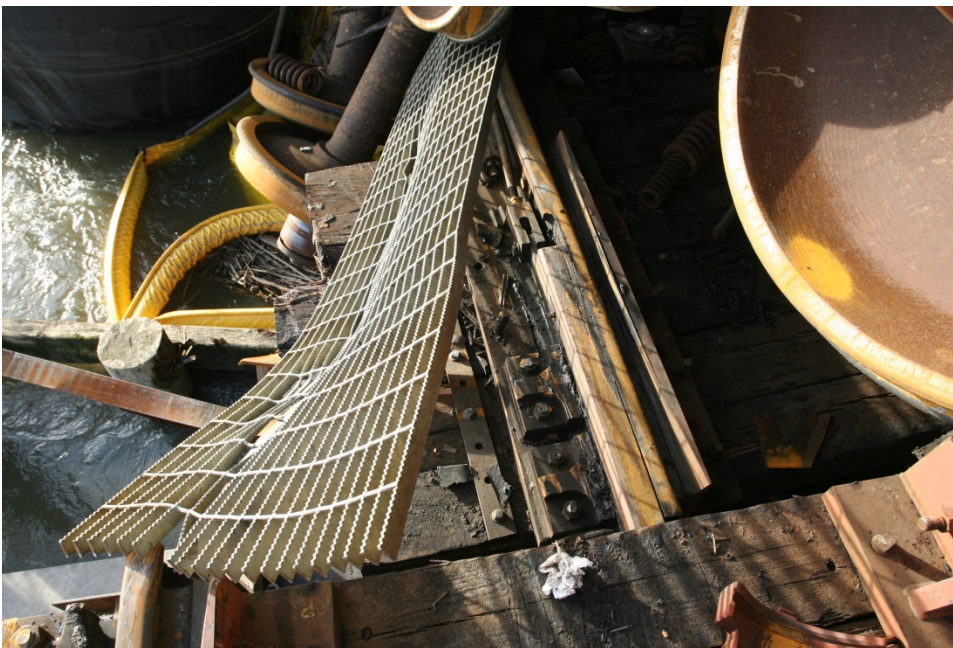
Figure 2A  
Northeast Slide Lock Assembly on the North Swing Span and POD

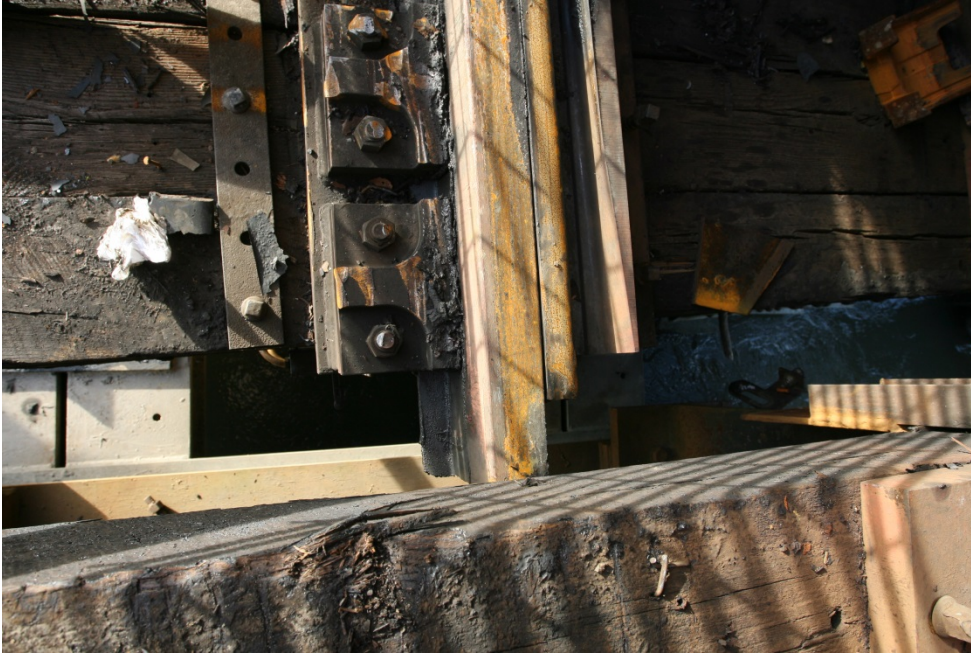
Figure 3A  
Northeast Slide Lock Assembly on the North End of the Swing Span and Initial Sign of  
Wheel Marks Crossing the Movable Bridge

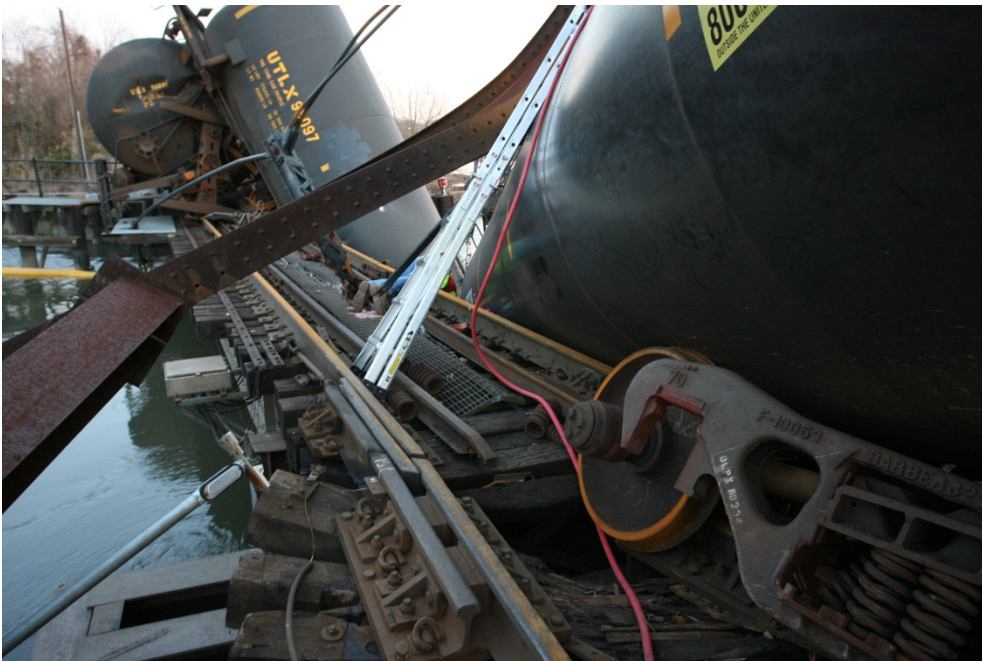
Figure 4A  
Looking from the Southwest End of the Swing Span Toward the North End Tracing  
Wheel Marks
