## Transport Canada

# Aviation Safety Ultralight and Balloon 1/1999

## Swaging Methods Cause Structural Failures

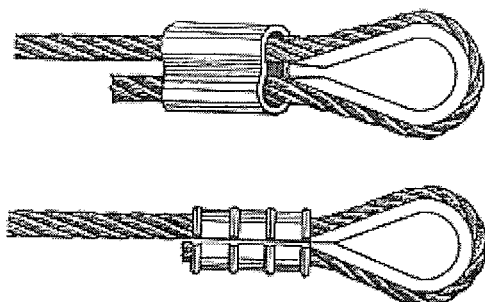
Typical thimble-eye splice.

*Diagrams illustrate a correctly swaged fitting and the use of a terminal gauge to ensure that the correct sleeve is used and that the sleeve is properly formed around the cable.*

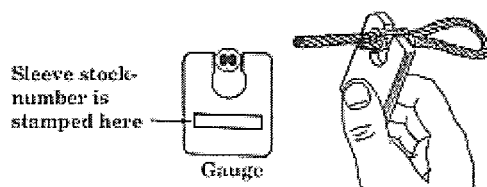
Typical terminal gauge.

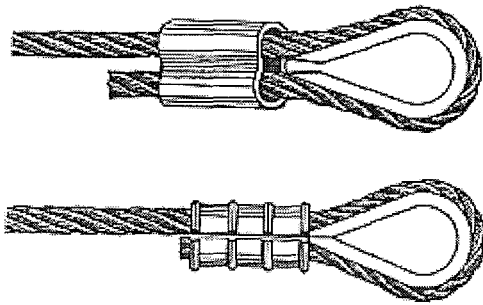
Typical thimble-eye splice.

Typical terminal gauge.

*Diagrams illustrate a correctly swaged fitting and the use of a terminal gauge to ensure that the correct sleeve is used and that the sleeve is properly formed around the cable.*
