ENGINEERING REPORT

ENGINEERING REPORT RAPPORT TECHNIQUE	LP125/2006
Compressor Turbine Blade	
DHC-6-200, N203E	
Occurrence Date: 29-Jul-06

1.0 INTRODUCTION

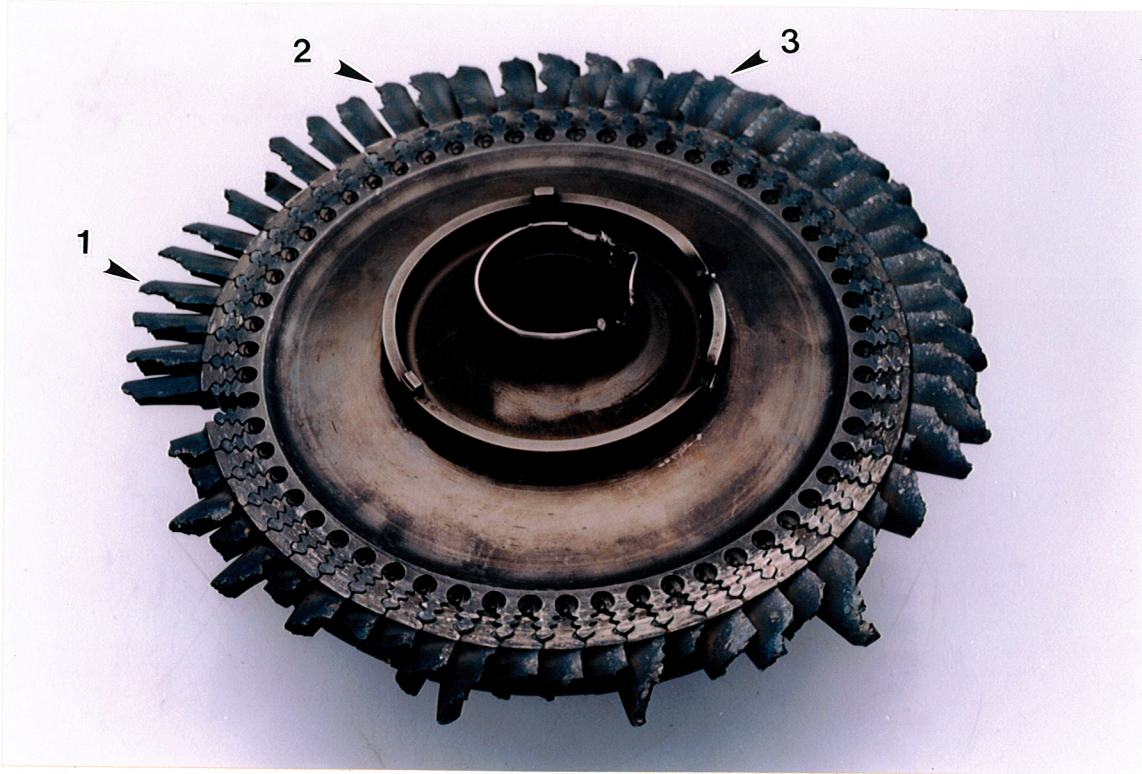
- 2.1 The as received parts as shown in Figure 1 comprise a bladed P/N 3013511 H, S/N A7189 compressor turbine wheel. A single blade had been removed from the wheel prior to submission in order to identify the blade part number. The part number, T-023401, was that of a PMA produced blade manufactured by Doncasters Inc. and carried a heat code marking 8ERE. The blade which is a cast IN738 alloy has been installed in place of the original PWC blades which are made from an IN 713C nickel-based superalloy.

Figure 1 As received P/N 3013511, S/N A7189; compressor turbine wheel. The numbers 1, 2 and 3 indicate the location of the three blades removed for metallographic examination. The other open slot in the wheel is the location of the blade removed by PWC in order to identify the part number.

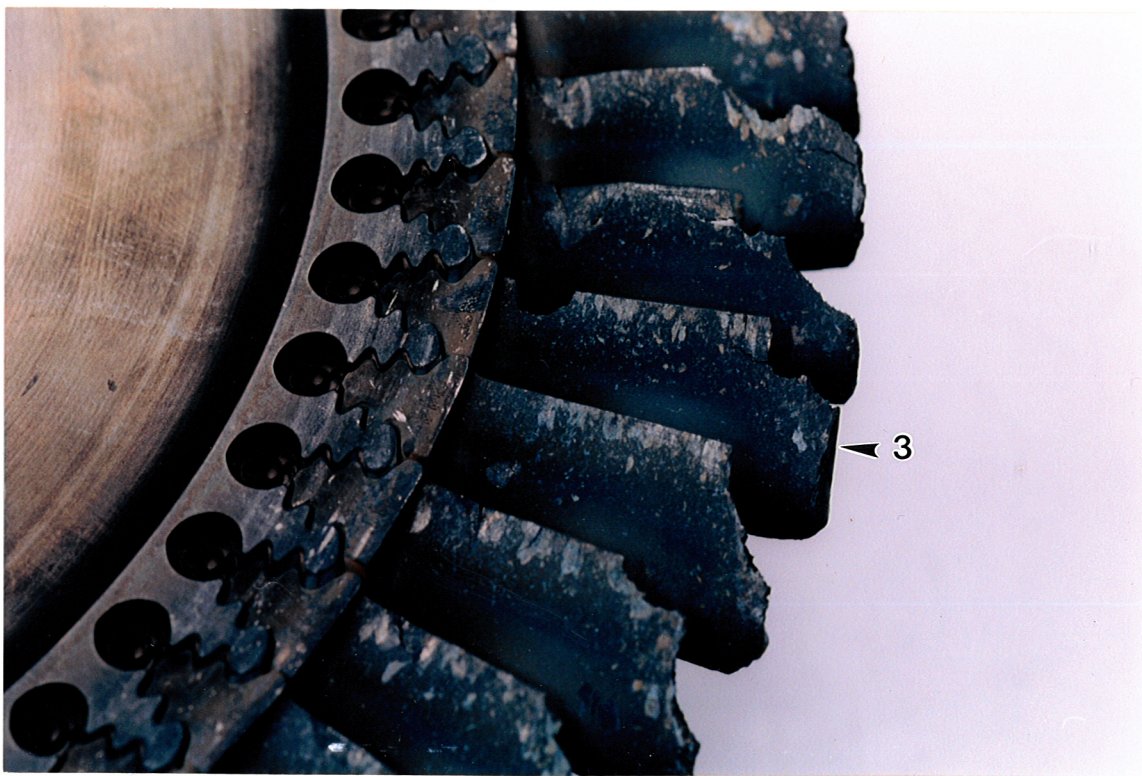
- 2.2 All blades on the wheel as received show damage ranging from the loss of blade structure in the region of the tip, as Figure 2, to complete loss of the airfoils by fracture just above the blade platform, see Figure 3. The fracture surfaces of all missing portions were examined in the in situ blades using the binocular microscope. The fracture surfaces had a uniform dark appearance with a coarse granular texture, as Figure 4, usually associated with the overload fracture of a cast material. The overall appearance is consistent with fracture of an interdendritic nature. No evidence was found of any precrack formation such as a change in the colouration of the surface or in the fracture surface topography. The possibility that precracking had occurred in another location only for the impact of released blade material to cause further blade loss cannot be entirely discounted, although progressive failures are most often found close to the blade platform and one surface of the fracture is usually retained. Because of the uniformity of the fracture surfaces further examination using the scanning electron microscope was considered unnecessary. Three blades, shown as #1, #2 and #3 in Figure 1, were selected. These blades, which show the longest

Figure 2 Section of as received turbine wheel showing the most intact blades, including blade #3, indicated. Limited damage with loss of airfoil section both on the tip and blade edges.

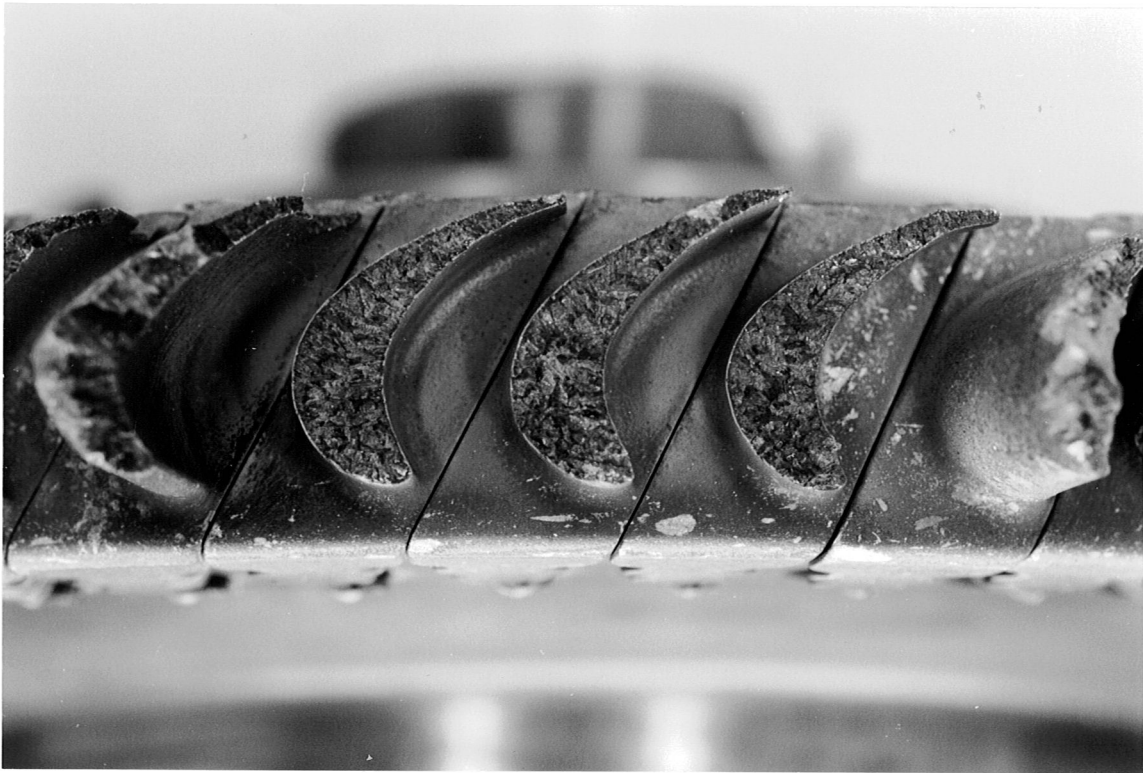
Figure 3 Fracture surfaces of a section of the wheel showing fractures in the blades just above the blade platform. Fracture surfaces are of uniform appearance with no evidence of precracking.

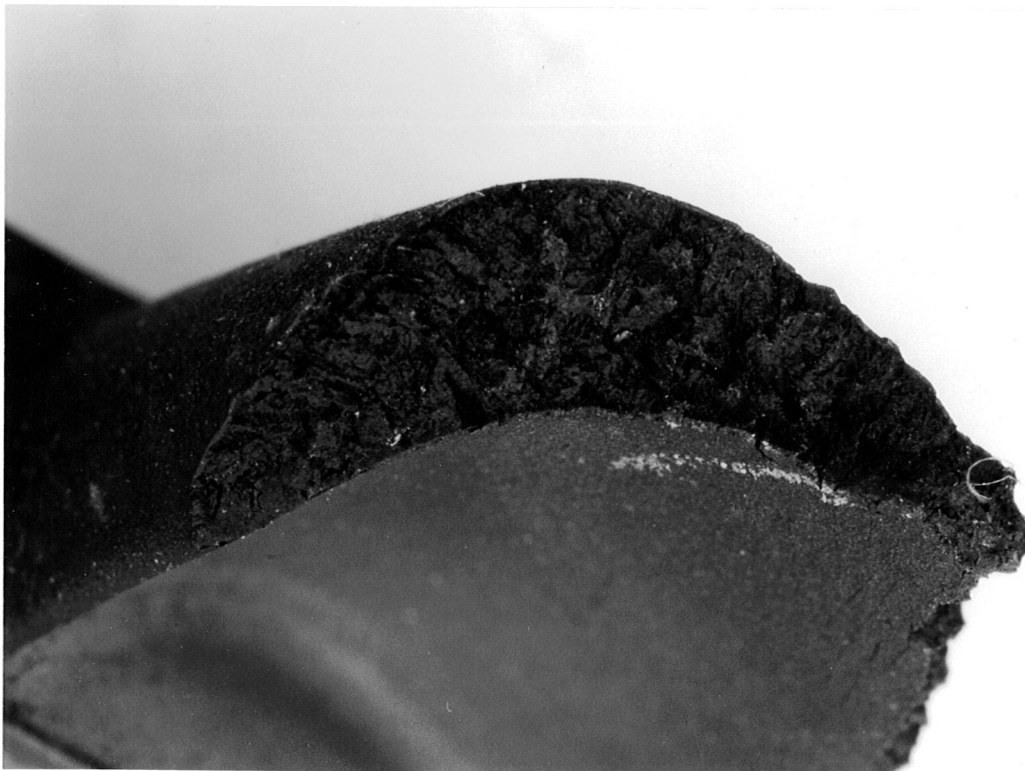
3.1 Examination of the blade fractures found surface features which were consistent with an overload separation. No fractures were found which showed evidence of precracking or of any form of progressive failure.

Figure 4 Close up view of a typical blade fracture surface showing an interdendritic fracture from applied overloads.

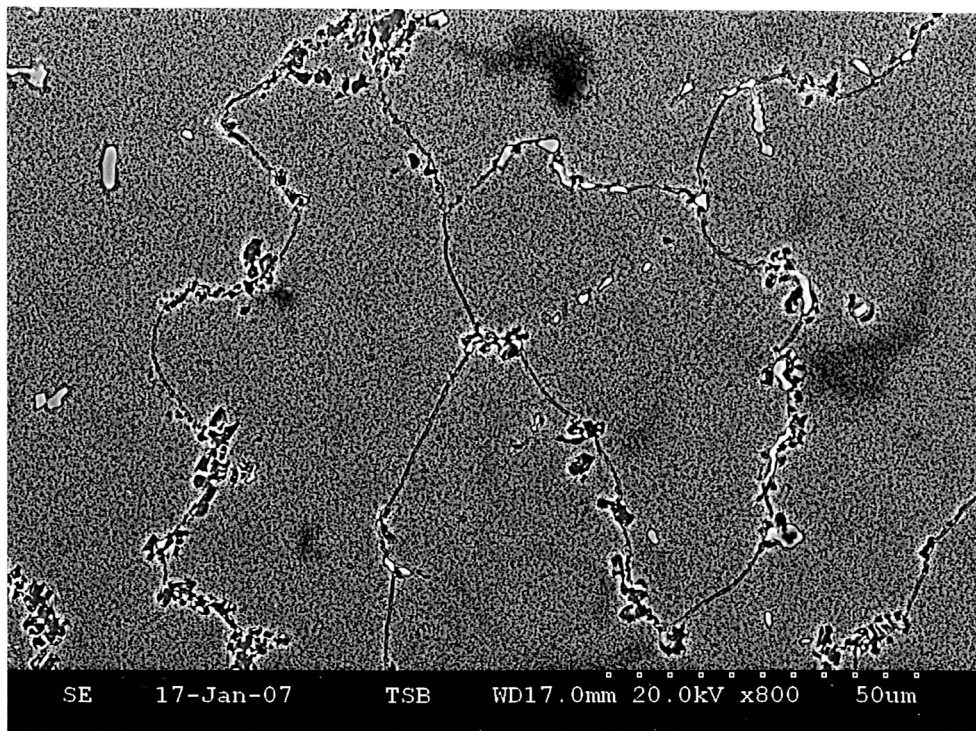
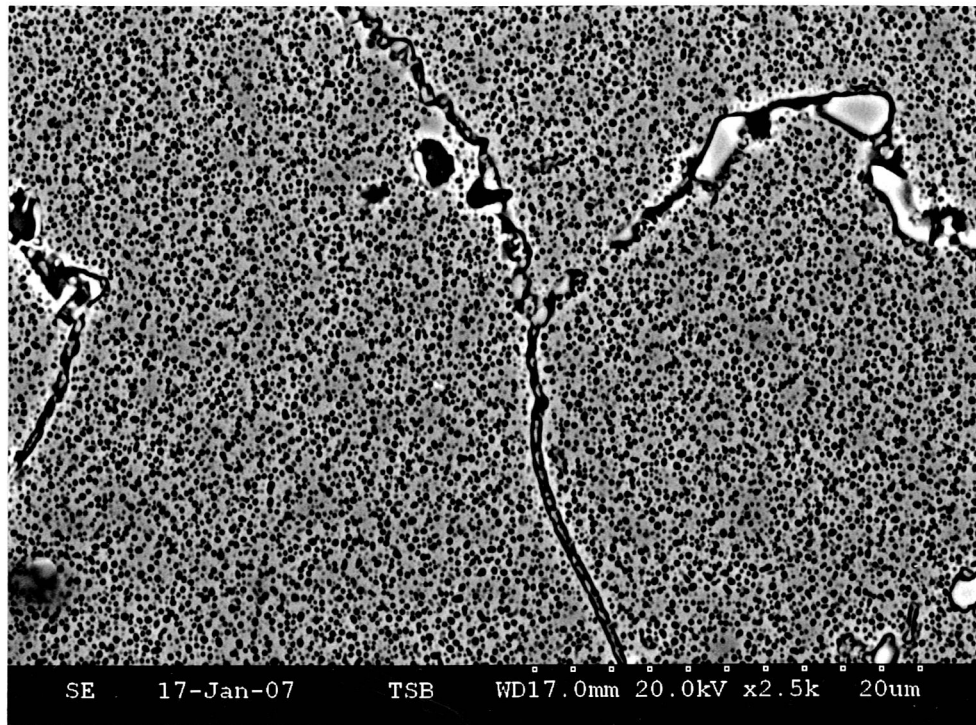
3.2 Examination of the blade microstructures found no evidence of creep failure either in the form of grain boundary microcracking or formation of microvoids. Some changes in the morphology of the gamma prime precipitation hardening phase and overall microstructures were found out towards the blade tips relative to an exemplar new blade which are believed to represent natural aging of the

Figure 5 Microstructure of Blade #3 in the region of the tip. No evidence of grain boundary voids or inter-crystalline cracking. Magnification (a) 800X, (b) 2500X.

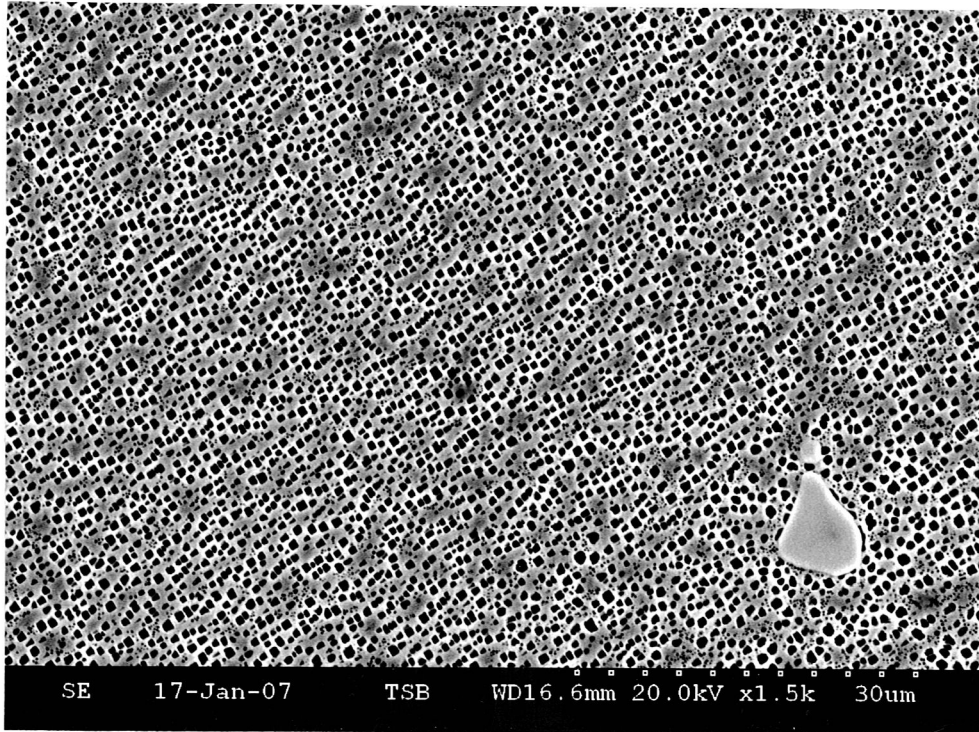
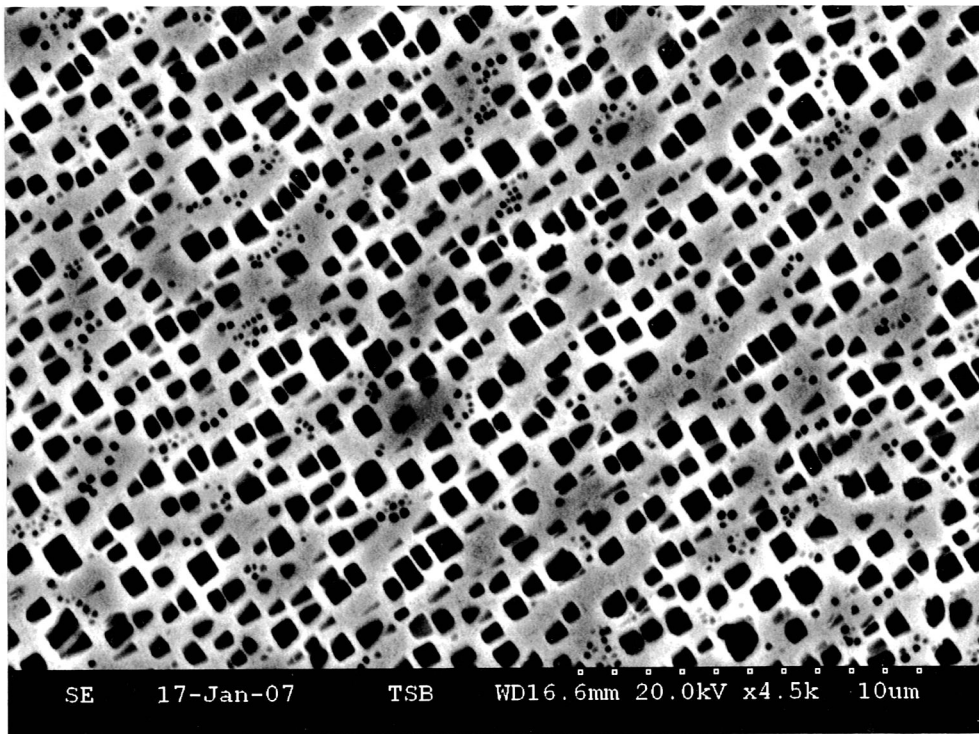
Figure 6 Microstructure of Blade #3 in the blade root region. Magnification (a) 1500X, (b) 4500X.

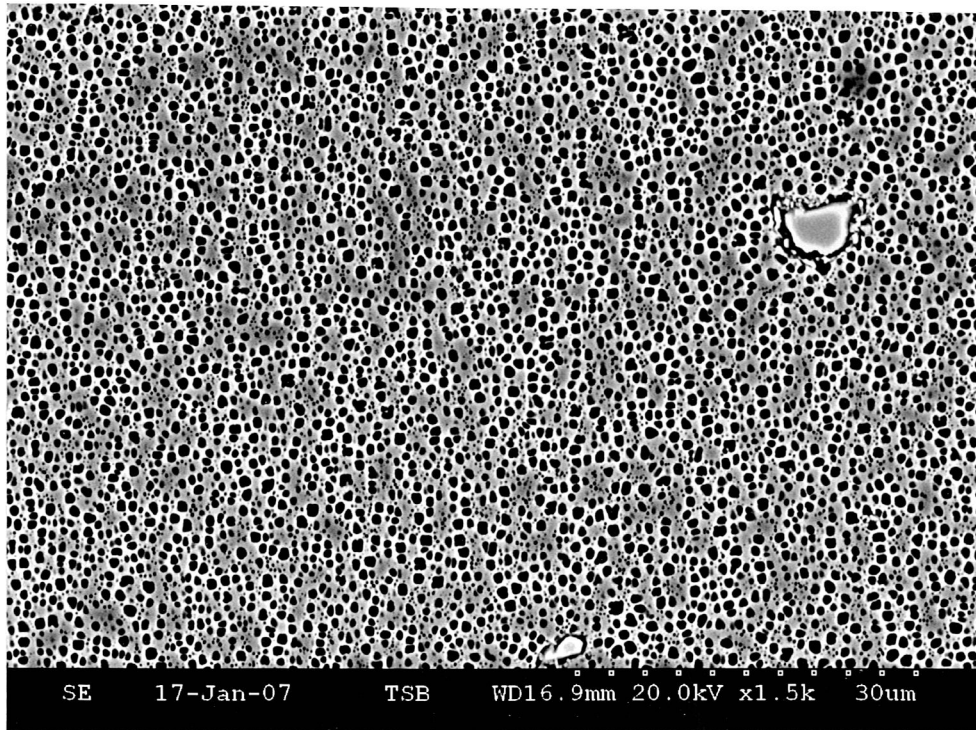
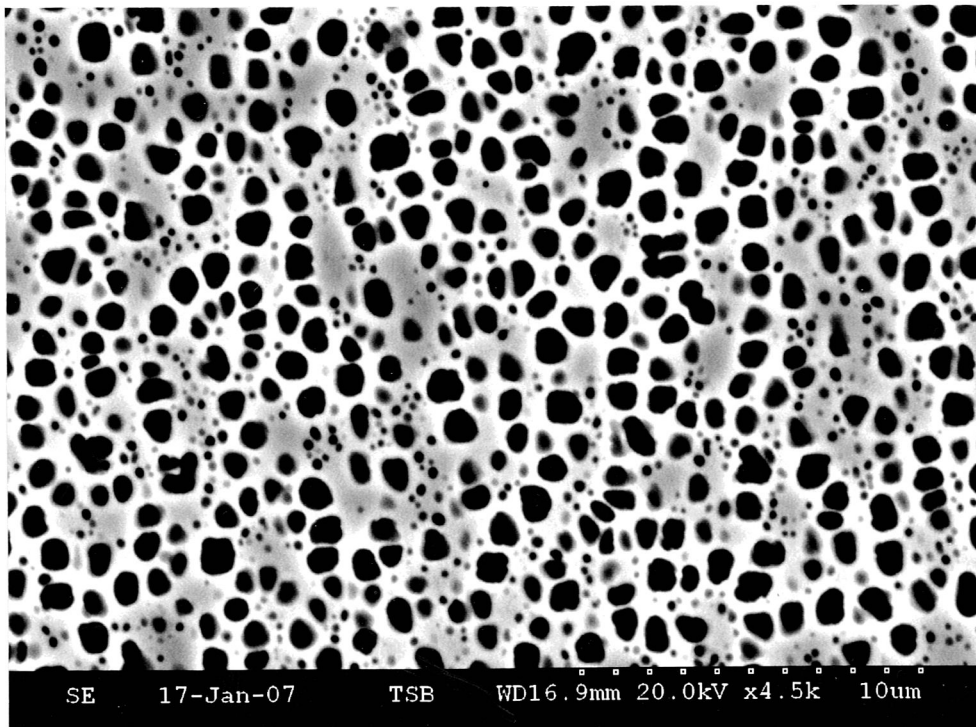
Figure 7 Microstructure of Blade #3 at approximately blade mid-span. Magnification (a) 1500X, (b) 4500X.

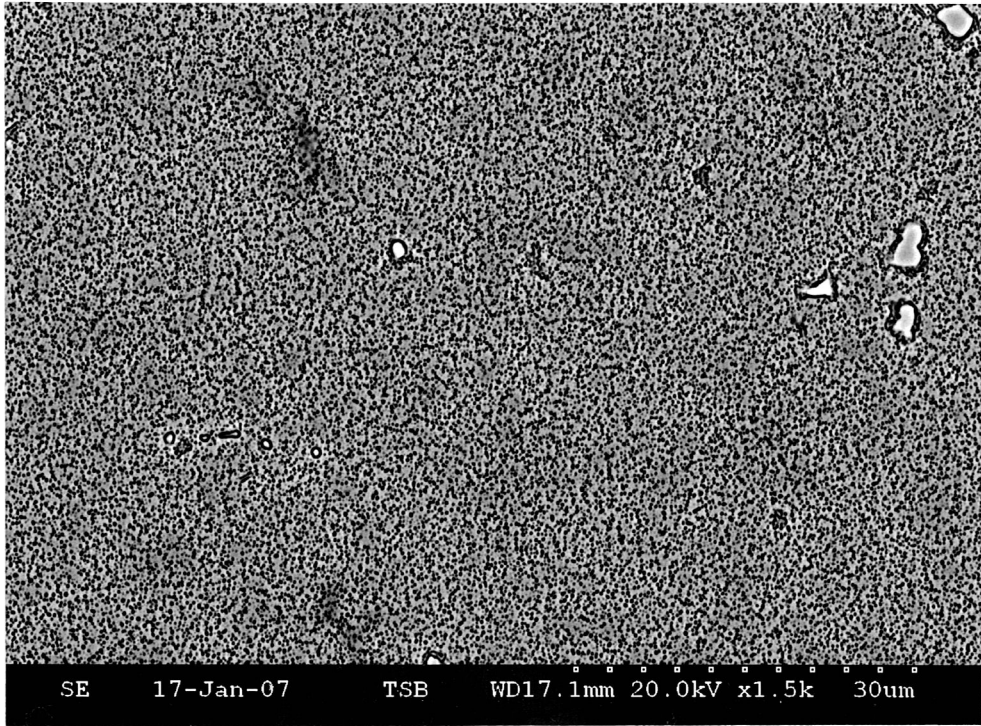
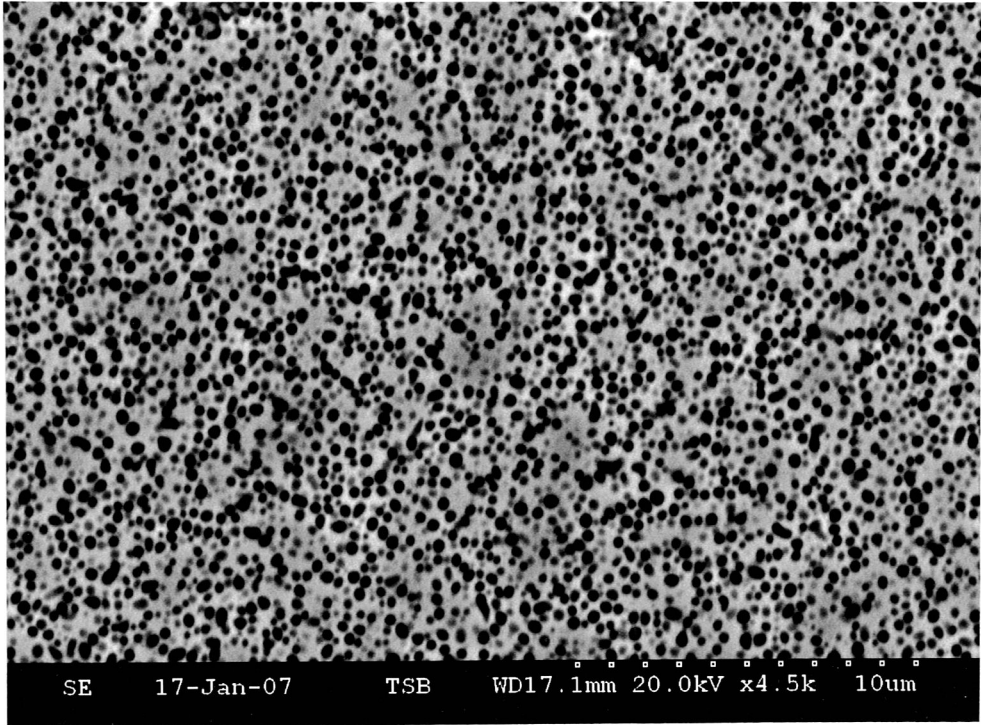
Figure 8 Microstructure of Blade #3 at the blade tip. Magnification (a) 1500X, (b) 4500X.

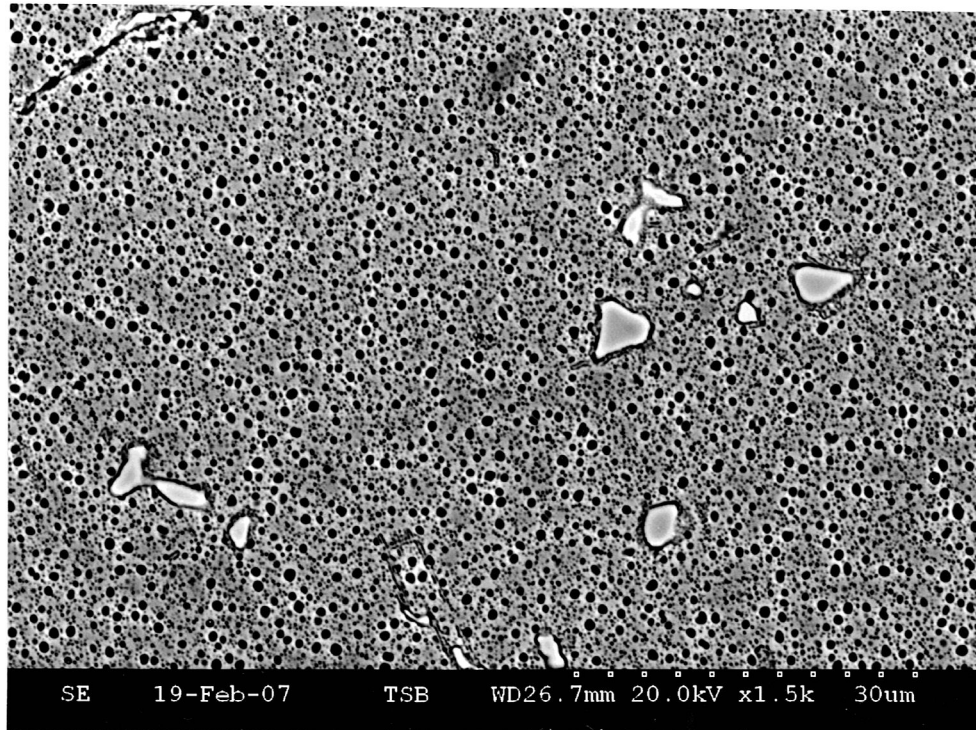
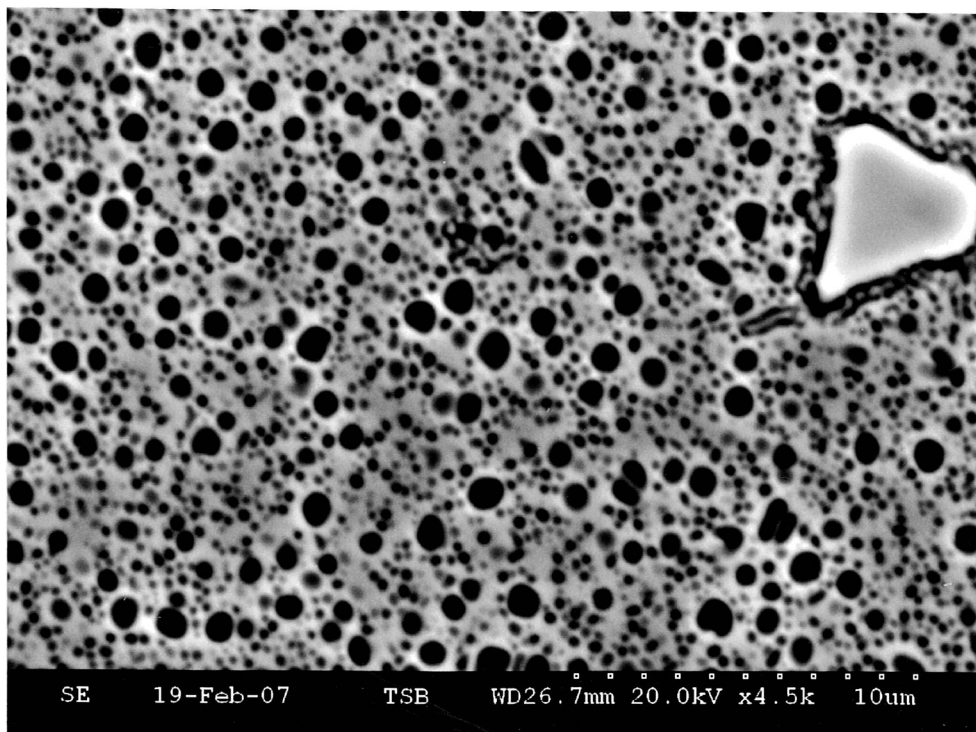
microstructure of the IN 738 material as the result of operation in service at normal turbine temperatures.

Figure 9 Microstructure of blade #3 in area between mid-span and the tip end showing the re-resolution of the original gamma prime and appearance of a distribution of smaller second phase particles. Magnification (a) 1500X, (b) 4500X.

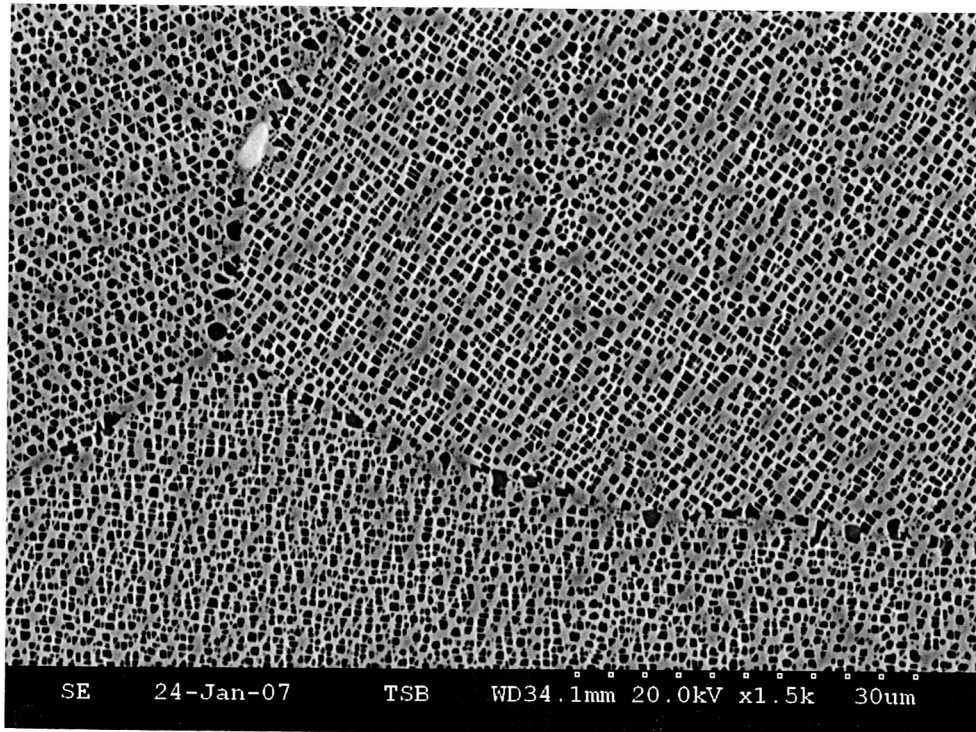
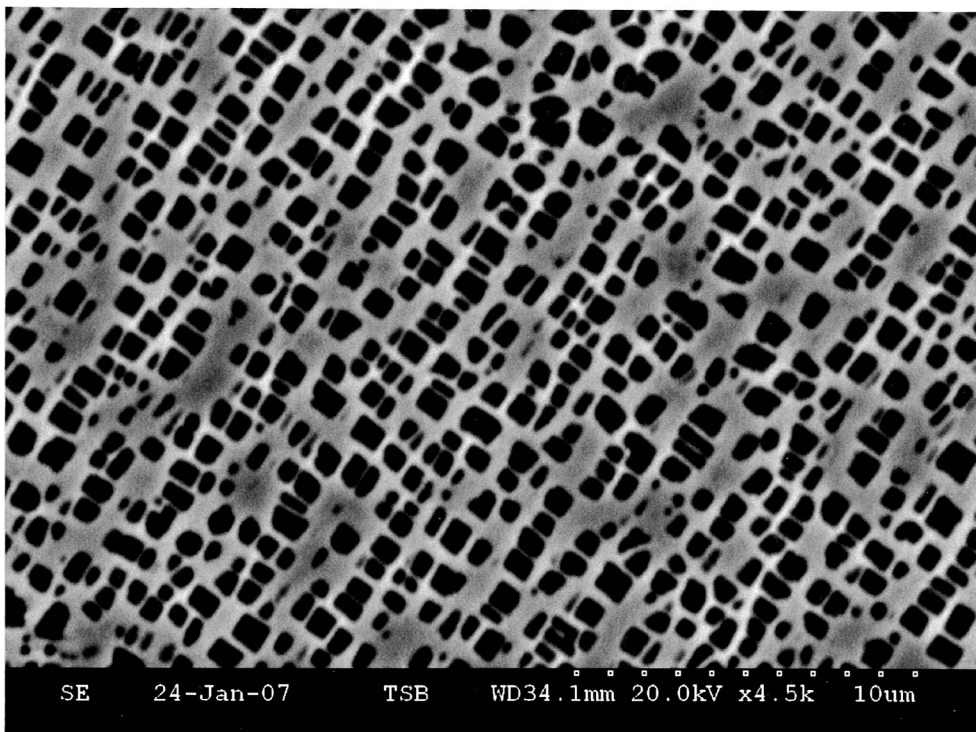
Figure 10 Microstructure of the exemplar blade in the blade root region. Magnification (a) 1500X, (b) 4500X.

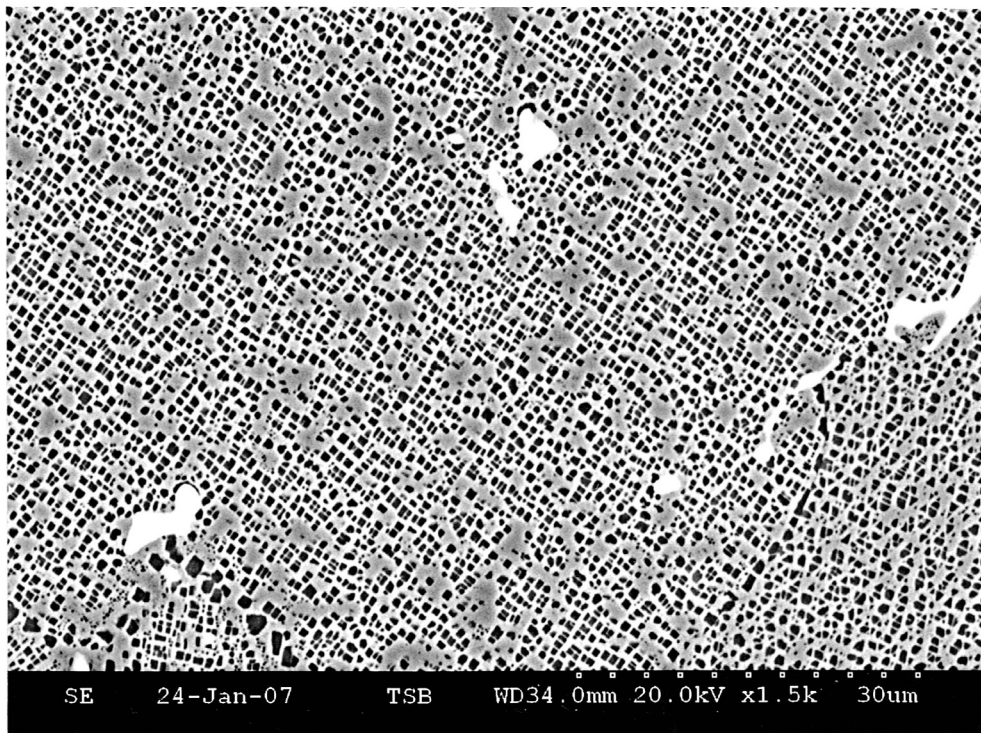
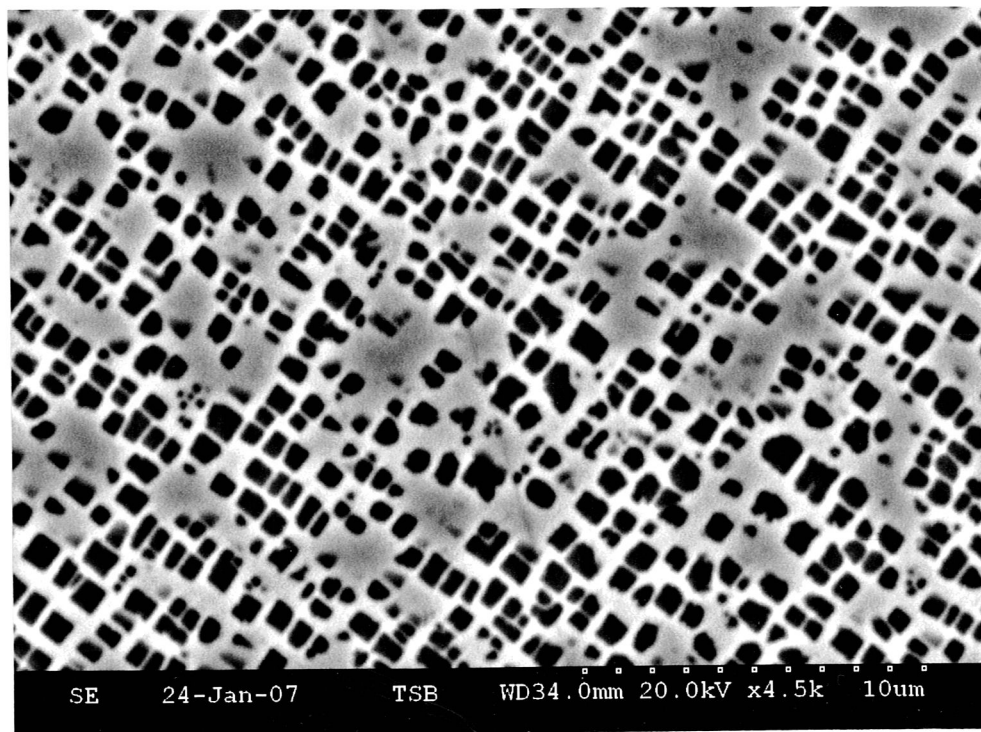
Figure 11 Microstructure of the exemplar blade at blade mid-span. Magnification (a) 1500X, (b) 4500X. Magnification (a) 1500X, (b) 4500X.

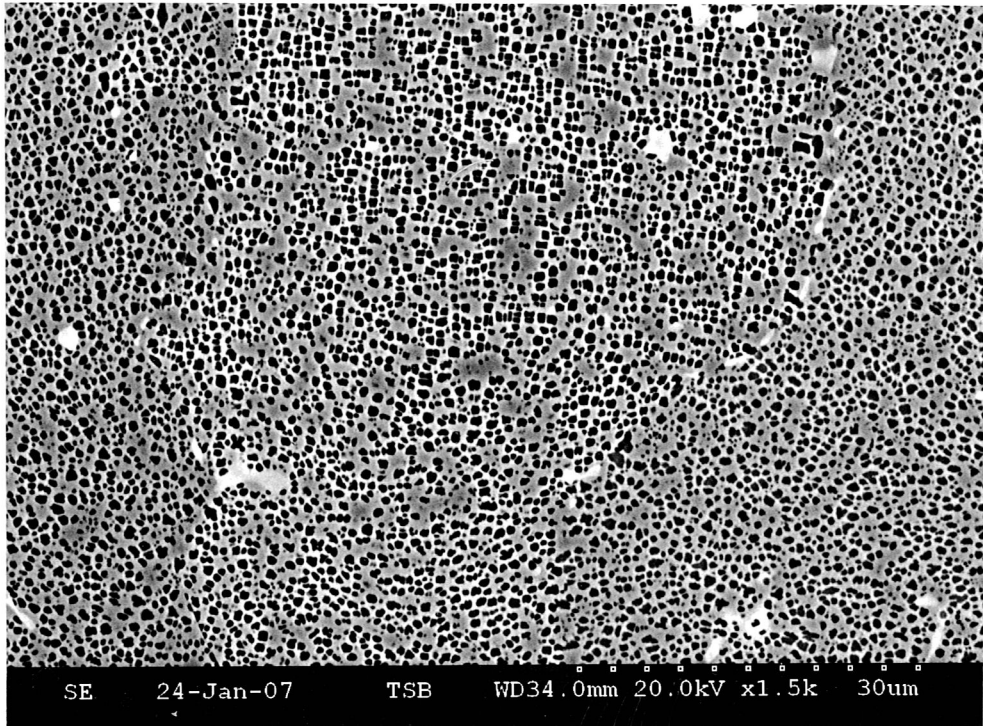
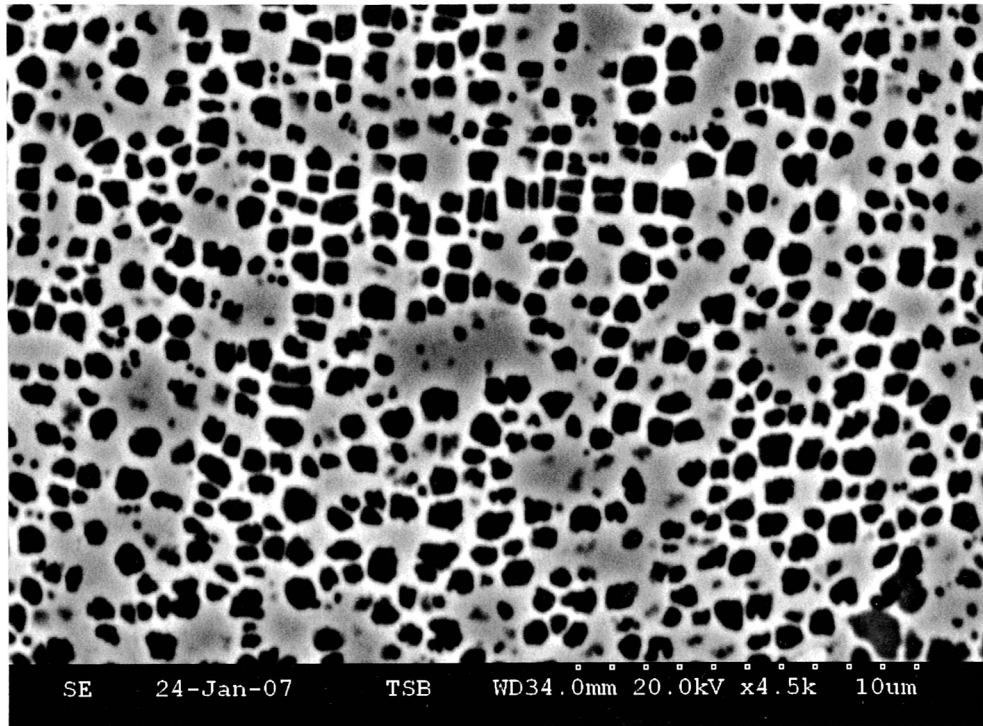
Figure 12 Microstructure of the exemplar blade at the blade tip. Magnification (a) 1500X, (b) 4500X.

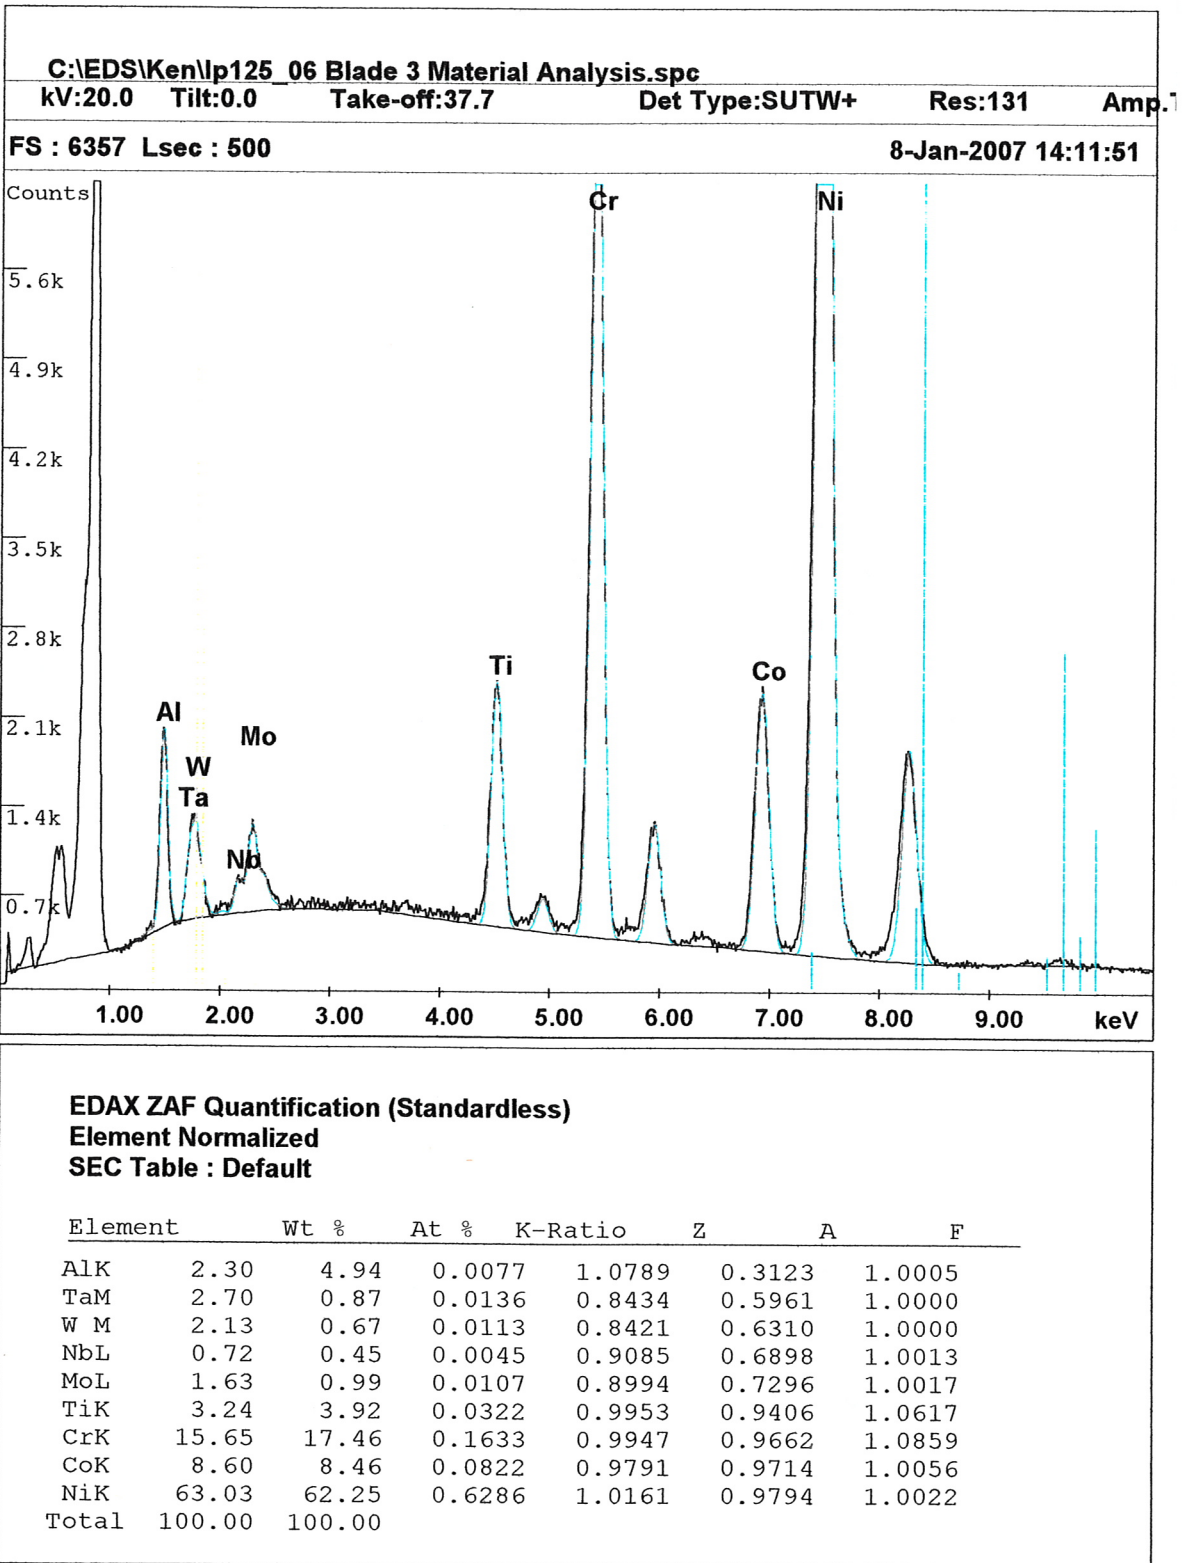
2.4 Energy dispersive X-ray analysis of the blade material indicated a complex nickel base alloy containing quantities of chromium, cobalt, titanium, aluminum, tungsten, tantalum, niobium and molybdenum consistent semi-quantitatively with the IN 738 material specified by the PMA Part manufacturer. Metallographic examination of the blade microstructures showed no microstructural anomalies or deficiencies which would account for the blade failure.

Figure 13 Energy dispersive X-ray analysis spectrum of the material of Blade #3.
