Railway Investigation R15H0021

Derailment and fire of second Canadian National crude oil train near Gogama, Ontario

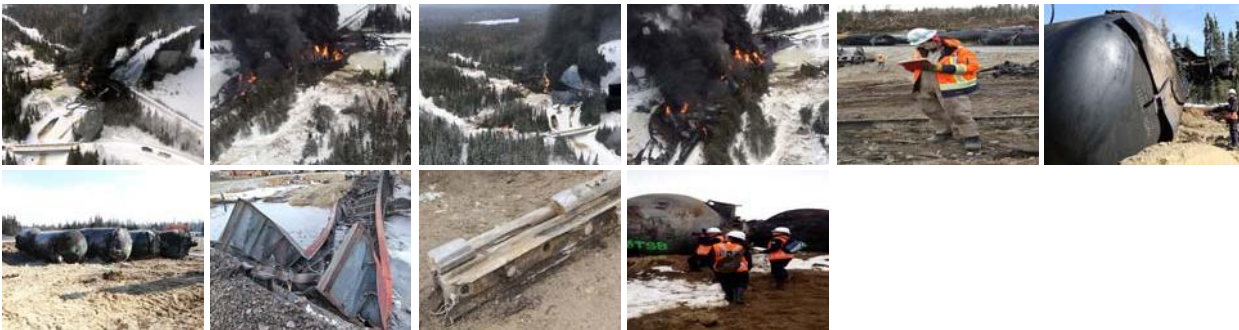
Photos

While firefighters dealt with the fire, investigators from the Transportation Safety Board of Canada (TSB) examined the area at the west end of the bridge and recovered a section of broken rail within a plug rail joint that had been installed 2 days prior to the accident (see Photo 2). The plug rail was put in place as a repair for an in-service thermite weld failure identified previously at that location. The recovered rail components were sent to the TSB Engineering Laboratory in Ottawa for further analysis.
