**Date of Accident:** April 7, 2015

**NTSB File No.:** CEN15FA190

**Aircraft:** Cessna 414A

**Turbocharger Teardown Report****Date of Investigation:** September 3, 2015**Location:** Hartzell Engine Technologies, Montgomery, AL

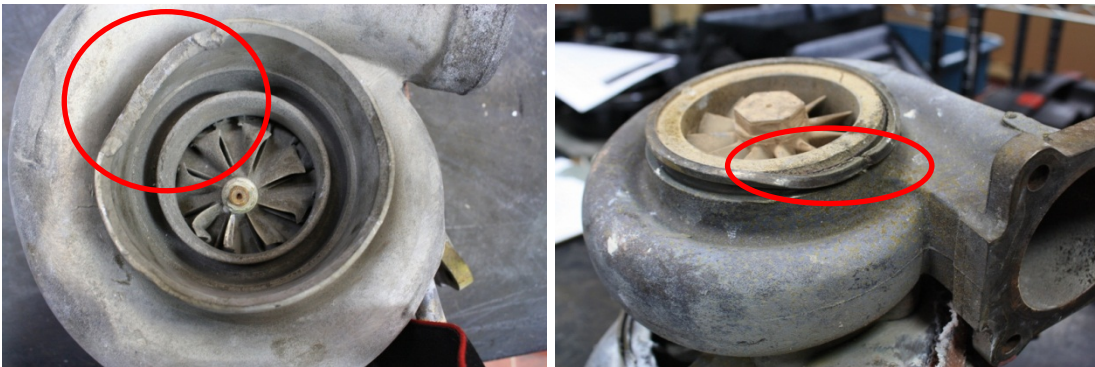
Any evidence of eroding, fretting, or damage to attachment/mounting surfaces?  
**DAMAGED INLET ON THE COMPRESSOR HSG & TURBINE EXIT FLANGE**

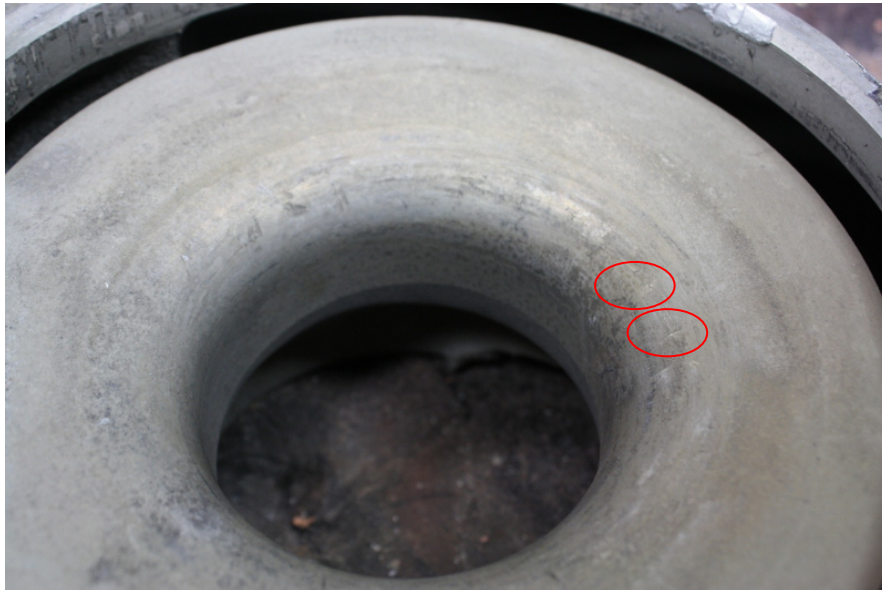
Clearance Between Impeller Blades and Housing NO; DUE TO IMPACT DAMAGE

Compressor Wheel Rub? NO Witness Marks on C Hsg? SLIGHT IMPACT MARKS

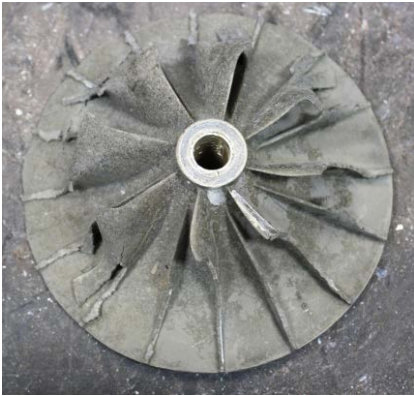
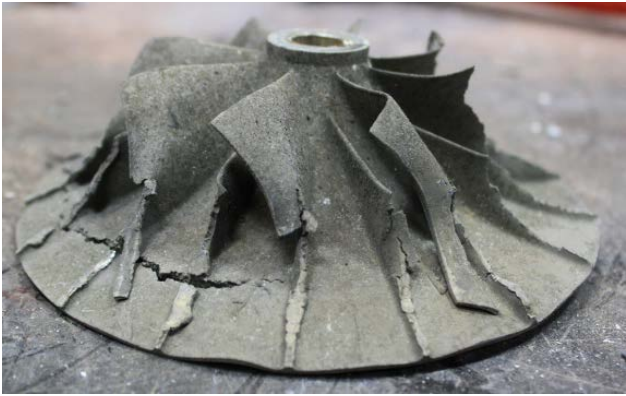
Compressor Wheel: None \_\_\_\_\_ Light \_\_\_\_\_ Moderate \_\_\_\_\_ Heavy X\* Extreme \_\_\_\_\_

\* DUE TO IMPACT

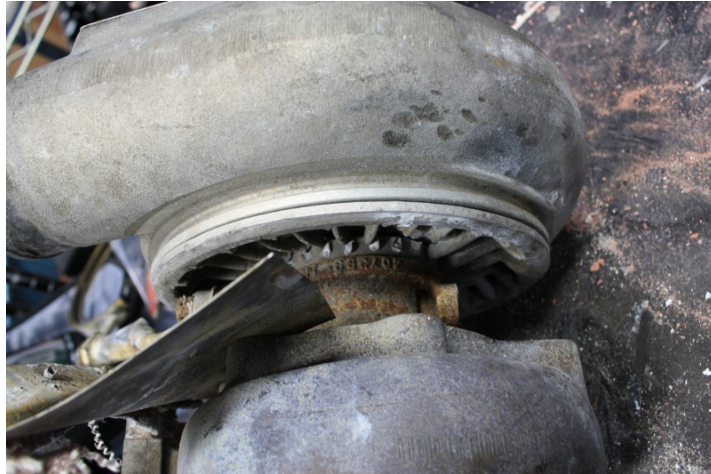
- Condition FRACTURED; SEE PHOTO
- Damage to attachment surfaces? FRACTURED
- Seal Bore ID for spacer damaged or scored? \_\_\_\_\_
- Oil Squirt Holes Clear? \_\_\_\_\_

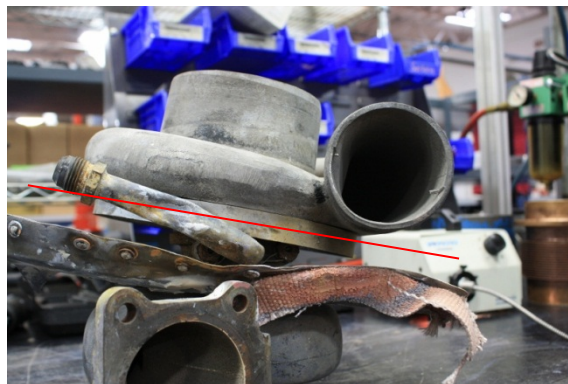
FIGURE 1: BENT COMPRESSOR

THE DAMAGE TO THE COMPRESSOR BACKPLATE, COMPRESSOR WHEEL/HSG AND THE BENT TURBINE WHEEL SHAFT WAS CONSISTENT WITH THE ACCIDENT IMPACT (SEE FIGURE 1).

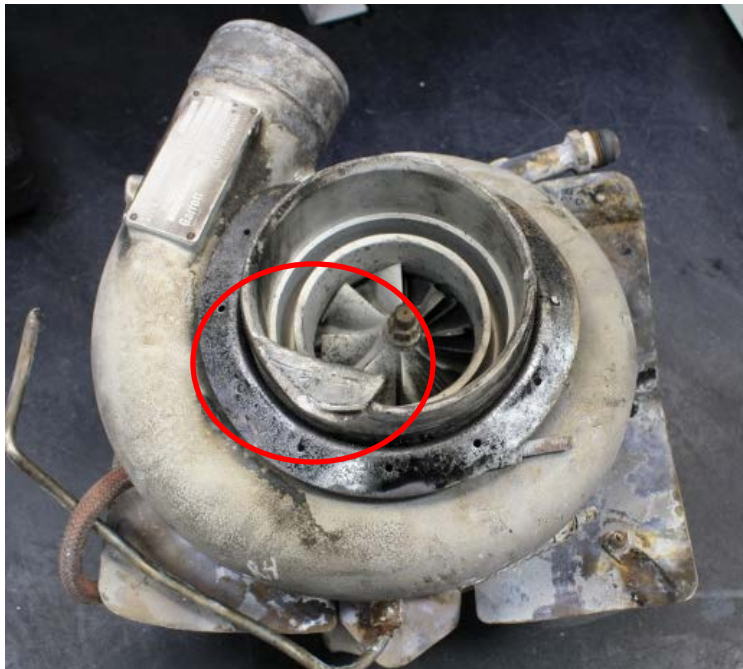
Any evidence of eroding, fretting, or damage to attachment/mounting surfaces?  
DAMAGED INLET ON THE COMPRESSOR HSG.

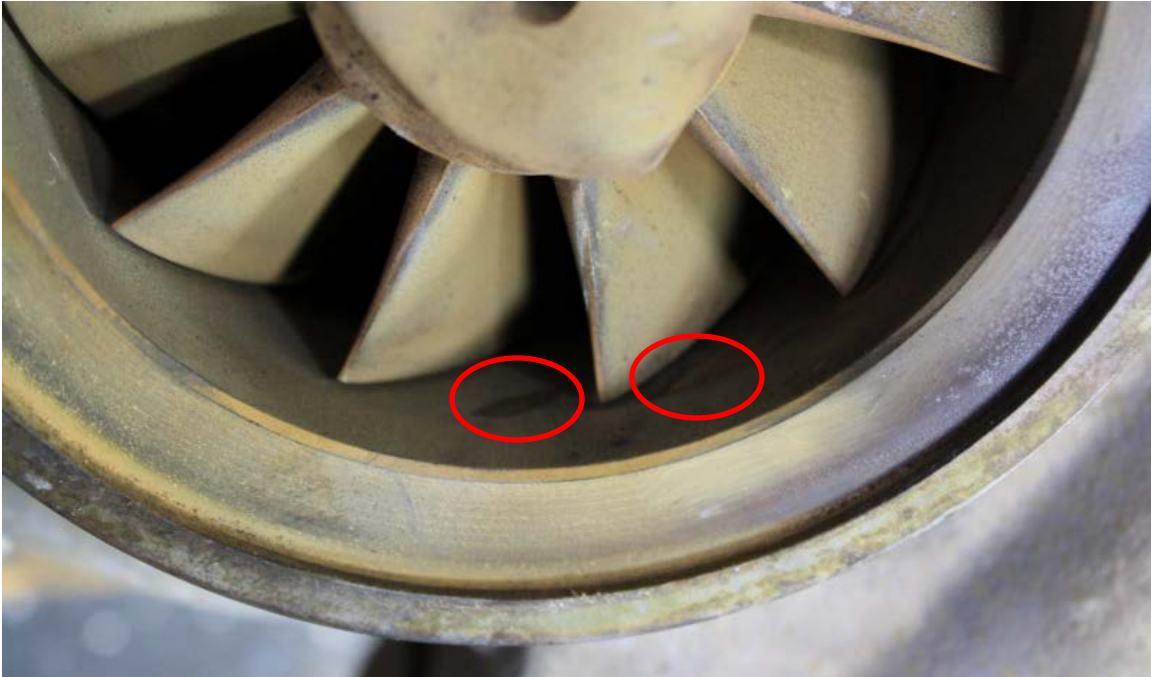
Witness Marks on T Hsg? SLIGHT IMPACT MARKS

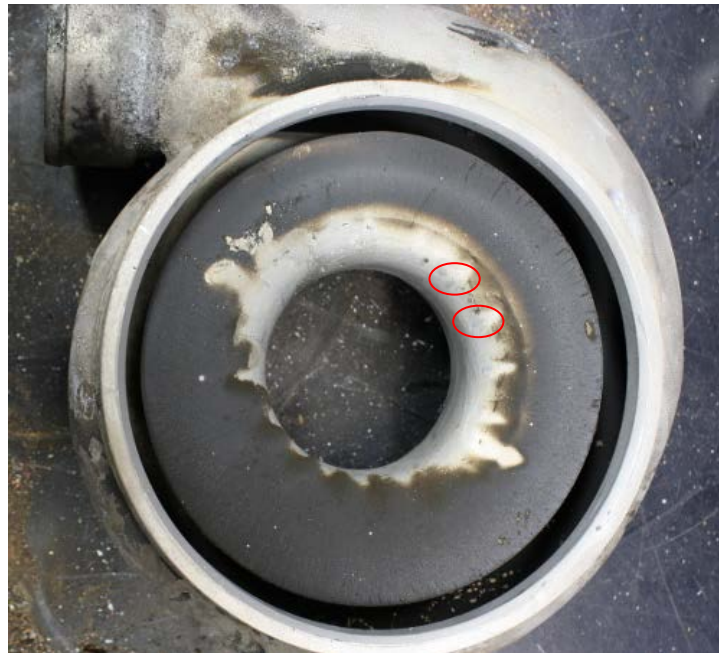
Witness Marks on C Hsg? SLIGHT IMPACT MARKS

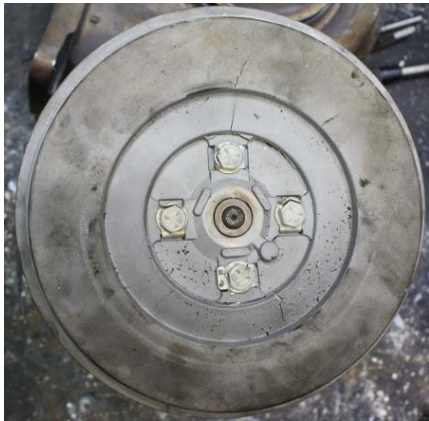
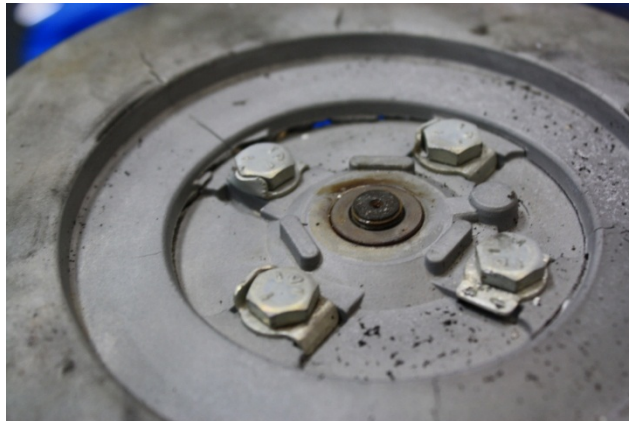
- Condition FRACTURED; SEE PHOTOS
- Damage to attachment surfaces? FRACTURED
- Seal Bore ID for spacer damaged or scored? \_\_\_\_\_
- Oil Squirt Holes Clear? \_\_\_\_\_

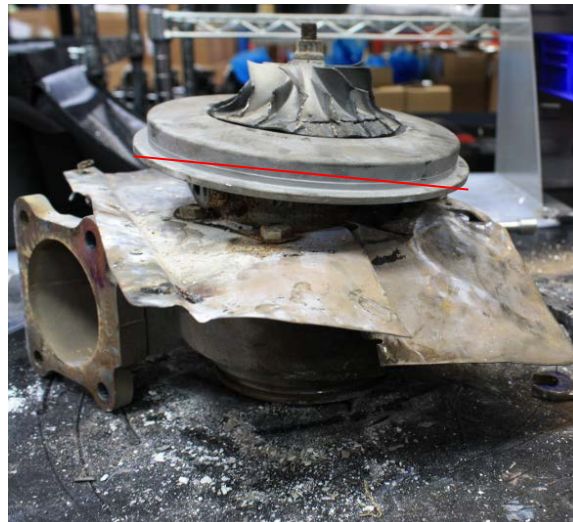
FIGURE 1: BENT COMPRESSOR

THE DAMAGE TO THE COMPRESSOR BACKPLATE, COMPRESSOR WHEEL/HSG AND THE BENT TURBINE WHEEL SHAFT WAS CONSISTENT WITH THE ACCIDENT IMPACT.
