Arriel 1D1 Engine S/N 9872 Examination

AS350 B2 S/N 3728

Registration N352LN

CEN11FA599 / A-2011-011 / RA-11-260

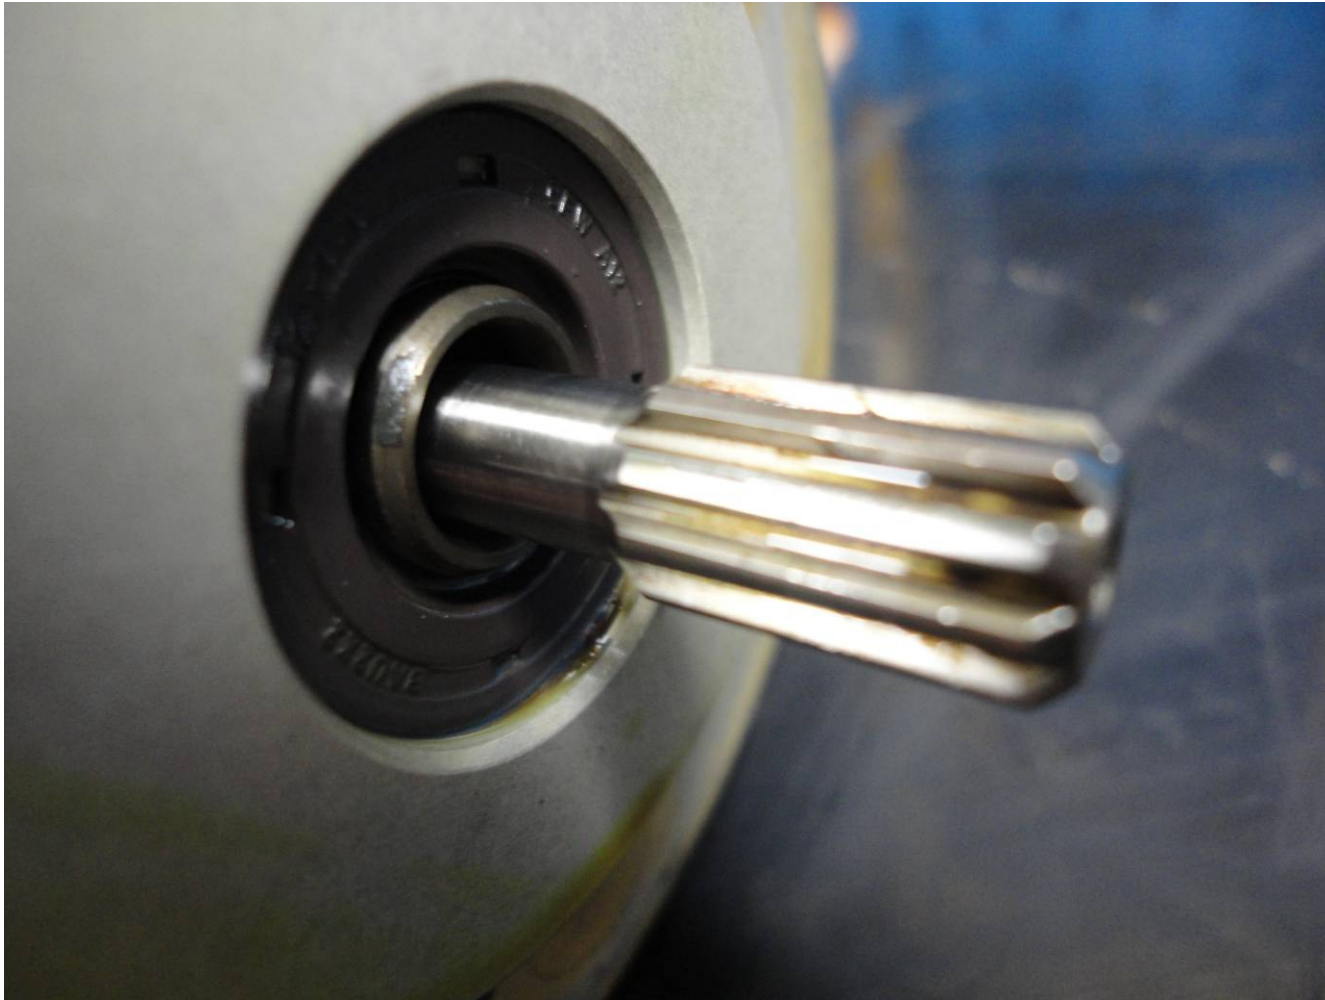
Photos / FCU Ng drive

- Boroscope unremarkable
 - Remove FCU and examine N1 and N2 drive shaft / splines.
 - Both drive shaft intact and rotation confirmed.
 - Remove external equipment from engine in preparation for modular disassembly.

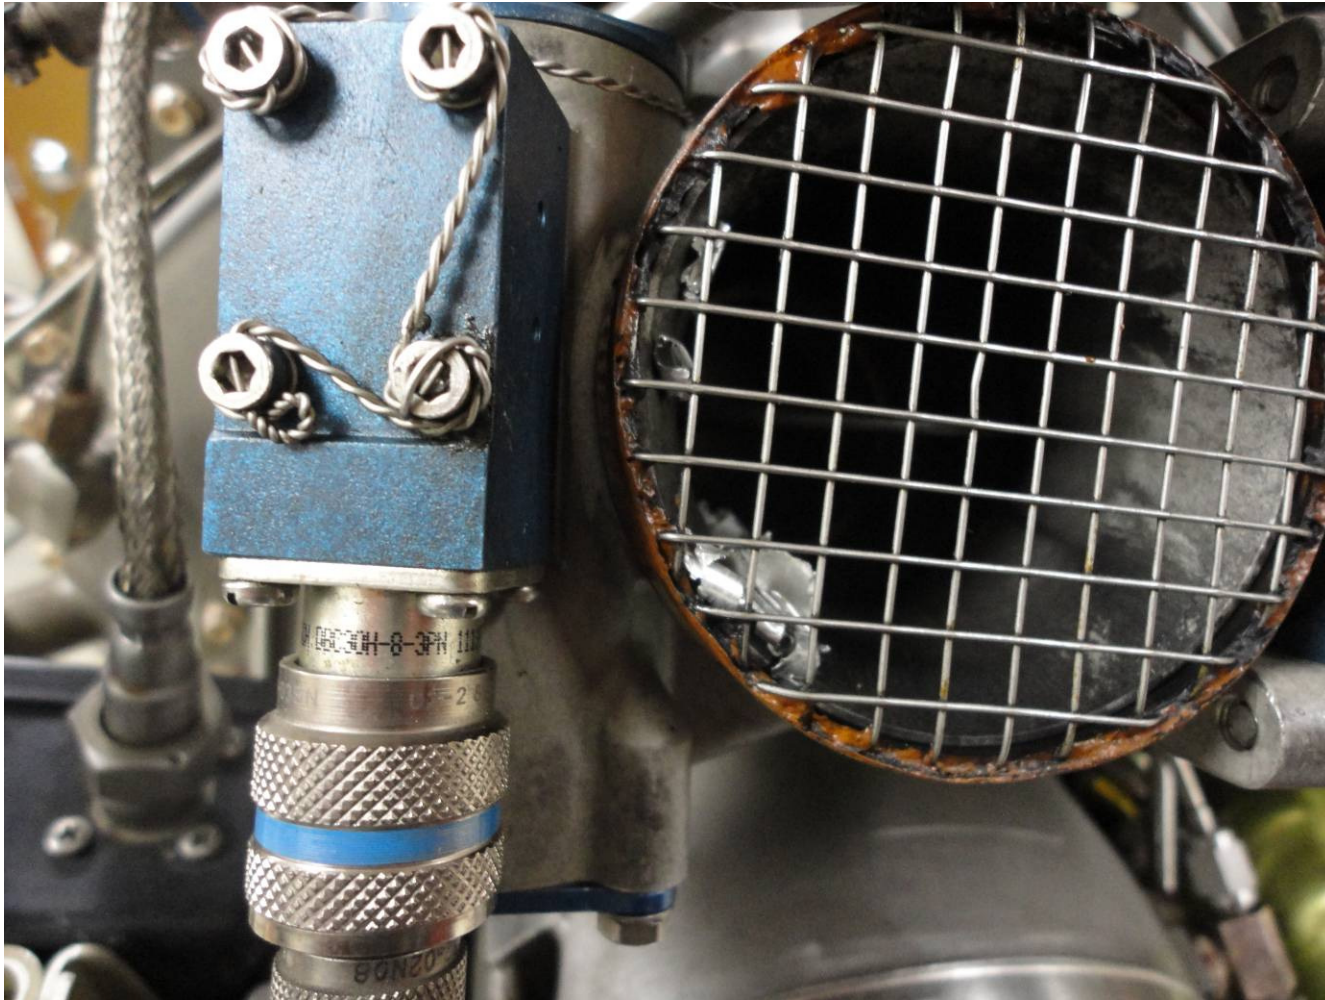
Photos / Bleed valve

- Module 2 : Remove Axial compressor, Inspect IGV's for FOD damage.
 - MO2 removed; observed FOD to axial compressor and debris (metal shavings) in compressor case and bleed valve housing.

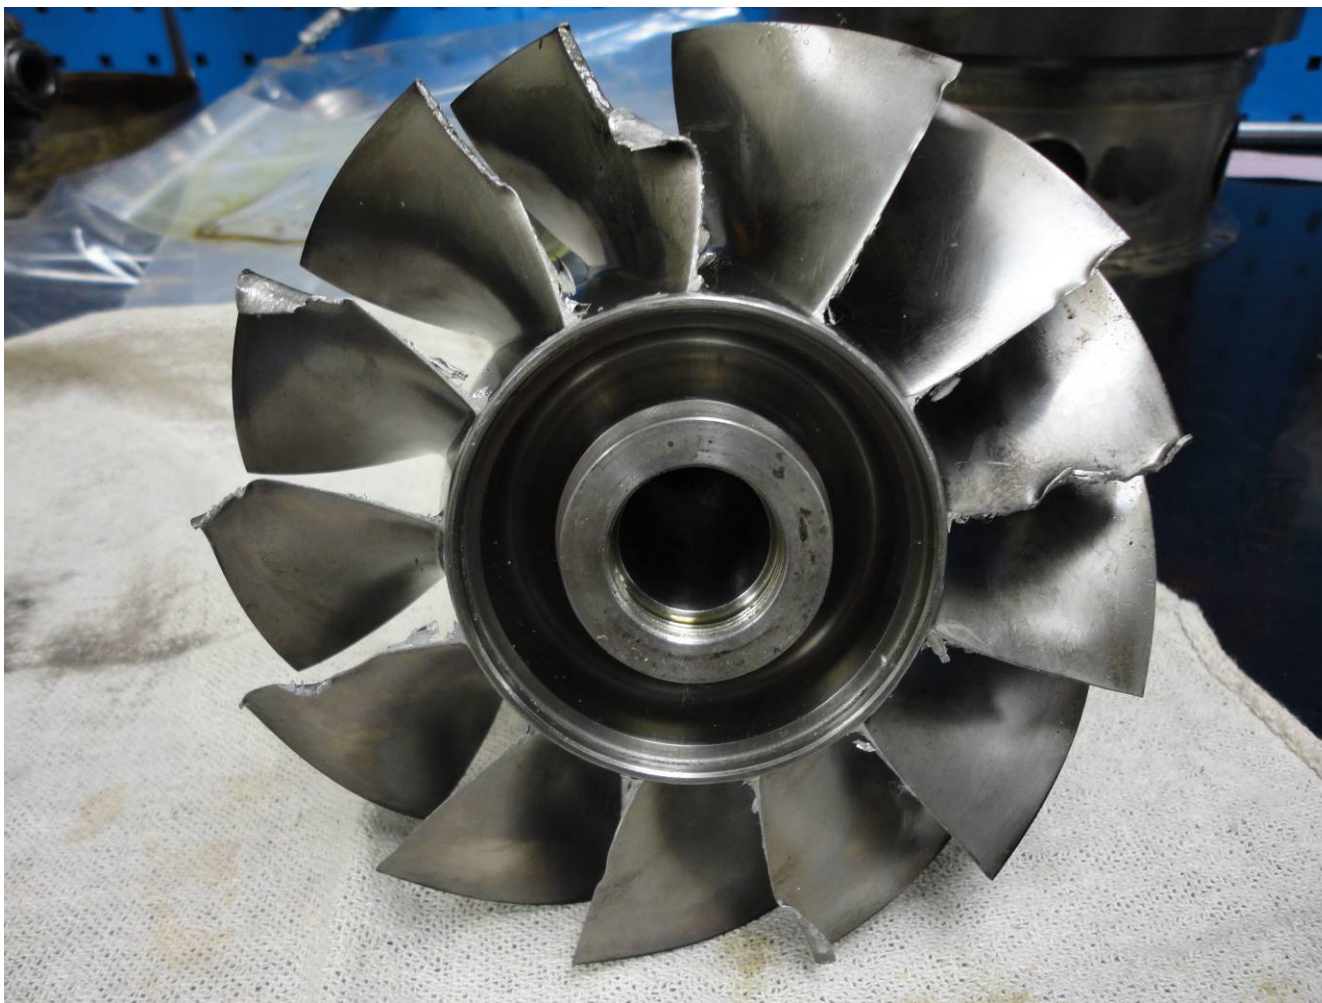
Photos / Axial compressor removed

Due to the presence of aluminum shavings throughout the engine without being melted it can be concluded that the engine was flamed out at the time of impact. The substantial damage to the axial compressor would indicate the gas generator was at a high rate of rpm at the time of impact. According to the attached Arriel 1 coast down chart, after shutdown the gas generator drops from 97% Ng to 30% within 5 seconds, and is to 15% after 11 seconds. Due to the amount of blade curling of the axial compressor and significant FOD damage it can be estimated that impact occurred within the 1st 10 seconds after flameout. Please see chart on the next page.

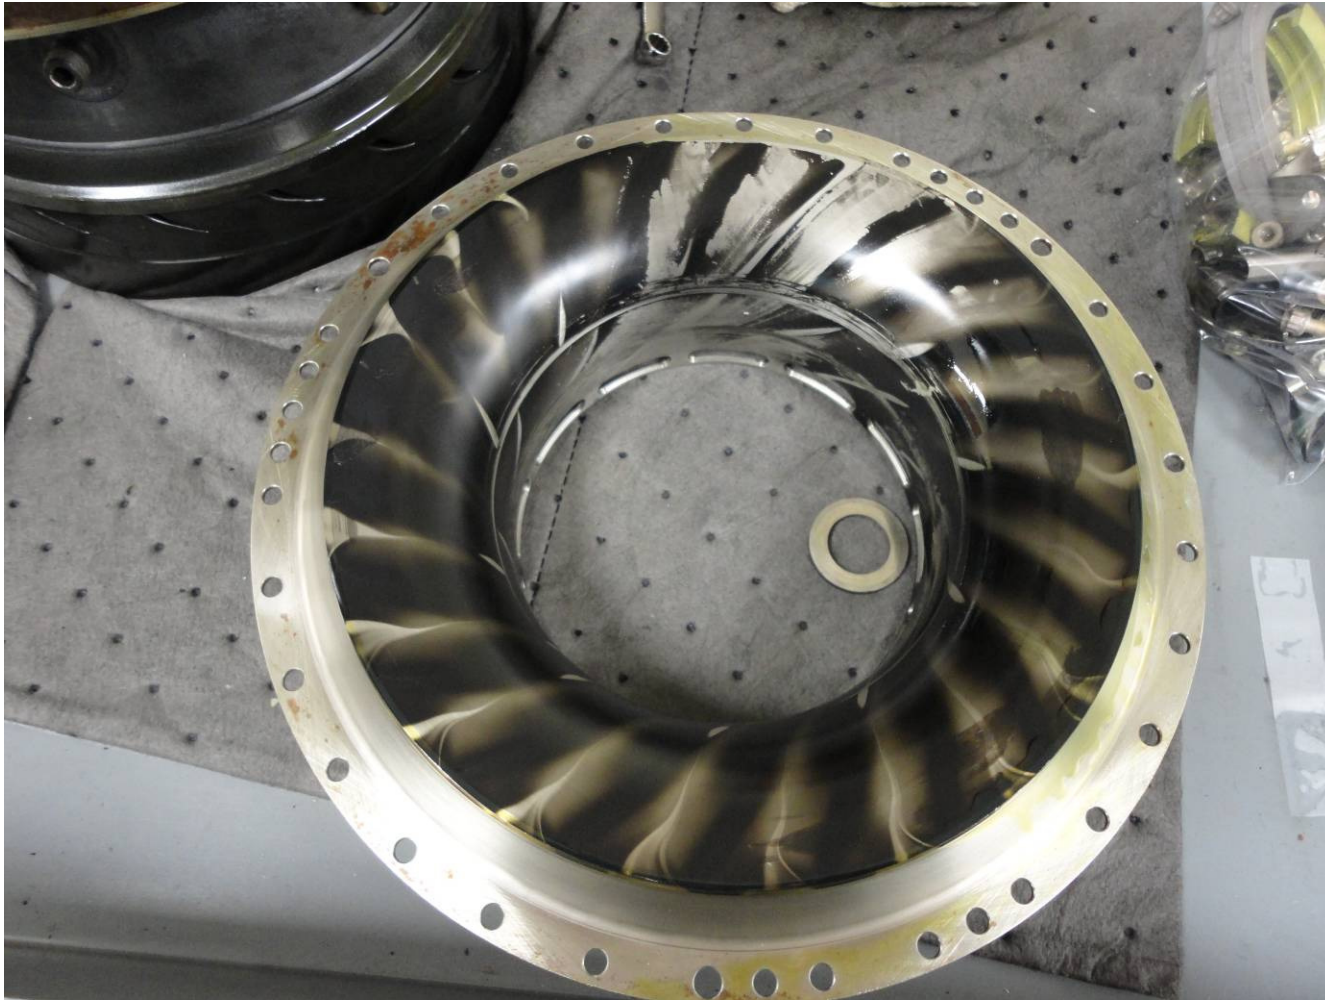
Photos / Inside of compressor cover

- **Module 3 : Complete disassembly . Inspect for the presence of melted foreign material (aluminum from A/C intake).**
- **Disassembly revealed debris (metal shavings) distributed throughout the module. The centrifugal compressor, combustion chamber, and turbine blades exhibited a black substance (soot). No FOD observed to the turbine blades. The rear bearing was intact and rotated by hand.**

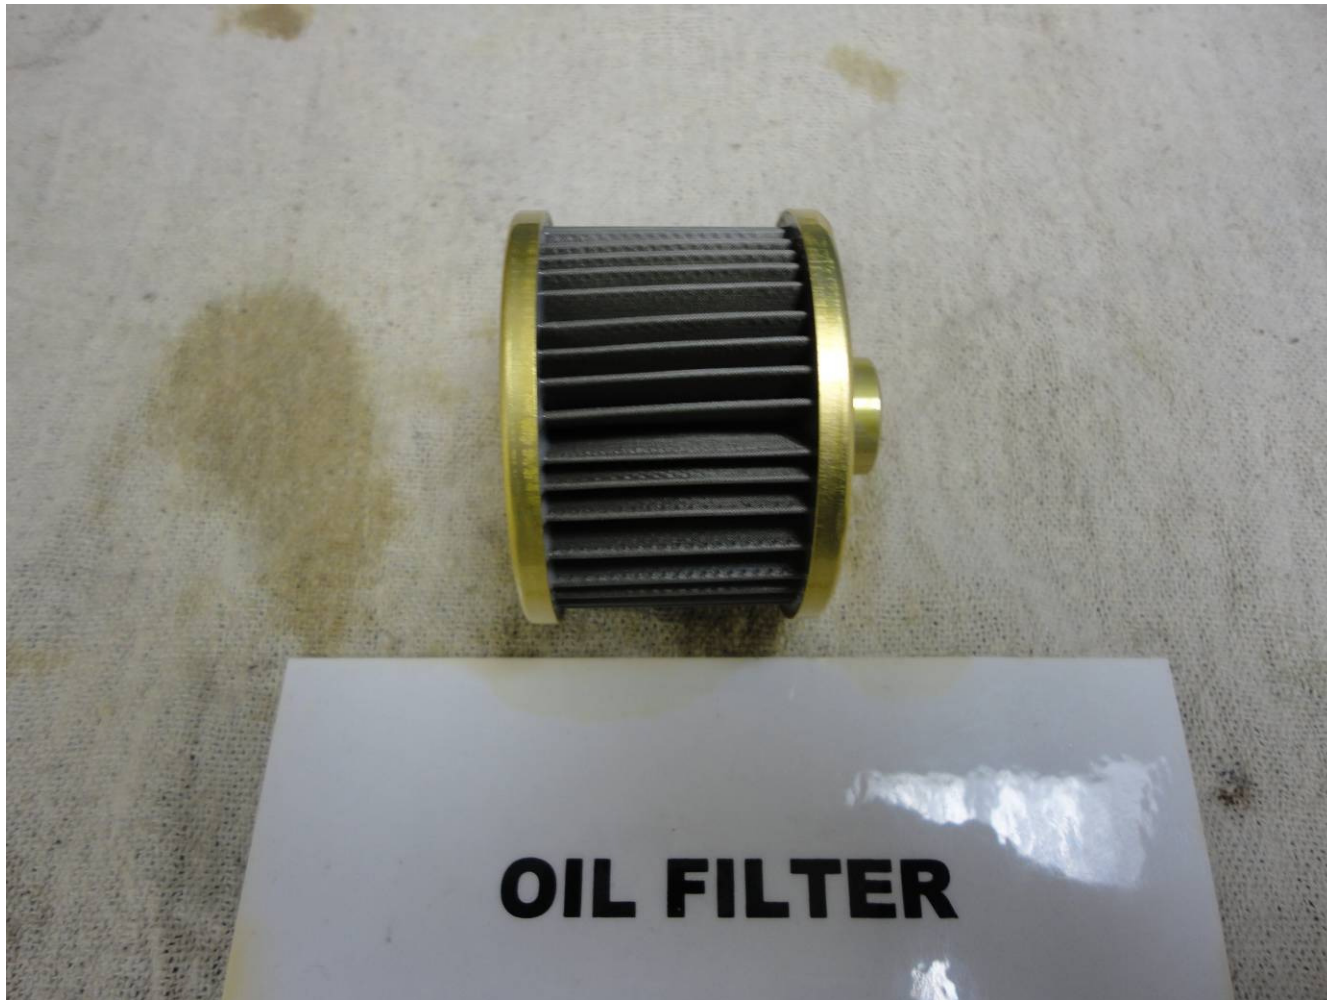
Photos / Oil filter

- The rotating assemblies (compressors, 1st and 2nd stage turbines, and power turbine) rotated freely. The free wheel shaft assembly and reduction gearbox (MO5) had been removed during wreckage examination on 29 Aug. 2011. The bleed valve was open. The magnetic plugs and chip detectors were clean. The oil filter, FCU fuel filter, and bleed air valve filter were clean. The oil filter clogging indicator was clear (not in by-pass).
