FINAL INVESTIGATION REPORT
TMUSA-2010-46268

ENGINE FAMILY		ENGINE S/N	DATE OF REPORT	WARRANTY CLAIM	COMMERCIAL FILE	
Arriel		46268	15 September 2010			
OPERATOR		DATE OF EXAM	REASON FOR ENGINE EXAM			
Air Methods		08-10 September 2010	Accident Investigation			
ACCIDENT		INCIDENT				
YES <input checked="" type="checkbox"/>	NO <input type="checkbox"/>	YES <input type="checkbox"/>	NO <input checked="" type="checkbox"/>			
REFERENCE ACCIDENT						
FIRST INFO REPORT N° A-2010-012; RA/10/225						
ENGINE MODULE	S / N	WORKS PERFORMED	TOTAL HOURS	TOTAL CYCLES	HOURS SINCE OH	CYCLES SINCE OH
Engine	46268	Disassembled	352.07	603.9		
Module 1	6442	Removed	352.07			
Module 2	7653	Removed	352.07	603.9		
Module 3	9853	Disassembled	352.07	603.9		
Module 4	7618	Removed	352.07	235		
Module 5	10546	Removed	352.07			
FCU	26603	Partial disassembled	352.07

Circumstances Reported to Turbomeca:

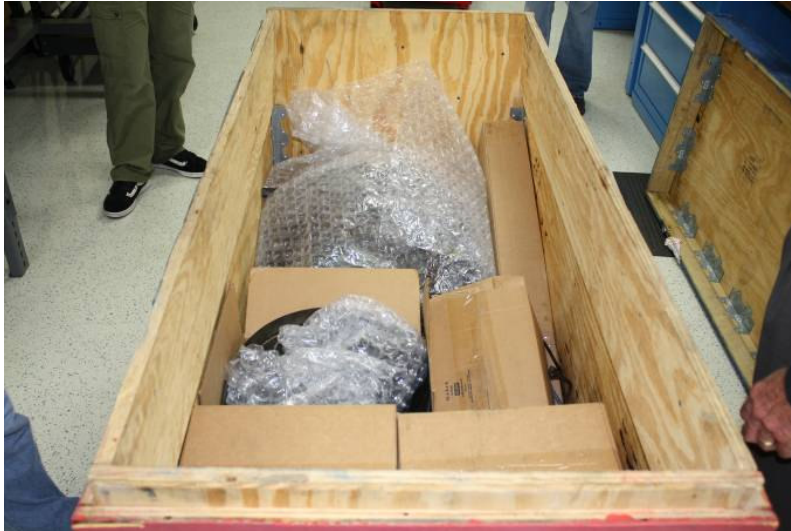
Figure 1 Engine s/n 46268 in shipping container

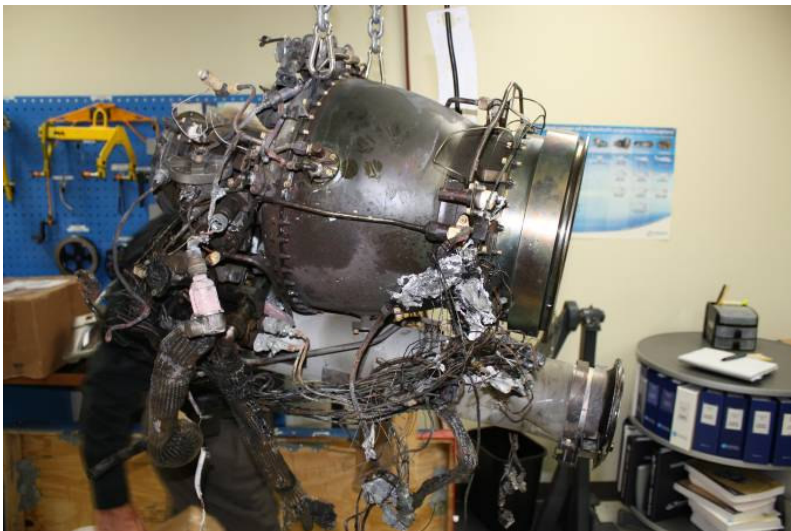
Figure 2 Engine removed from container

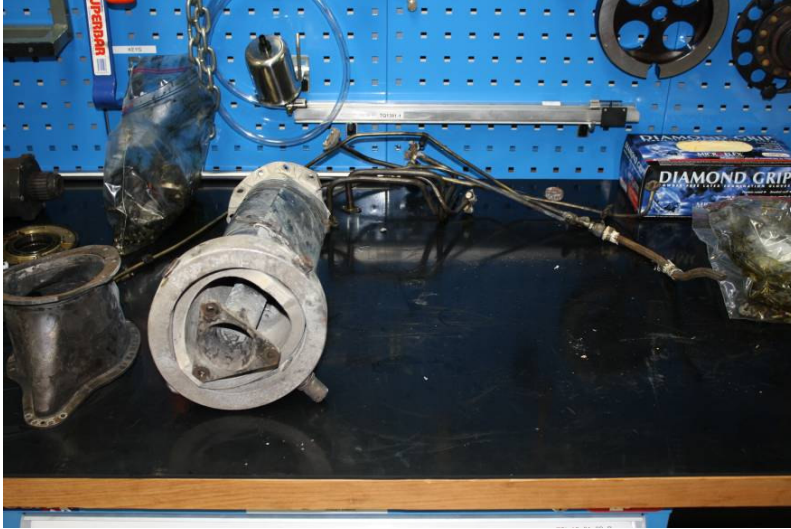
Figure 3: Transmission shaft - aircraft connection

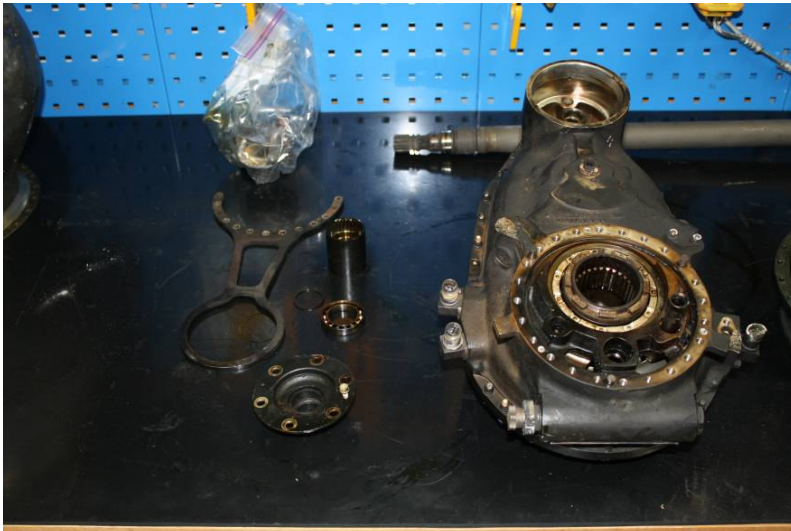
Figure 4: Reduction gearbox (MO5) - removed during wreckage recovery

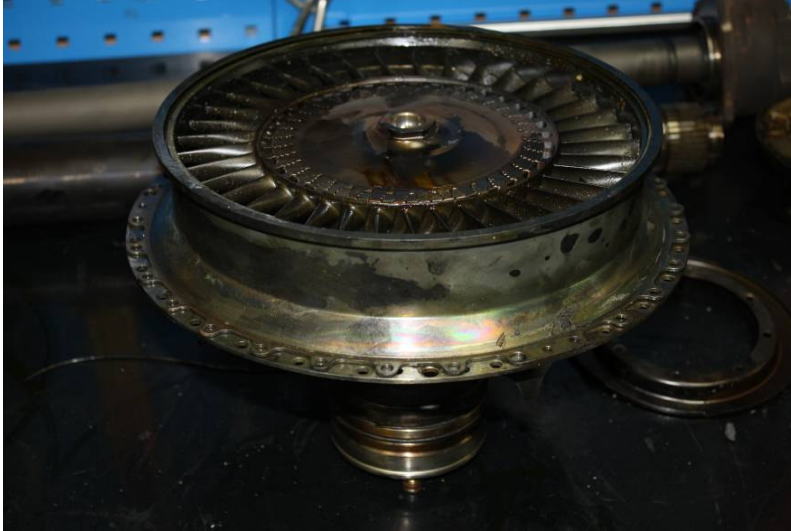
Figure 5: Power turbine - removed during wreckage recovery

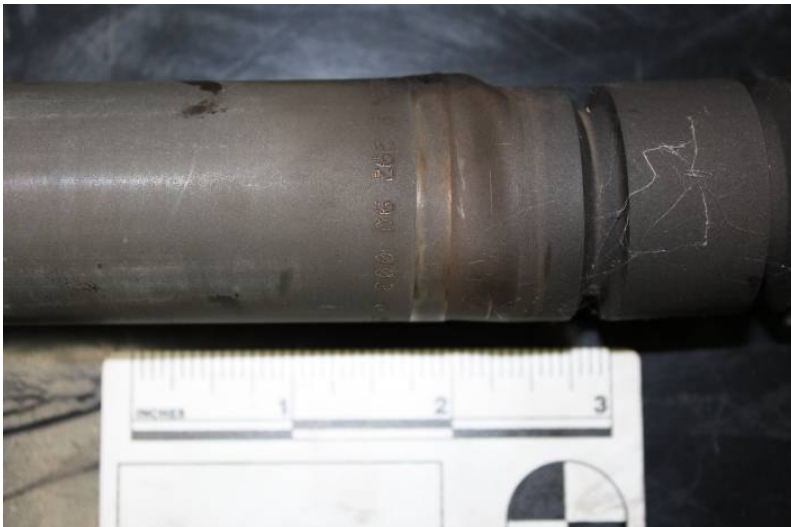
The engine disassembly revealed signatures of rotation during the accident sequence. No evidence of sudden stoppage or engine over speed was observed. Group notes of the engine and HMU examination were signed by party representatives. The intermediate casing, diffuser, fuel injection manifold, fuel pipe, jet union, and gasket were shipped to the NTSB lab in Washington D.C. for further investigation.

Figure 6 Free Wheel Shaft – torsional deformation

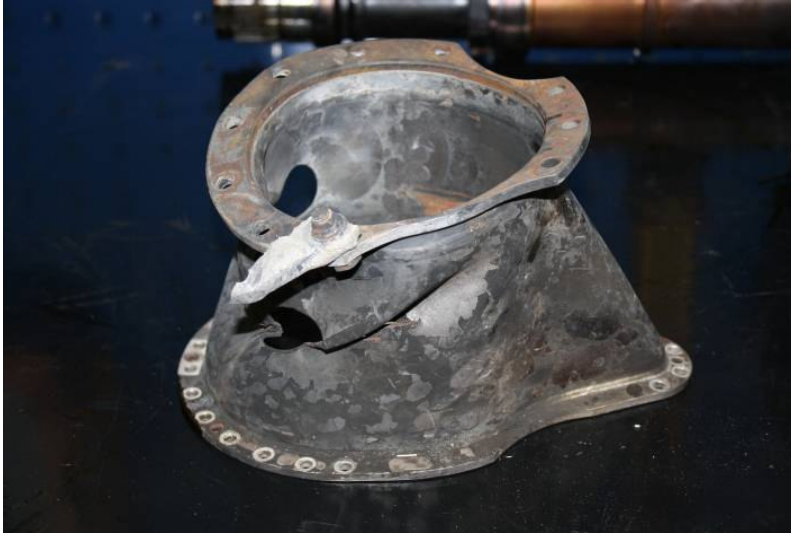
Figure 7 Engine front support

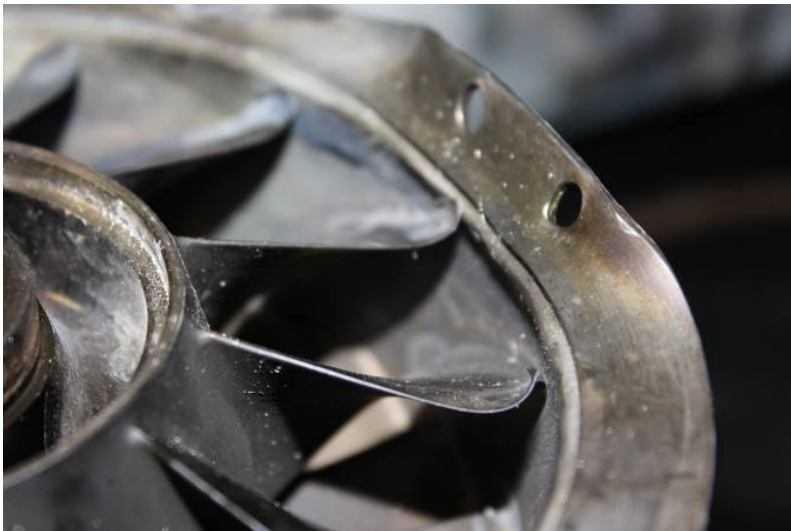
Figure 8 Axial compressor blades

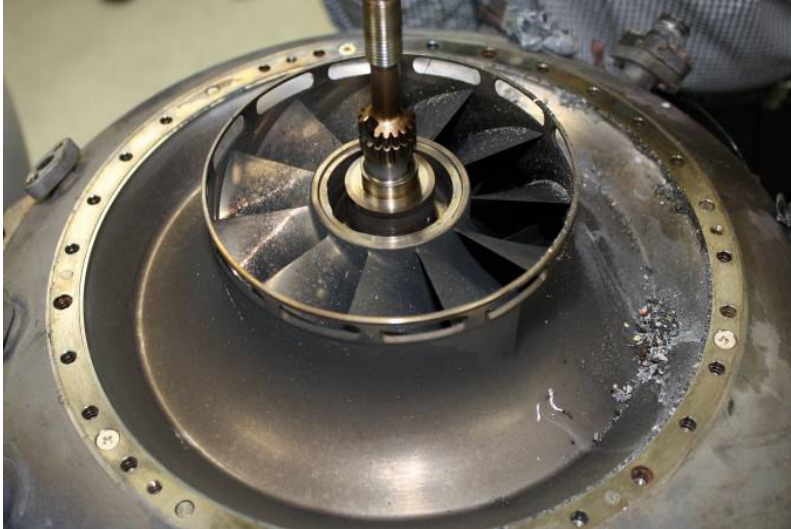
Figure 9 Centrifugal compressor

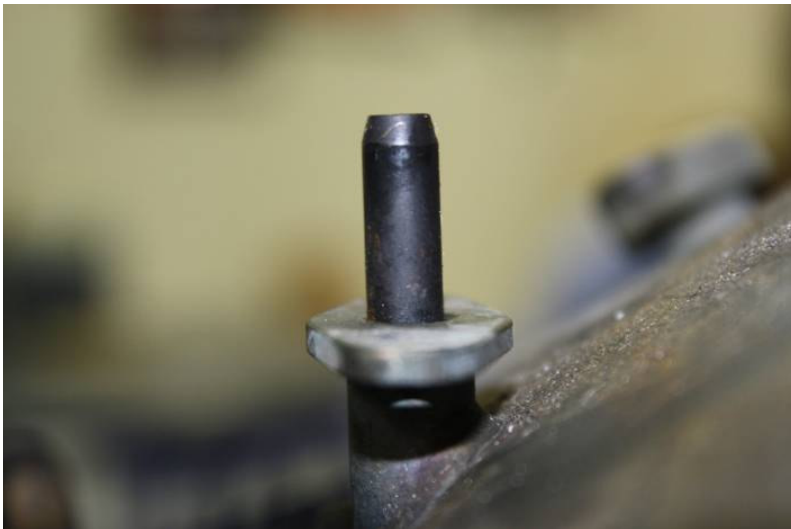
Figure 10 Fuel injection manifold pipe

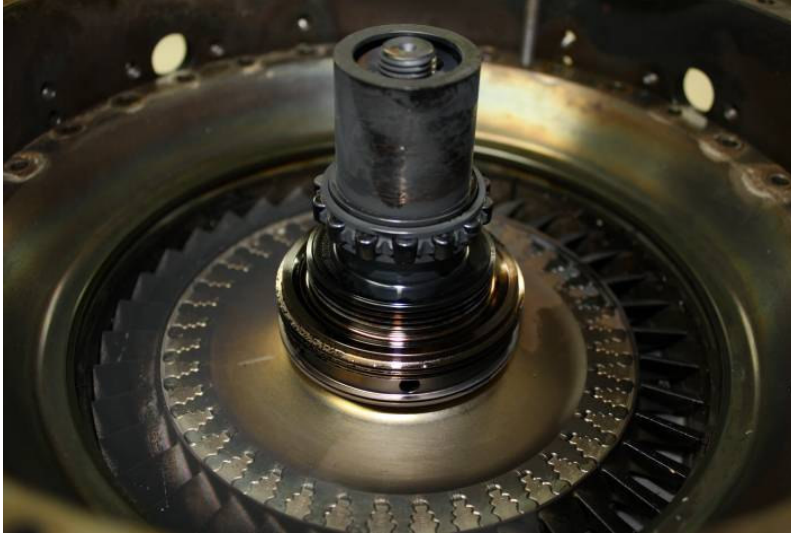
Figure 11 Rear bearing

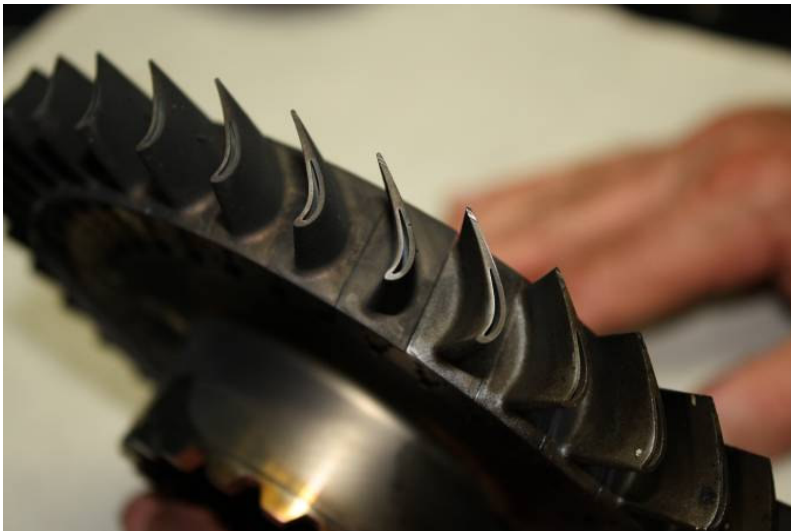
Figure 12 High pressure turbine

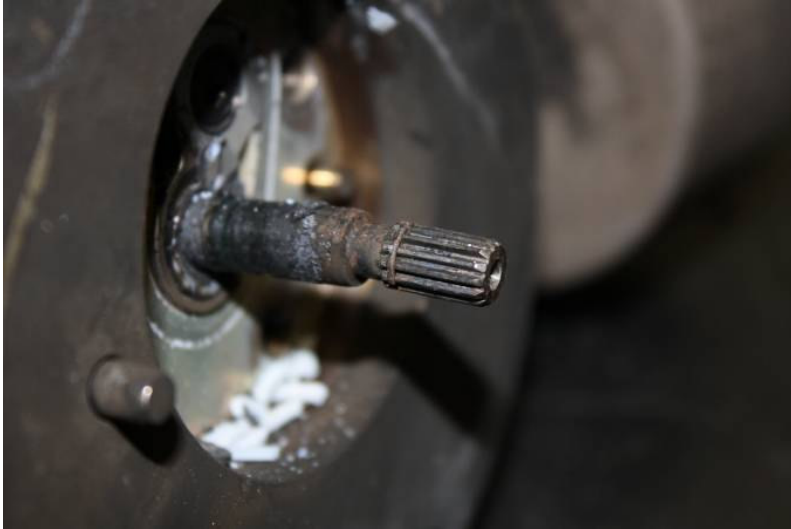
The HMU was deemed incapable of being run on the test bench due to impact and fire damage

Figure 13 HMU shaft damage

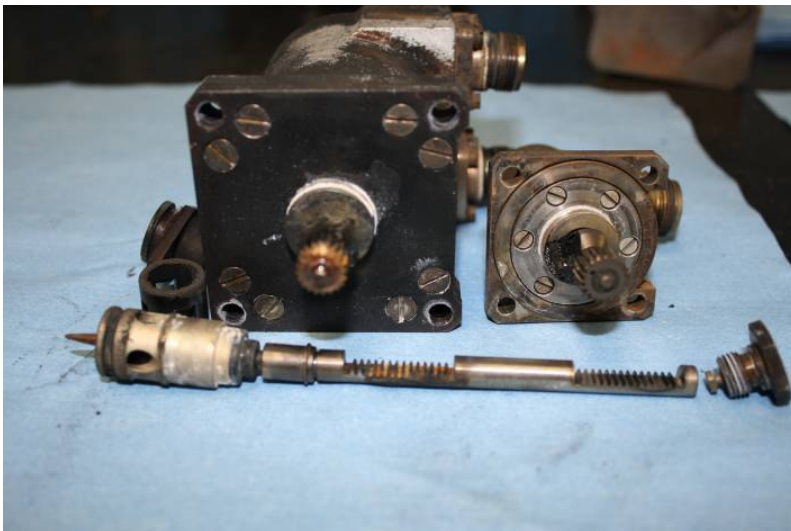
Figure 14 HMU stepper, resolve motors, rack and pinion, and metering needle

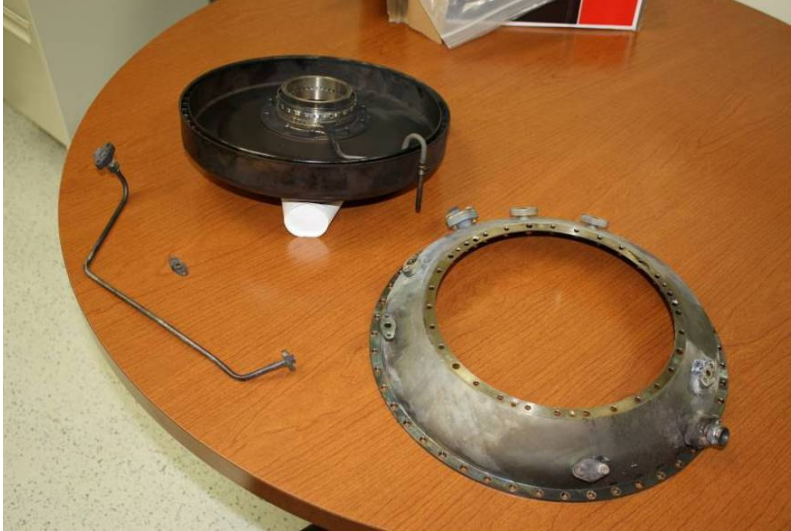
Figure 15 Parts sent to NTSB lab for investigation
