Twin Commander Aircraft Field Notes

NTSB Identification: WPR14LA194

Accident occurred Saturday, May 17, 2014 in Fort Huachuca, AZ

Aircraft: Aero Commander 500 S, Registration: N40TC

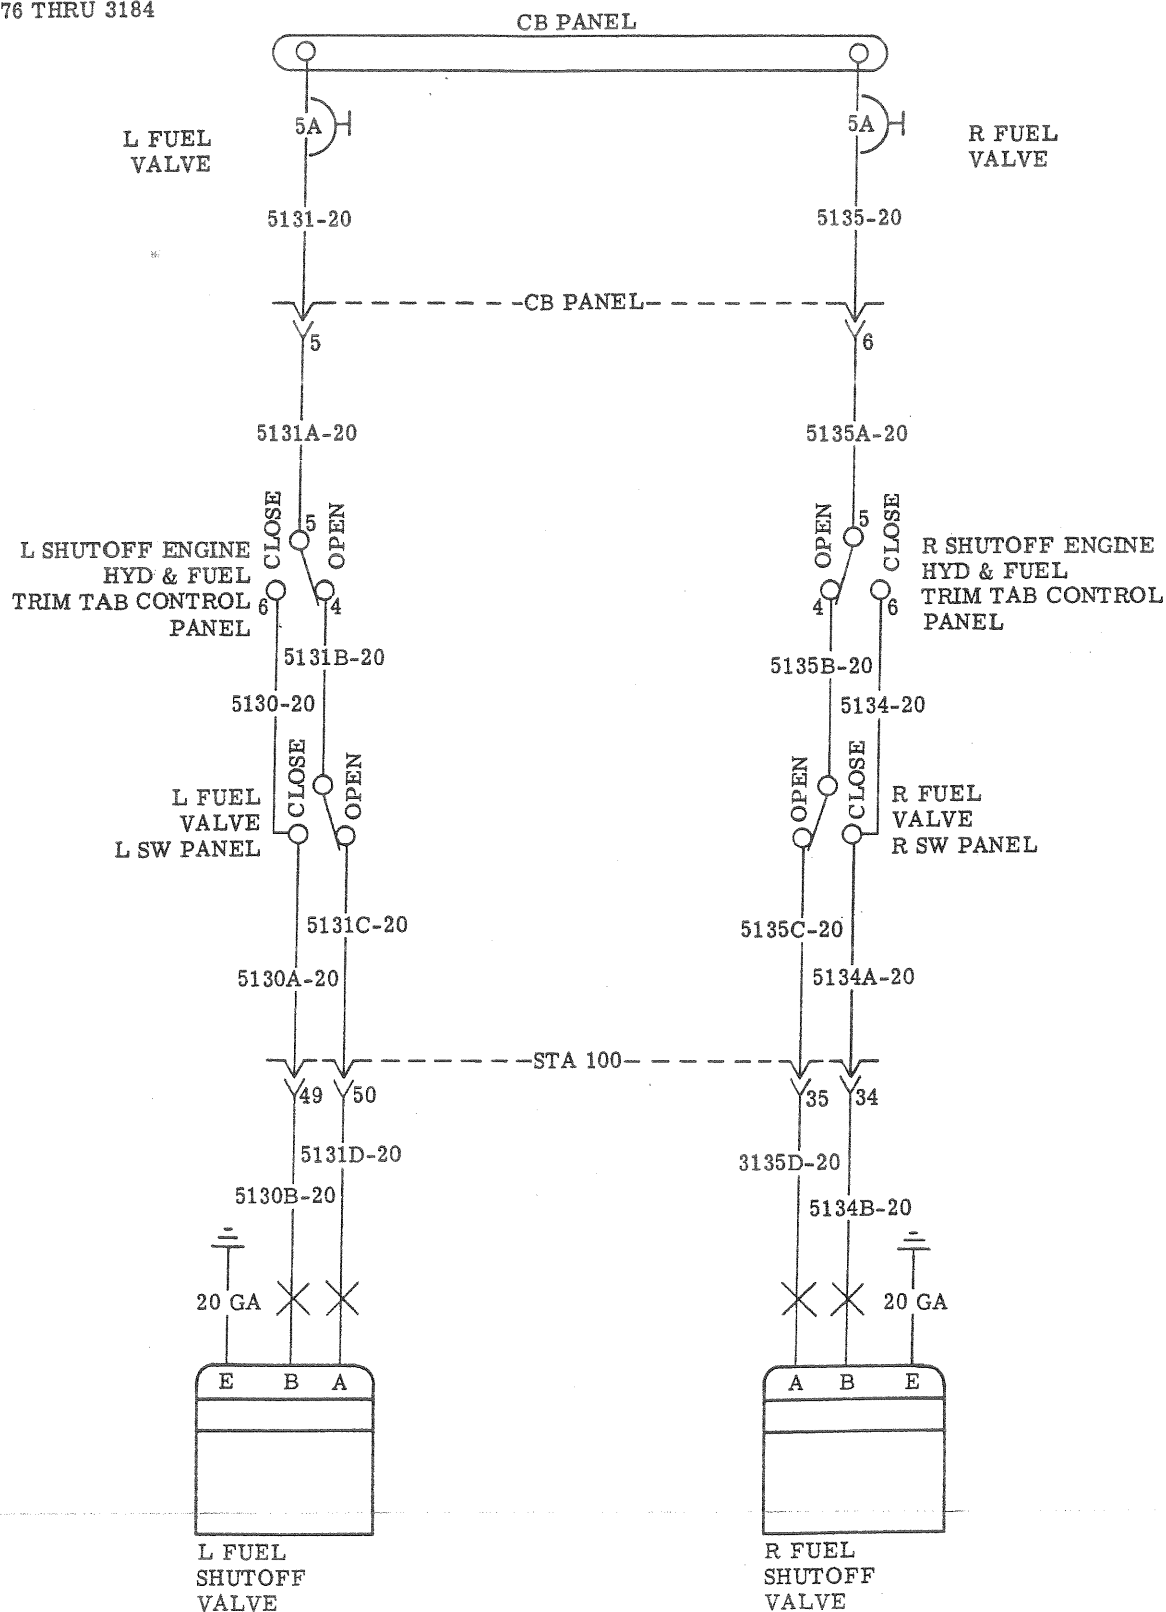
Figure 10-29. Fuel Shutoff Valves (Sheet 2 of 2)

The wire numbers to the fuel shut off valves were identified utilizing the Maintenance Manual wiring diagrams and confirmed as going into the valve connectors installed in the aircraft. The overhead wiring bundle had been cut forward of the connector located at Fuselage Station 100. Wires forward of the cut to the Left Fuel Shut off switches were identified as 5130A-20 for the closed position and 5131C-20 for the open position. Power to the switches from the circuit breaker panel was supplied by wire 5131A-20. Continuity from 5131A-20 to 5130A-20 was confirmed by switch activation on /off. Continuity from 5131A-20 to 5131C-20 was not established. Further examination of the 5131C-20 wire revealed that the wire had separated in the cockpit overhead as a result of possible stresses applied during the crash sequence, during wreckage recovery or for reasons unknown. Wires to the Right Hand Fuel Shut Off switches were identified as 5135C-20 for the open position and 5134A-20 to the closed position. Power to the switches was supplied by 5135A-20 from the circuit breaker panel. Continuity between 5135A-20 and 5135C-20 was established through the shut off switches by switch activation on/off. Continuity between 5135A-20 and 5134A-20 was established through the shut off switches by switch activation on/off. See figure 10-29 and figure 10-19 for wiring details.

A check was made for continuity from the cut aft to the fuel shut off connectors. Wires 5131D-20 and 5130B-20 to the Left Hand valve connector "A" and "B" pins were both open. Wires 5135D-20 and 5134B-20 to the Right Hand valve connector "A" and "B" pins were both open. The wires were followed to the connector at Fuselage Station 100 where a number of wires were observed to have been pulled forward and the pins disengaged from the connector creating an open circuit aft to the shut off valves.

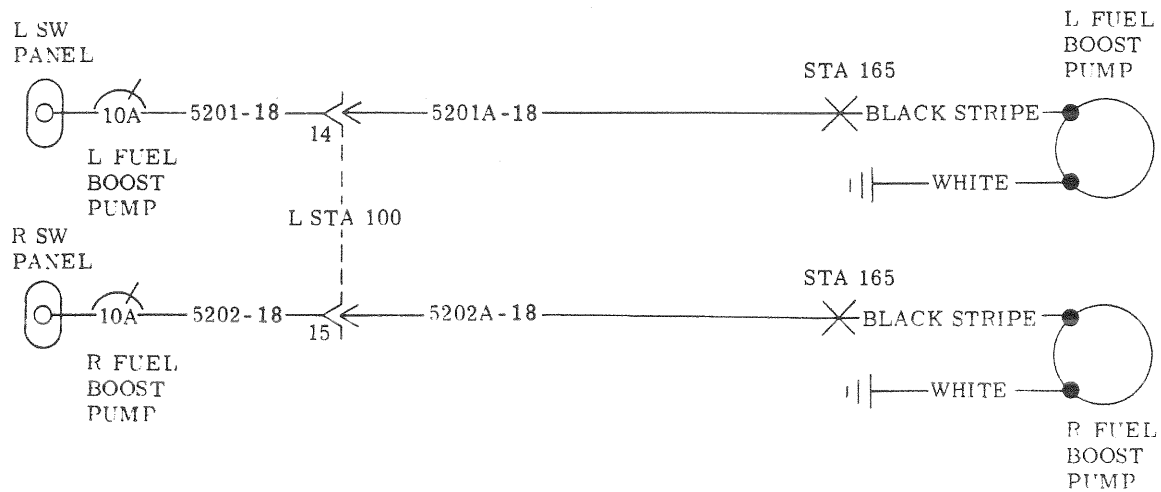
Figure 10-28. Fuel Boost Pumps

Power was applied to the Black Stripe wire and a Ground applied to the White wire on the LH and RH fuel boost pumps. Both of the pumps operated normally without being submersed in fuel. There was no grinding or binding noises noted. Damage to the wiring to the LH pump did not affect operation. Refer to Figure 10-28 for fuel boost pump wiring detail.
