NATIONAL TRANSPORTATION SAFETY BOARD

SYSTEMS EXAMINATION

WPR16L019

Location: Folsom, California
Date: October 24, 2015
Aircraft: Eurocopter AS-350 B3, N911WL, Serial #: 4587
NTSB IIC: Elliott Simpson

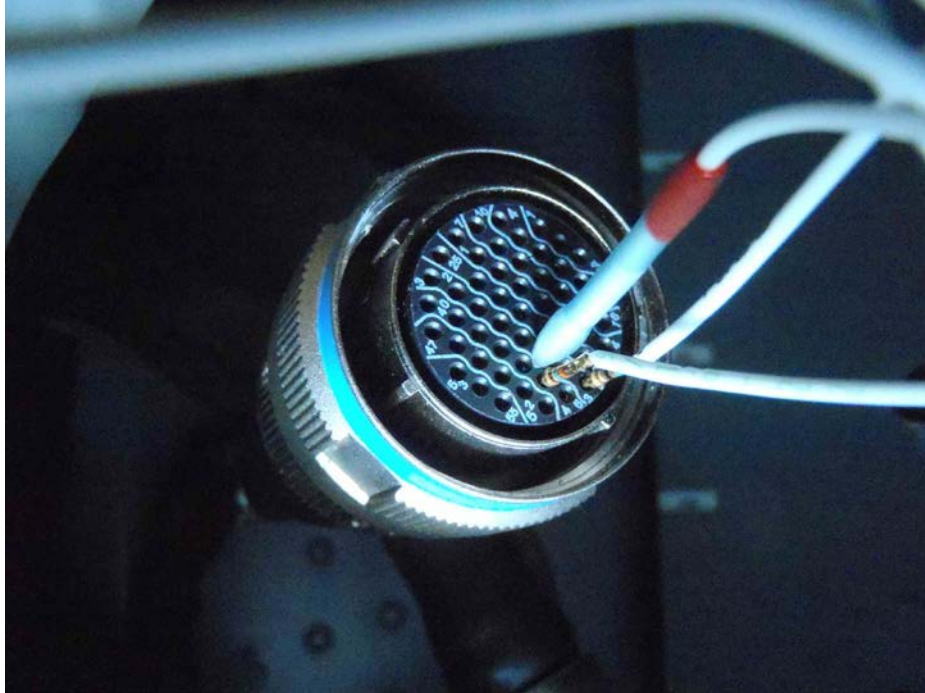
Photo 1 - The DECUC connector 55K.P2

The digital engine control unit (DECU) connector 55K.P2 was utilized (with the DECU removed) to test the electrical logic inputs to the DECU at the IDLE, FLIGHT, and COM pins. (Photo 1)

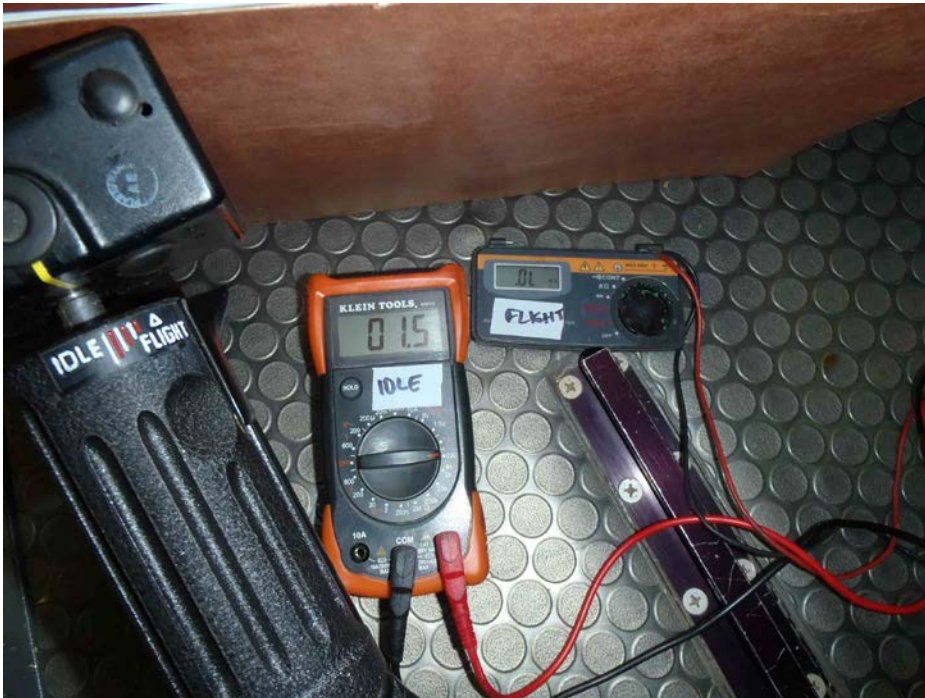
Photo 2 - Resistance at IDLE

With the twist grip in the IDLE position, the resistance between IDLE and COM pins was 1.5 ohms, with the resistance between the FLIGHT and COM pins exceeding the ohmmeters range, indicating an open circuit. (Photo 2)

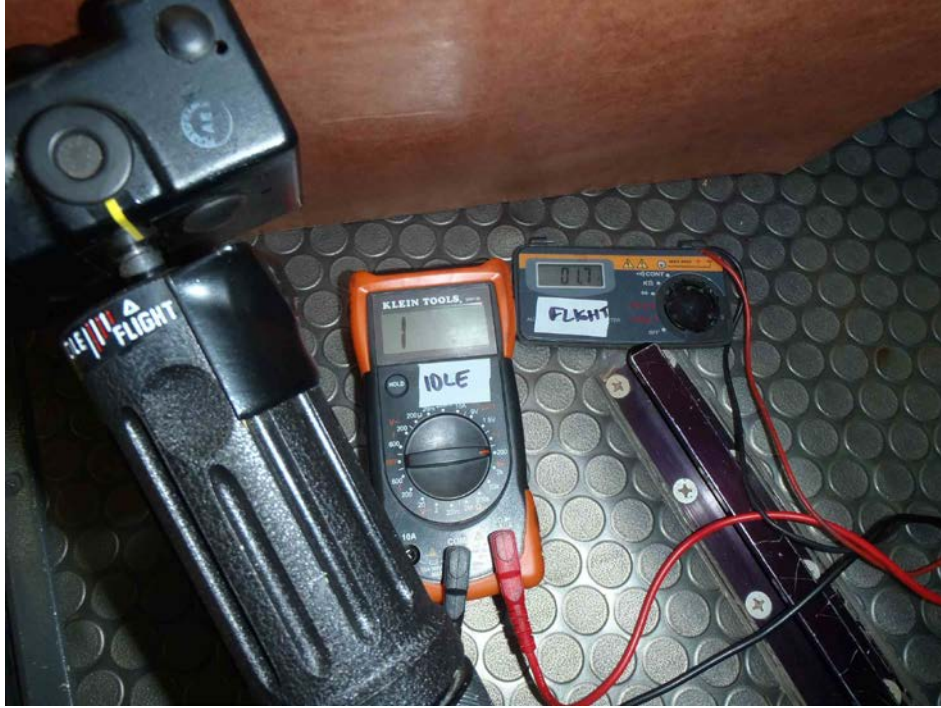
Photo 3 - Resistance at FLIGHT

The twist grip was then rotated just out of the IDLE detent until the first microswitch "click" was heard. At that time, the resistance between FLIGHT and COM pins changed to 1.7 ohms, with the resistance between the COM and IDLE pins exceeding the ohmmeters range, indicating an open circuit. The resistance values remained unchanged as the twist grip was rotated through to the FLIGHT position. (Photo 3)

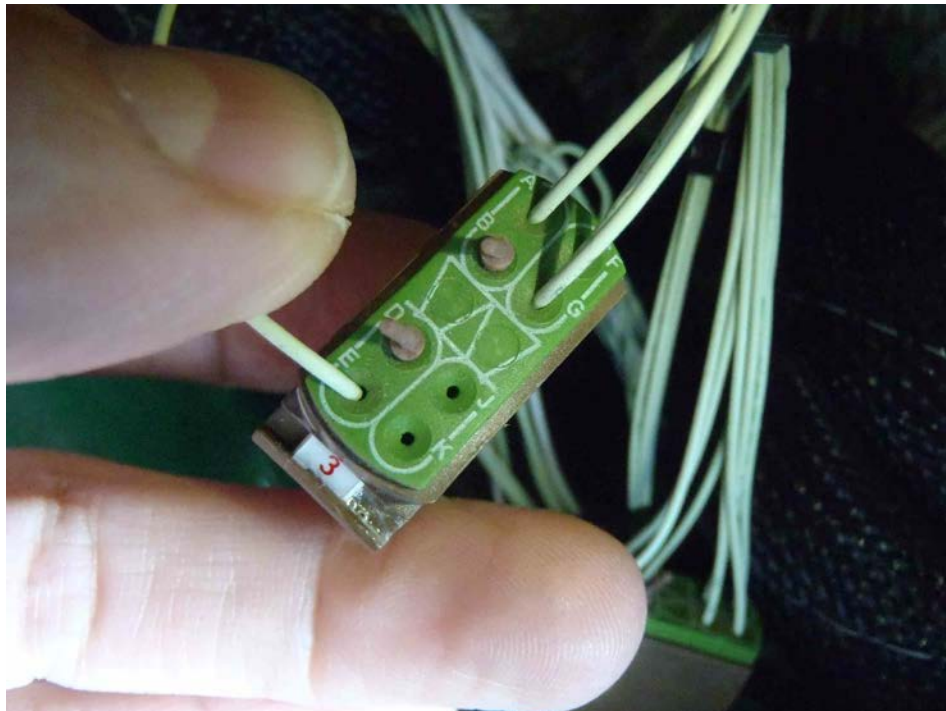
Photo 4 - Diode 3 on 66K Block

The electrical system was visually examined to confirm the completion of AS350-80.00.09 Revision 2 (Post Revision 1). Specifically, it was confirmed that the cathode of Diode 3, pins 3K and 3J (66K block), had been disconnected in accordance with the bulletin (Photo 4). According to the technician who performed the bulletin, the cable (1KK44E) which was connected to the diode, was removed from the airframe rather than terminated, in an effort to eliminate unnecessary cabling. This was confirmed by airframe examination, and specifically cable 1KK44E was determined to no longer be connected to the 54K relay, pin A1 (Photo 5)

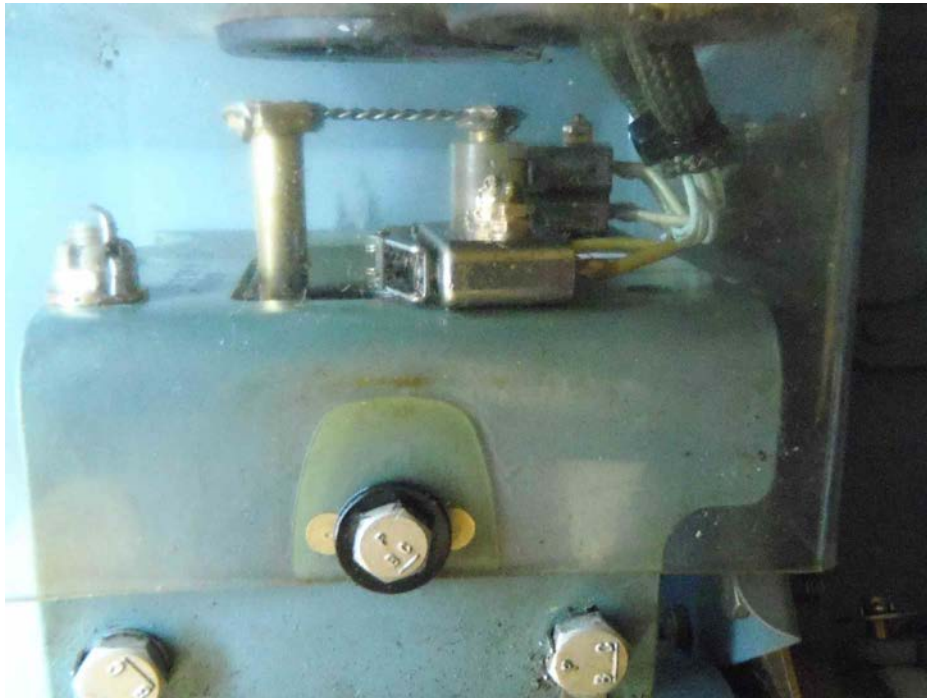
Photo 6 - Twist Grip Microswitches

Oil was observed on the microswitch protective cover (Photo 6), and according to the technician this was a common occurrence, and explained by a breakdown of the grease within the twist grip rotary mechanism.
