NATIONAL TRANSPORTATION SAFETY BOARD

UAS Aerial Imagery Report

A. ACCIDENT HWY18MH005

Location: Crozet, VA
Date: January 31, 2018

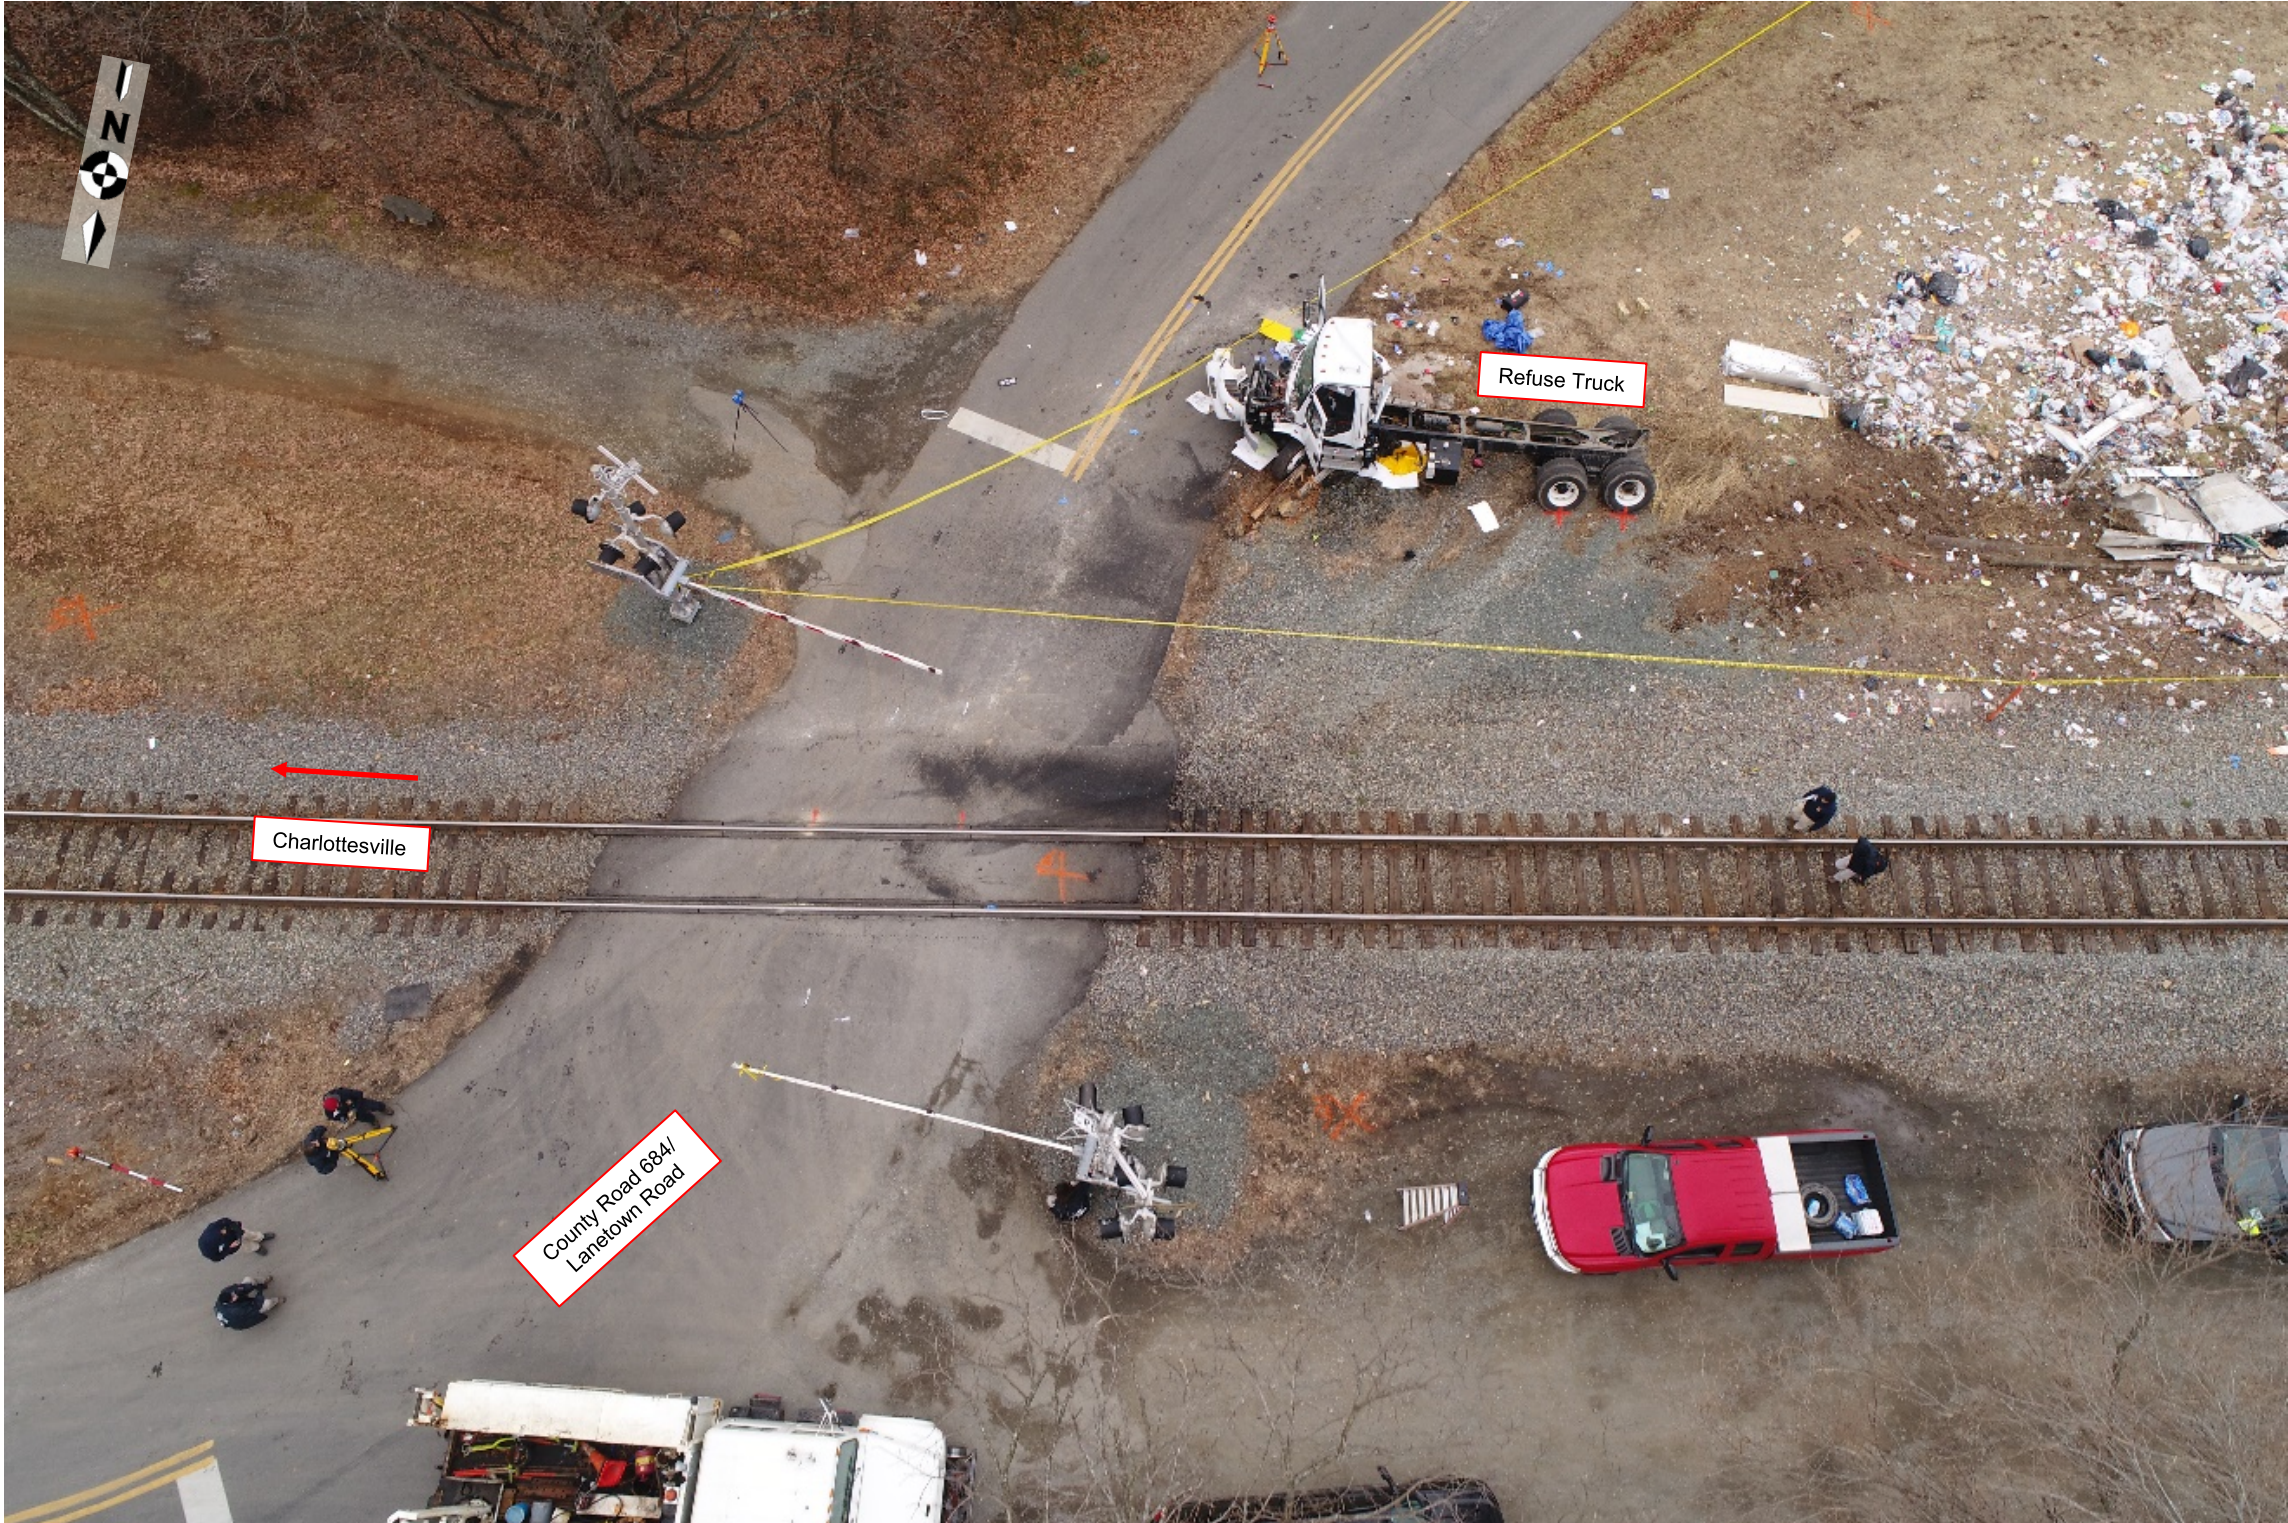
Figure 1 – Photo, Grade Crossing and Refuse Truck (directional arrow approximated)

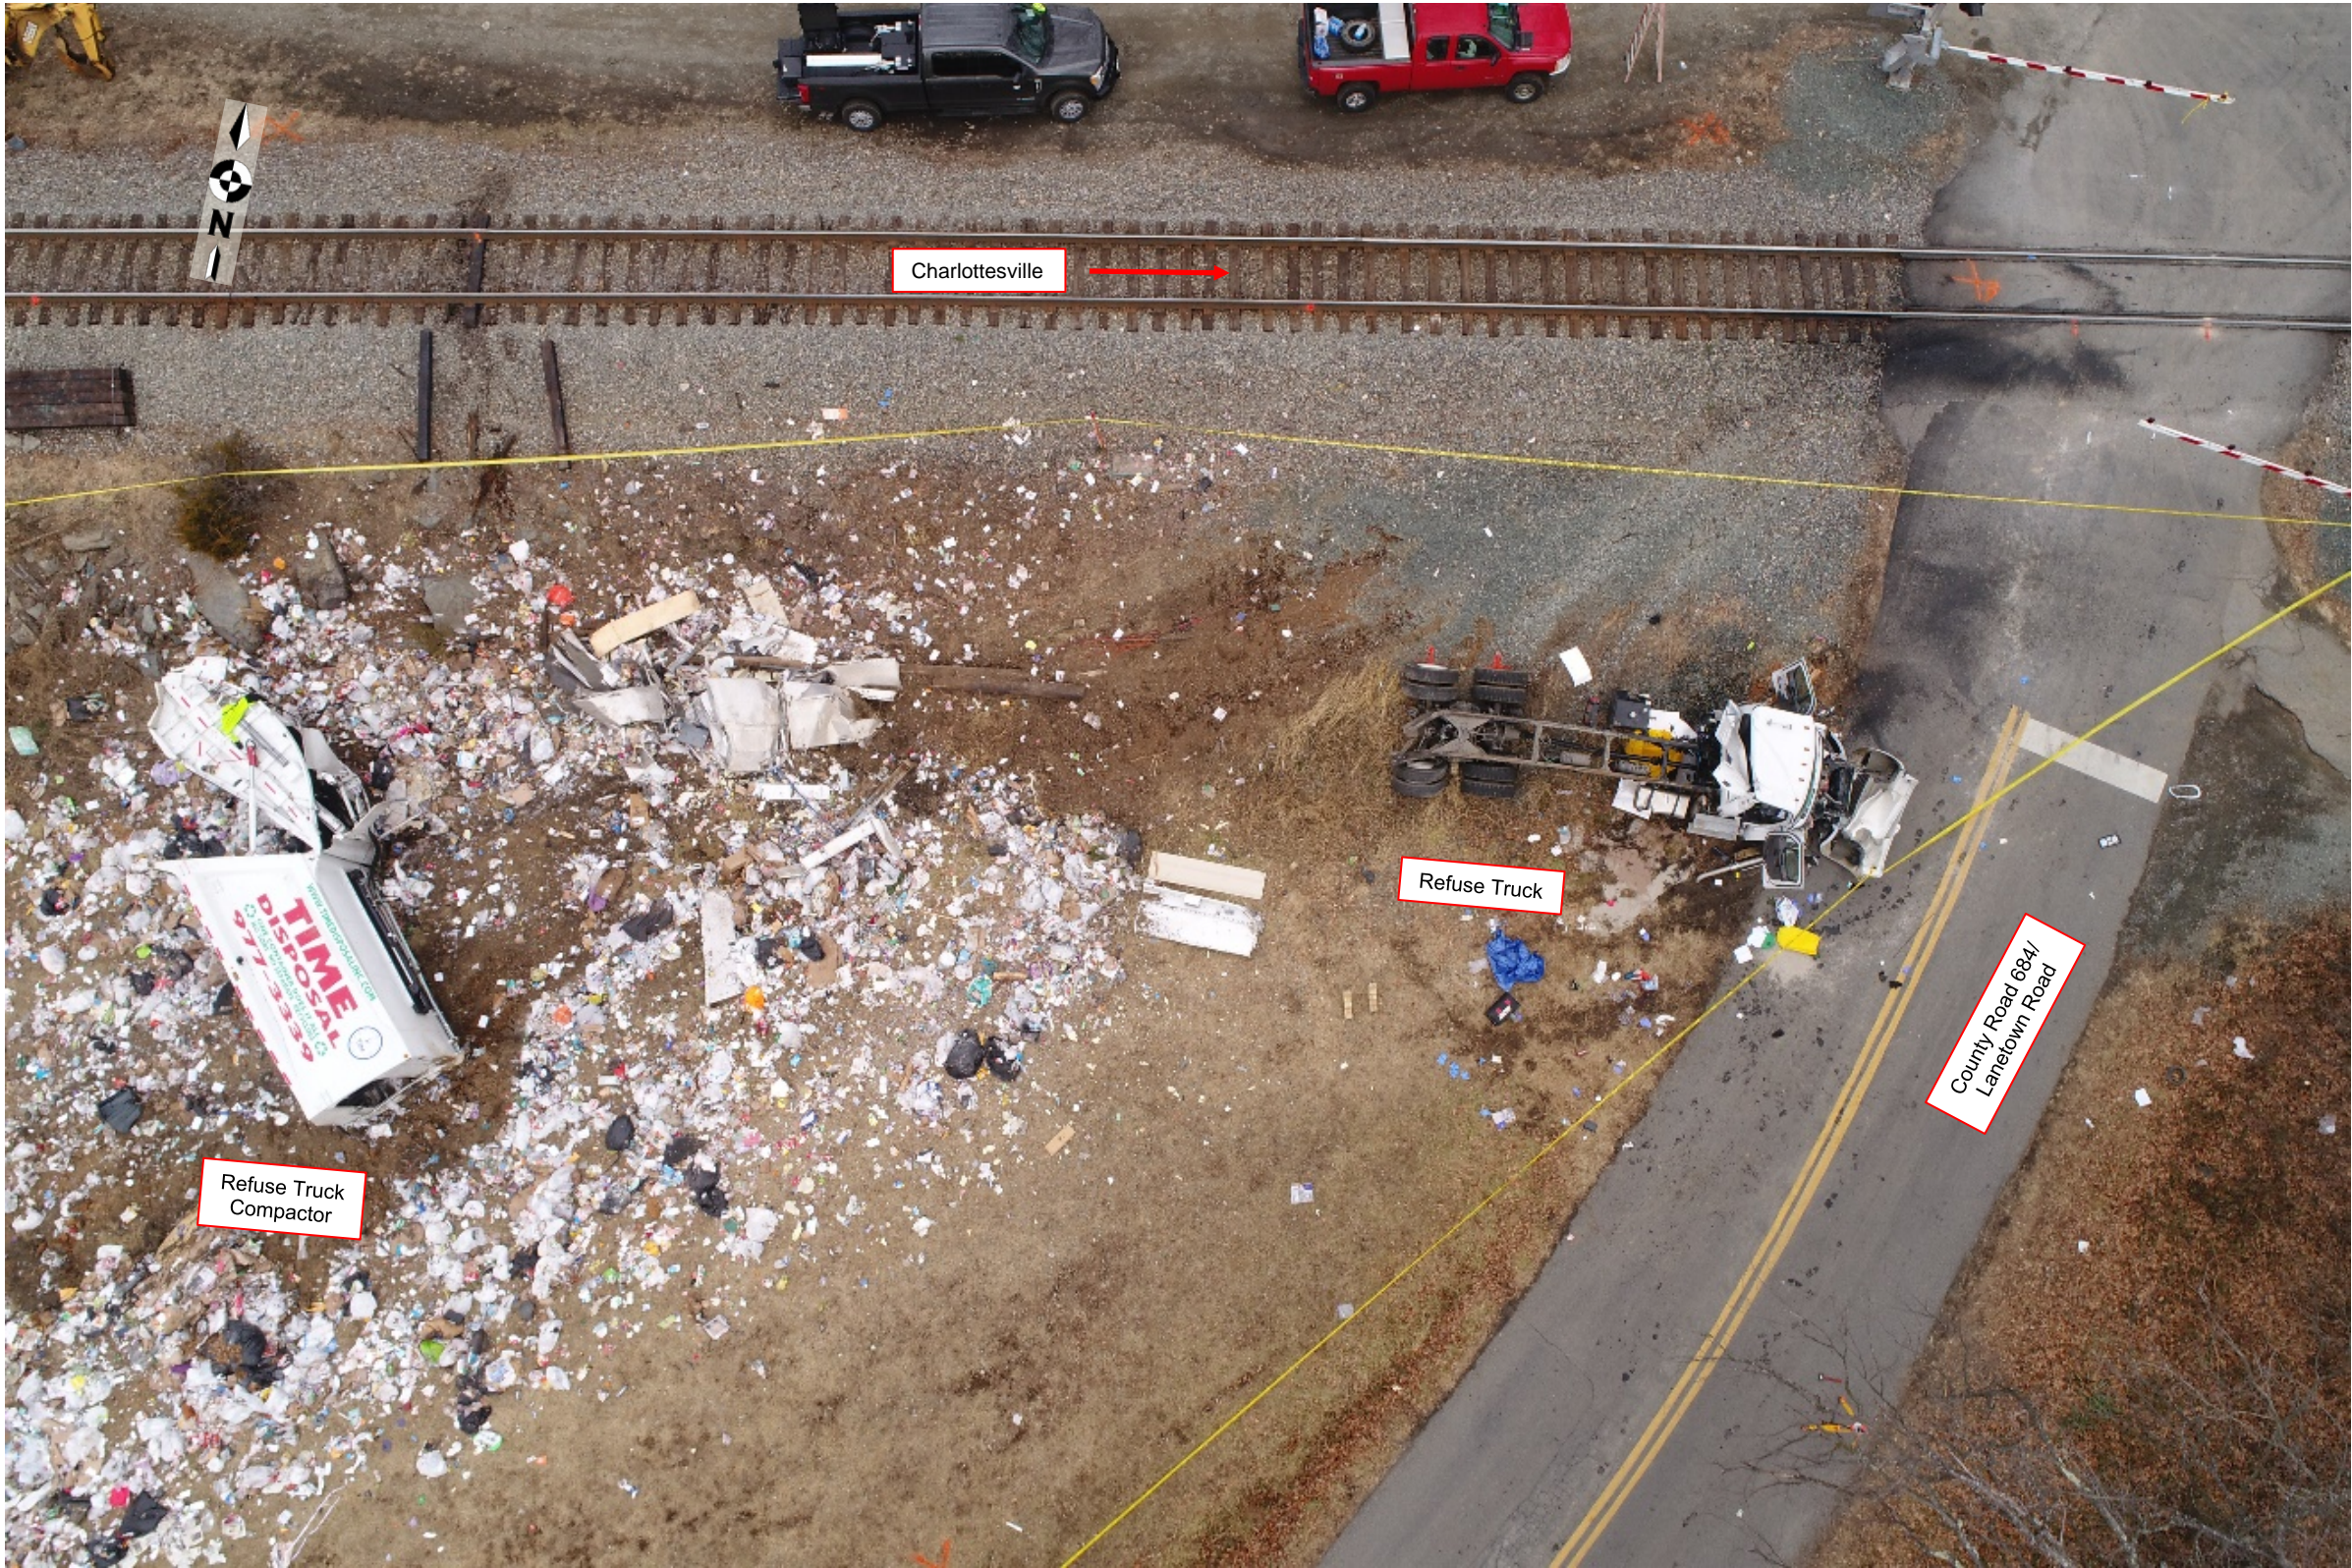
Figure 2 – Photo - Grade Crossing, Refuse Truck and Refuse Truck Compactor (directional arrow approximated)

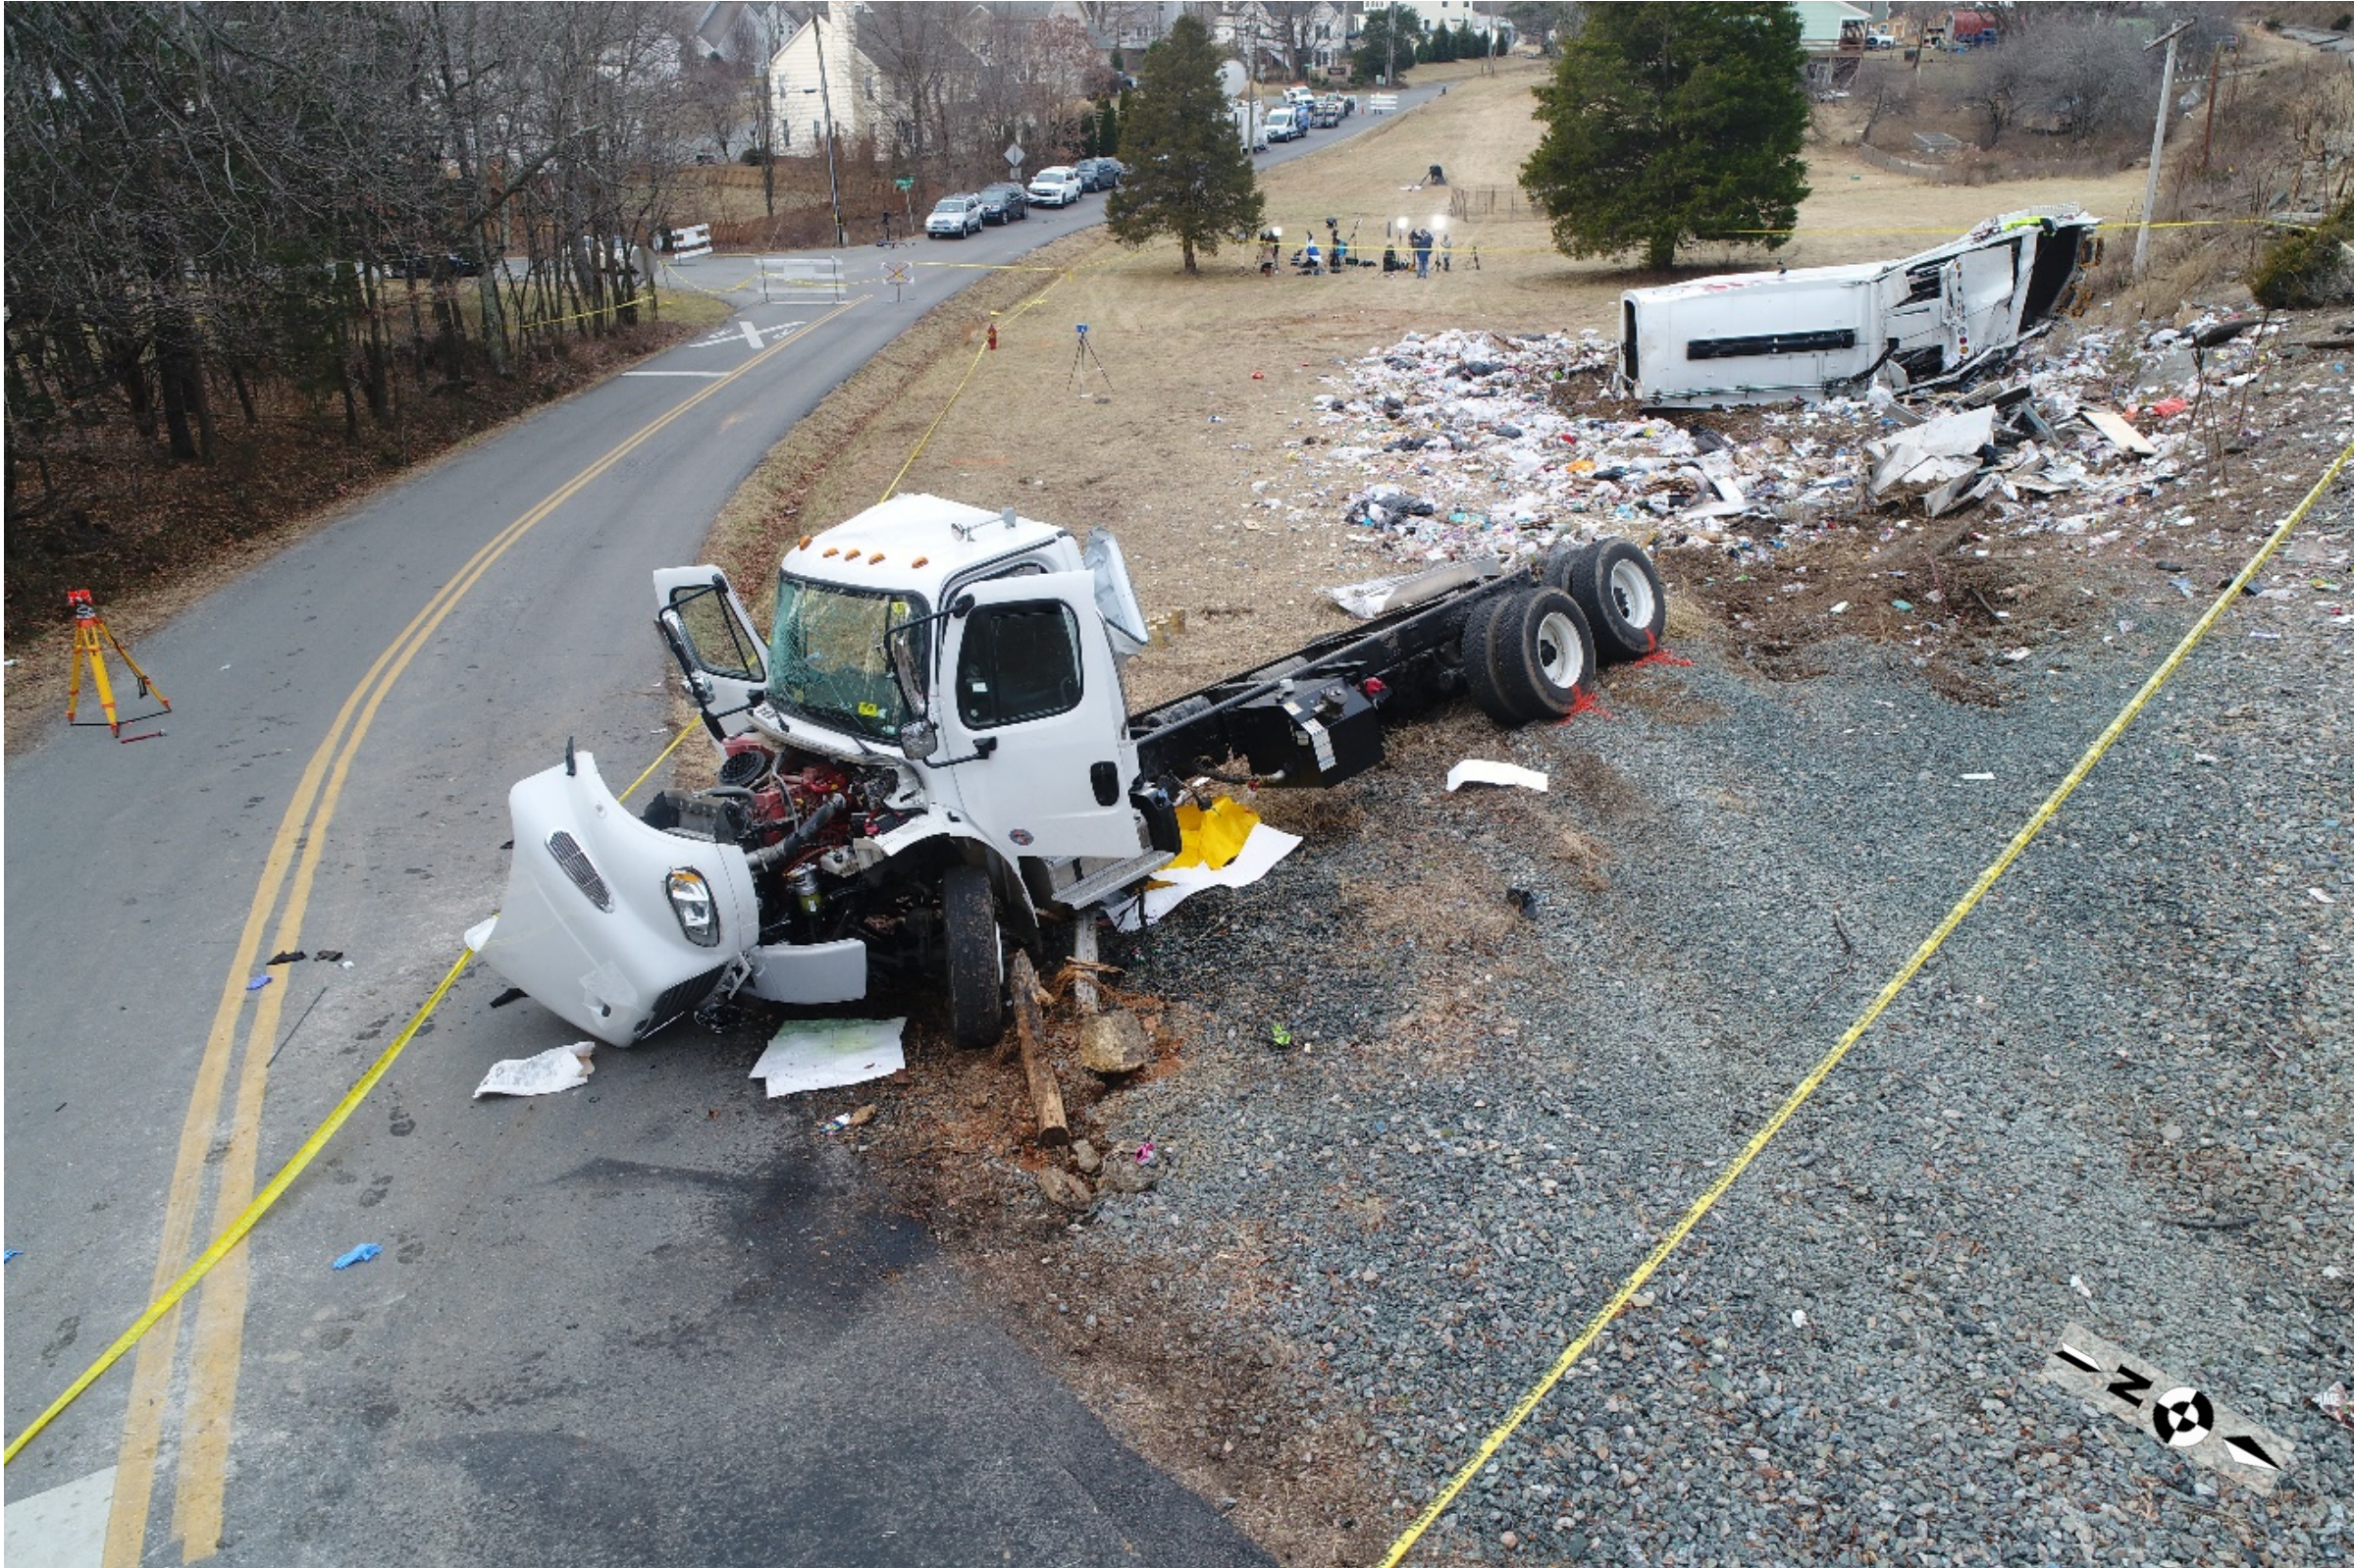
Figure 3 – Photo - Refuse Truck in final location (directional arrow approximated)

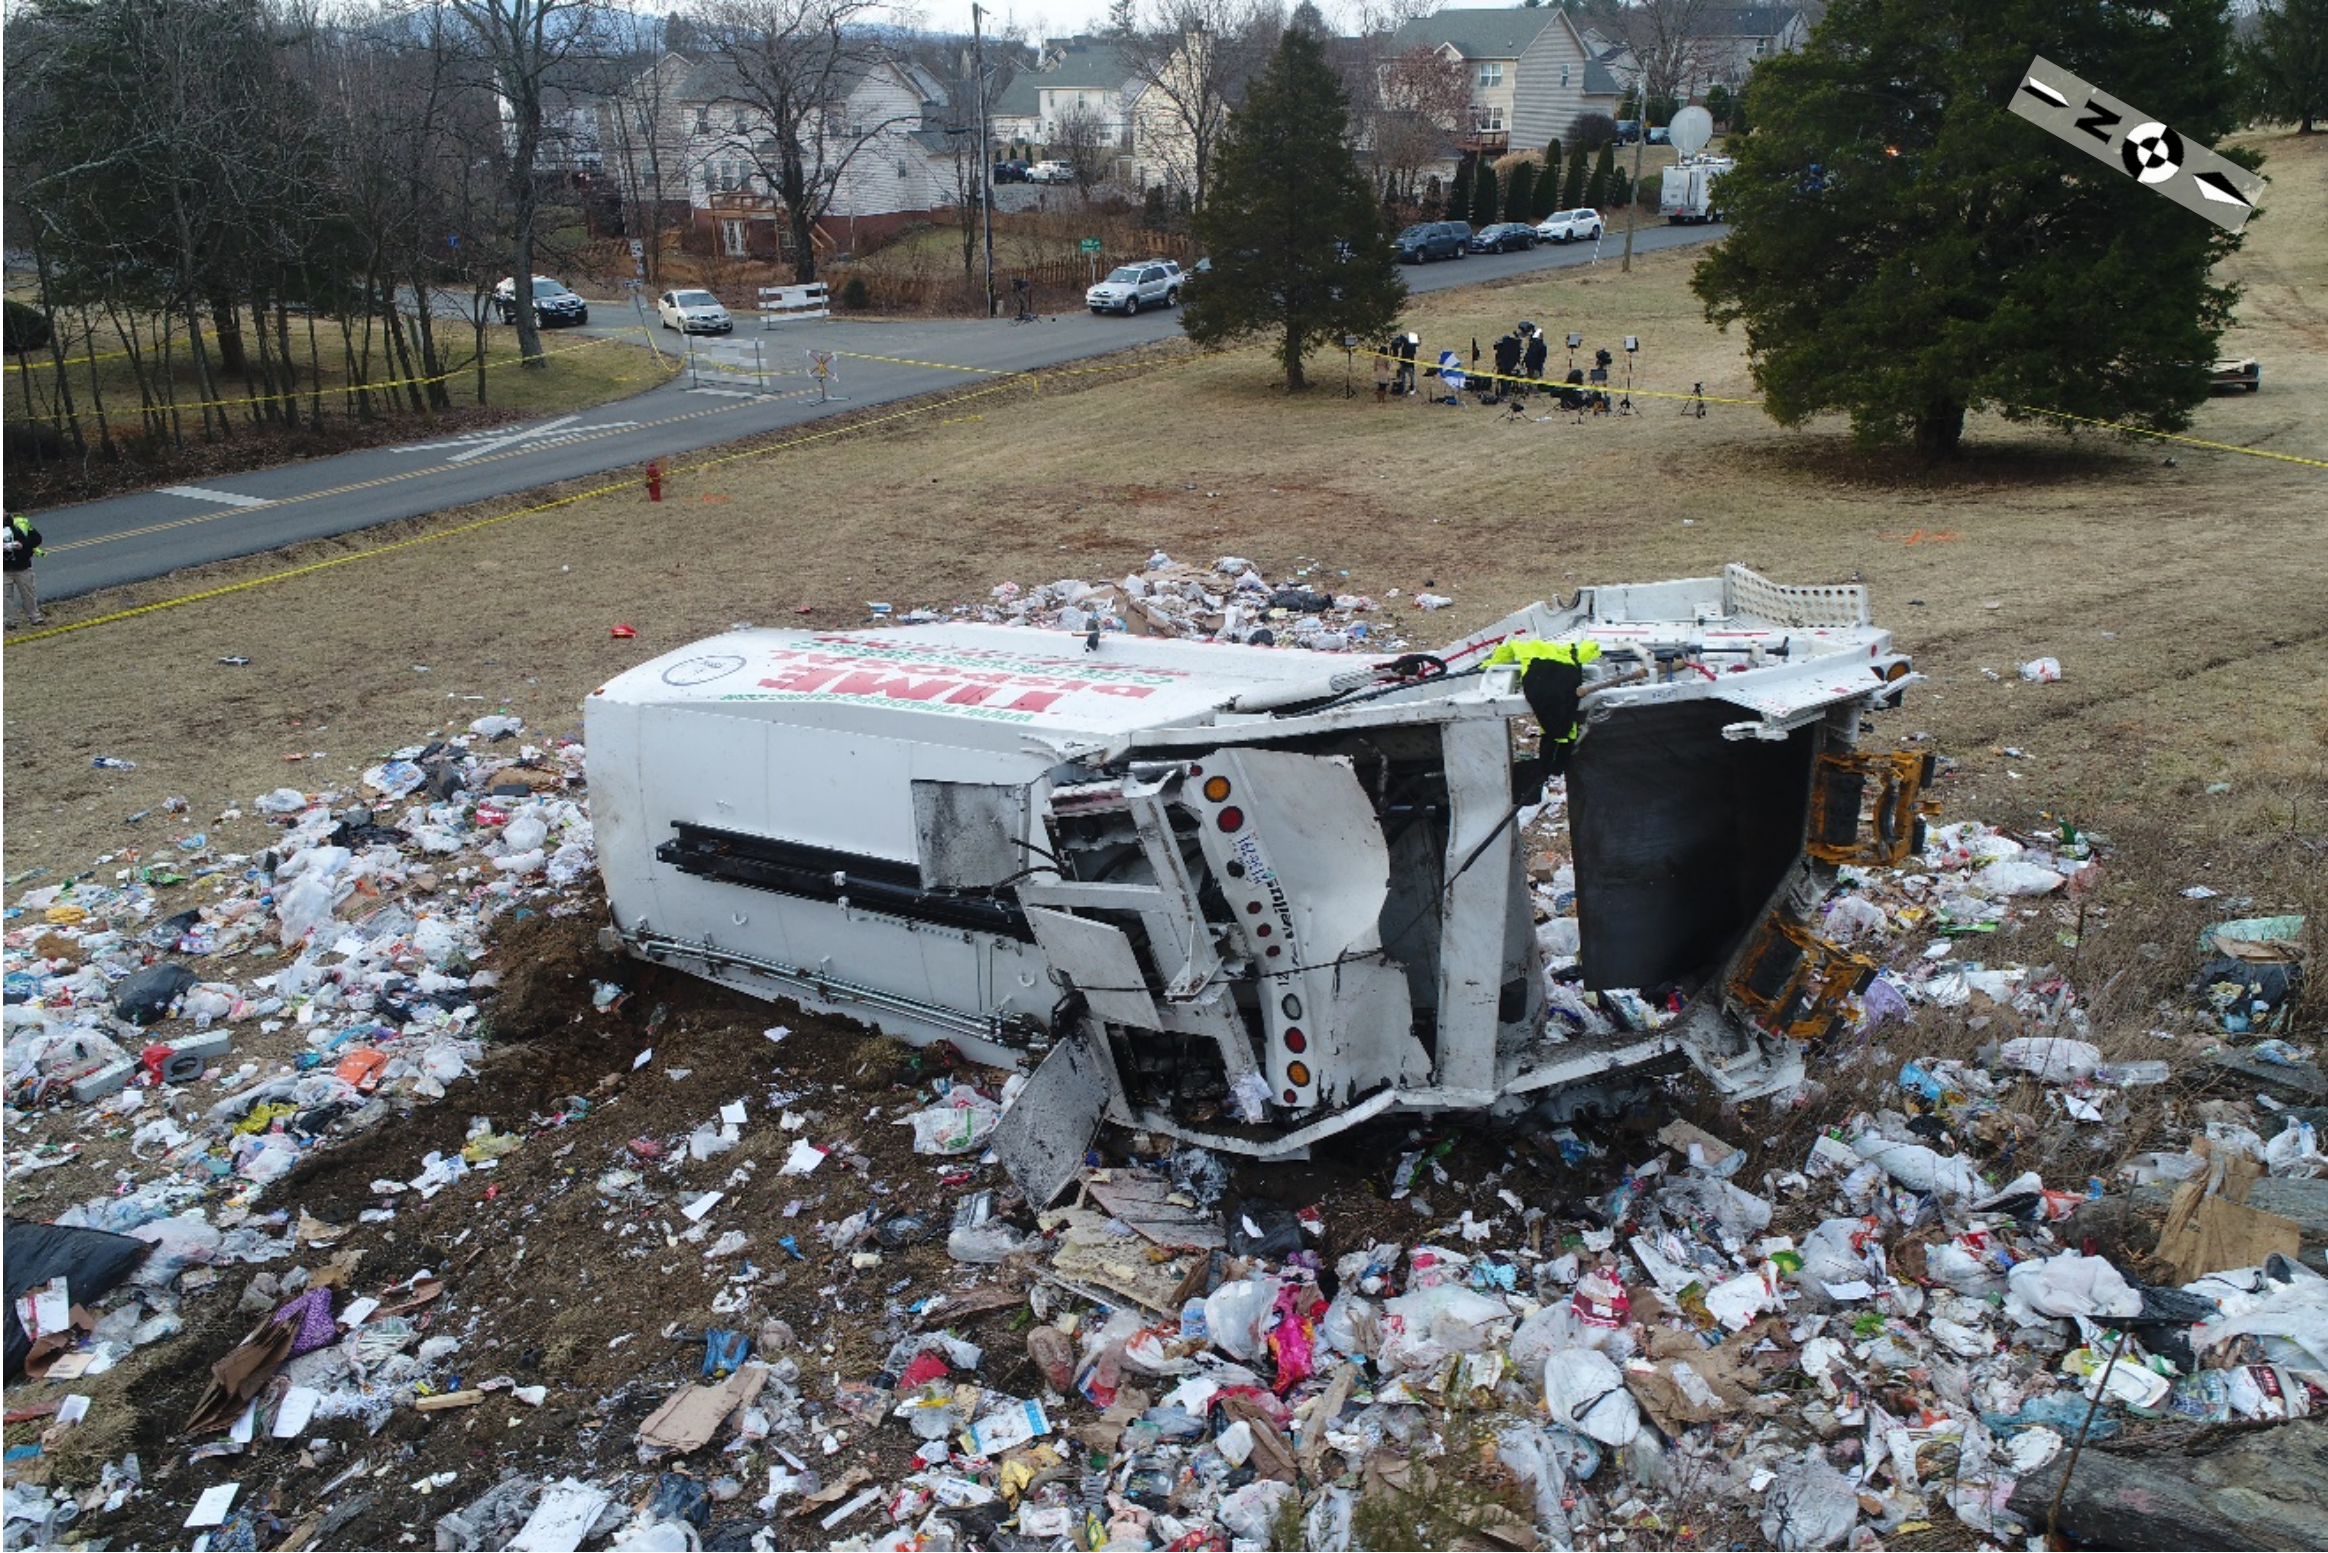
Figure 4 – Photo - Refuse Truck Compactor in final location (directional arrow approximated)

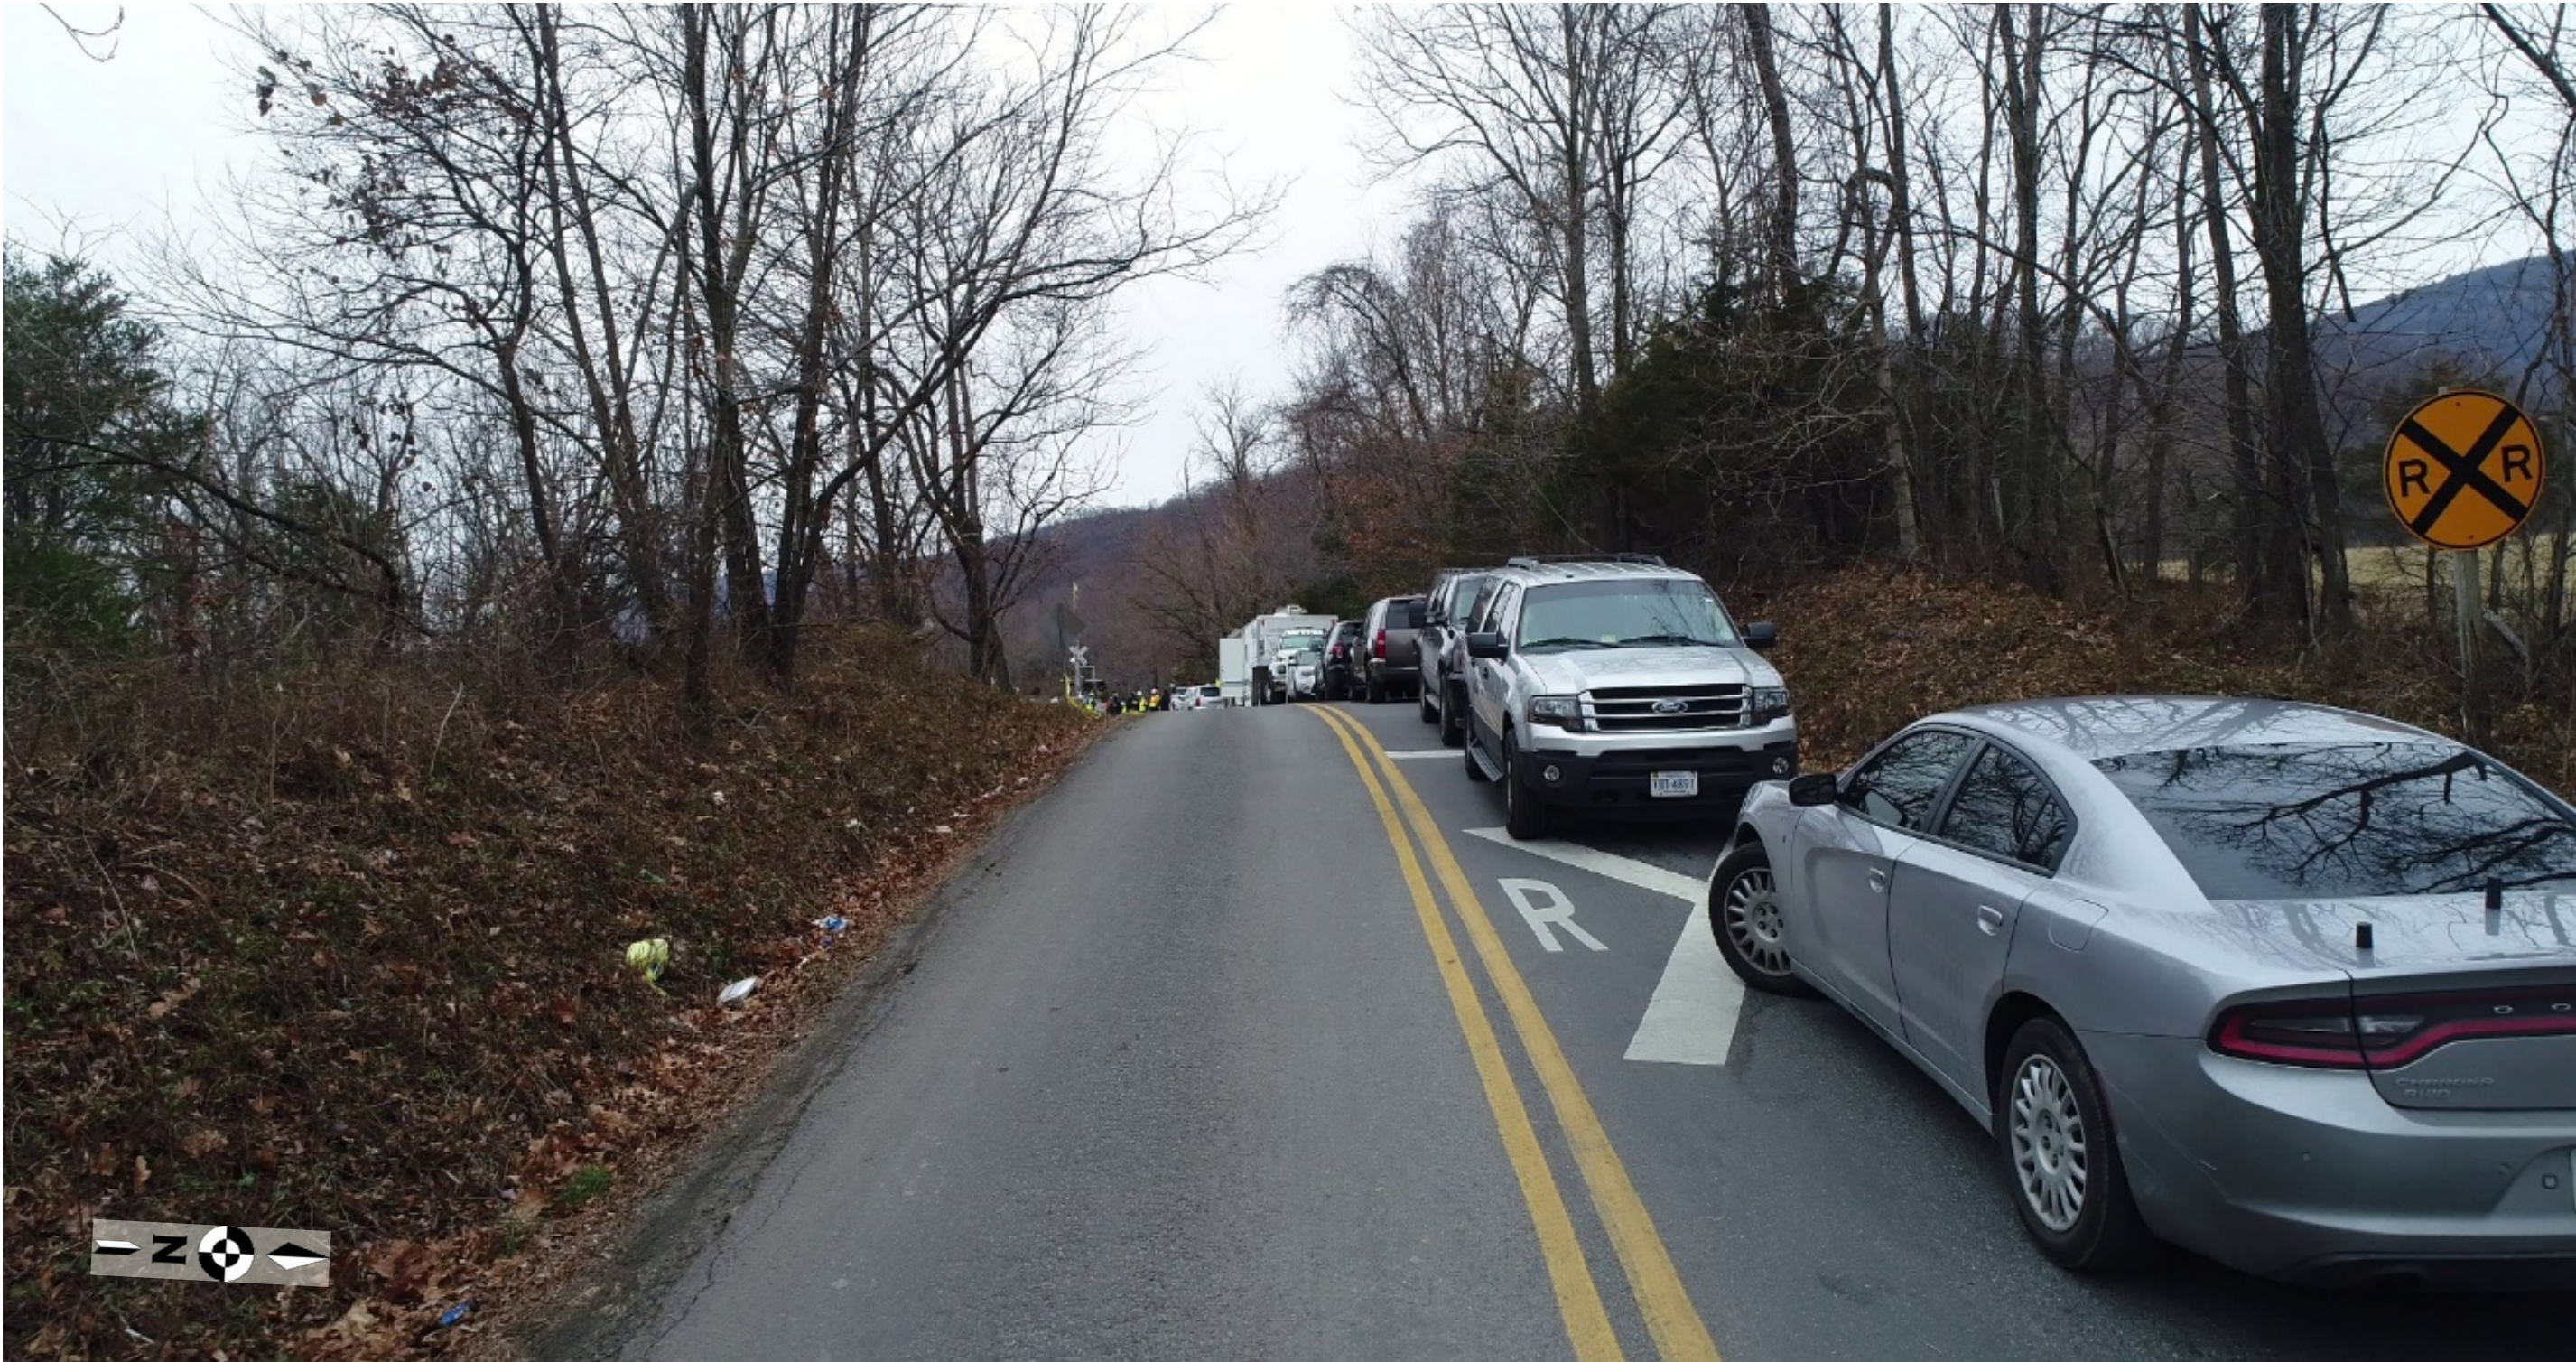
Figure 5 - Video Snapshot from drone video on Lanetown Road approaching grade crossing (directional arrow approximated).

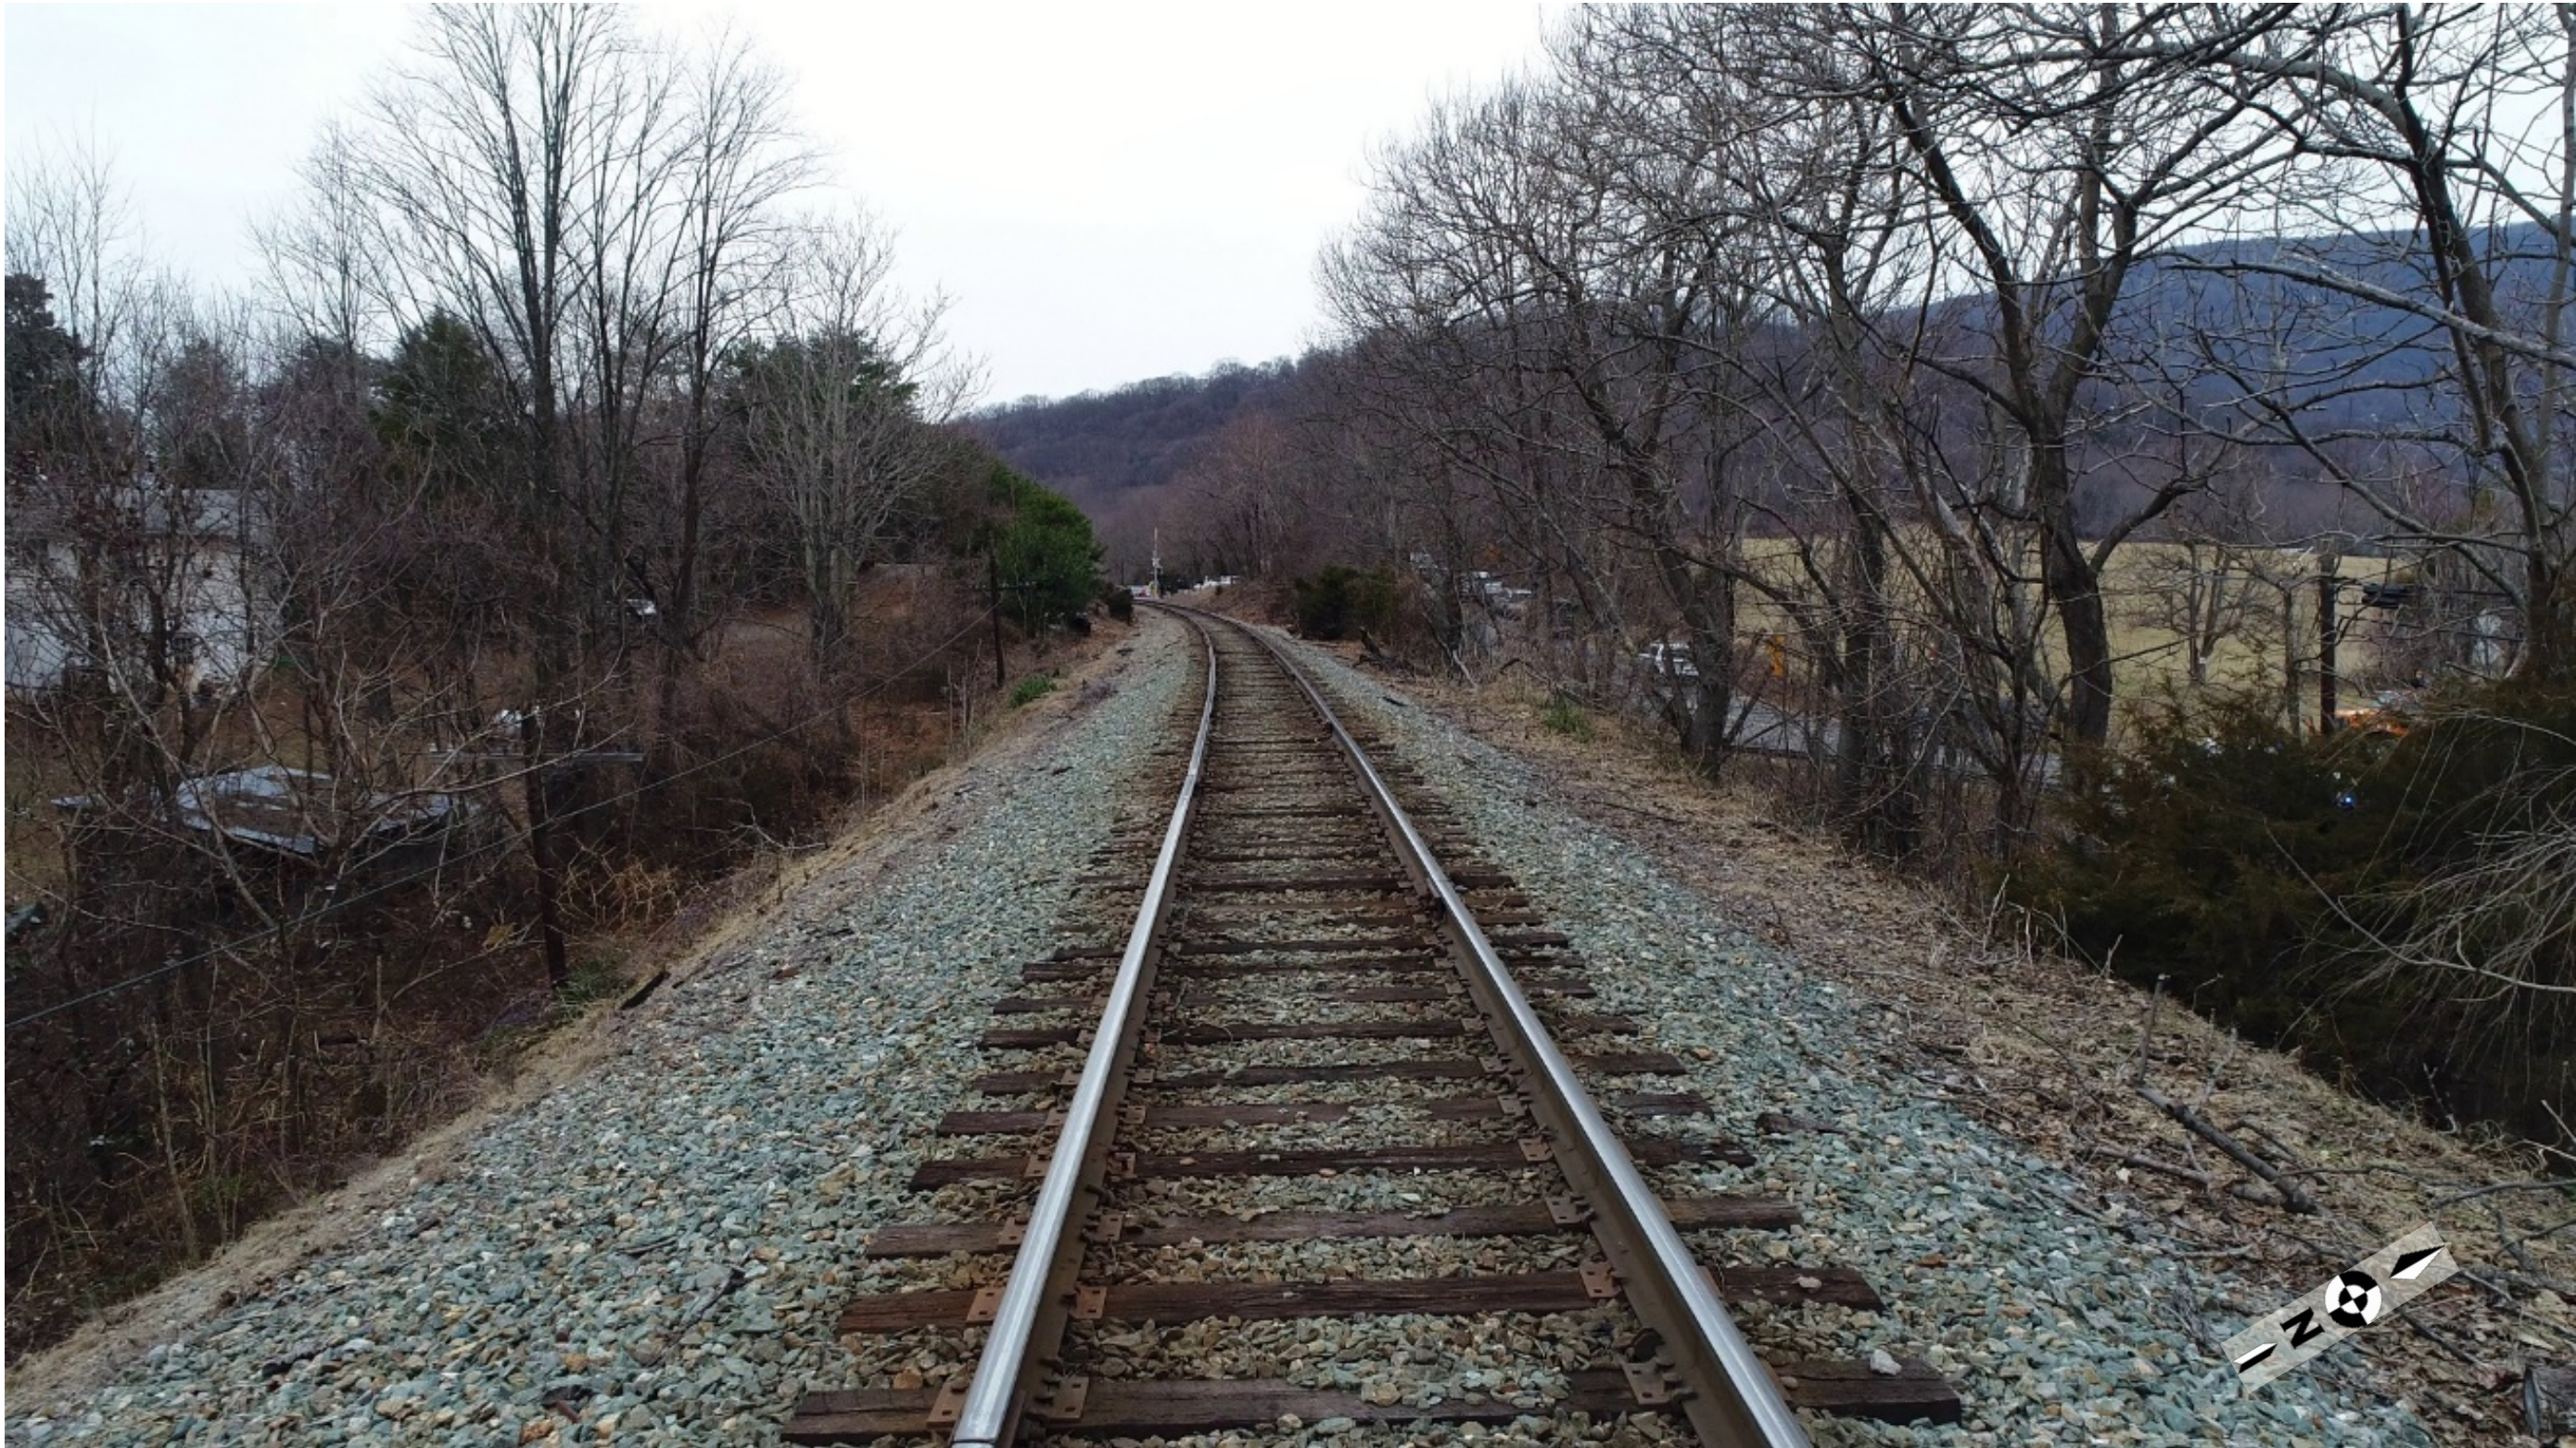
Figure 6 - Video Snapshot from railway approaching Lanetown Road grade crossing (directional arrow approximated).
