NATIONAL TRANSPORTATION SAFETY BOARD

UAS Aerial Imagery Report

A. ACCIDENT HWY18MH005

Location: Crozet, VA
Date: January 31, 2018

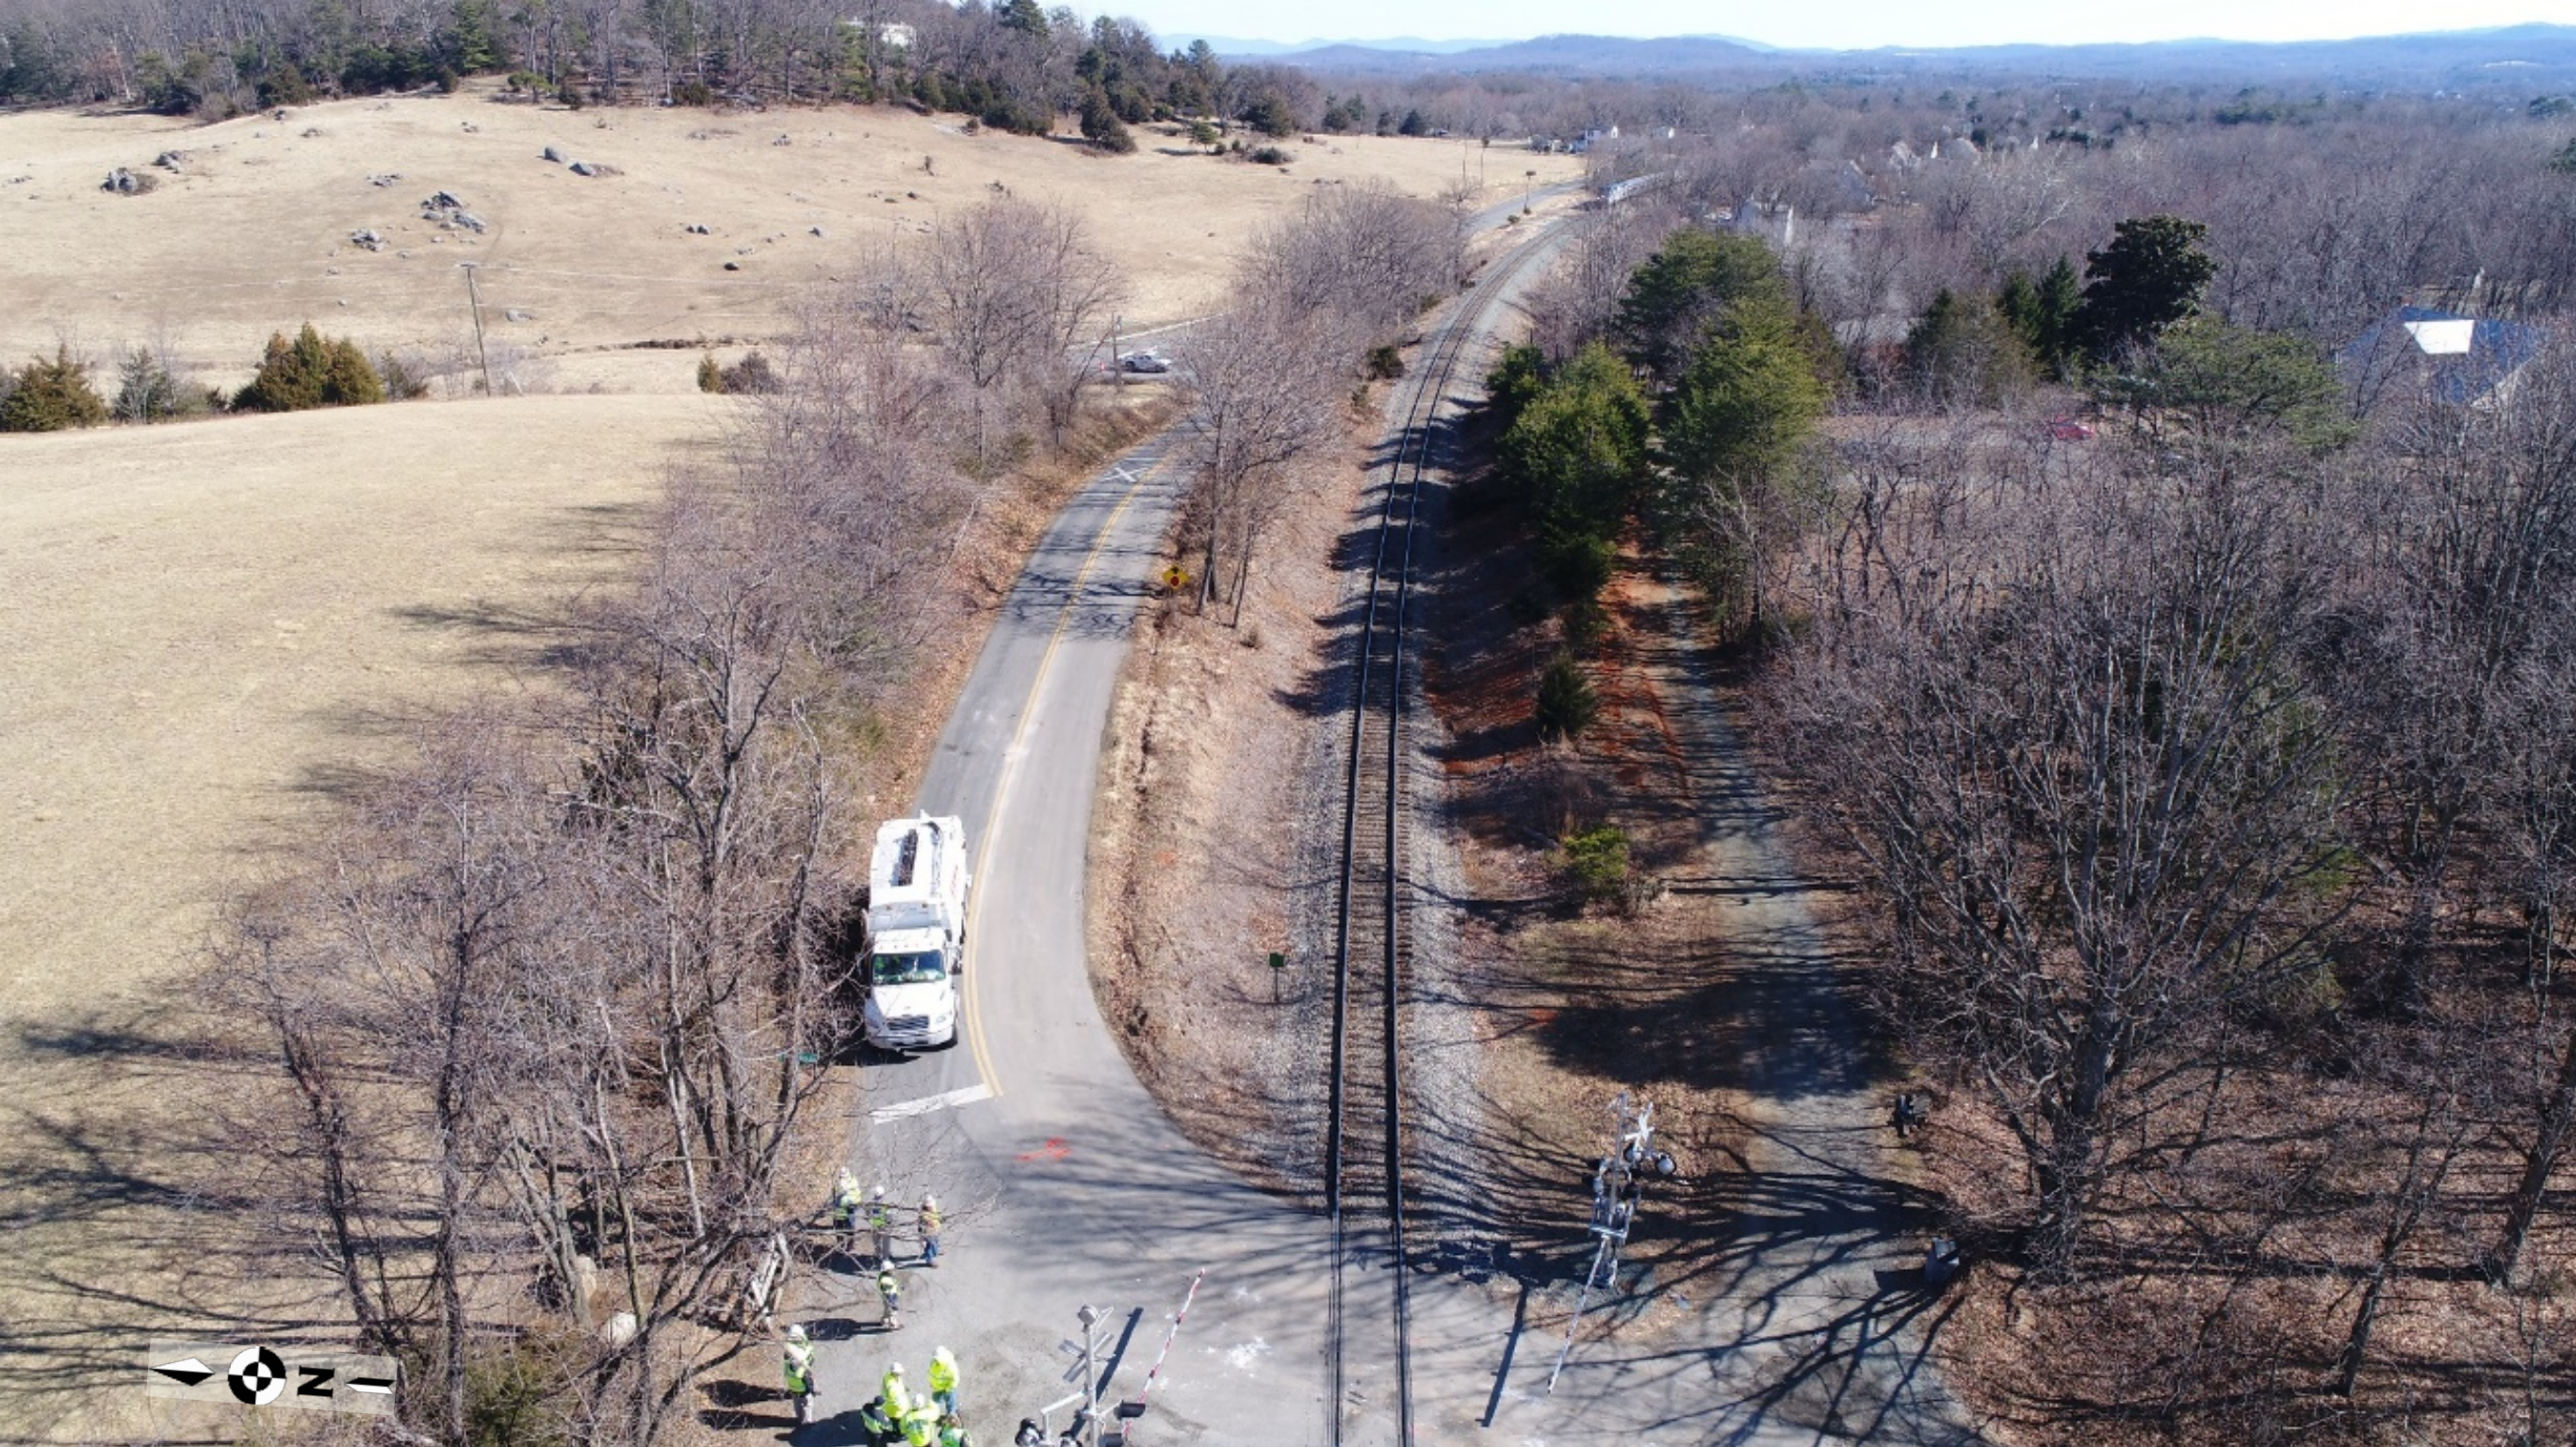
Figure 7 - Train positioned at Rail Point 1 (directional arrow approximated)

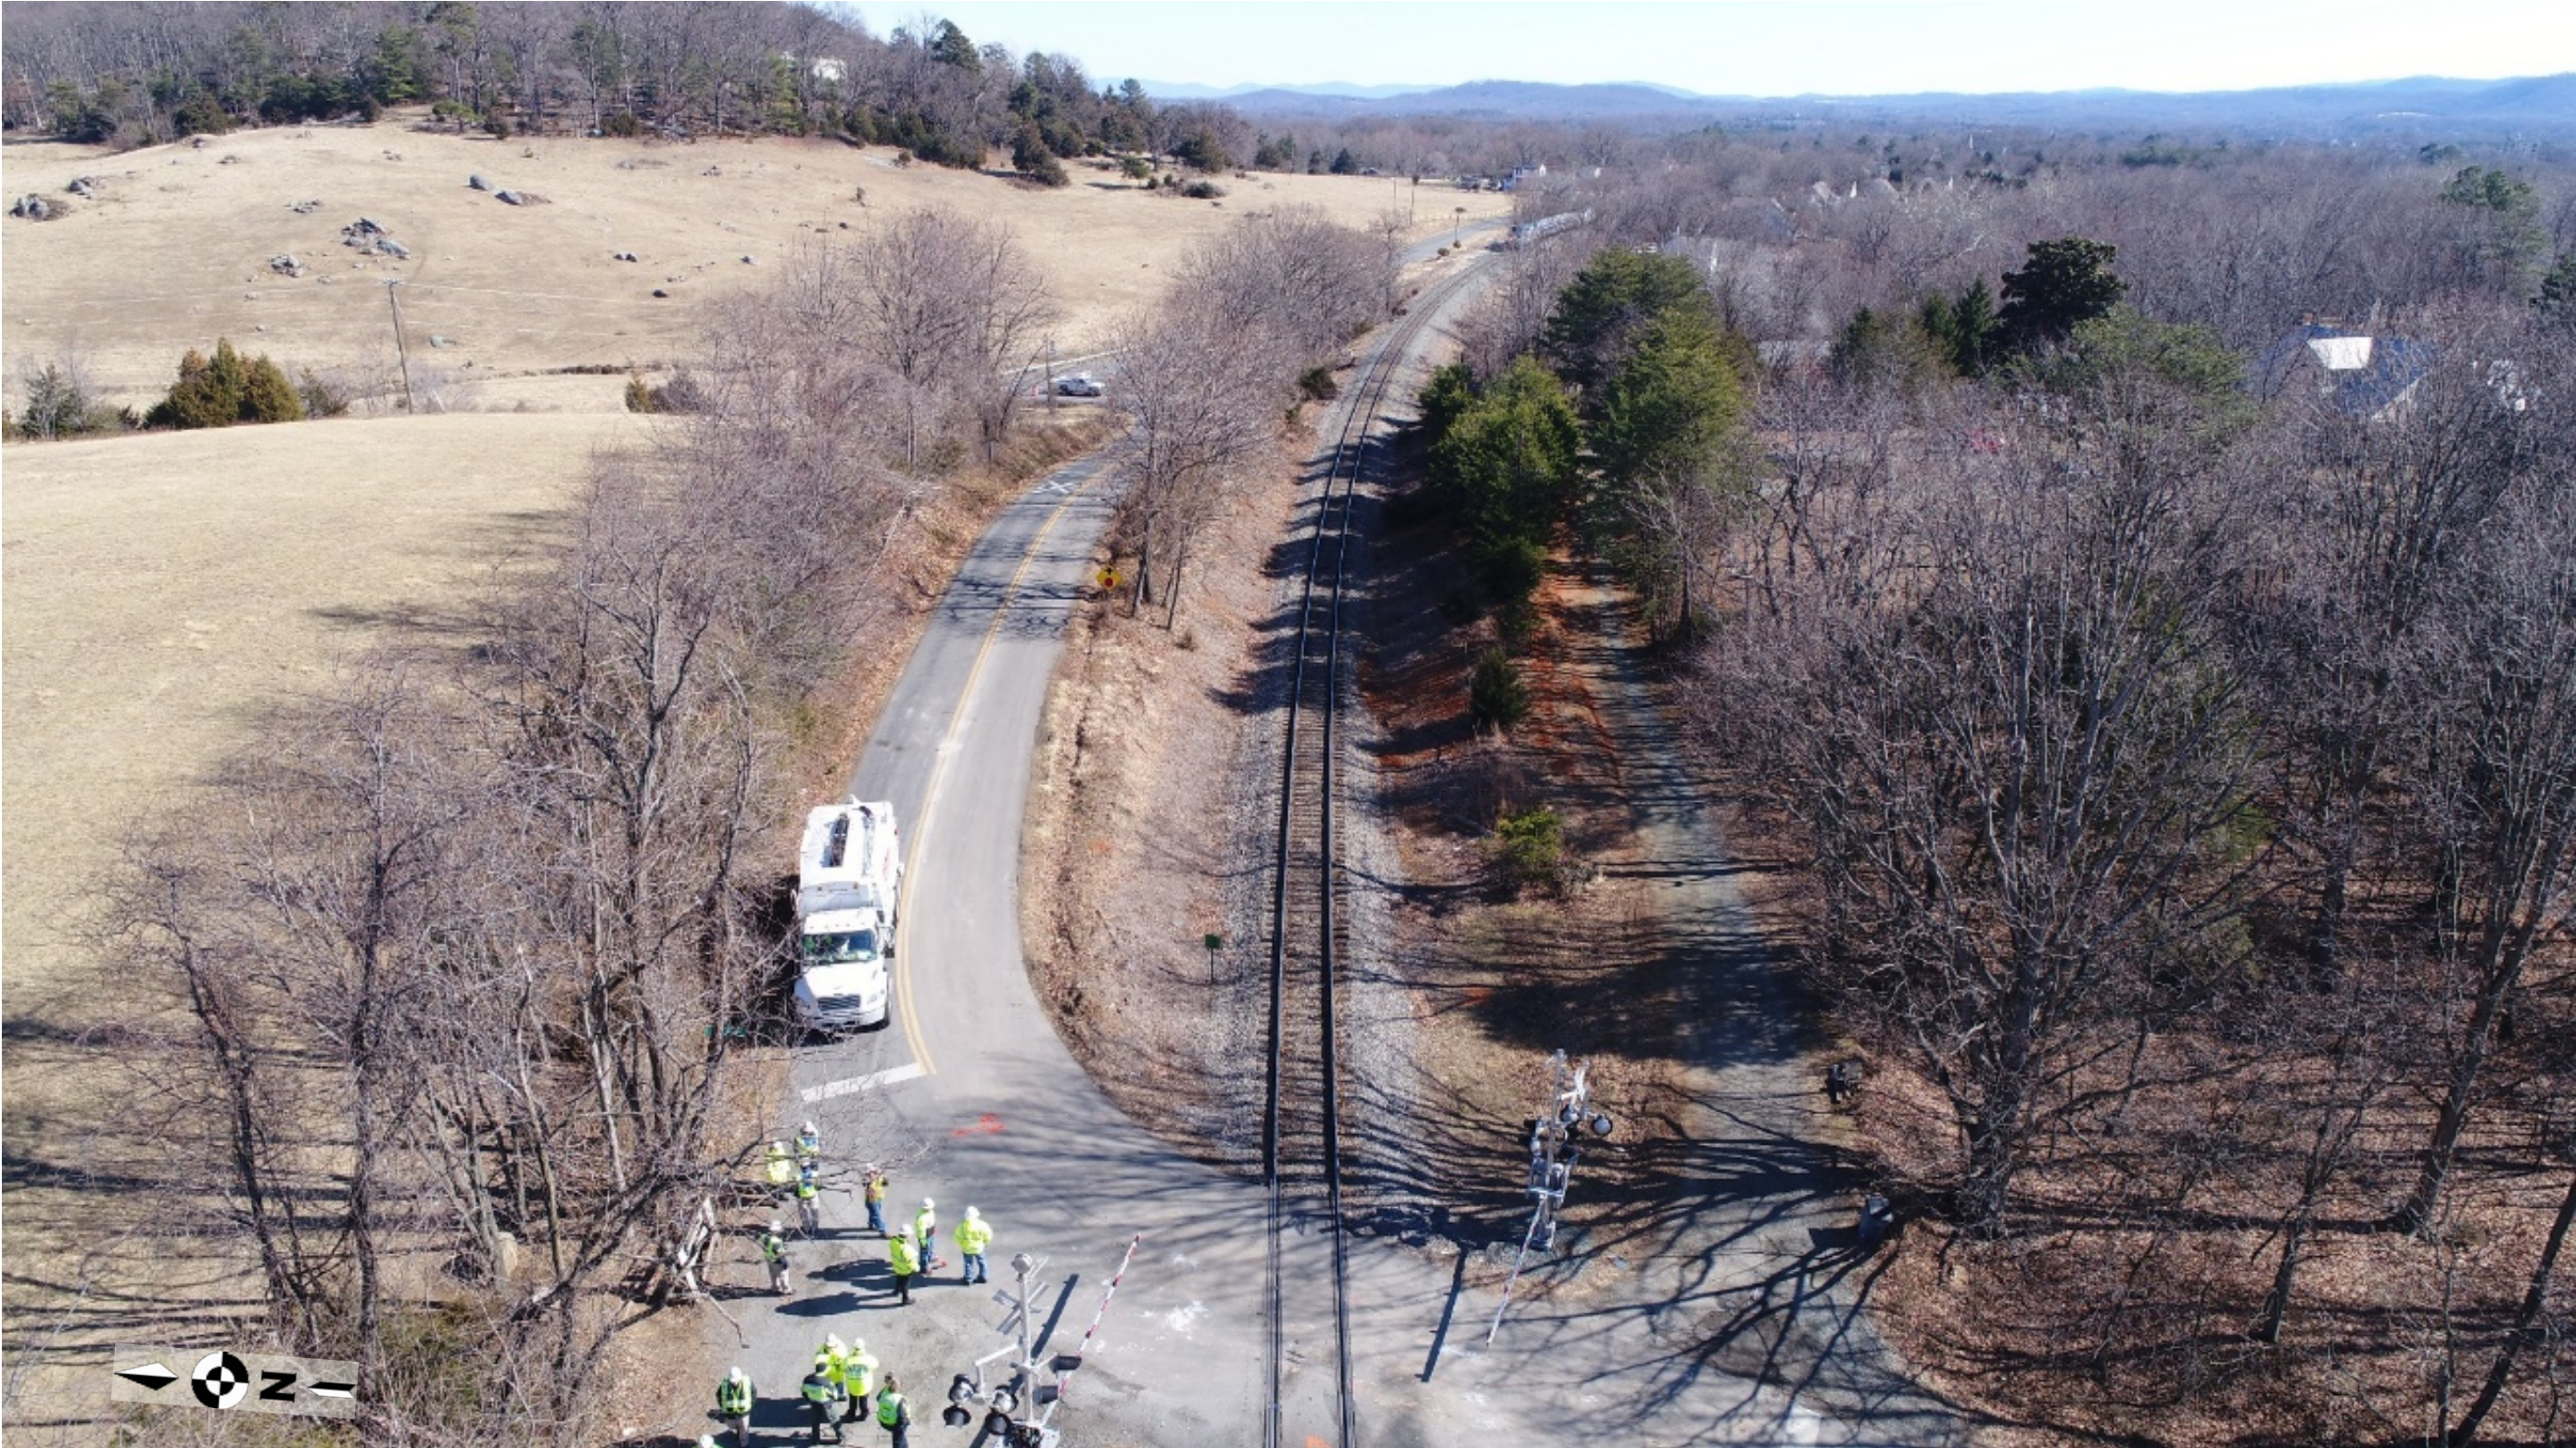
Figure 8 - Train positioned at Rail Point 2 (directional arrow approximated)

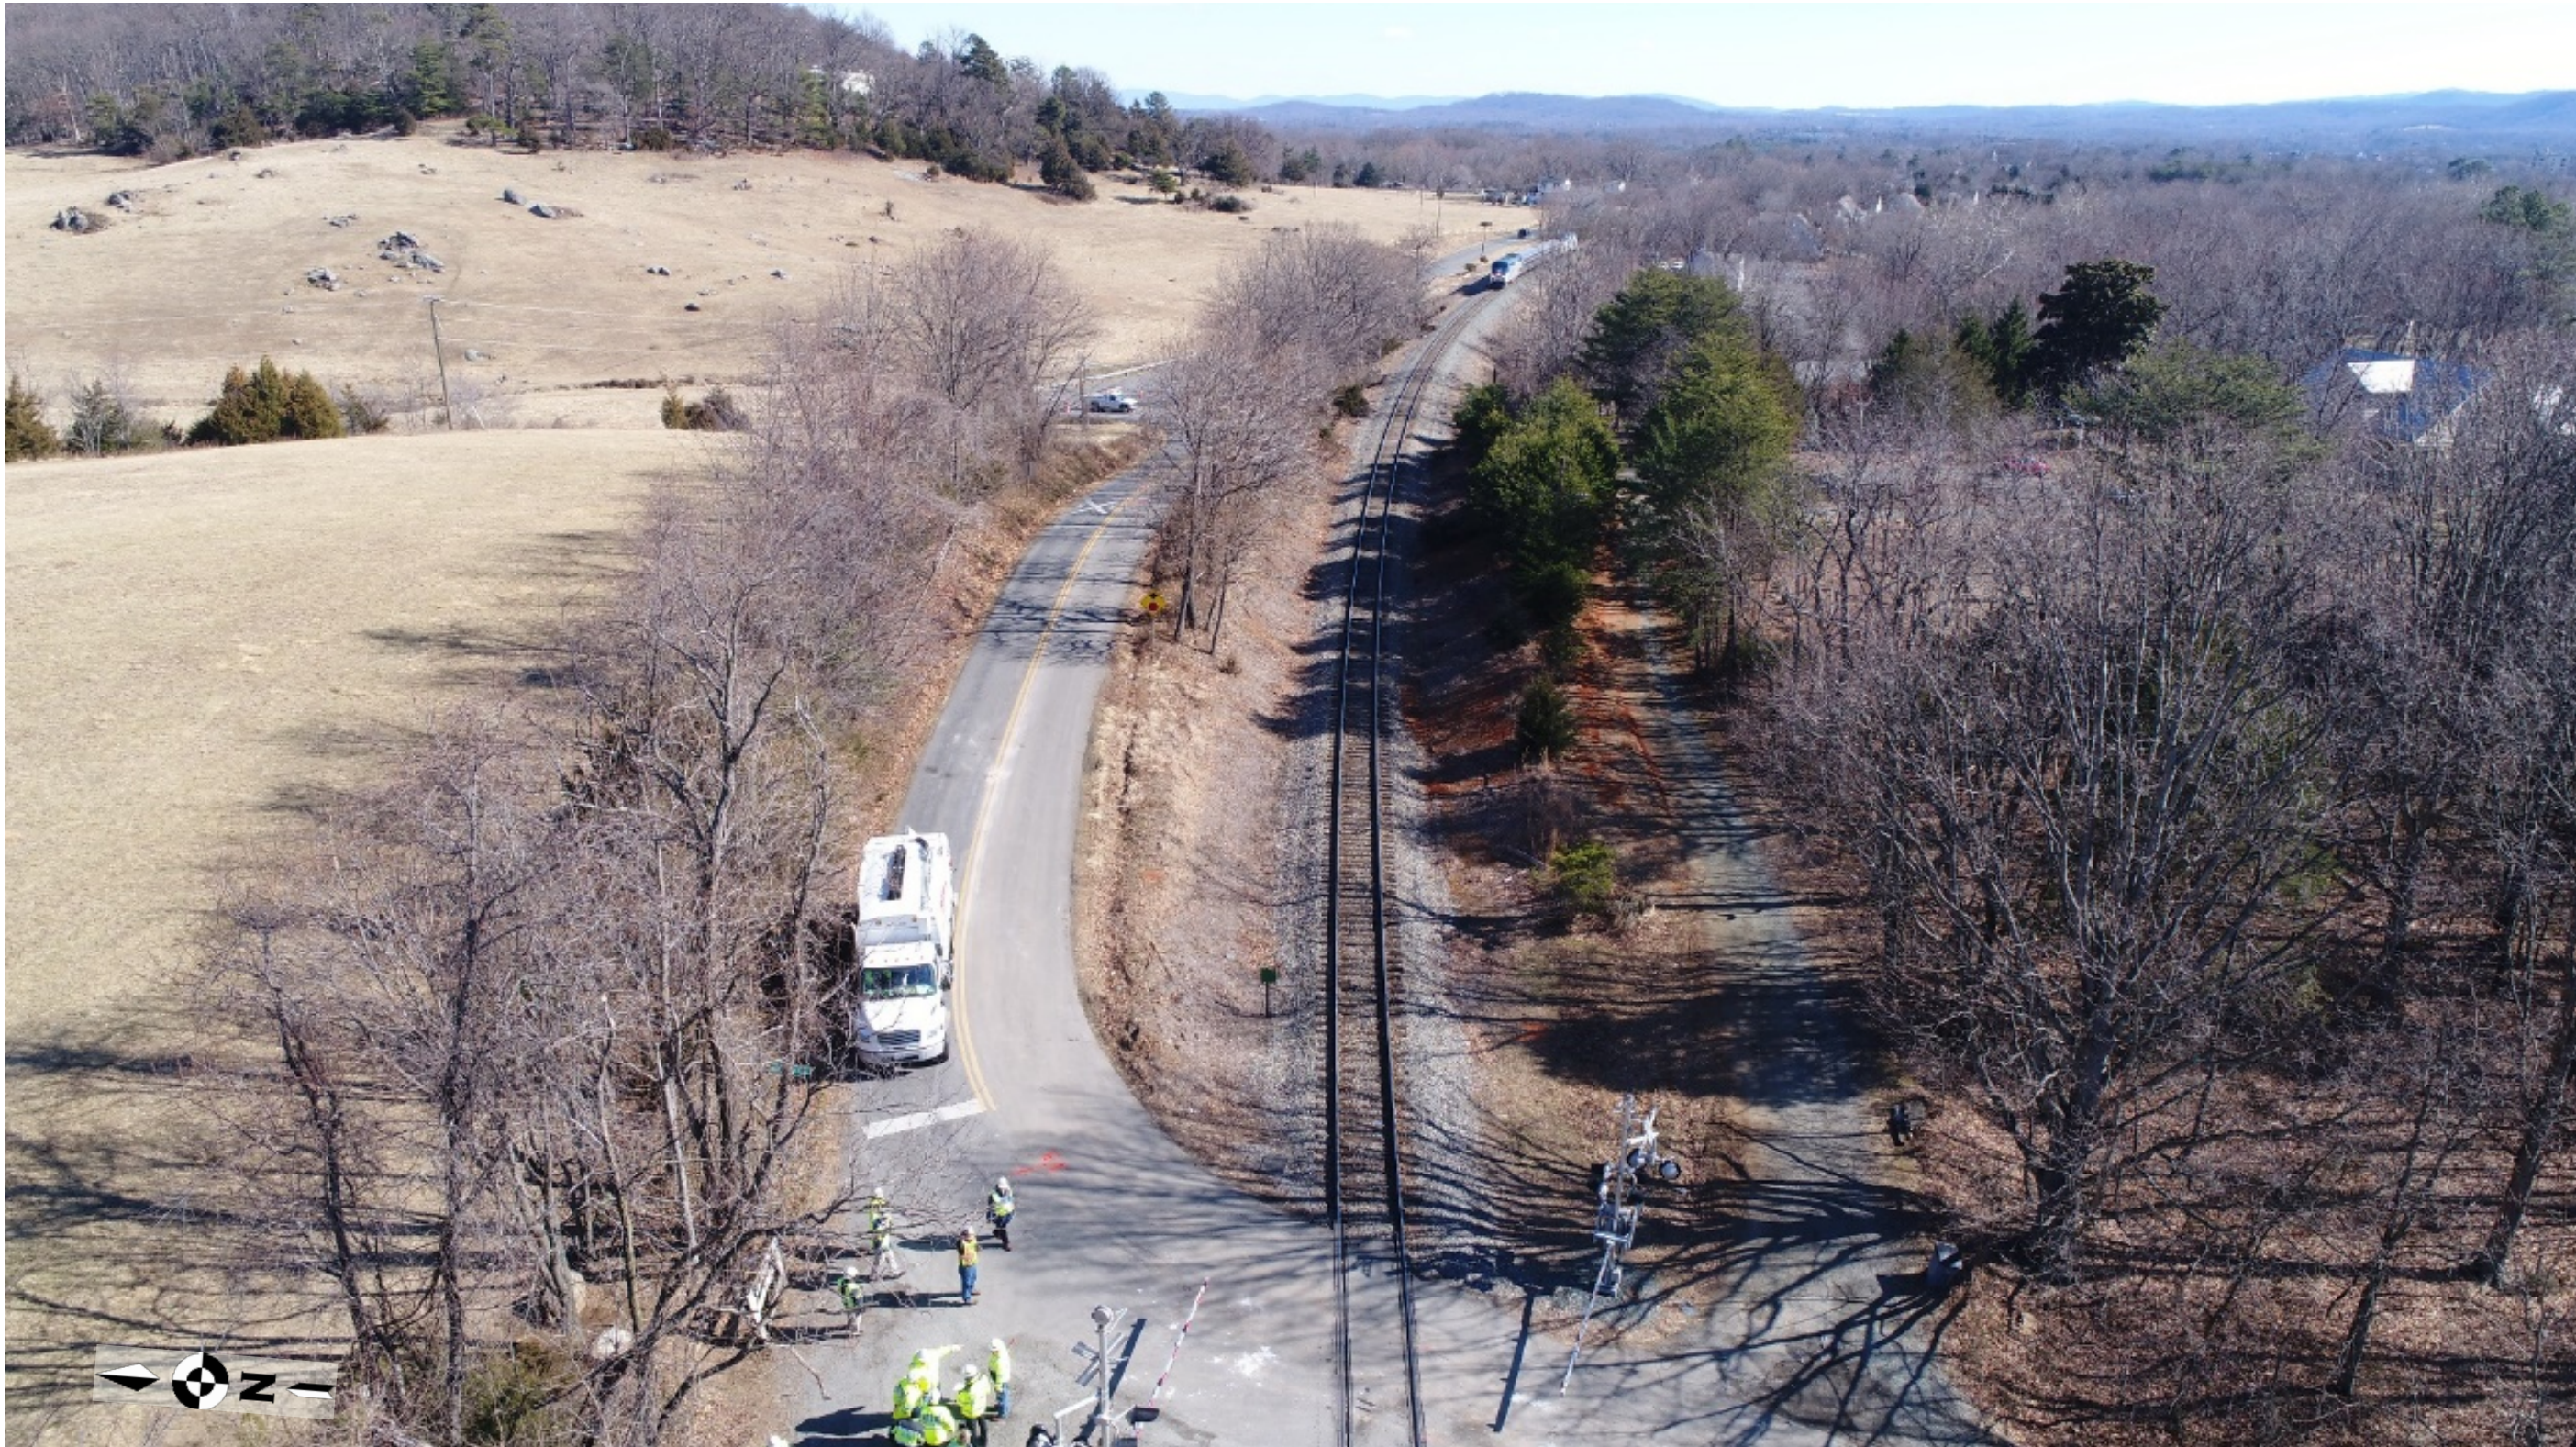
Figure 9 - Train positioned at Rail Point 3 (directional arrow approximated)

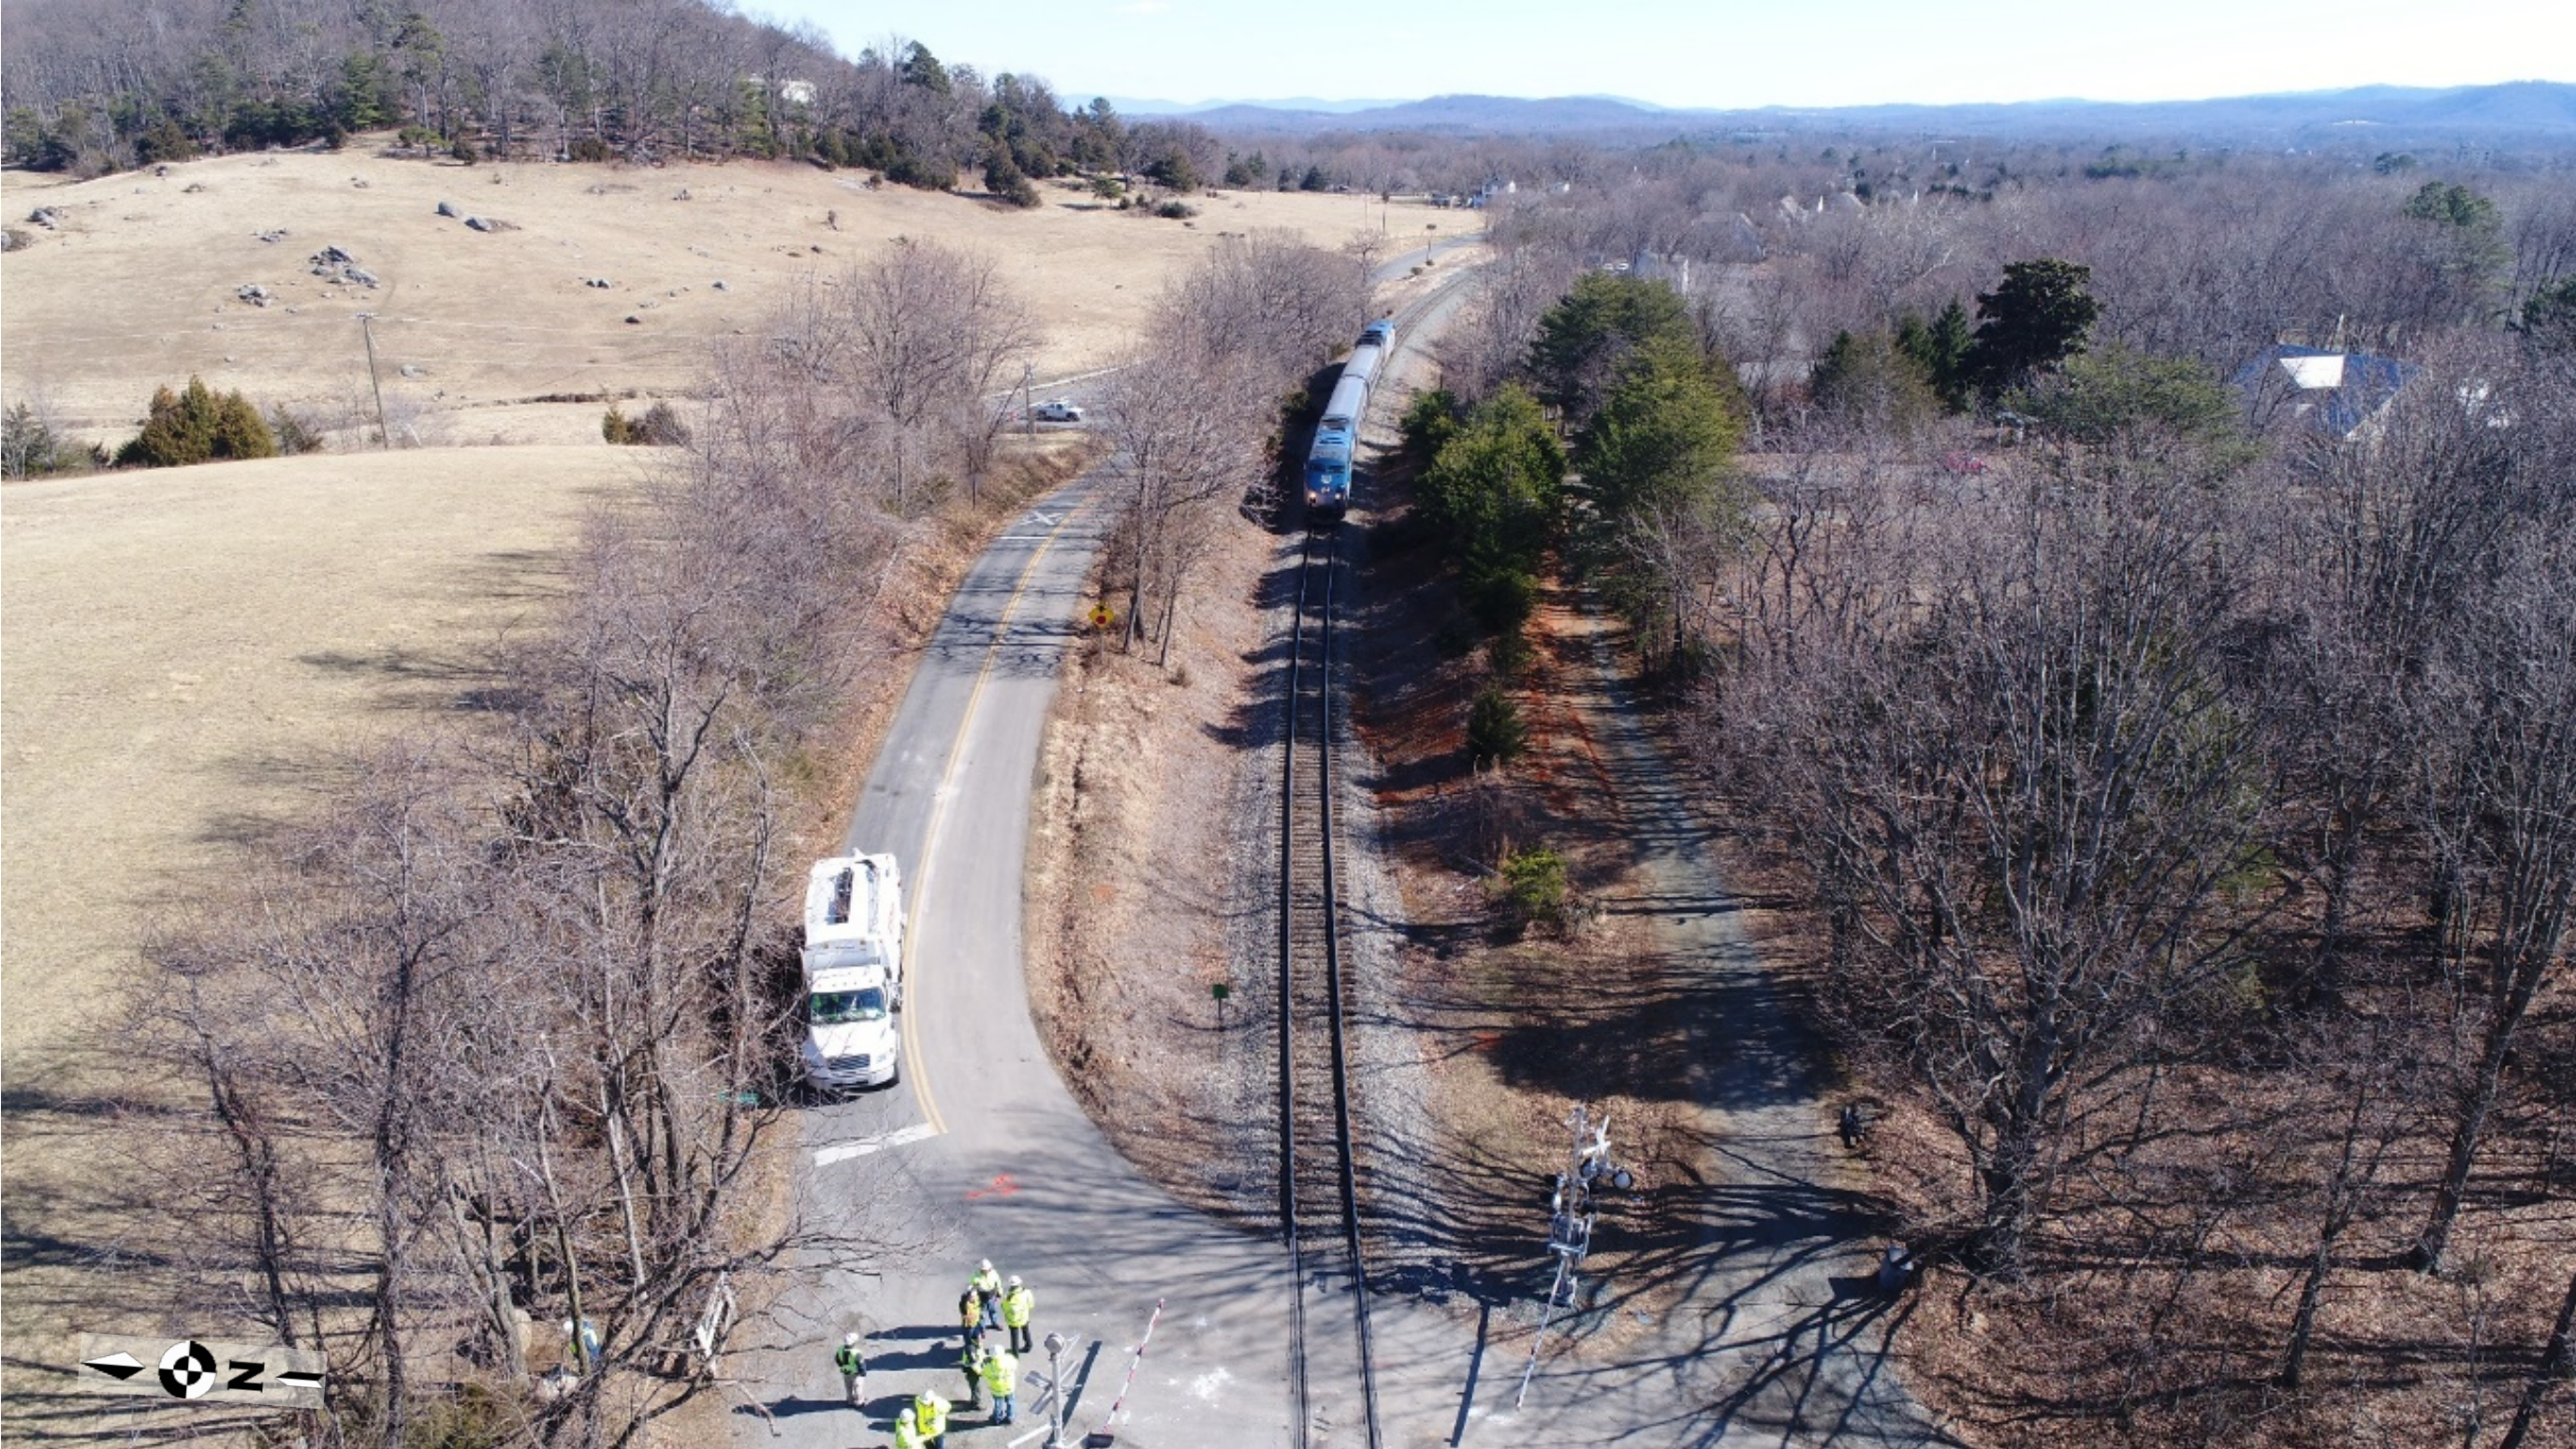
Figure 10 - Train positioned at Rail Point 4 (directional arrow approximated)

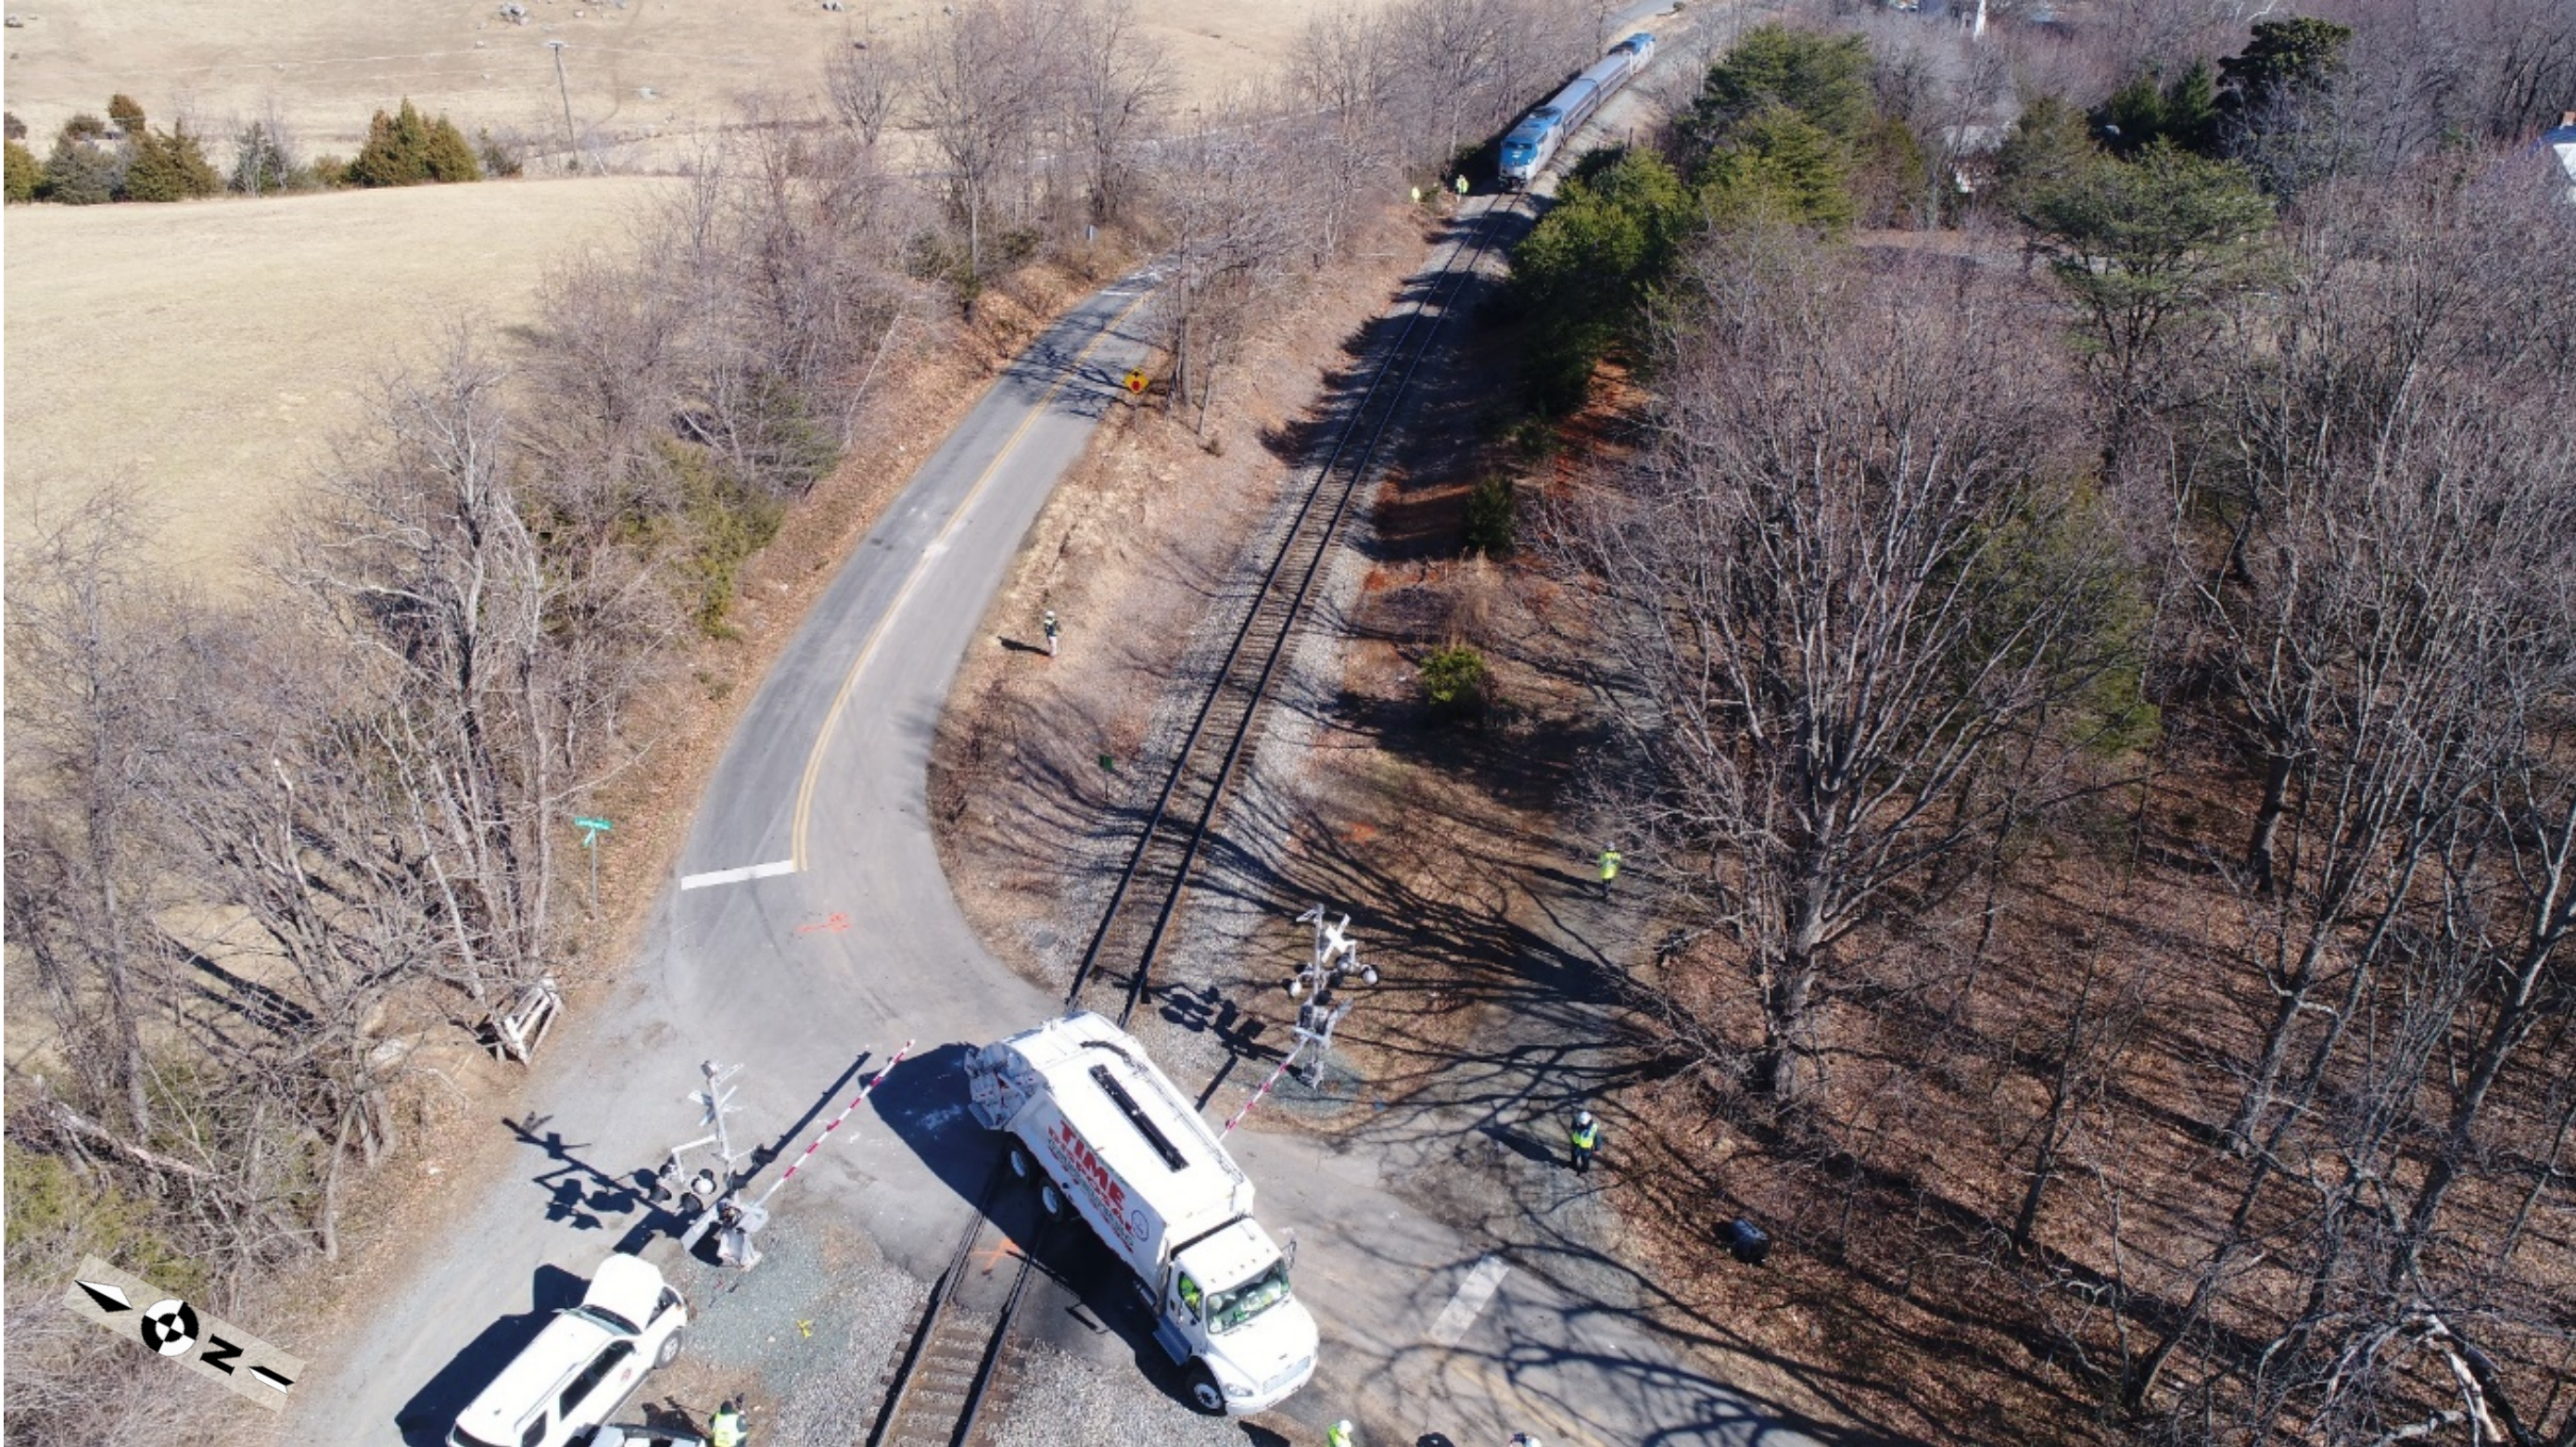
Figure 11 - Train approaching grade crossing with refuse truck positioned in crossing (directional arrow approximated).

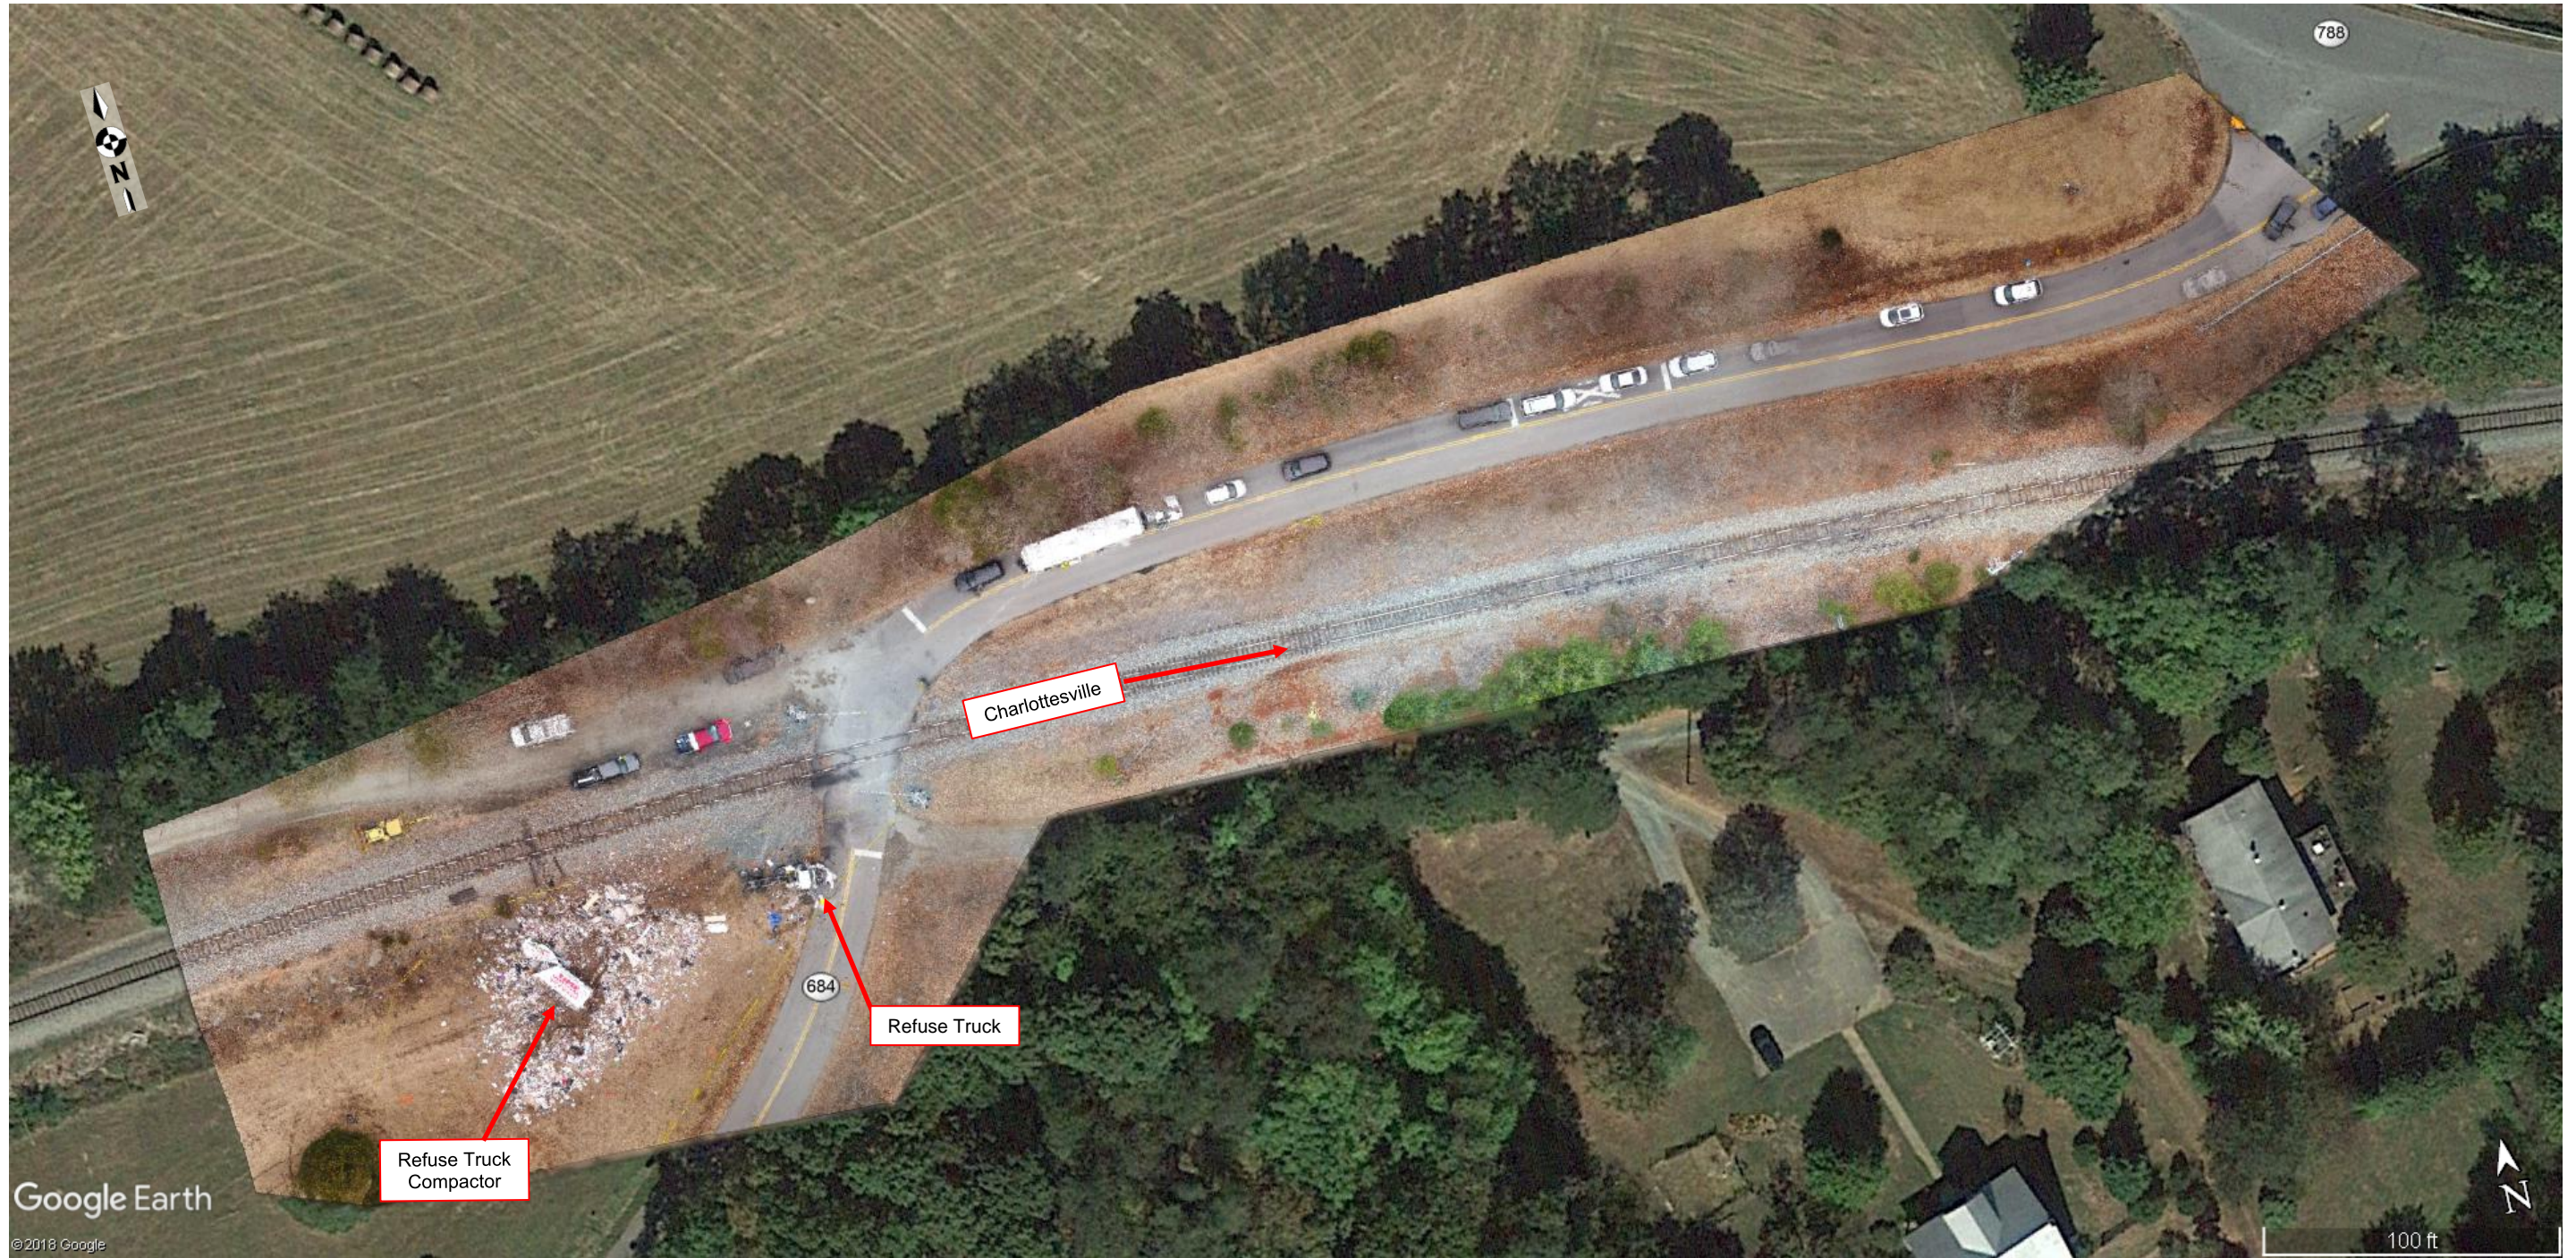
Figure 12 - Orthomosaic of accident site overlaid on Google Earth.
