NATIONAL TRANSPORTATION SAFETY BOARD

UAS Aerial Imagery Report

A. ACCIDENT HWY18MH005

Location: Crozet, VA
Date: January 31, 2018

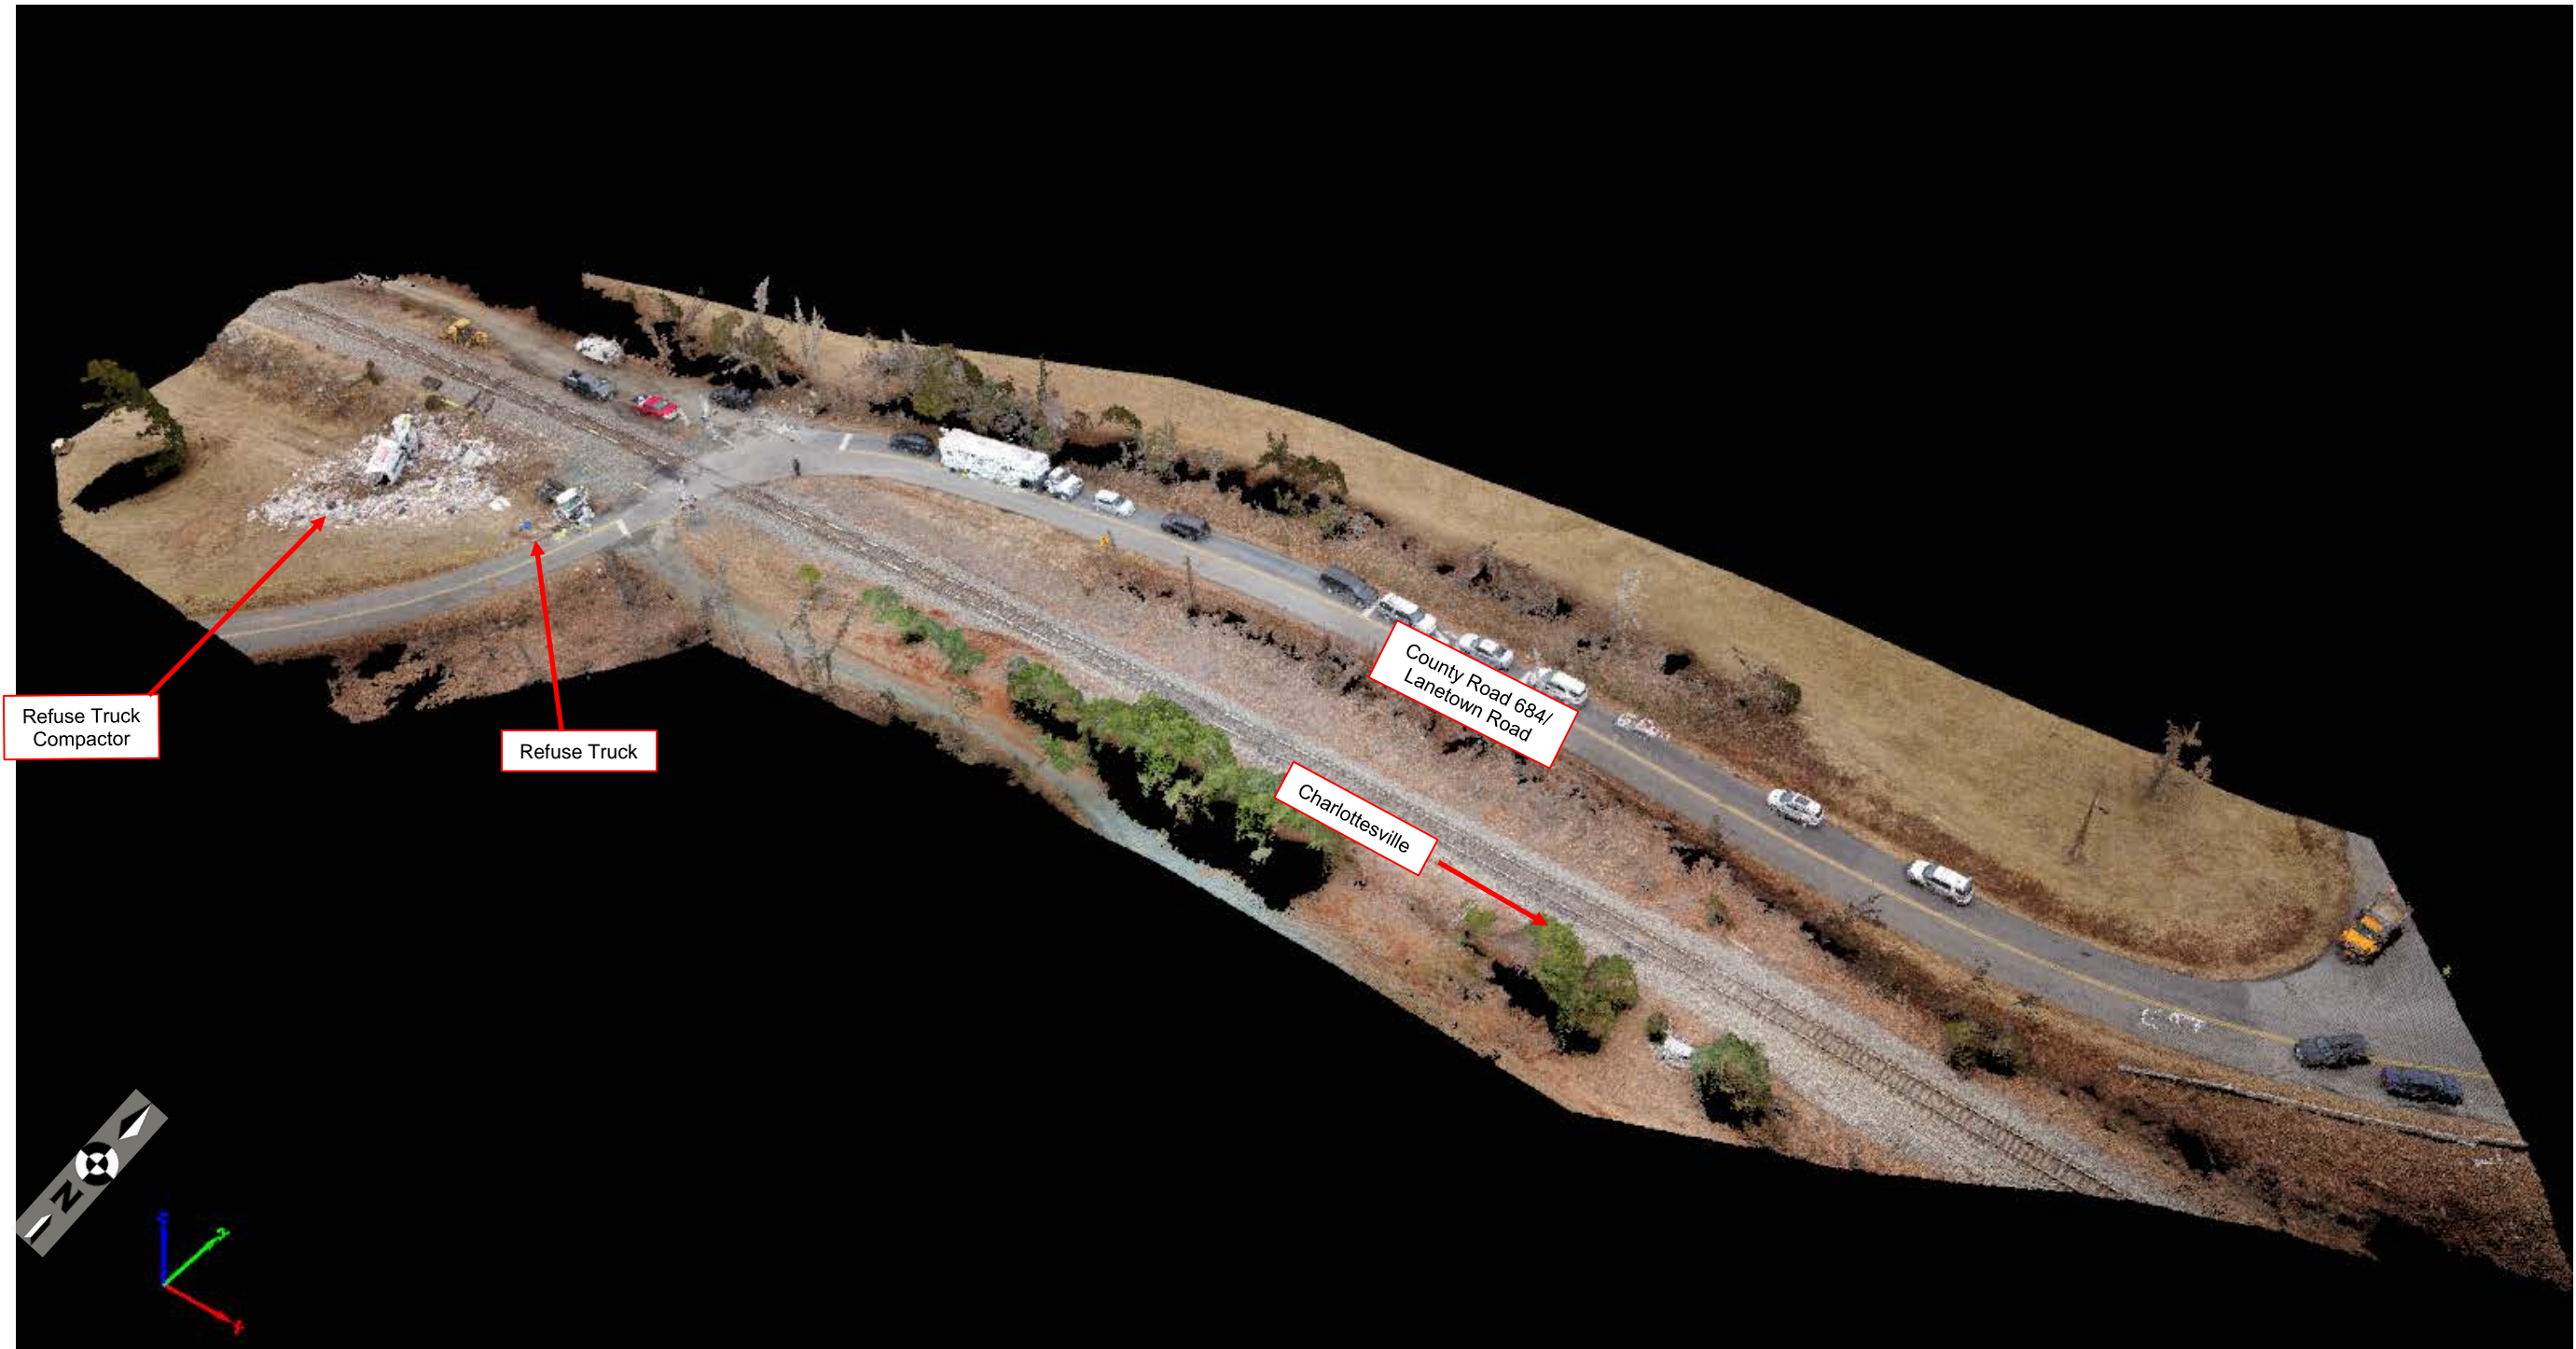
Figure 13 - View of the processed point cloud from Pix4D

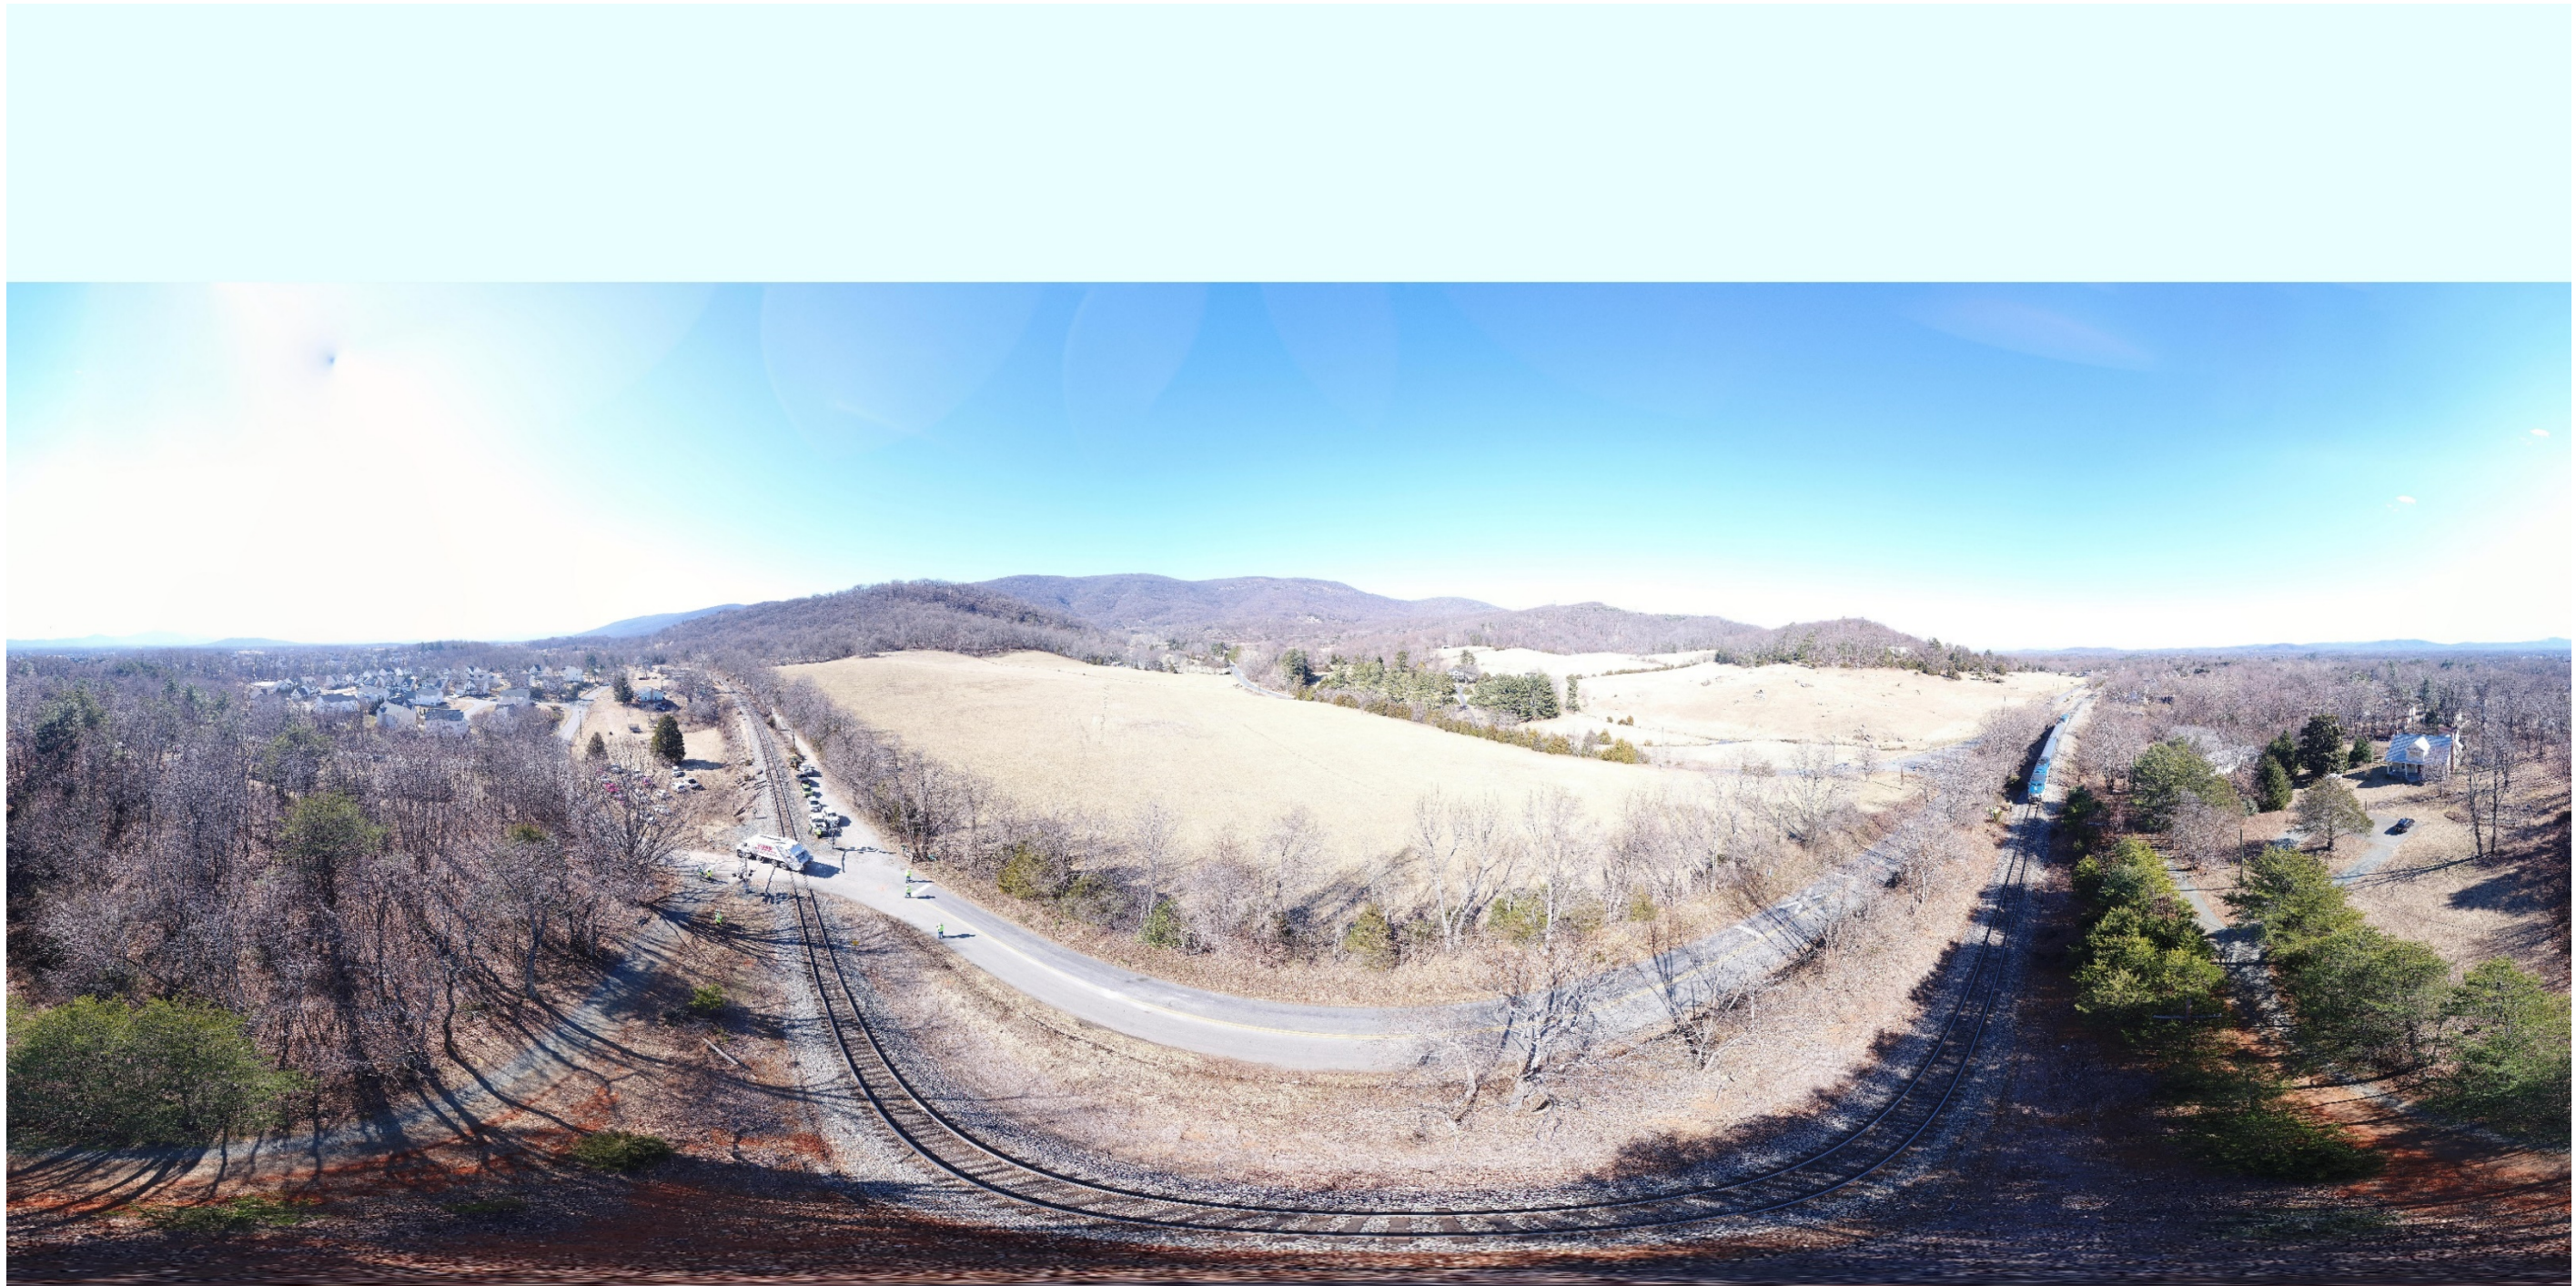
Figure 14 - Panoramic image of scene reconstruction (Image as shown contains distortions)⁴.

⁴ The image is intended to be viewed with 360 Panoramic viewer software and it is projected onto 2D for this report, creating various distortions (i.e. roadway and rail track curvature leading to grade crossing).
