NATIONAL TRANSPORTATION SAFETY BOARD

UAS Aerial Imagery Report

A. ACCIDENT WPR18FA200

Location: Sheboygan, Wisconsin

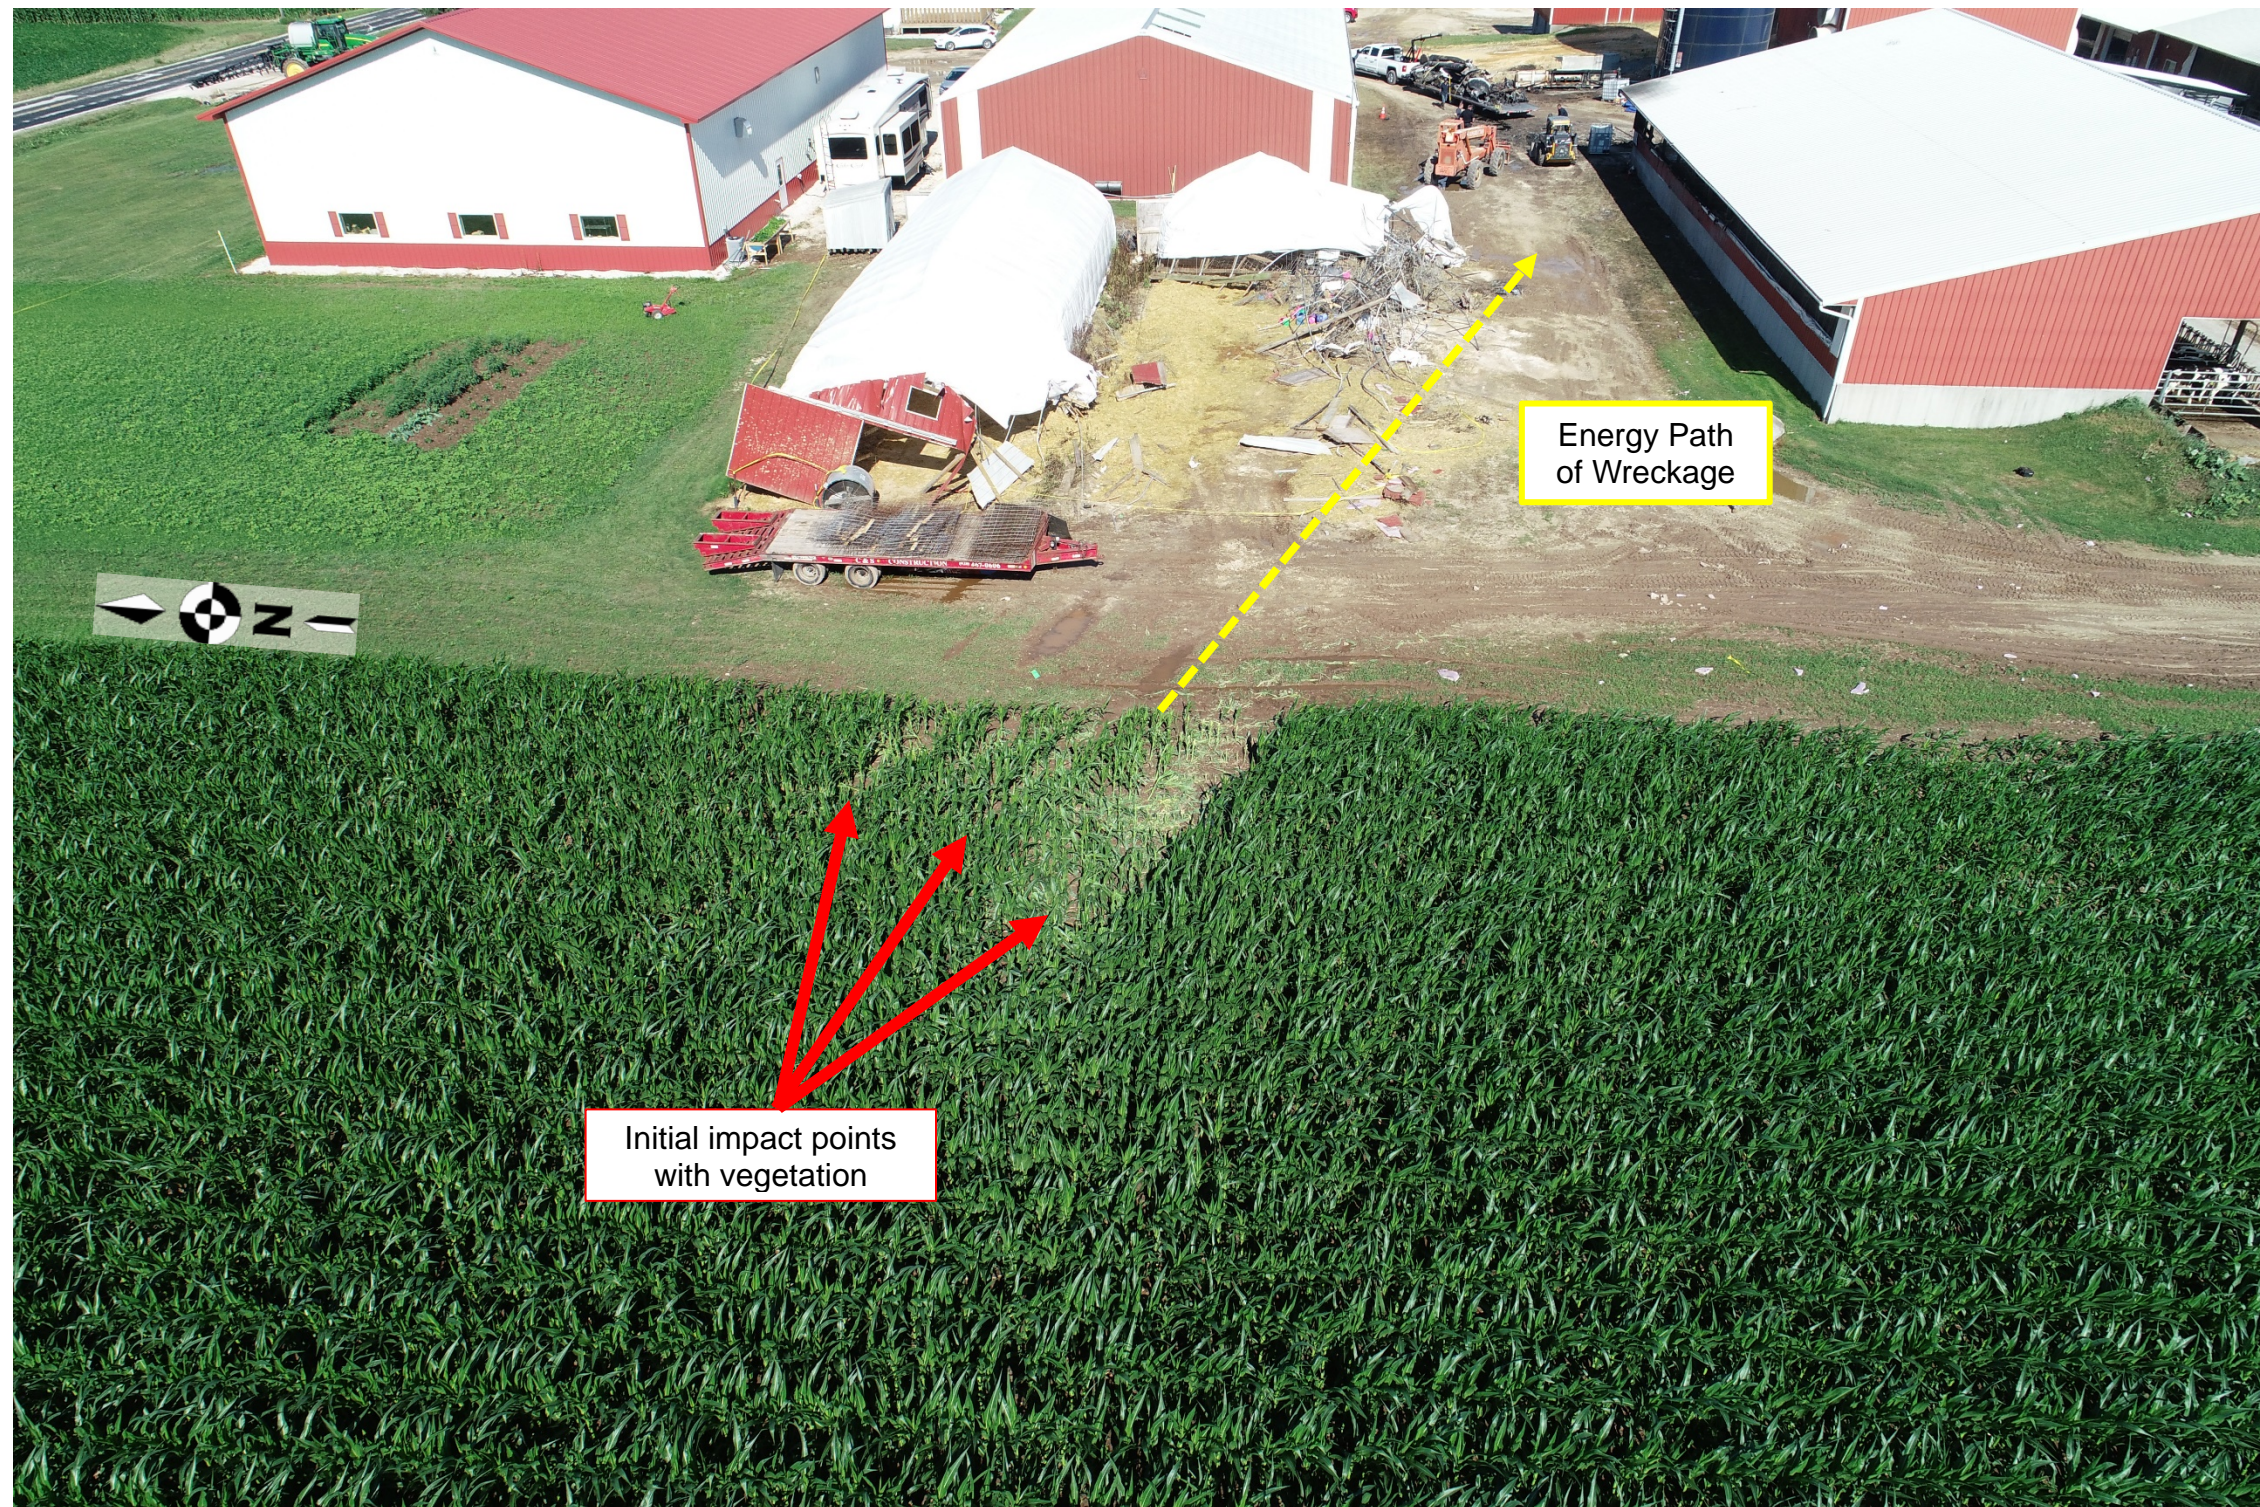
Figure 1 contains a still image taken from just prior to the aircraft initial impact point in vegetation (corn field) looking towards the aircraft's final resting place. The aircraft and building wreckage were in the process of being moved during the imagery gathering.

Figure 1 – Photo – Aerial view of main wreckage area, initial impact points, and energy path towards top of page (directional arrow approximated)

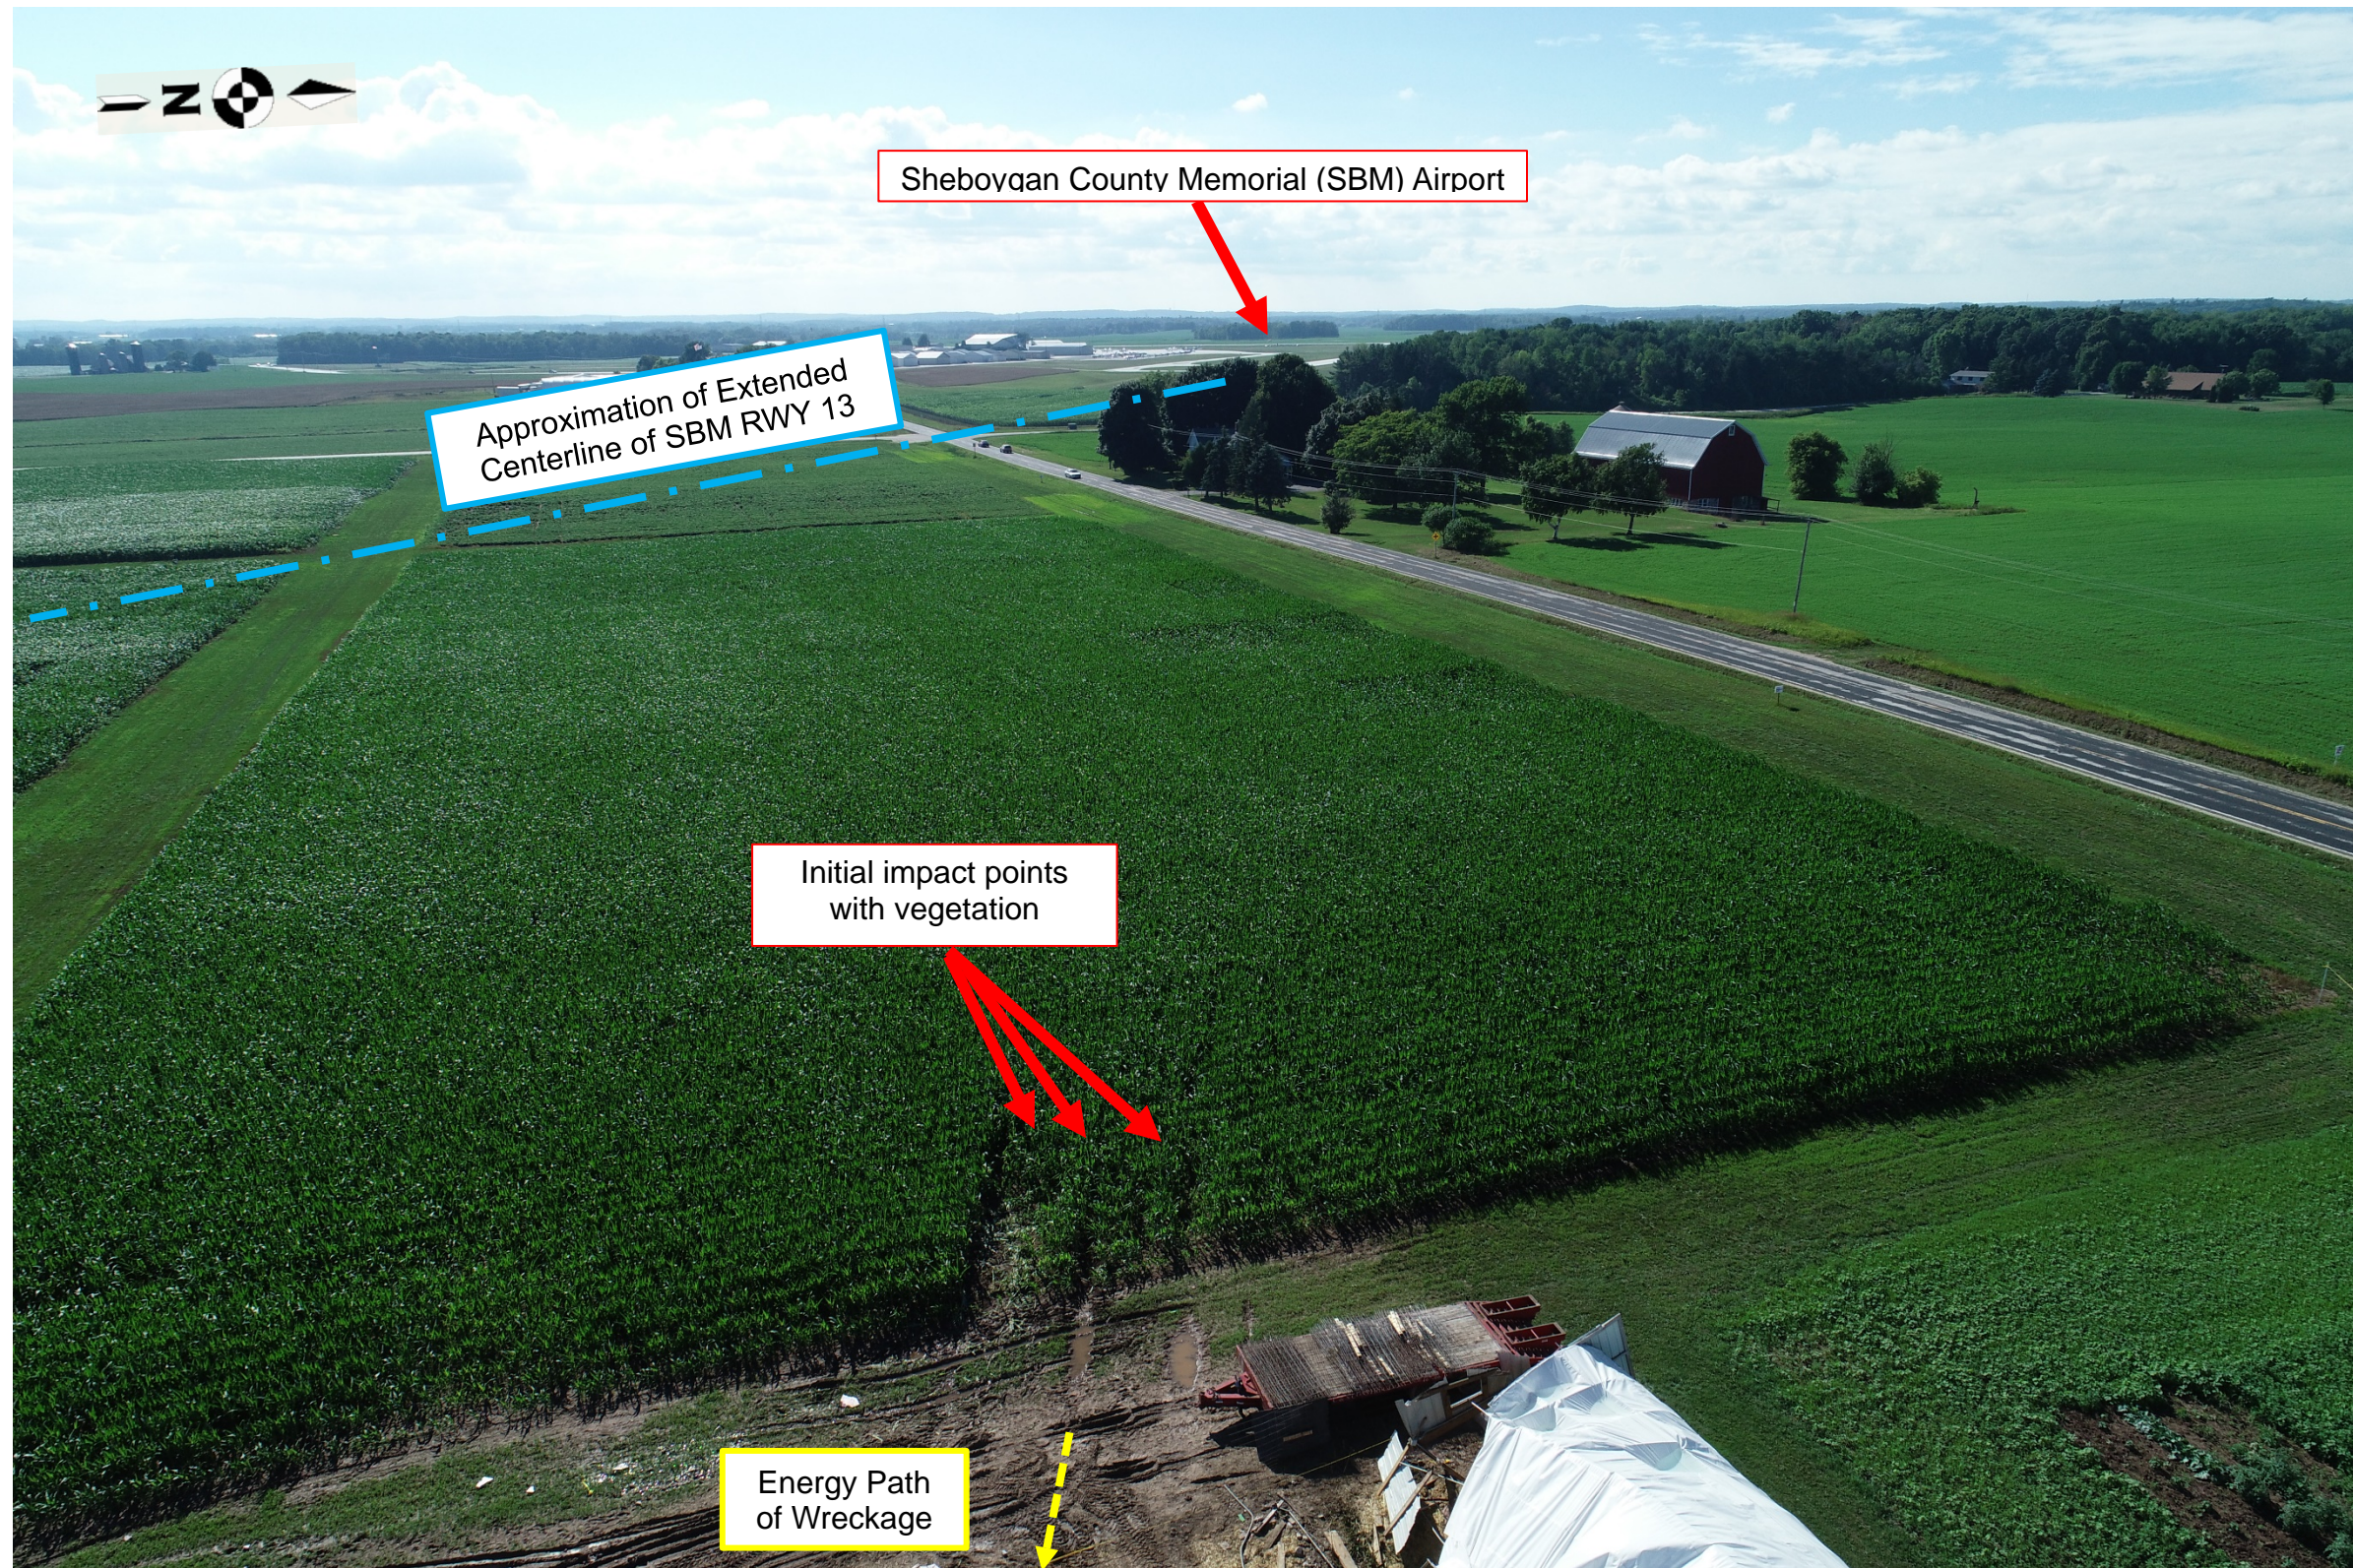
Figure 2 contains a still image taken from just aft of to the aircraft initial impact point in the vegetation (corn field) looking back towards departure airport. An approximate representation of the departing runway is overlaid on the image.

Figure 2 – Photo - Aerial view of initial impact points and energy path towards bottom of page (directional arrow approximated)

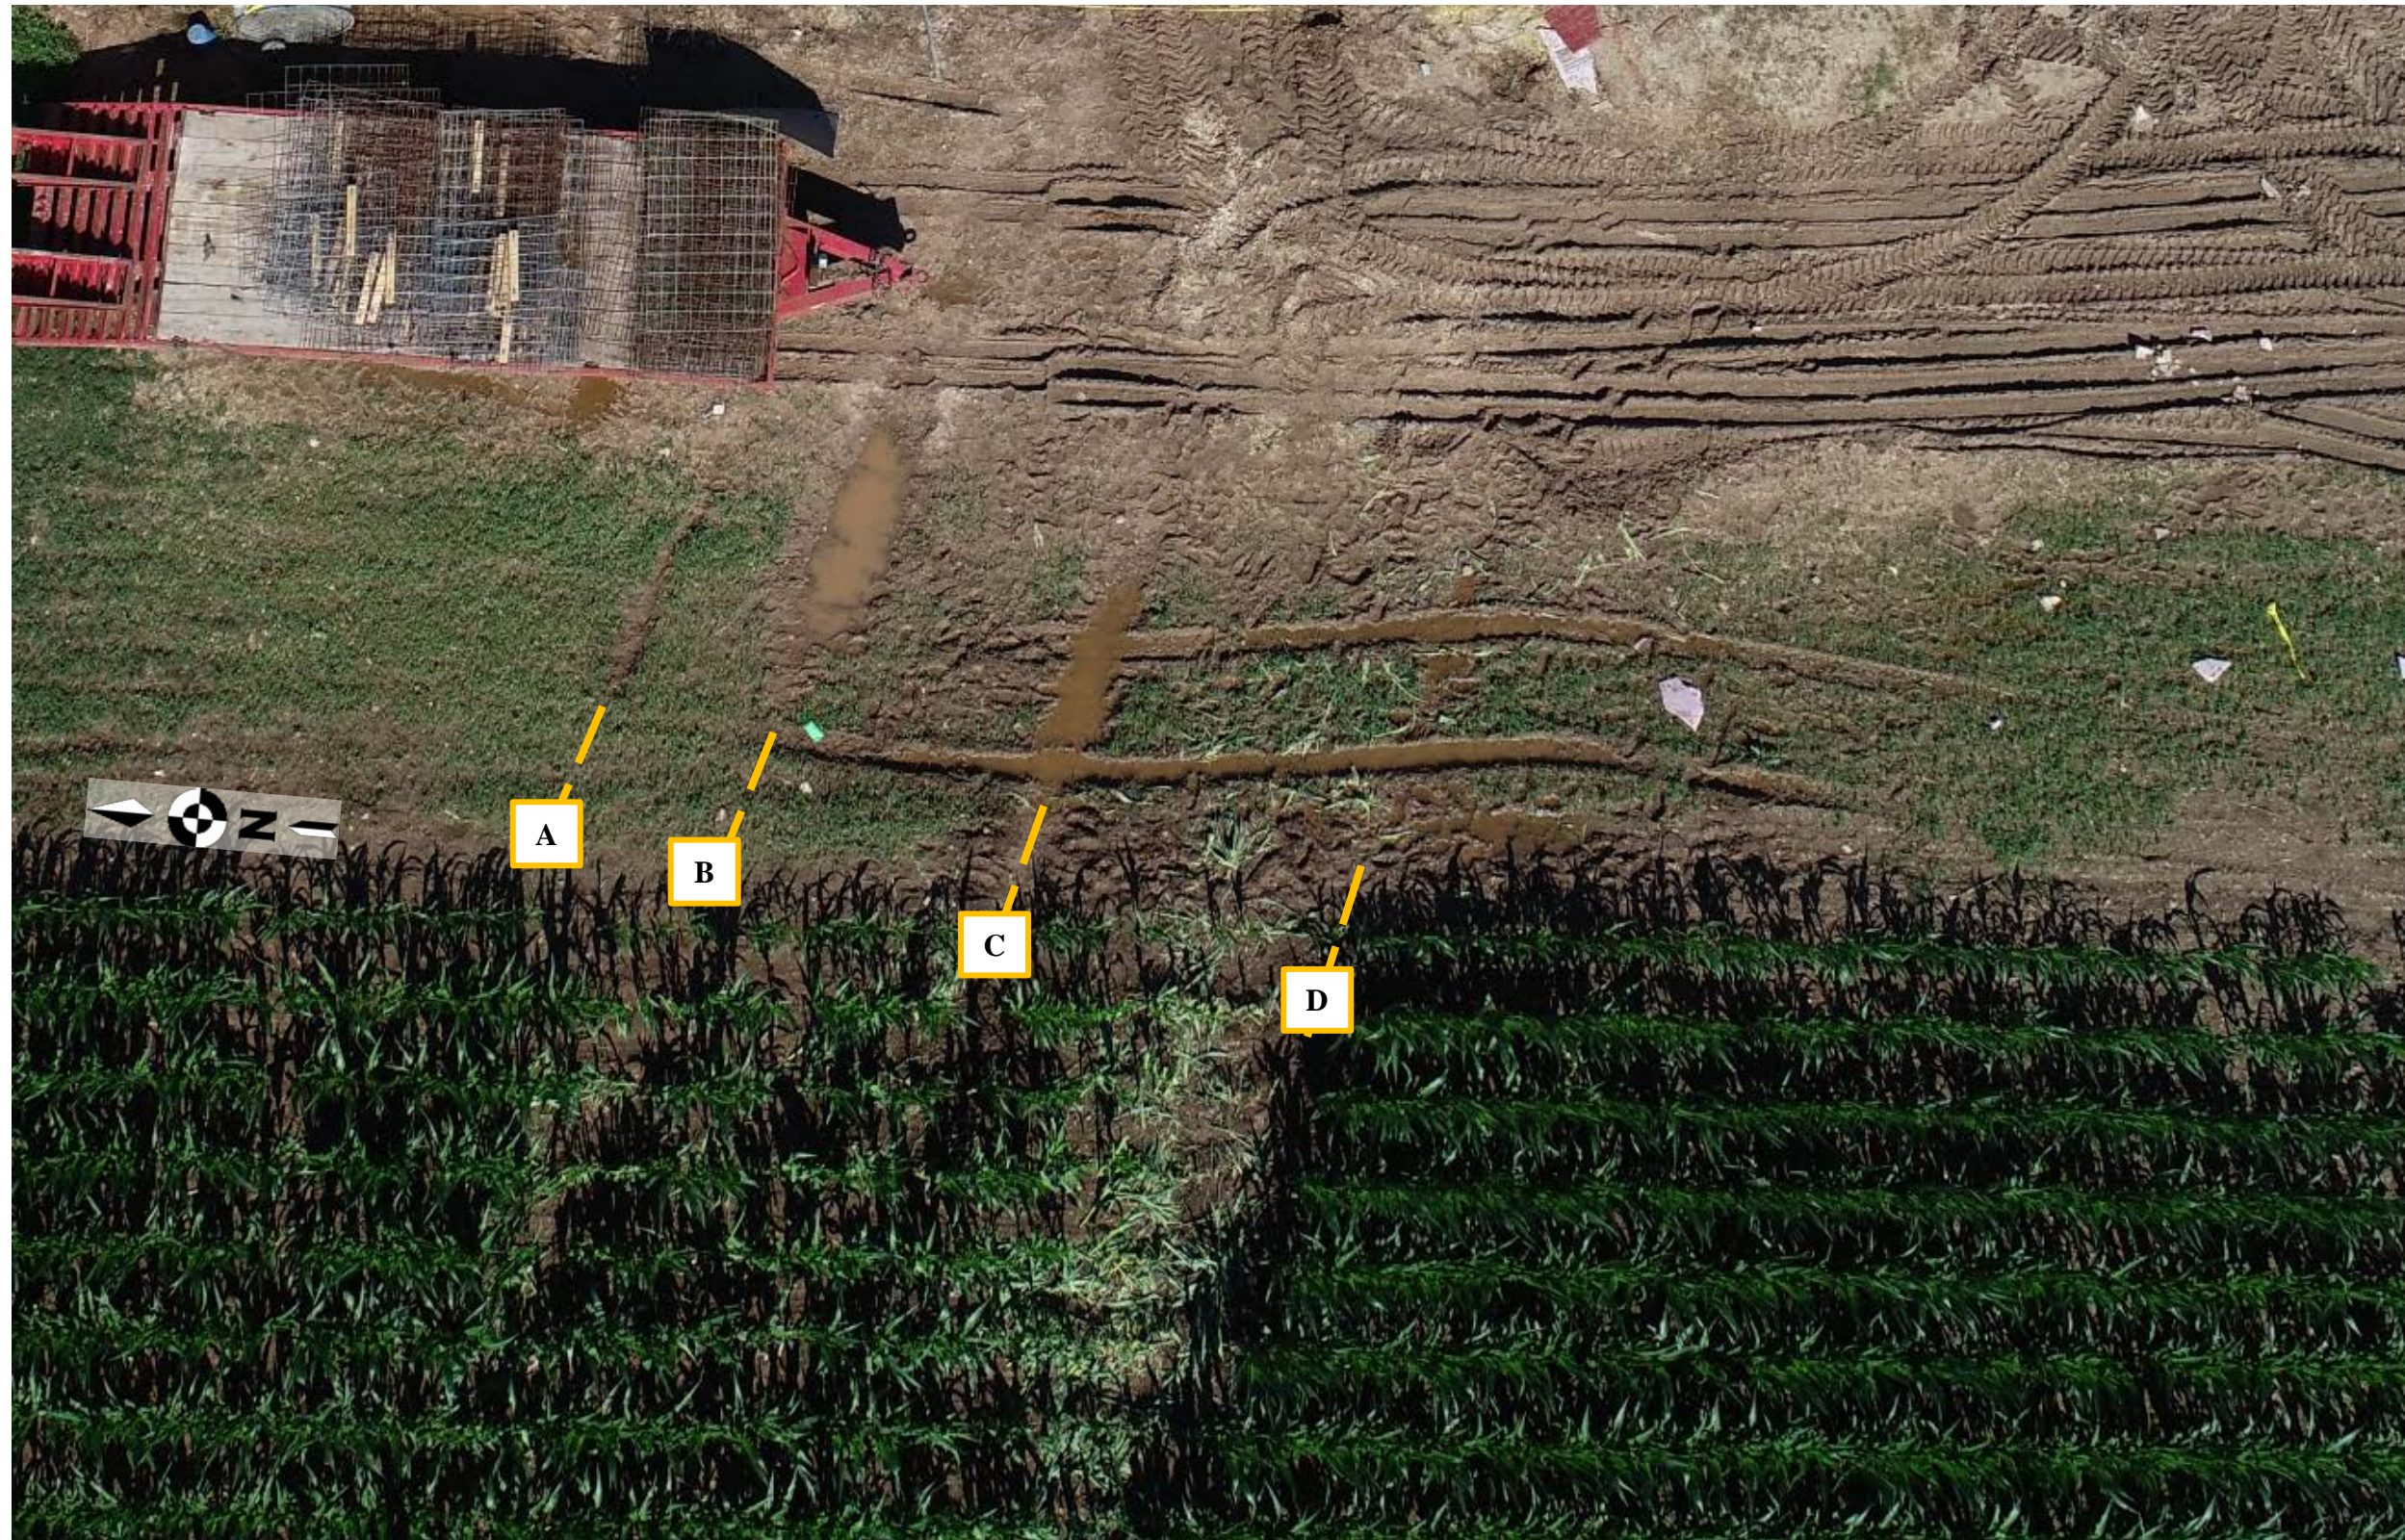
Figure 3 contains an overhead image of initial ground scars at the first visible points of the aircraft impacting the ground. The lines are labelled A, B, C and D from the left to the right of the image. Utilizing the 3D point cloud data created from the aerial imagery, perpendicular distance between the lines were measured. Table 1 contains the measured distances between the ground scars.

Line IDs	Distance (m)	Distance (ft)
A-B	1.72	5.64
B-C	2.73	8.96
C-D	3.37	11.06
A-D	7.82	25.66

Figure 3 – Photo (Cropped) - Aerial view of vegetation impact marks with three distinct lines identified A, B, C and D for measurement purposes (directional arrow approximated)

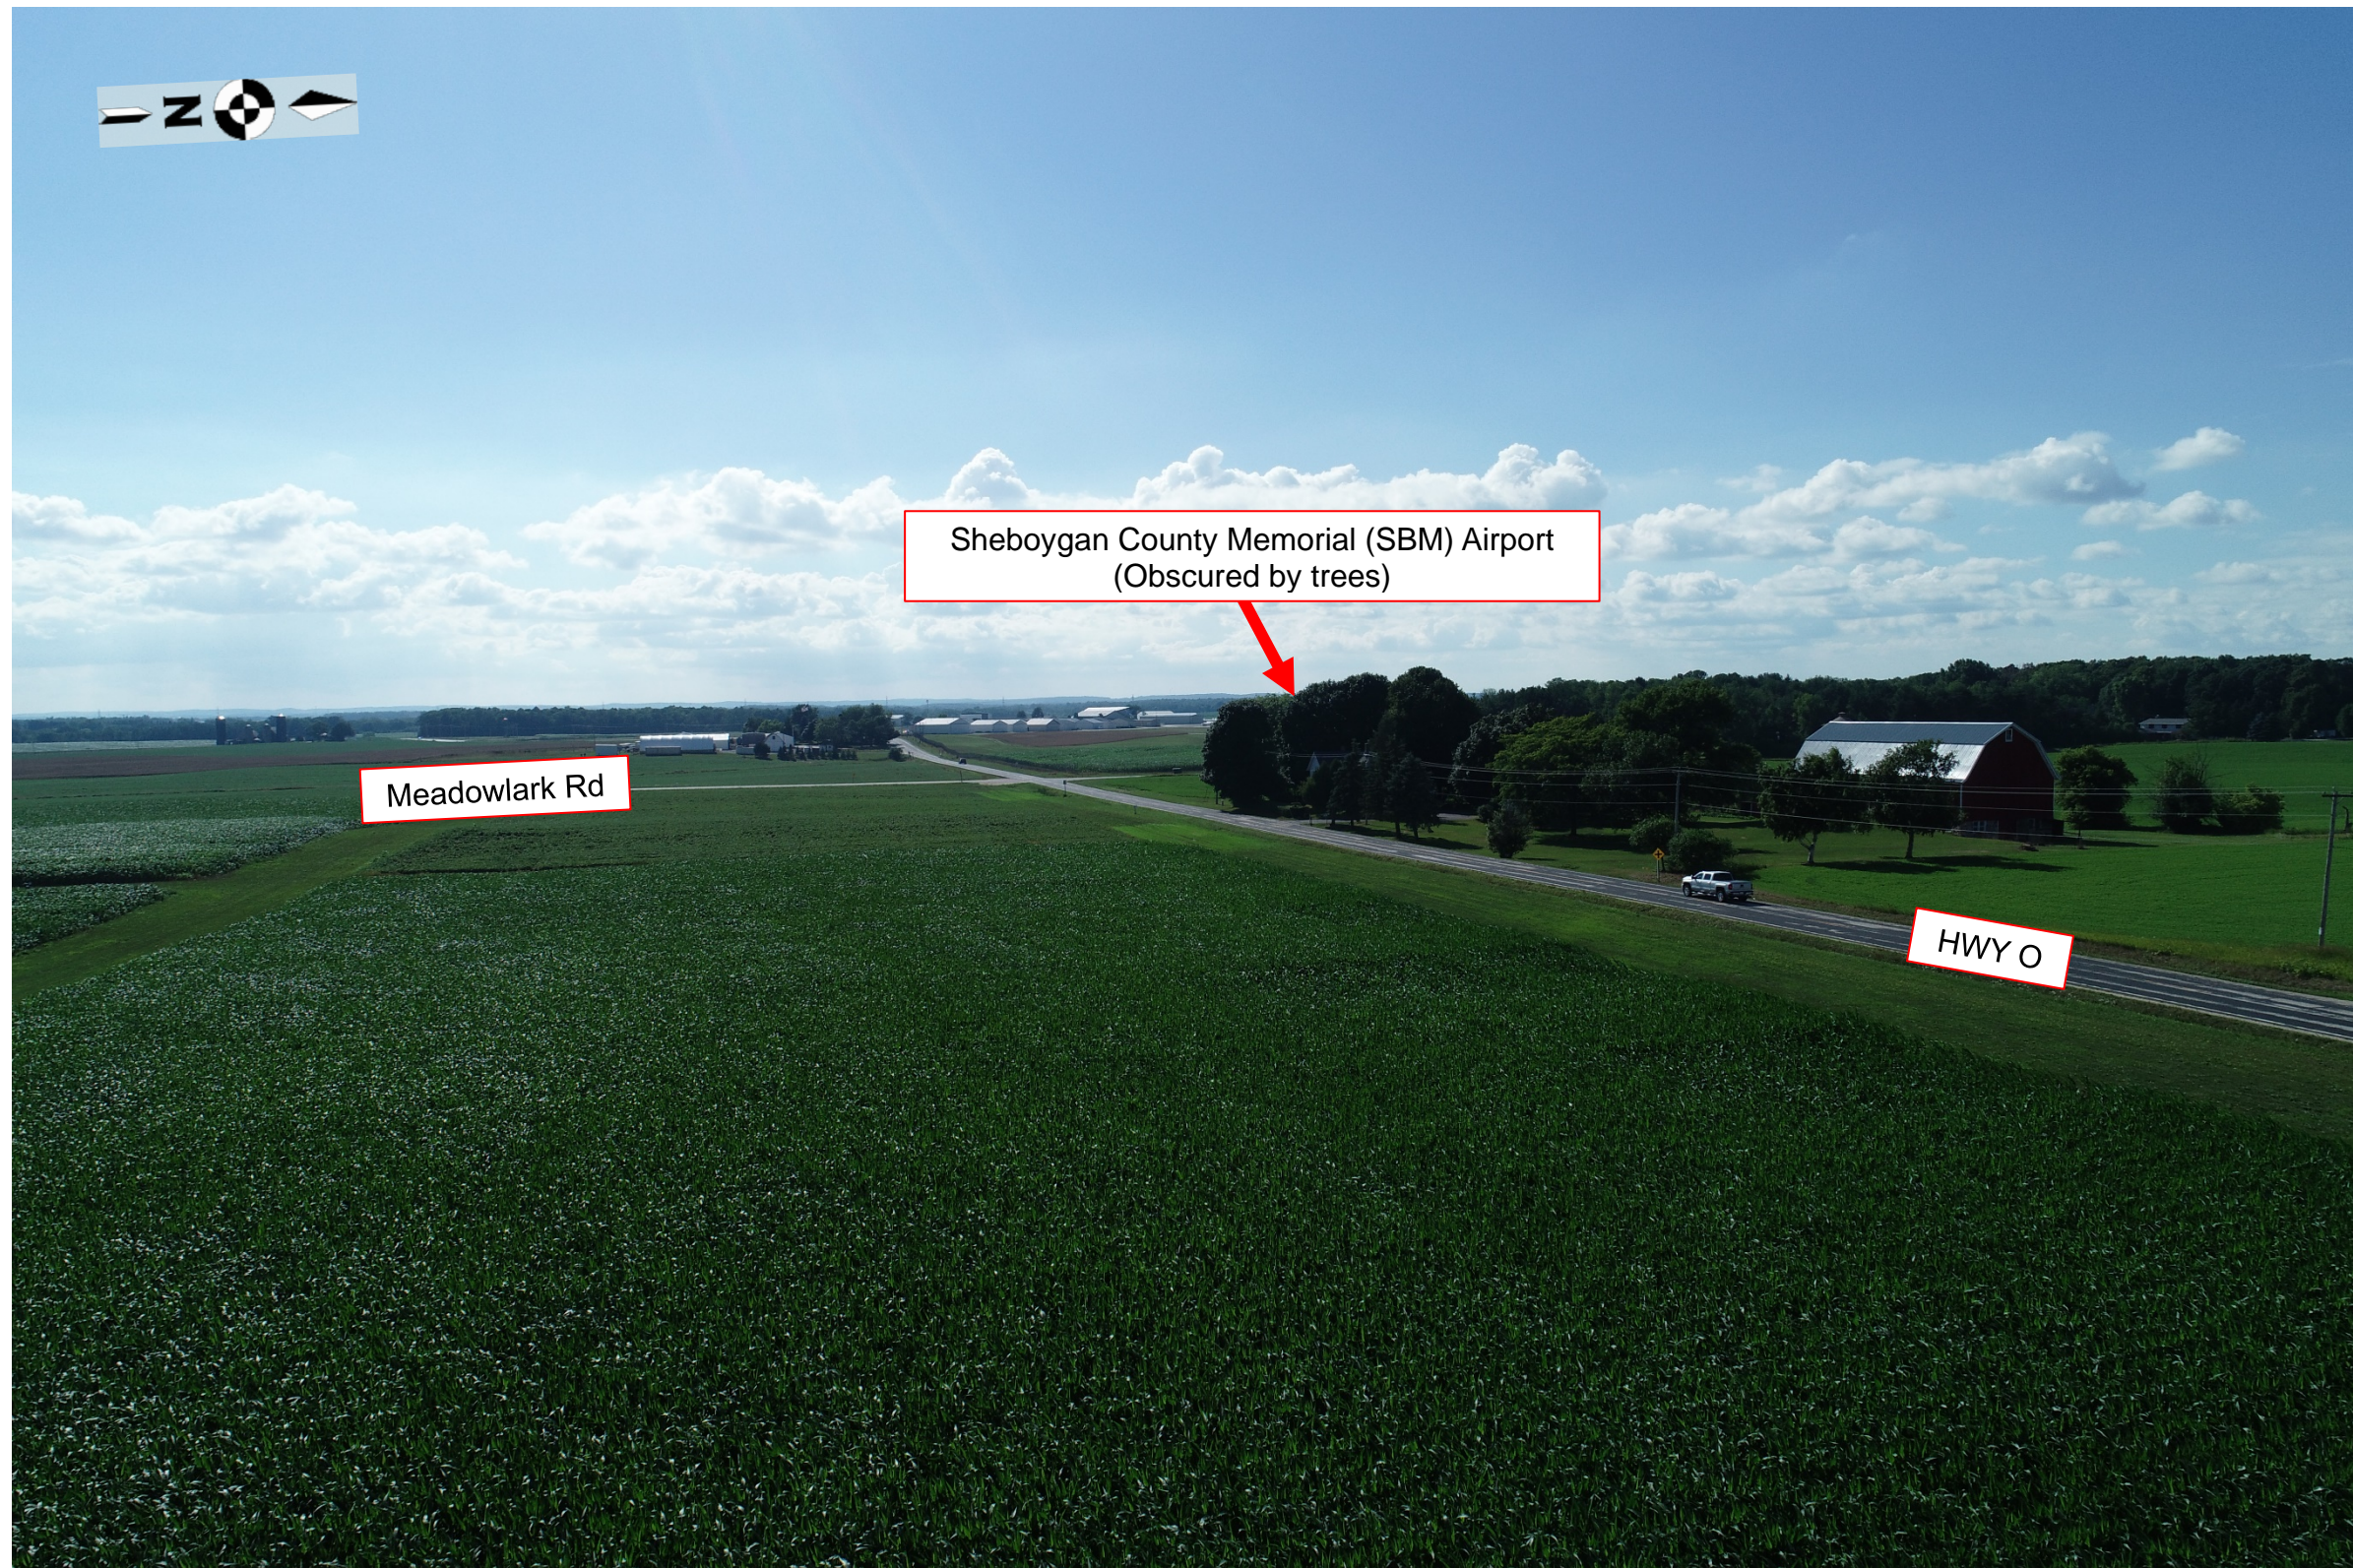
Figure 4 and Figure 5 are images taken with the sUAS placed above the initial indications of the aircraft impacting the vegetation (corn field). The view in each image is towards the departure runway. Figure 4 was taken at an altitude of approximately 20 ft above ground level (AGL). Figure 5 was taken at an altitude of approximately 86 ft above ground level (AGL)

Figure 4 – Photo - Aerial view taken from approximately 20 ft about initial vegetation impact points looking towards SBM (directional arrow approximated)

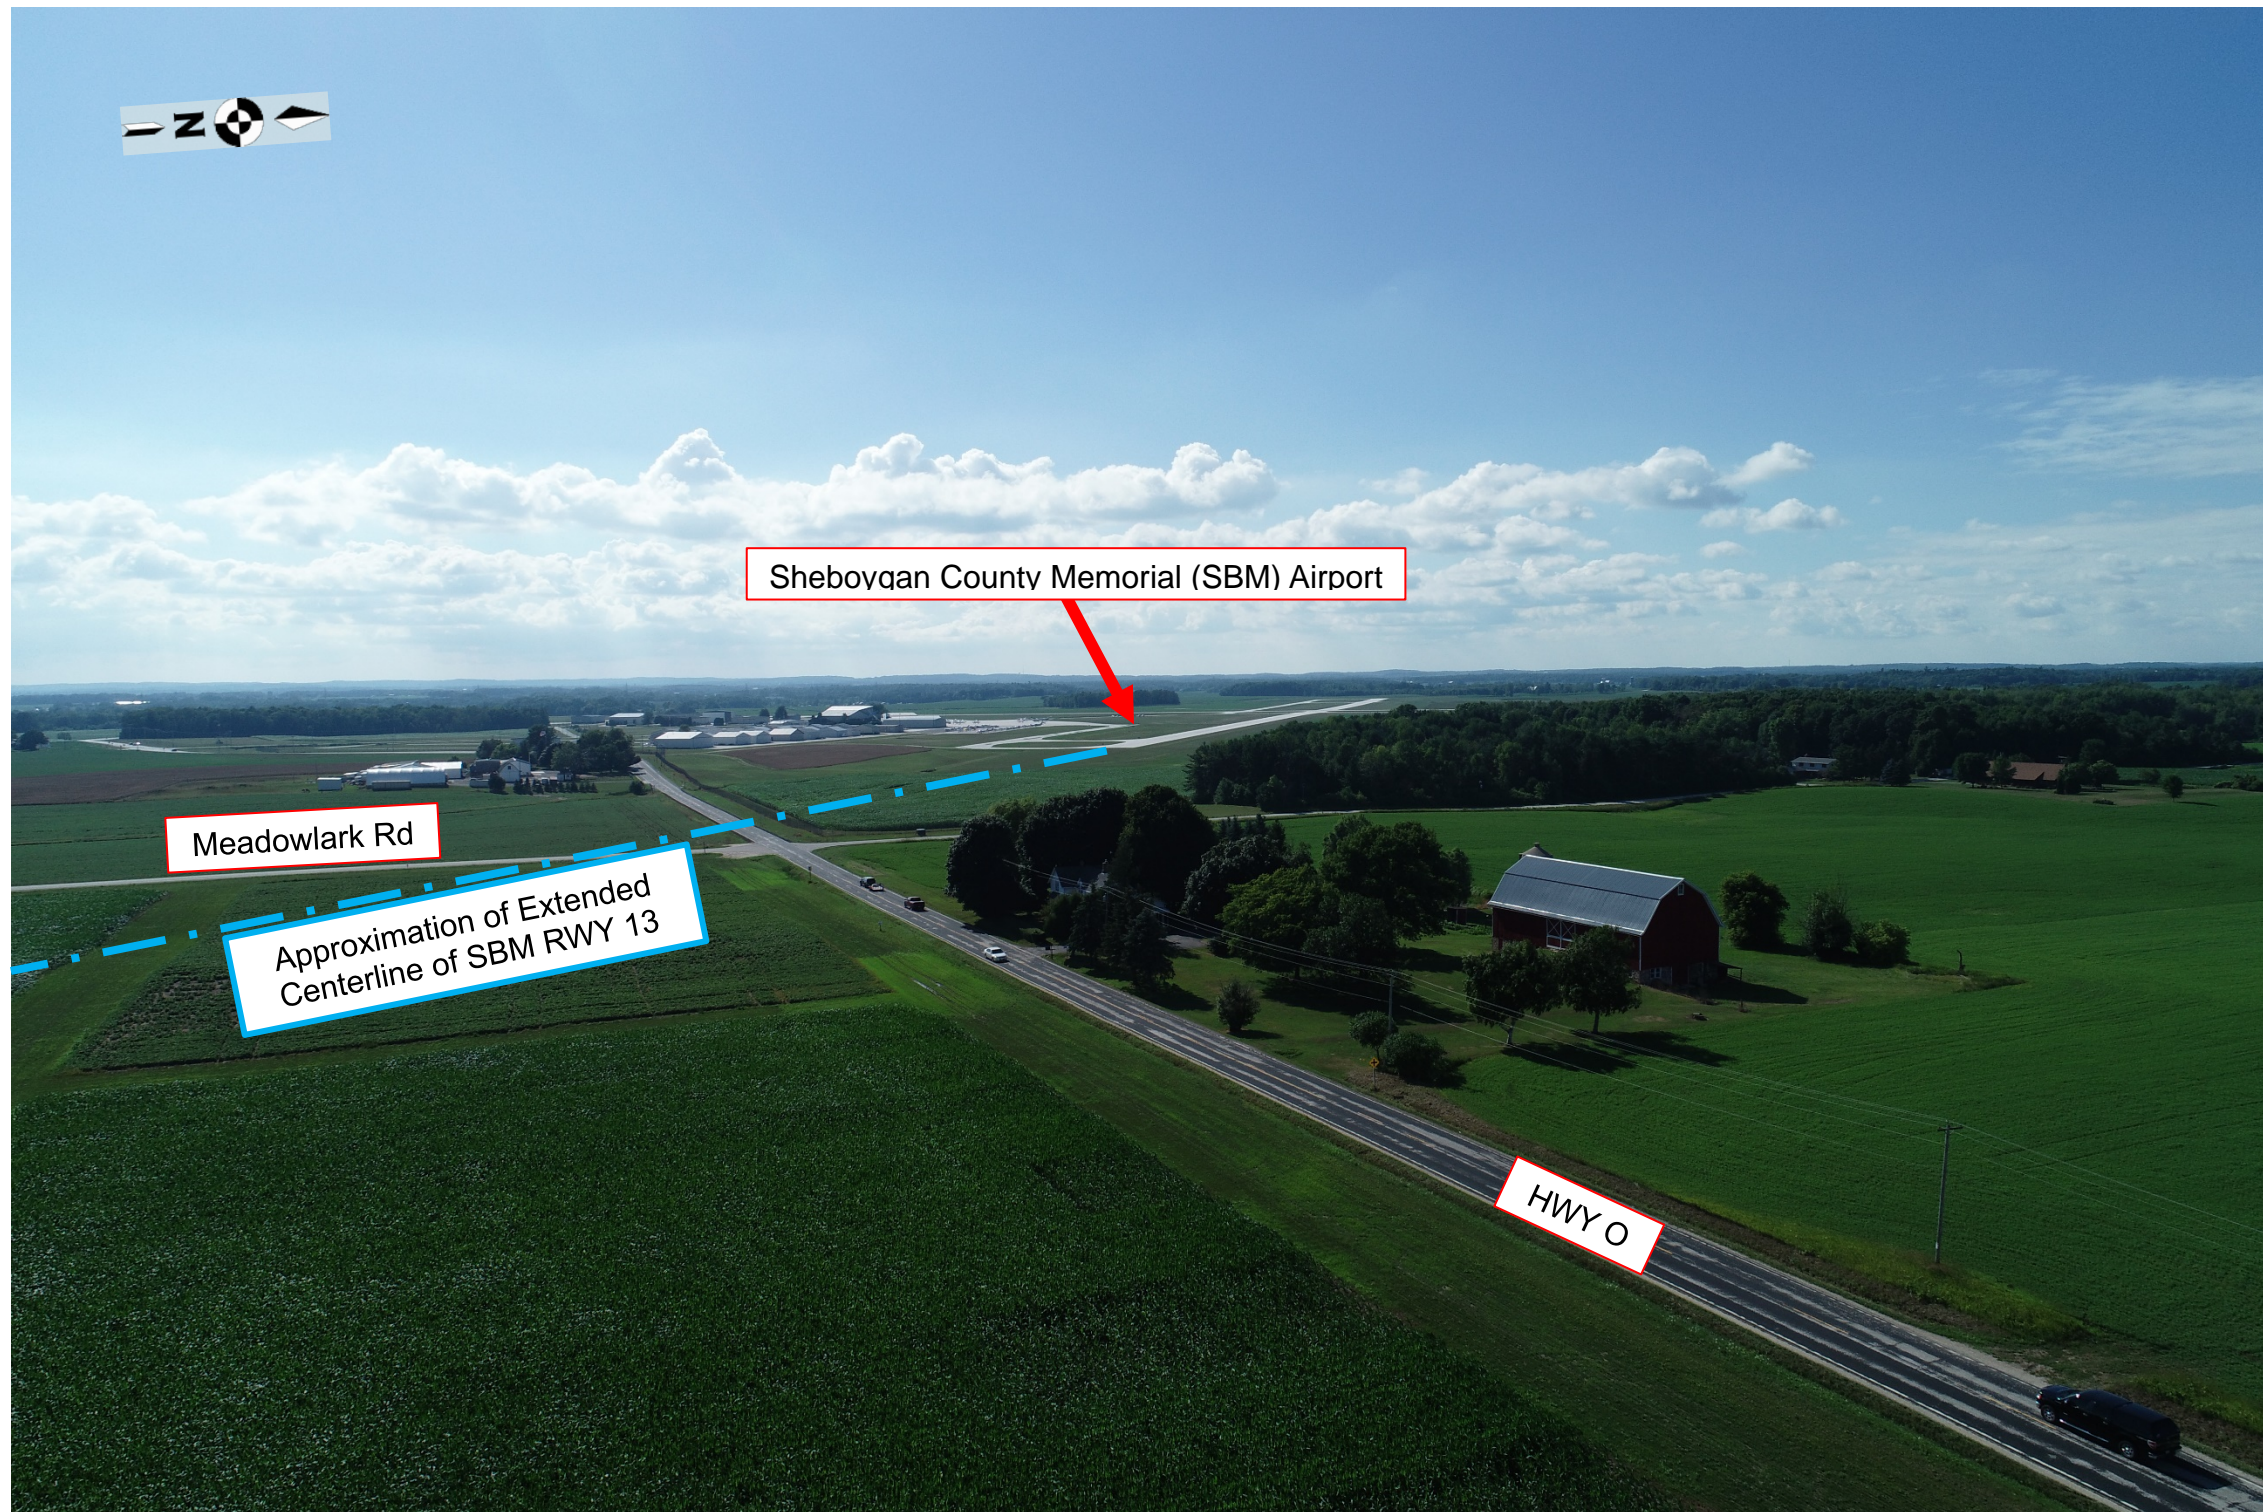
Figure 5 – Photo - Aerial view taken from approximately 86 ft above the initial vegetation impact points looking towards SBM (directional arrow approximated)

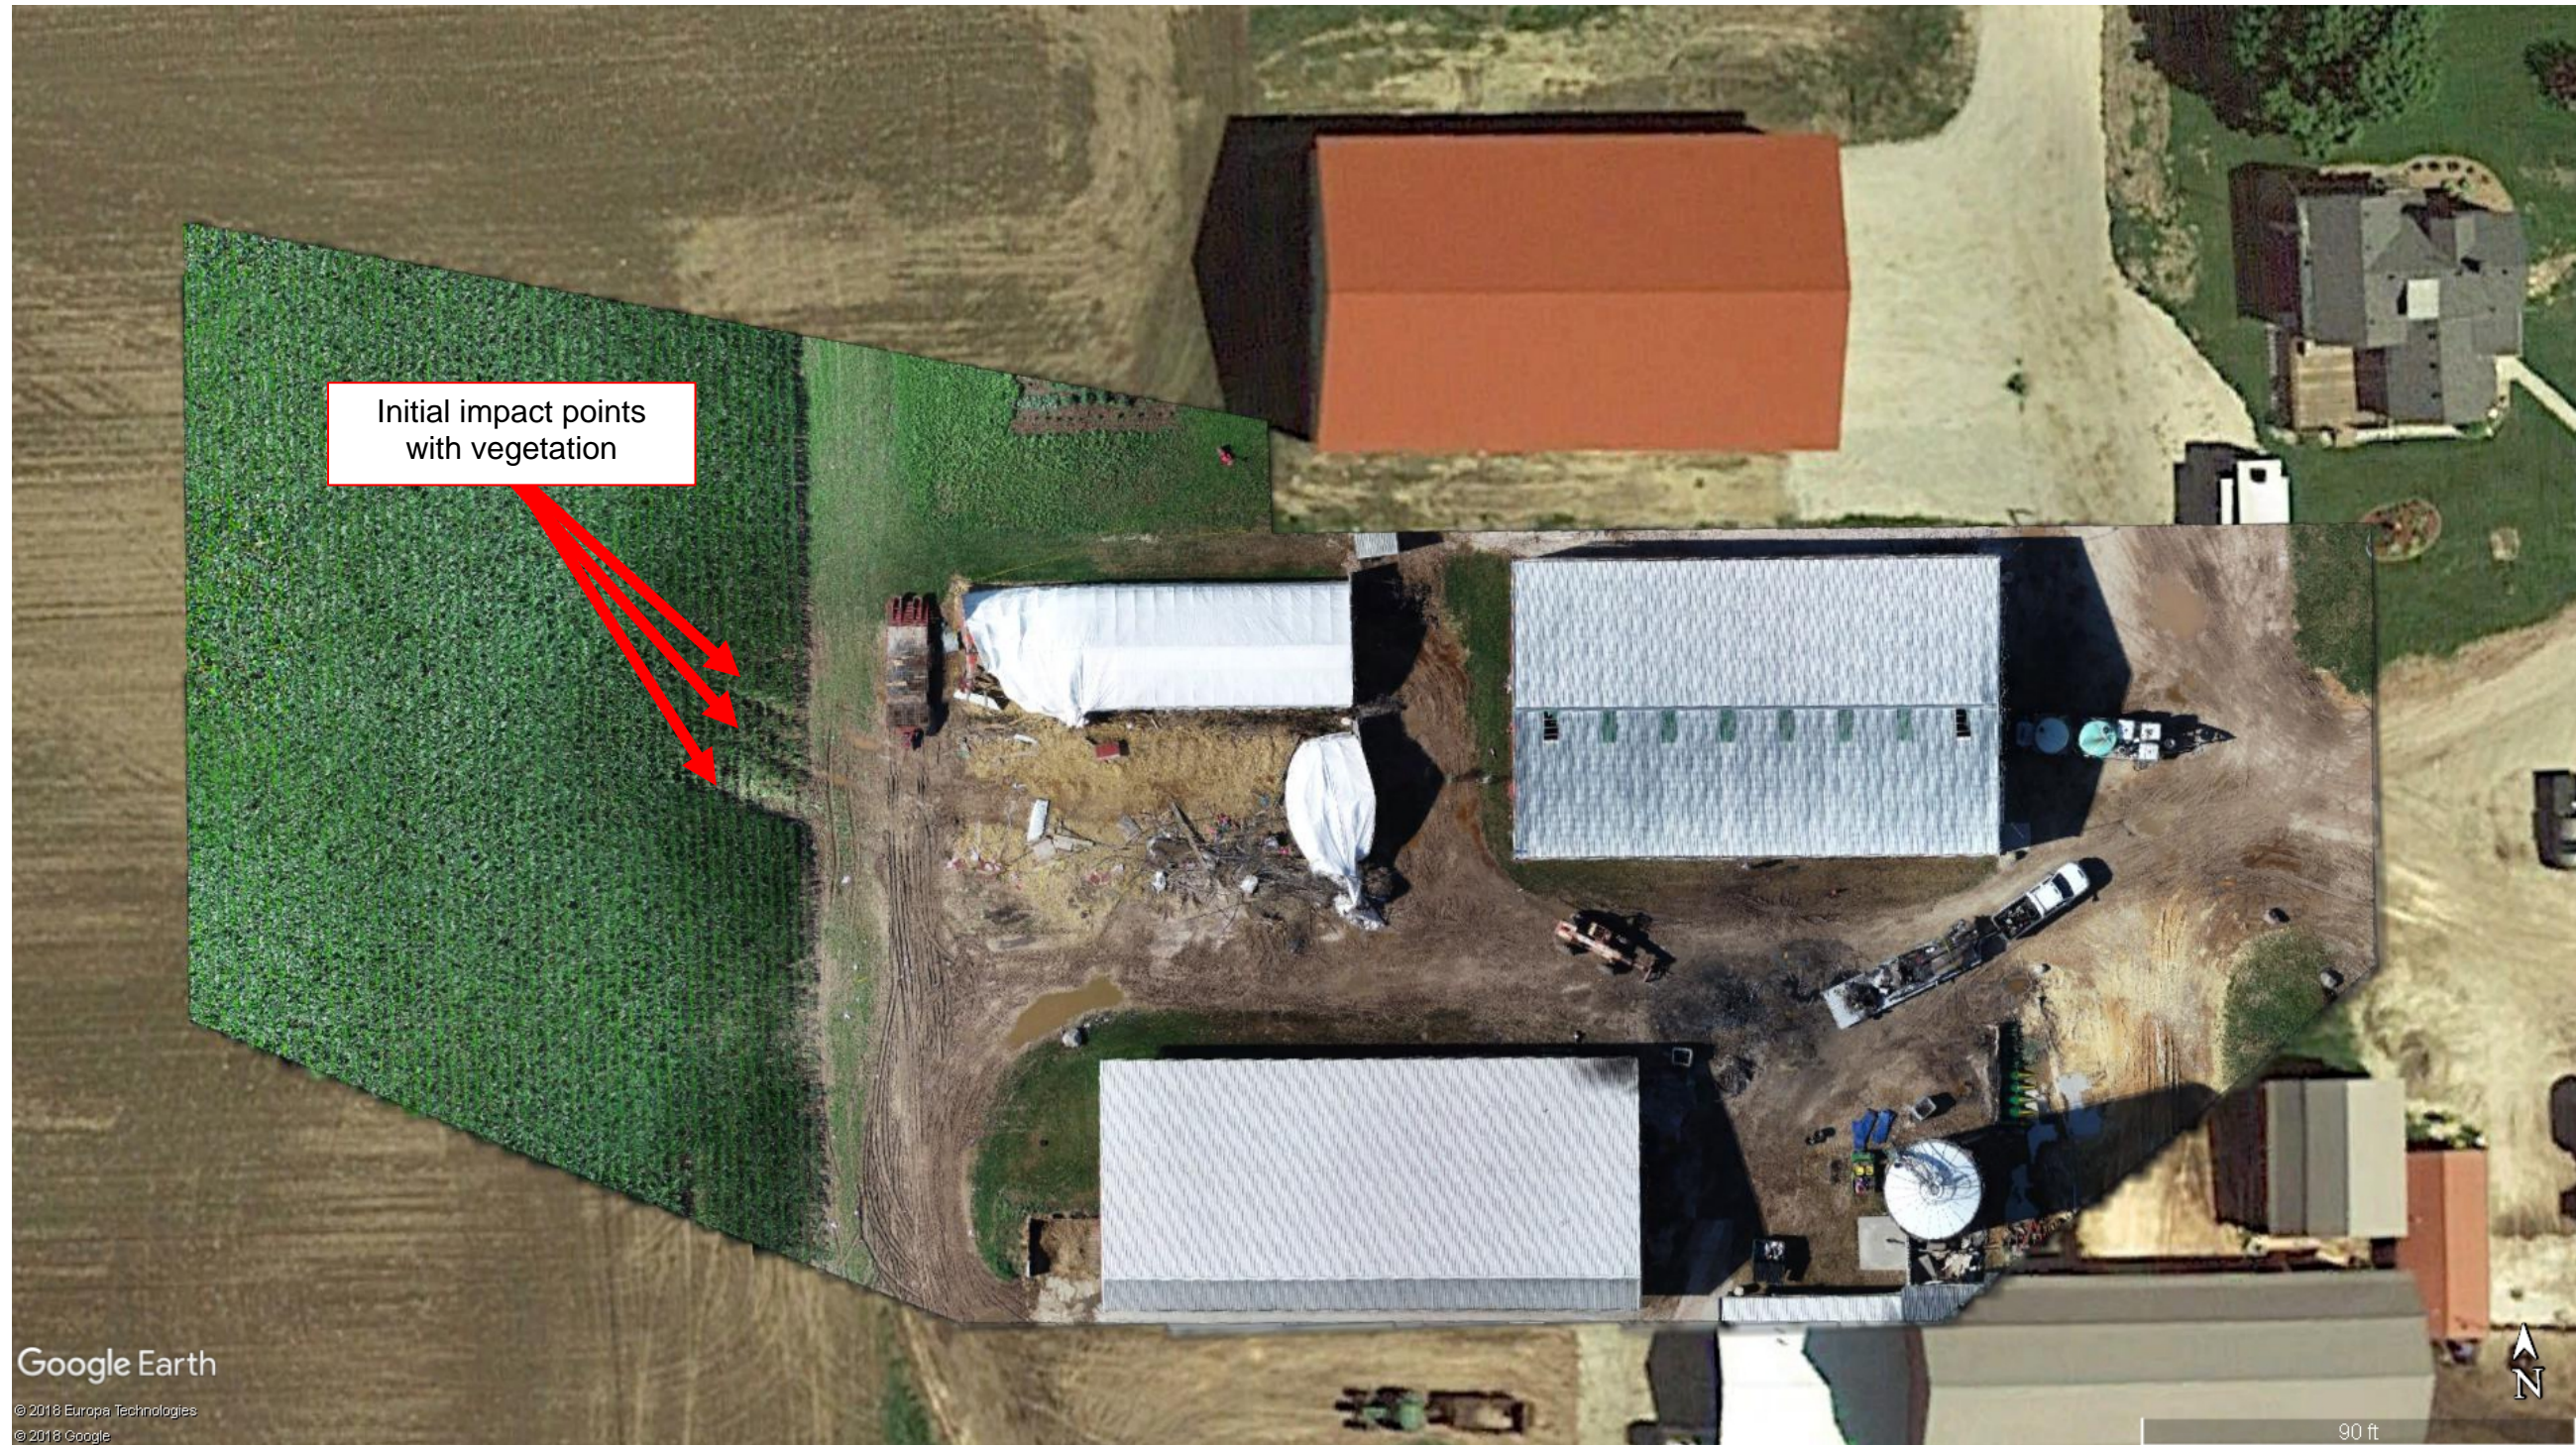
Figure 6 and Figure 7 contain screenshots of the orthomosaic map in Google Earth .kmz format. Figure 6 shows the overall accident site with showing initial impact points with the vegetation. Figure 7 is zoomed out to show the general area around the accident site and the proximity to the departing runway.

Figure 6 – Orthomosaic of accident site overlaid on Google Earth zoomed in to show main wreckage area.
