NATIONAL TRANSPORTATION SAFETY BOARD

UAS Aerial Imagery Report

A. ACCIDENT WPR18FA200

Location: Sheboygan, Wisconsin

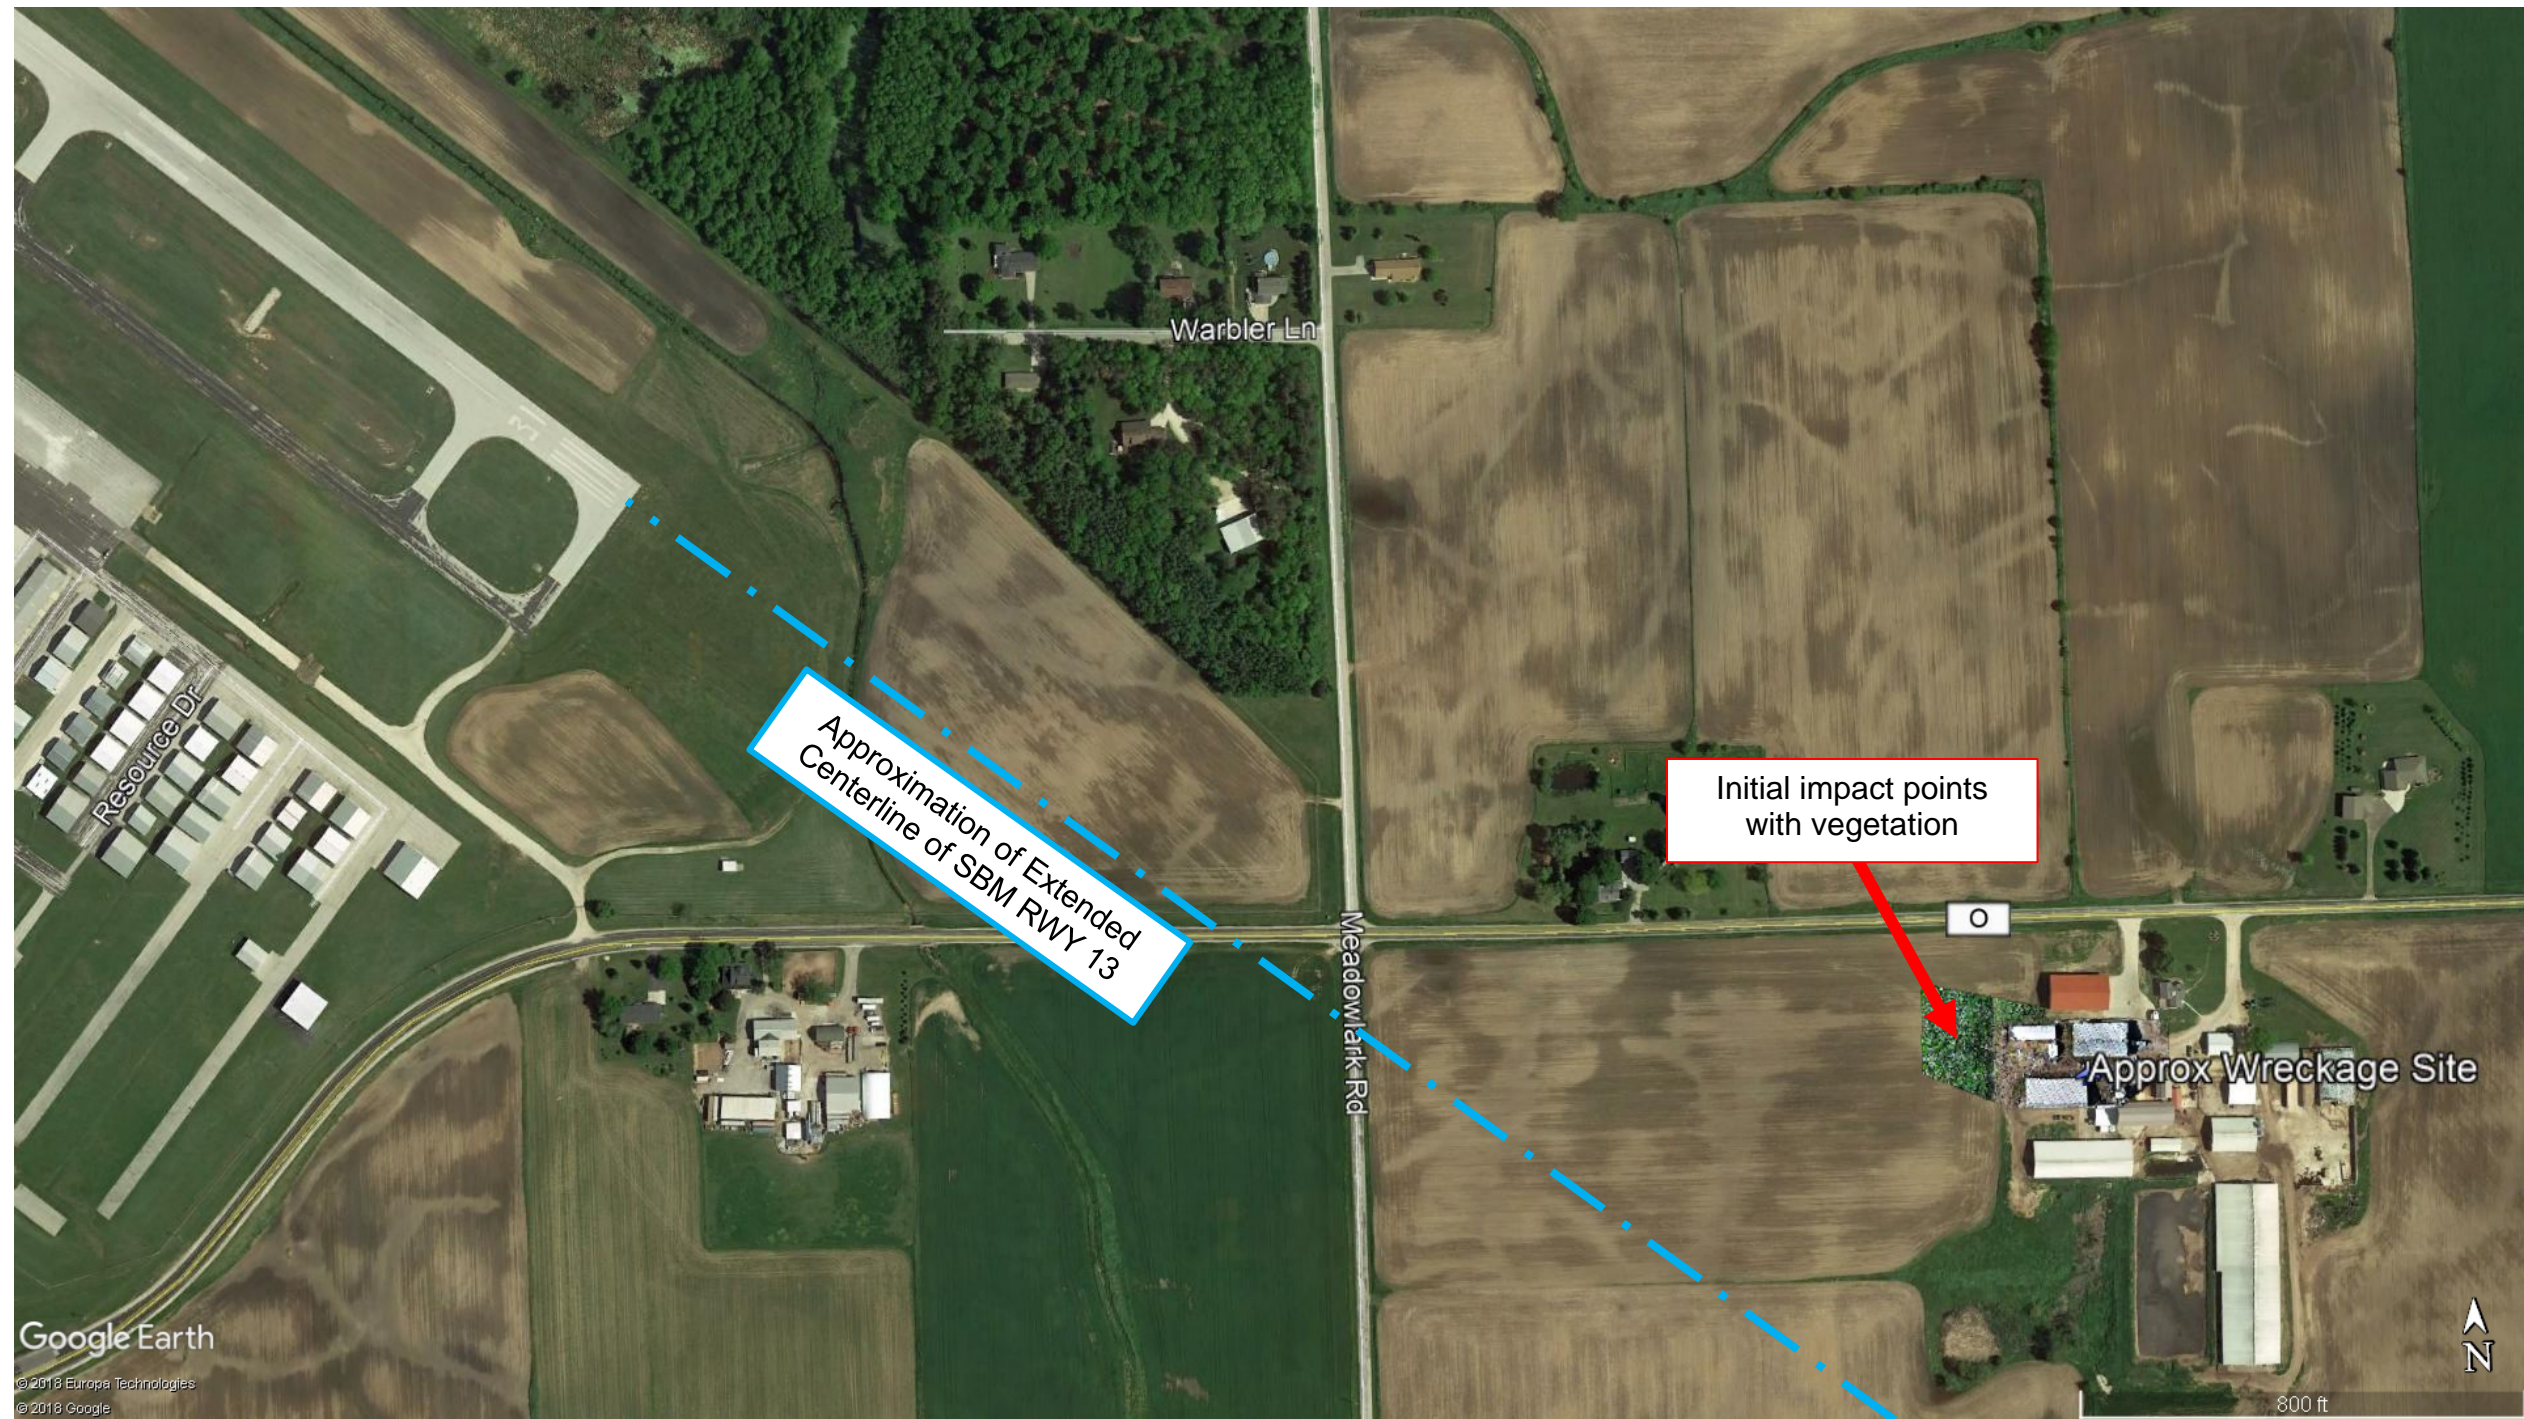
Figure 6 and Figure 7 contain screenshots of the orthomosaic map in Google Earth .kmz format. Figure 6 shows the overall accident site with showing initial impact points with the vegetation. Figure 7 is zoomed out to show the general area around the accident site and the proximity to the departing runway.

Figure 7 - Orthomosaic of accident site overlaid on Google Earth zoomed out to show SBM RWY 13 and the main wreckage area.
