NATIONAL TRANSPORTATION SAFETY BOARD

Aerial Imagery Factual Report
Accident Runaway and Site

A. ACCIDENT DCA17FA076

Operator: Ameristar Air Cargo, Inc. dba Ameristar Charters
Location: Willow Run Airport, Ypsilanti, Michigan
Date: March 8, 2017
Time: about 1452 EST
Aircraft: Boeing MD-83
Registration: N786TW

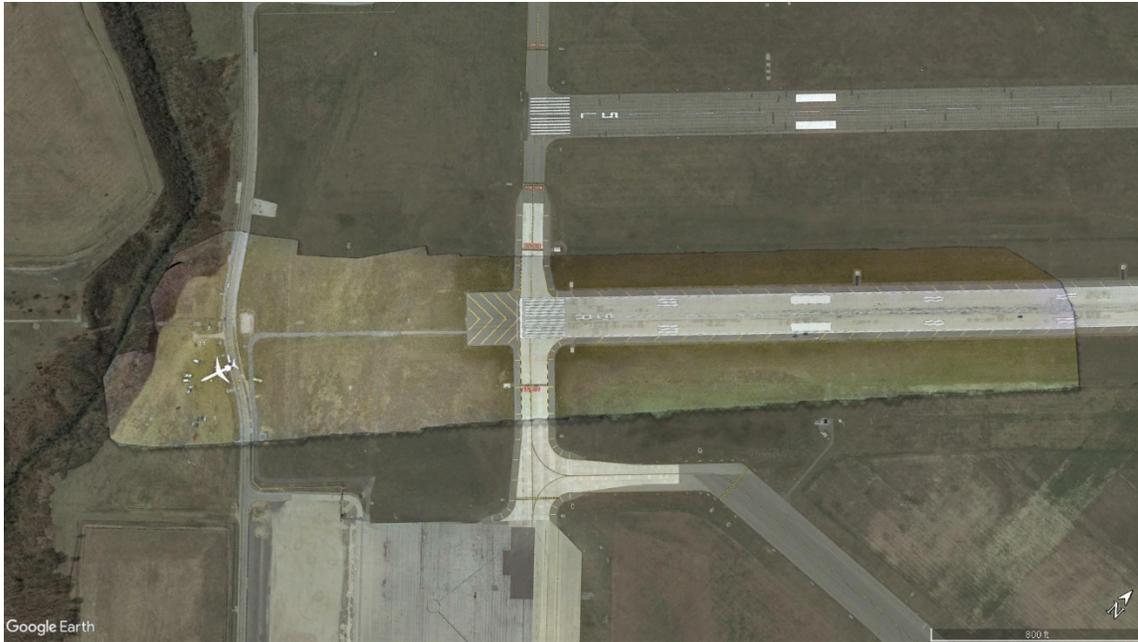
Figure 2 - Snapshot of Orthomosaic output overlaid on Google Earth

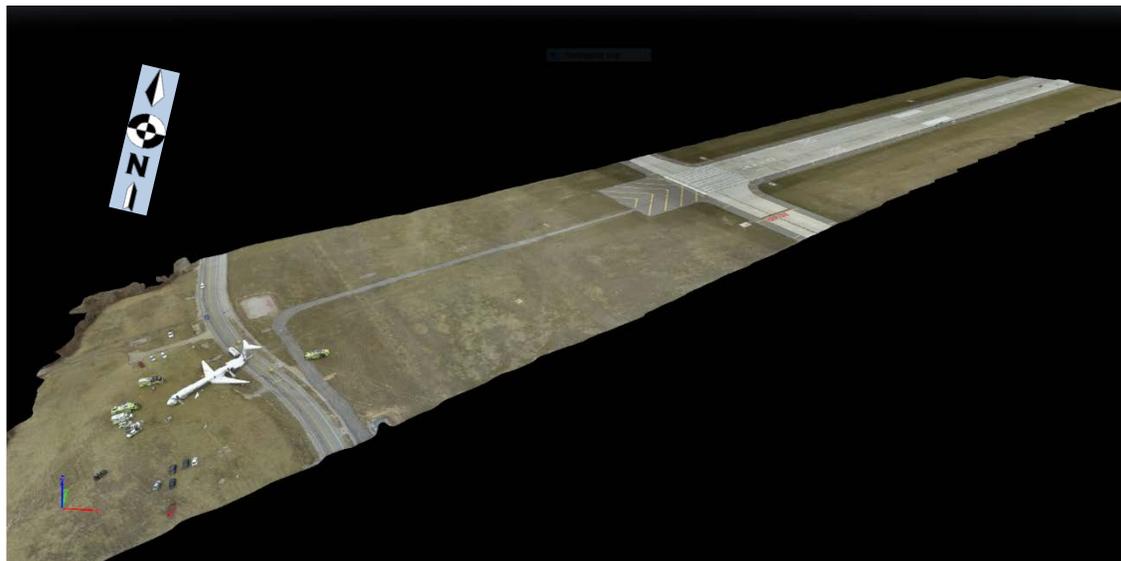
Figure 3 - Snapshot of mapped area 3D model

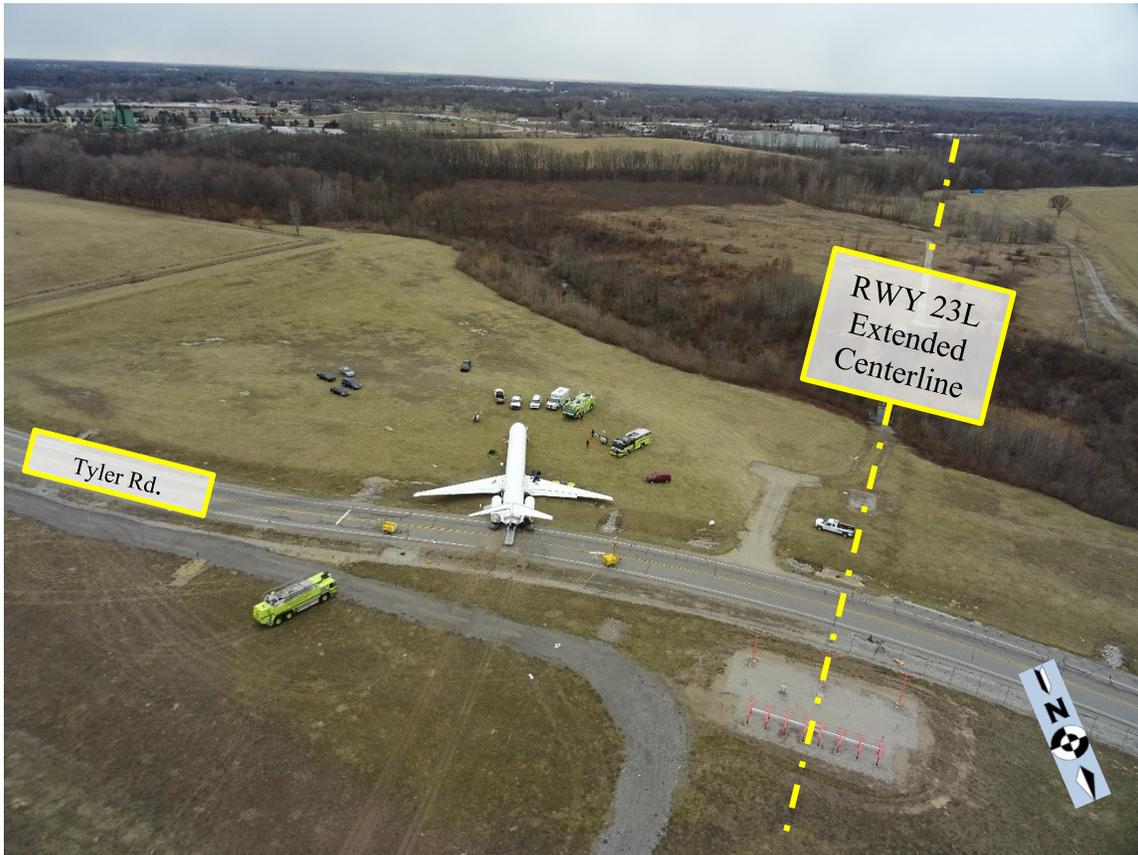
Figure 4 – Aerial image of accident site looking in a southwesterly direction (courtesy MSP)

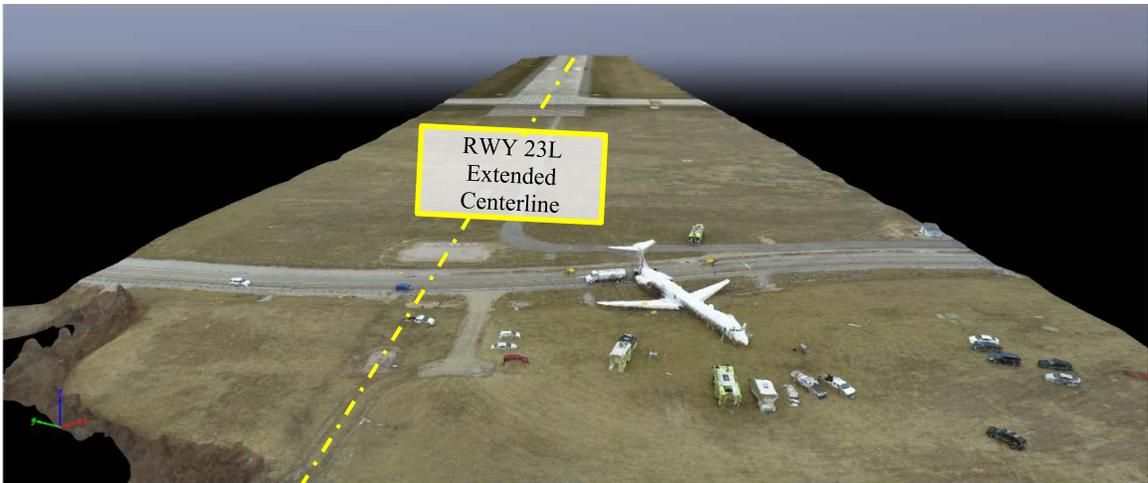
Figure 5 - Snapshot from 3D model of accident site

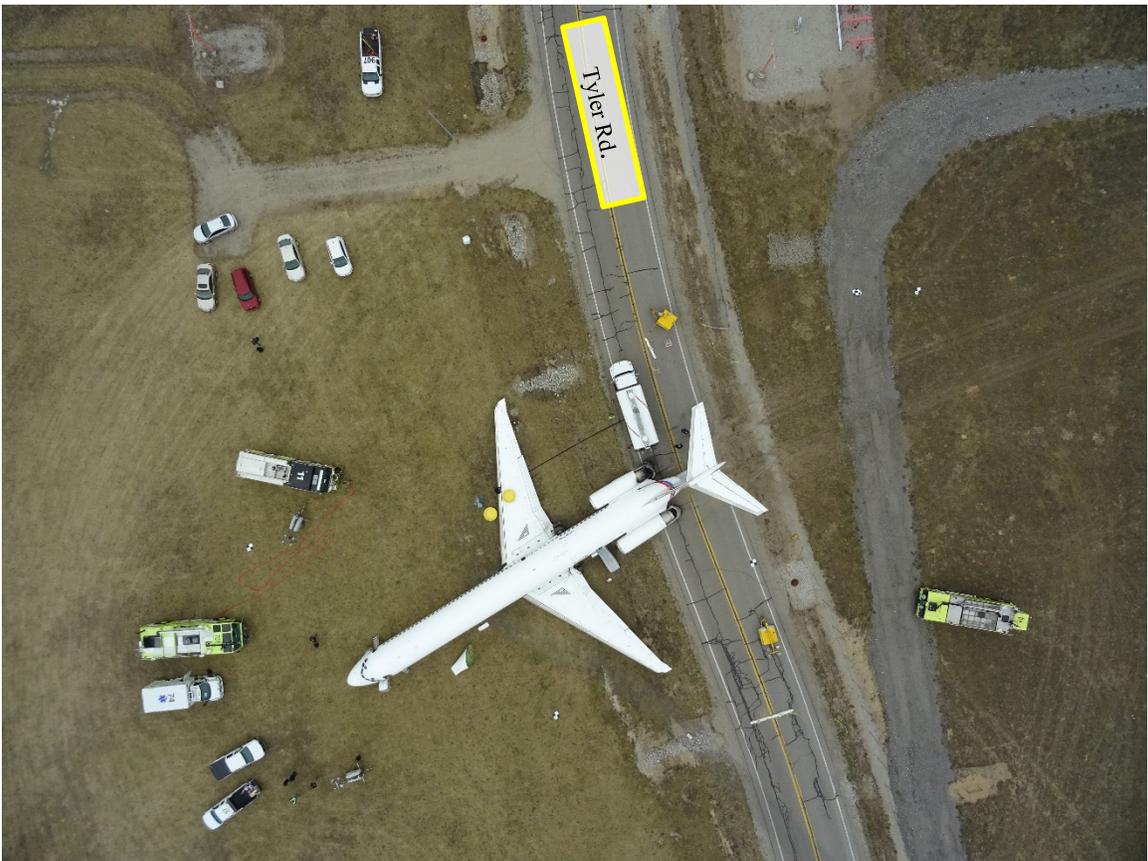
Figure 6 - Overhead aerial image of accident site (courtesy MSP)

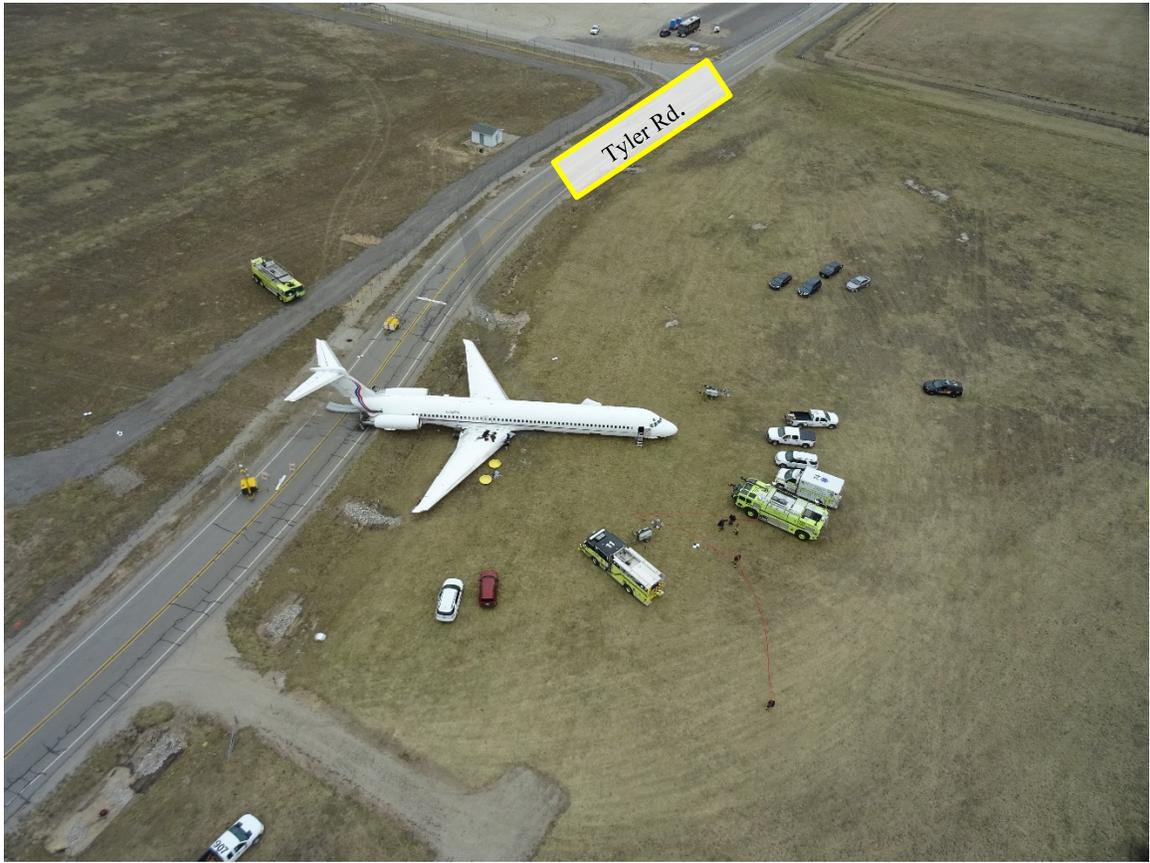
Figure 7 – Aerial image looking southeasterly at accident site

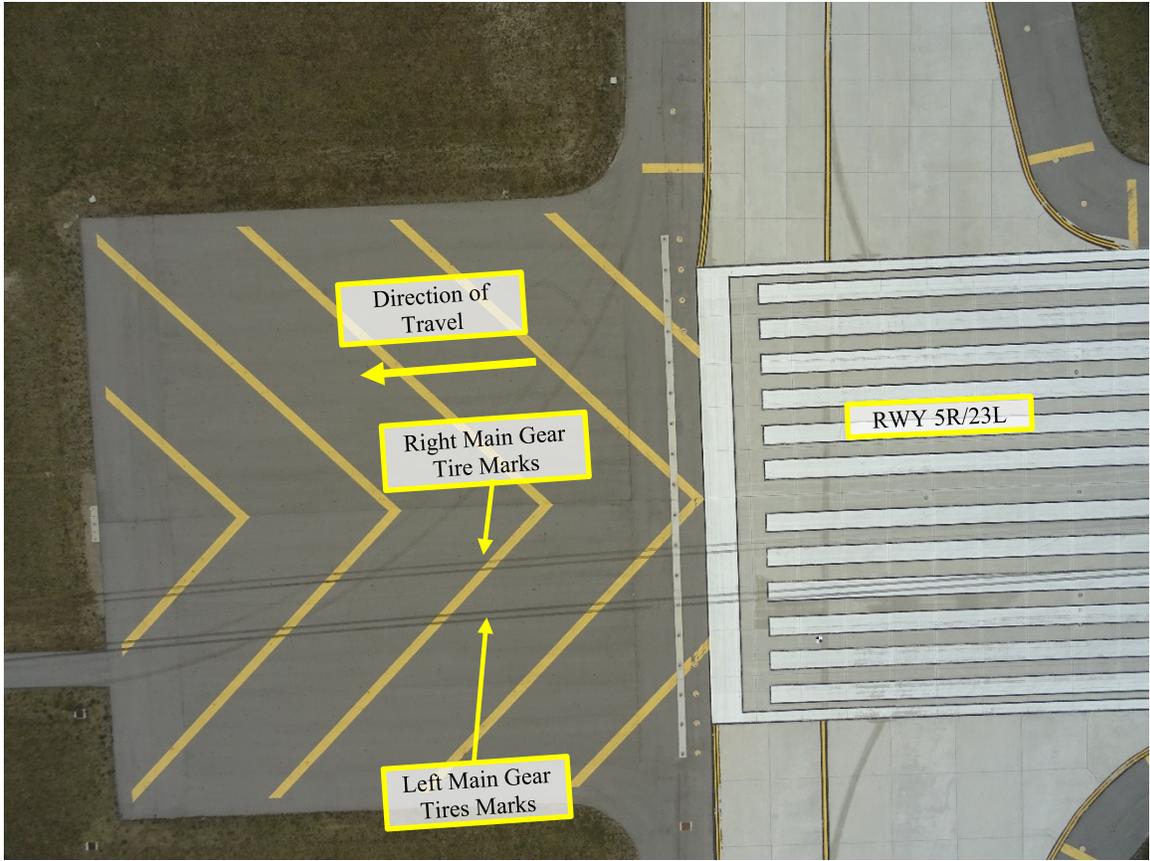
Figure 8 - Aerial image of departure end of RWY 23L and tire marks (courtesy MSP)

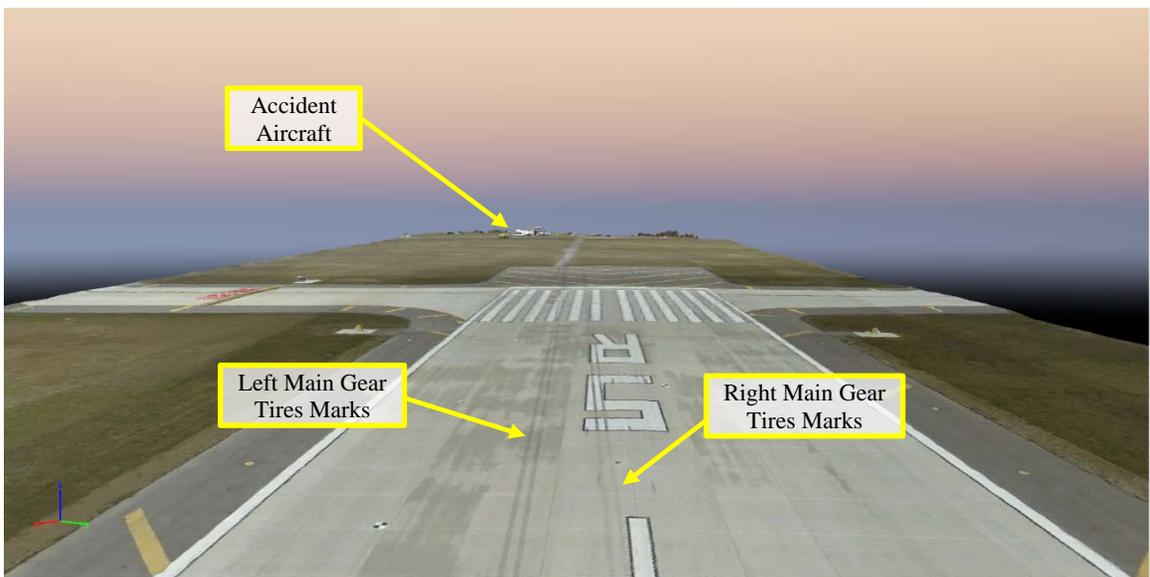
Figure 9 - Snapshot from 3D model of departure end of RWY 23L
