NATIONAL TRANSPORTATION SAFETY BOARD

UAS Aerial Imagery Factual Report

A. ACCIDENT CEN18FA053

Location: Oldenburg, Indiana
Date: December 16, 2017
Time: 2100 Eastern Standard Time (EST)
Event: N761YZ C210

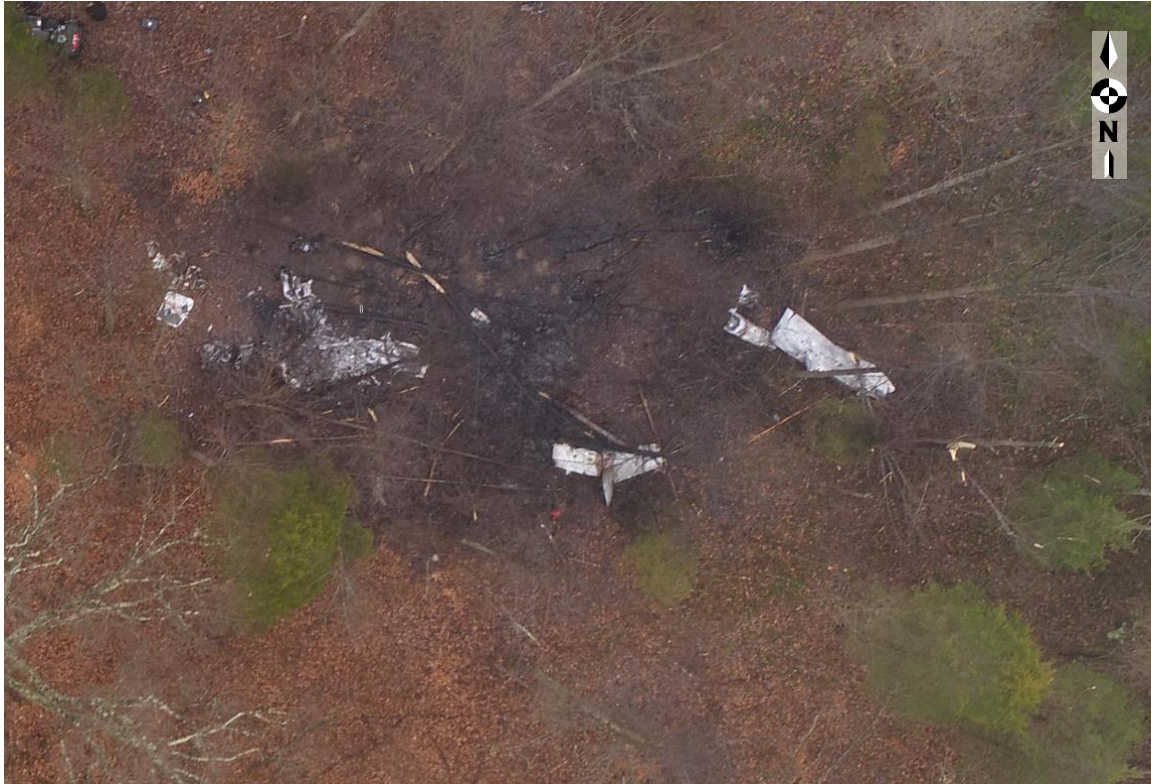
Figure 1 is a still photo overview of the main wreckage area. Figure 2 is a still photo overview of the initial tree strike and right wingtip lodged in a tree. The source photos are Attachment 1 and 2.

Figure 1 – Main wreckage area

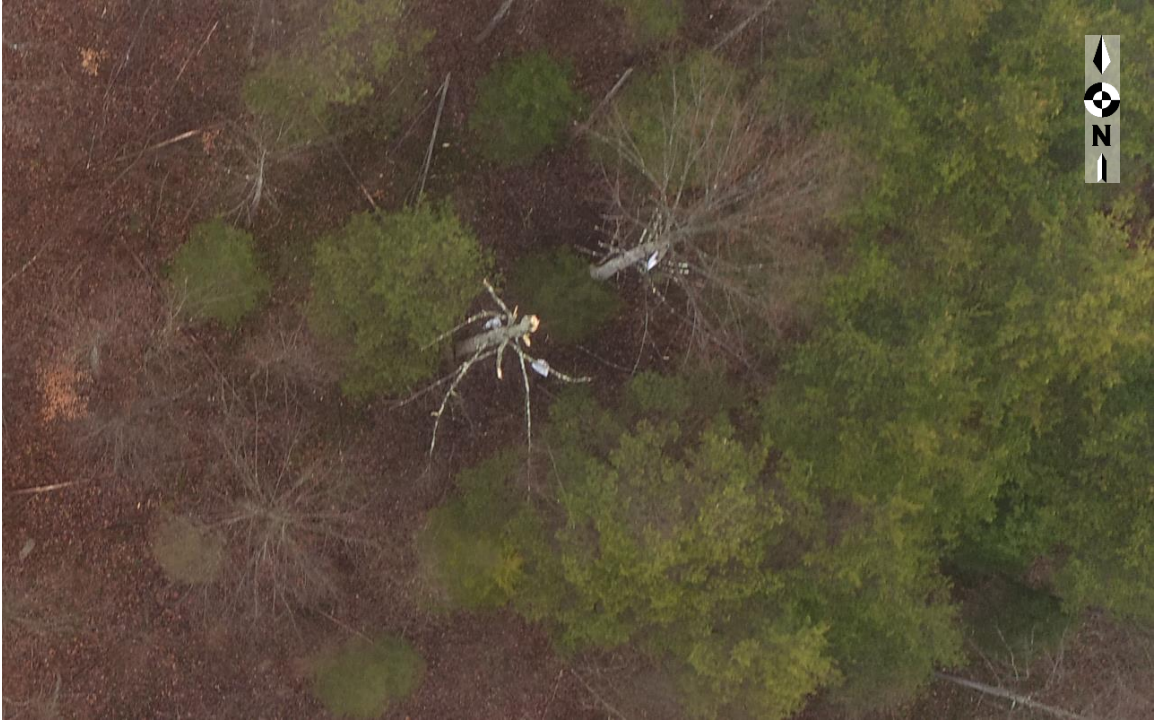
Figure 2 – Initial Impact and Right Wingtip

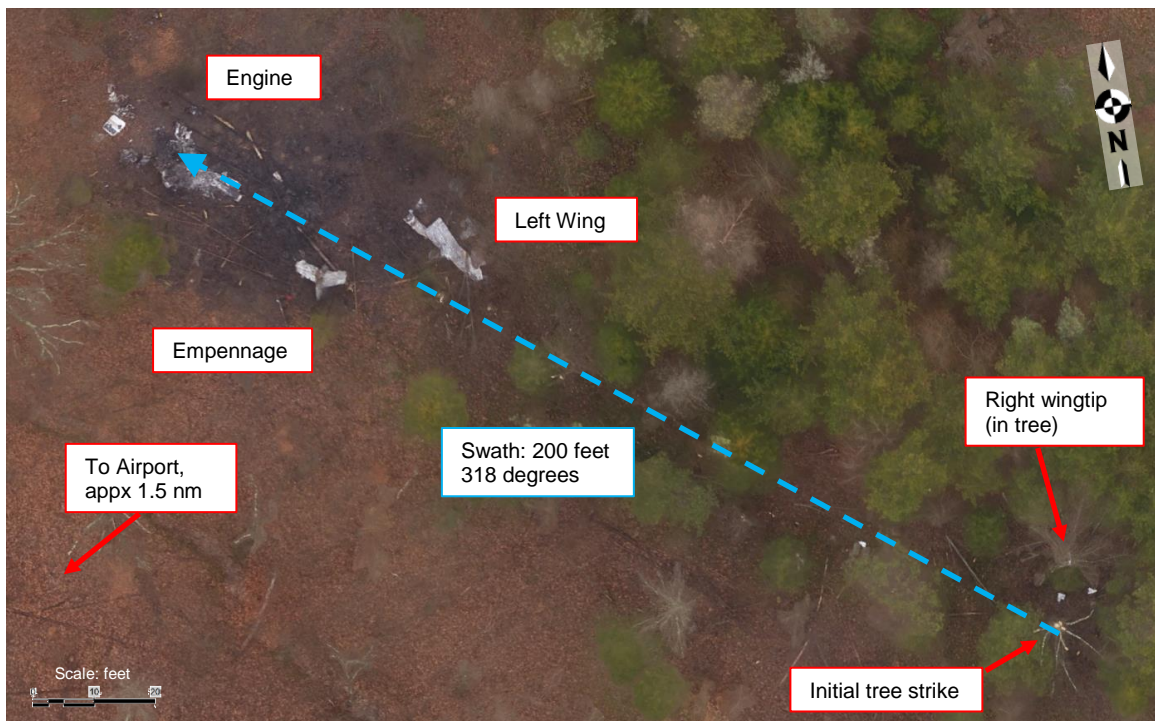
Figure 3 is a wreckage site diagram based on the full resolution orthomosaic Google Earth kmz export. The kmz file is Attachment 3.

Figure 3 –Google Earth orthomosaic map

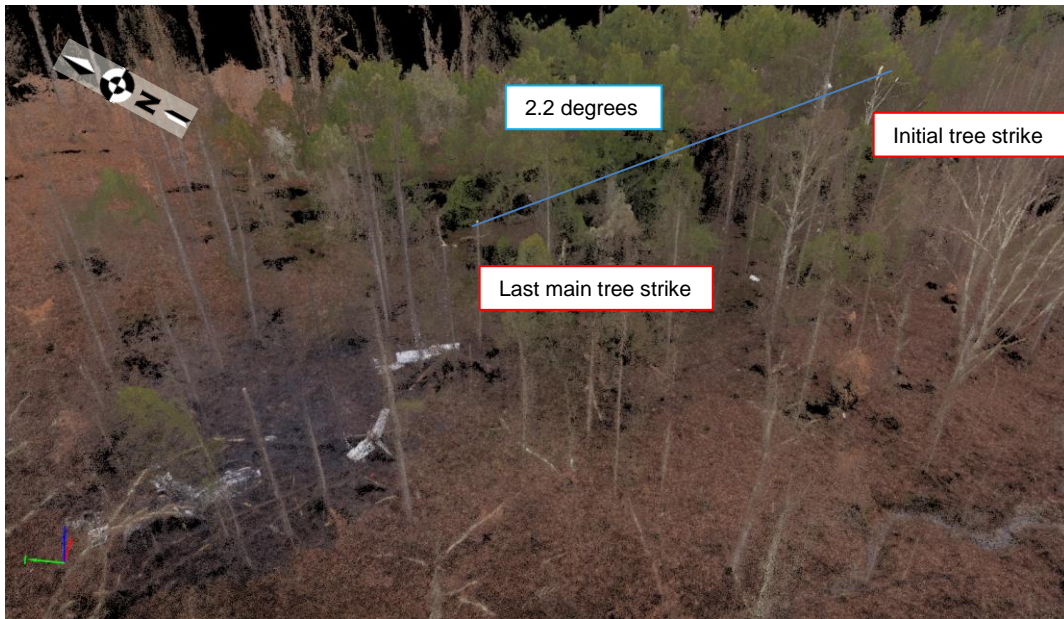
The Pix4D point cloud (attachments 4 and 5) was used to measure the angle between significant tree strikes in high locations along the main swath. The angle along the higher strikes was measured at 2.2 degrees. (Figure 4 and Table 1)

Figure 4 – 3D Point Cloud measurement of tree strike angle

Distance from initial tree impact to last tree strike (main swath) – 137.6 feet.

Elevation difference between initial and last tree strikes – 5.3 feet, angle – 2.2 degrees

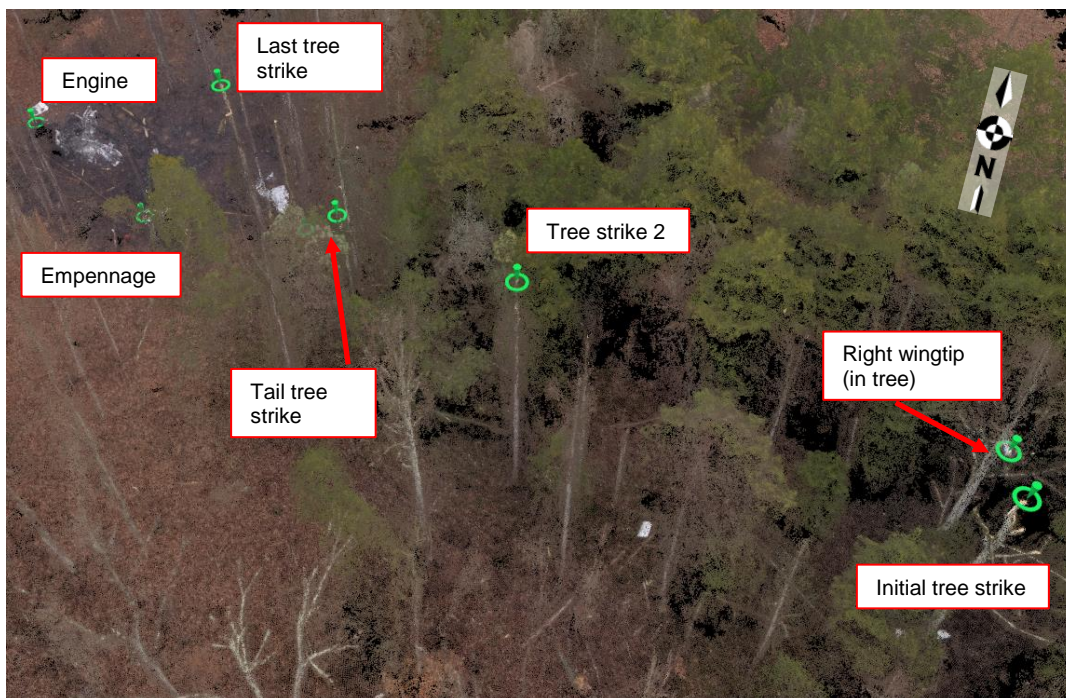
The point cloud also displayed intermediate tree strikes consistent with the path of the empennage after separation. Figure 5 indicates marked points of tree strikes and major portions of wreckage. Figure 6 is the same view with high vegetation removed via point cloud classification.

Figure 5 – 3D Point Cloud showing intermediate tree strike witness marks

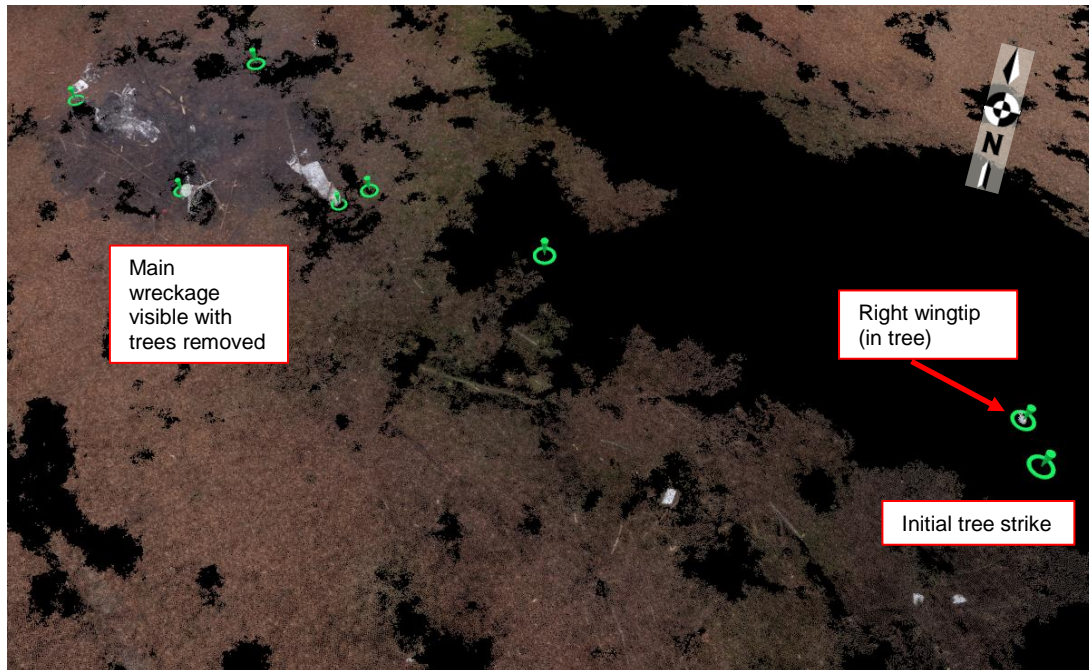
Figure 6 – 3D Point Cloud with “high vegetation” classification removed

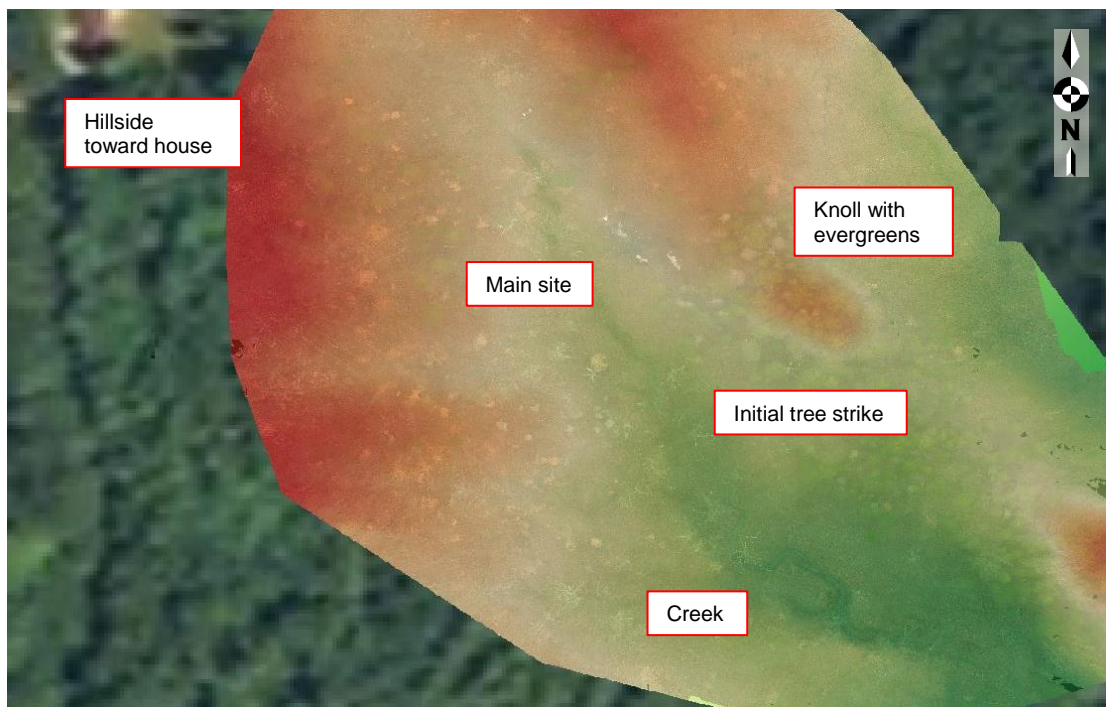
Point cloud classification also aided in mapping the elevation and contours of the underlying terrain, with trees removed). A digital terrain map was generated with false color and overlaid with the orthomosaic onto a GIS basemap. (Figure 7 and Attachment 6)

Figure 7 – Digital terrain model overlaid with orthomosaic and basemap

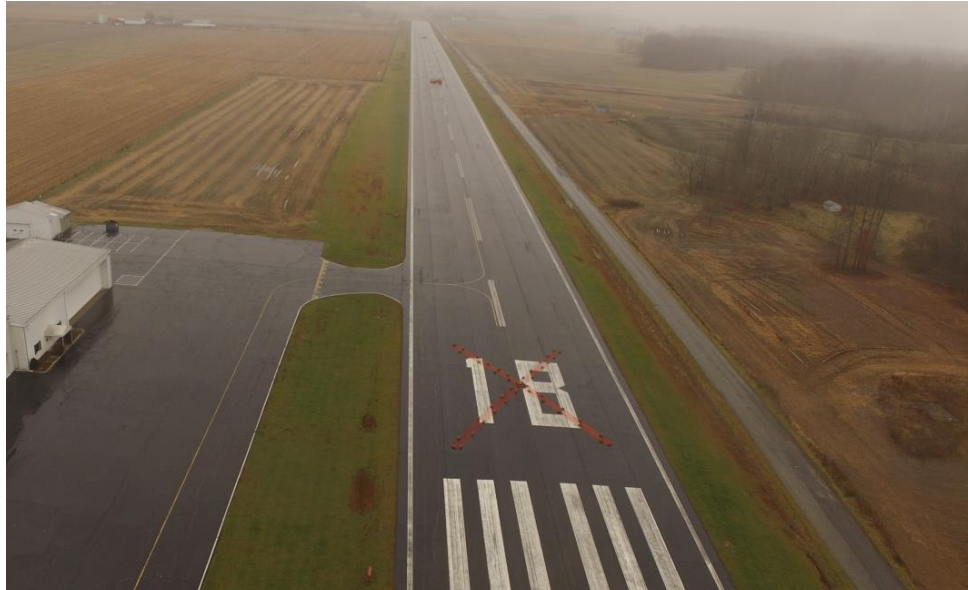
ATC radio communications indicated the pilot was attempting to land at Batesville airport, which was NOTAM'd closed. Photo documentation of the runway X markings and equipment placed on the runway was taken during daytime, from the approximate altitude of an airplane on short final (Figure 8 and Attachment 7).

Figure 8 – View of Runway 18 showing X and equipment

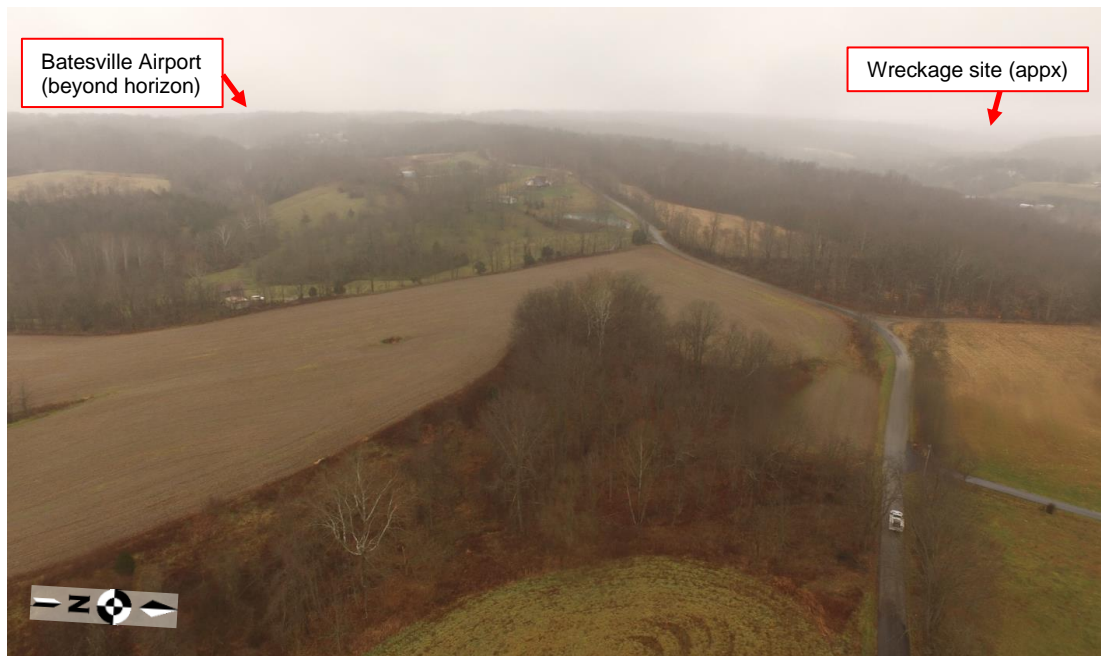
Photo documentation was also taken from the approximate location between the last two ADS-B ATC returns (Figure 9 and Attachment 8). Figure 10 is a combined map of the ADS-B returns and the orthomosaic, with a sectional chart overlay.

Figure 9 – View from last radar targets position/altitude/track looking along Stockpile Rd.

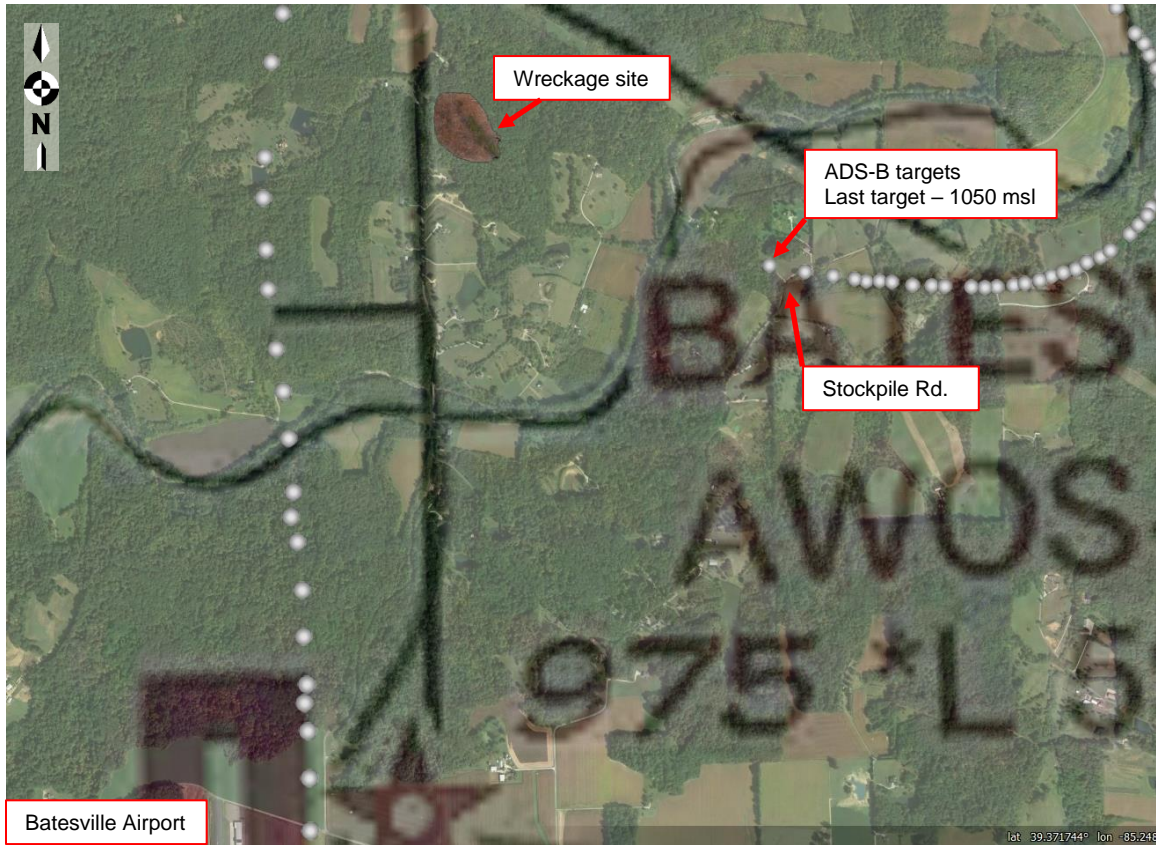
Figure 10 – ADS-B and Sectional overlaid on Google Earth with orthomosaic
