# NATIONAL TRANSPORTATION SAFETY BOARD

## UAS Aerial Imagery Report

### A. ACCIDENT ERA18FA167

Location: Springfield Township, NJ  
Date: June 13, 2018  
Time: 0908 Local Time (EDT)  
Event: BE58 N218BL

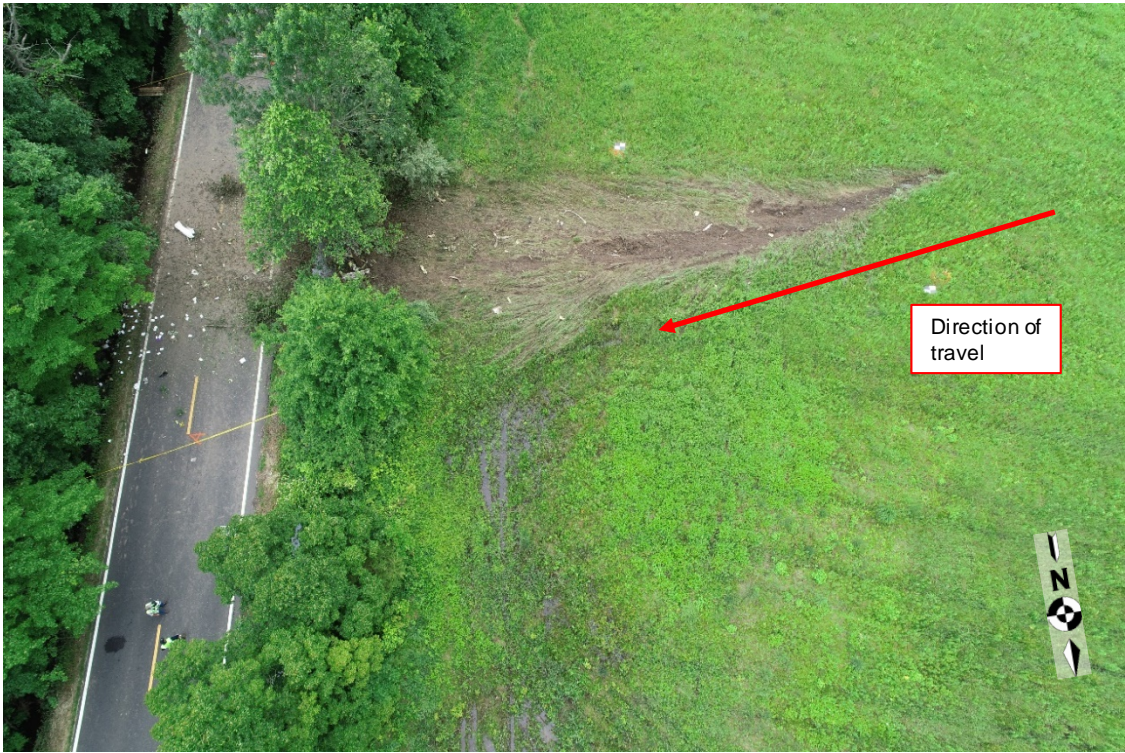
Approximately 390 high resolution photos and videos were gathered. Select source photos, excerpts from the orthomosaic map, and snapshots from the low resolution orthomosaic are shown below. Figure 1 is a view from the north looking toward the initial impact marks and ground scar. The curve of the ground scar is toward the east, and broken trees and wreckage indicate the aircraft passed through the treeline and across the road in an easterly direction.

**Figure 1 – Initial Impact mark**

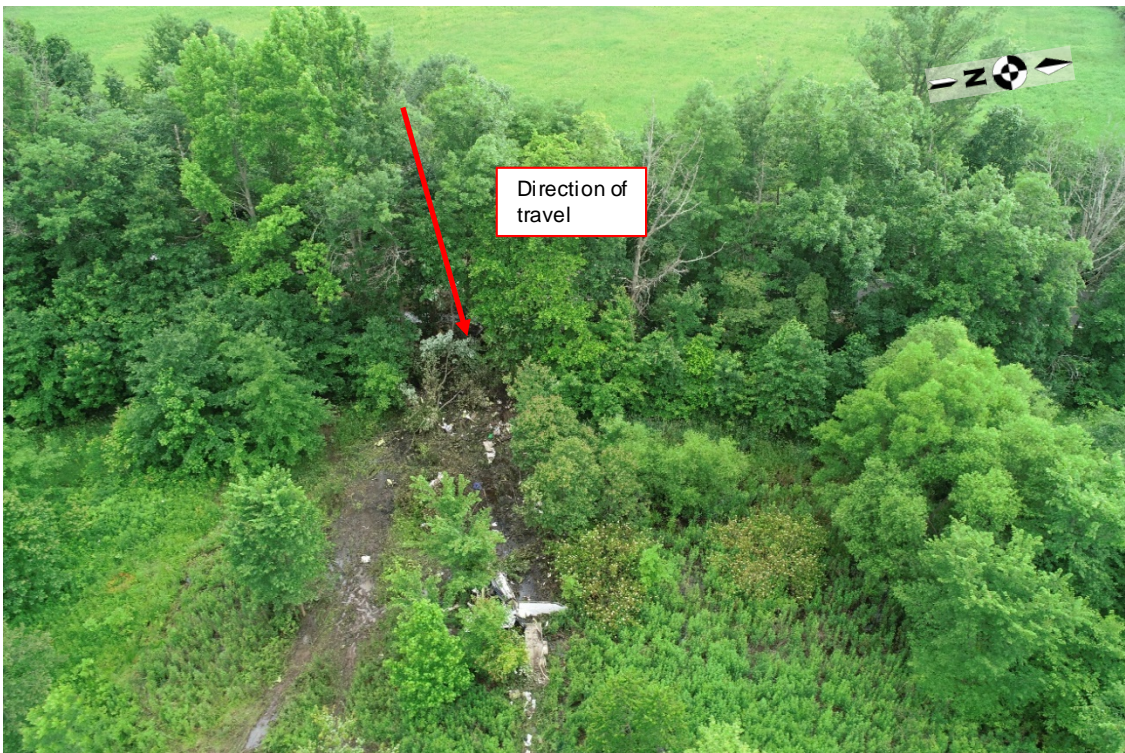
Figure 2 is a photo looking back along the direction of impact at the resting points of significant wreckage that passed across the road and through the opposite treeline.

**Figure 2 – Main wreckage looking back along direction of impact**

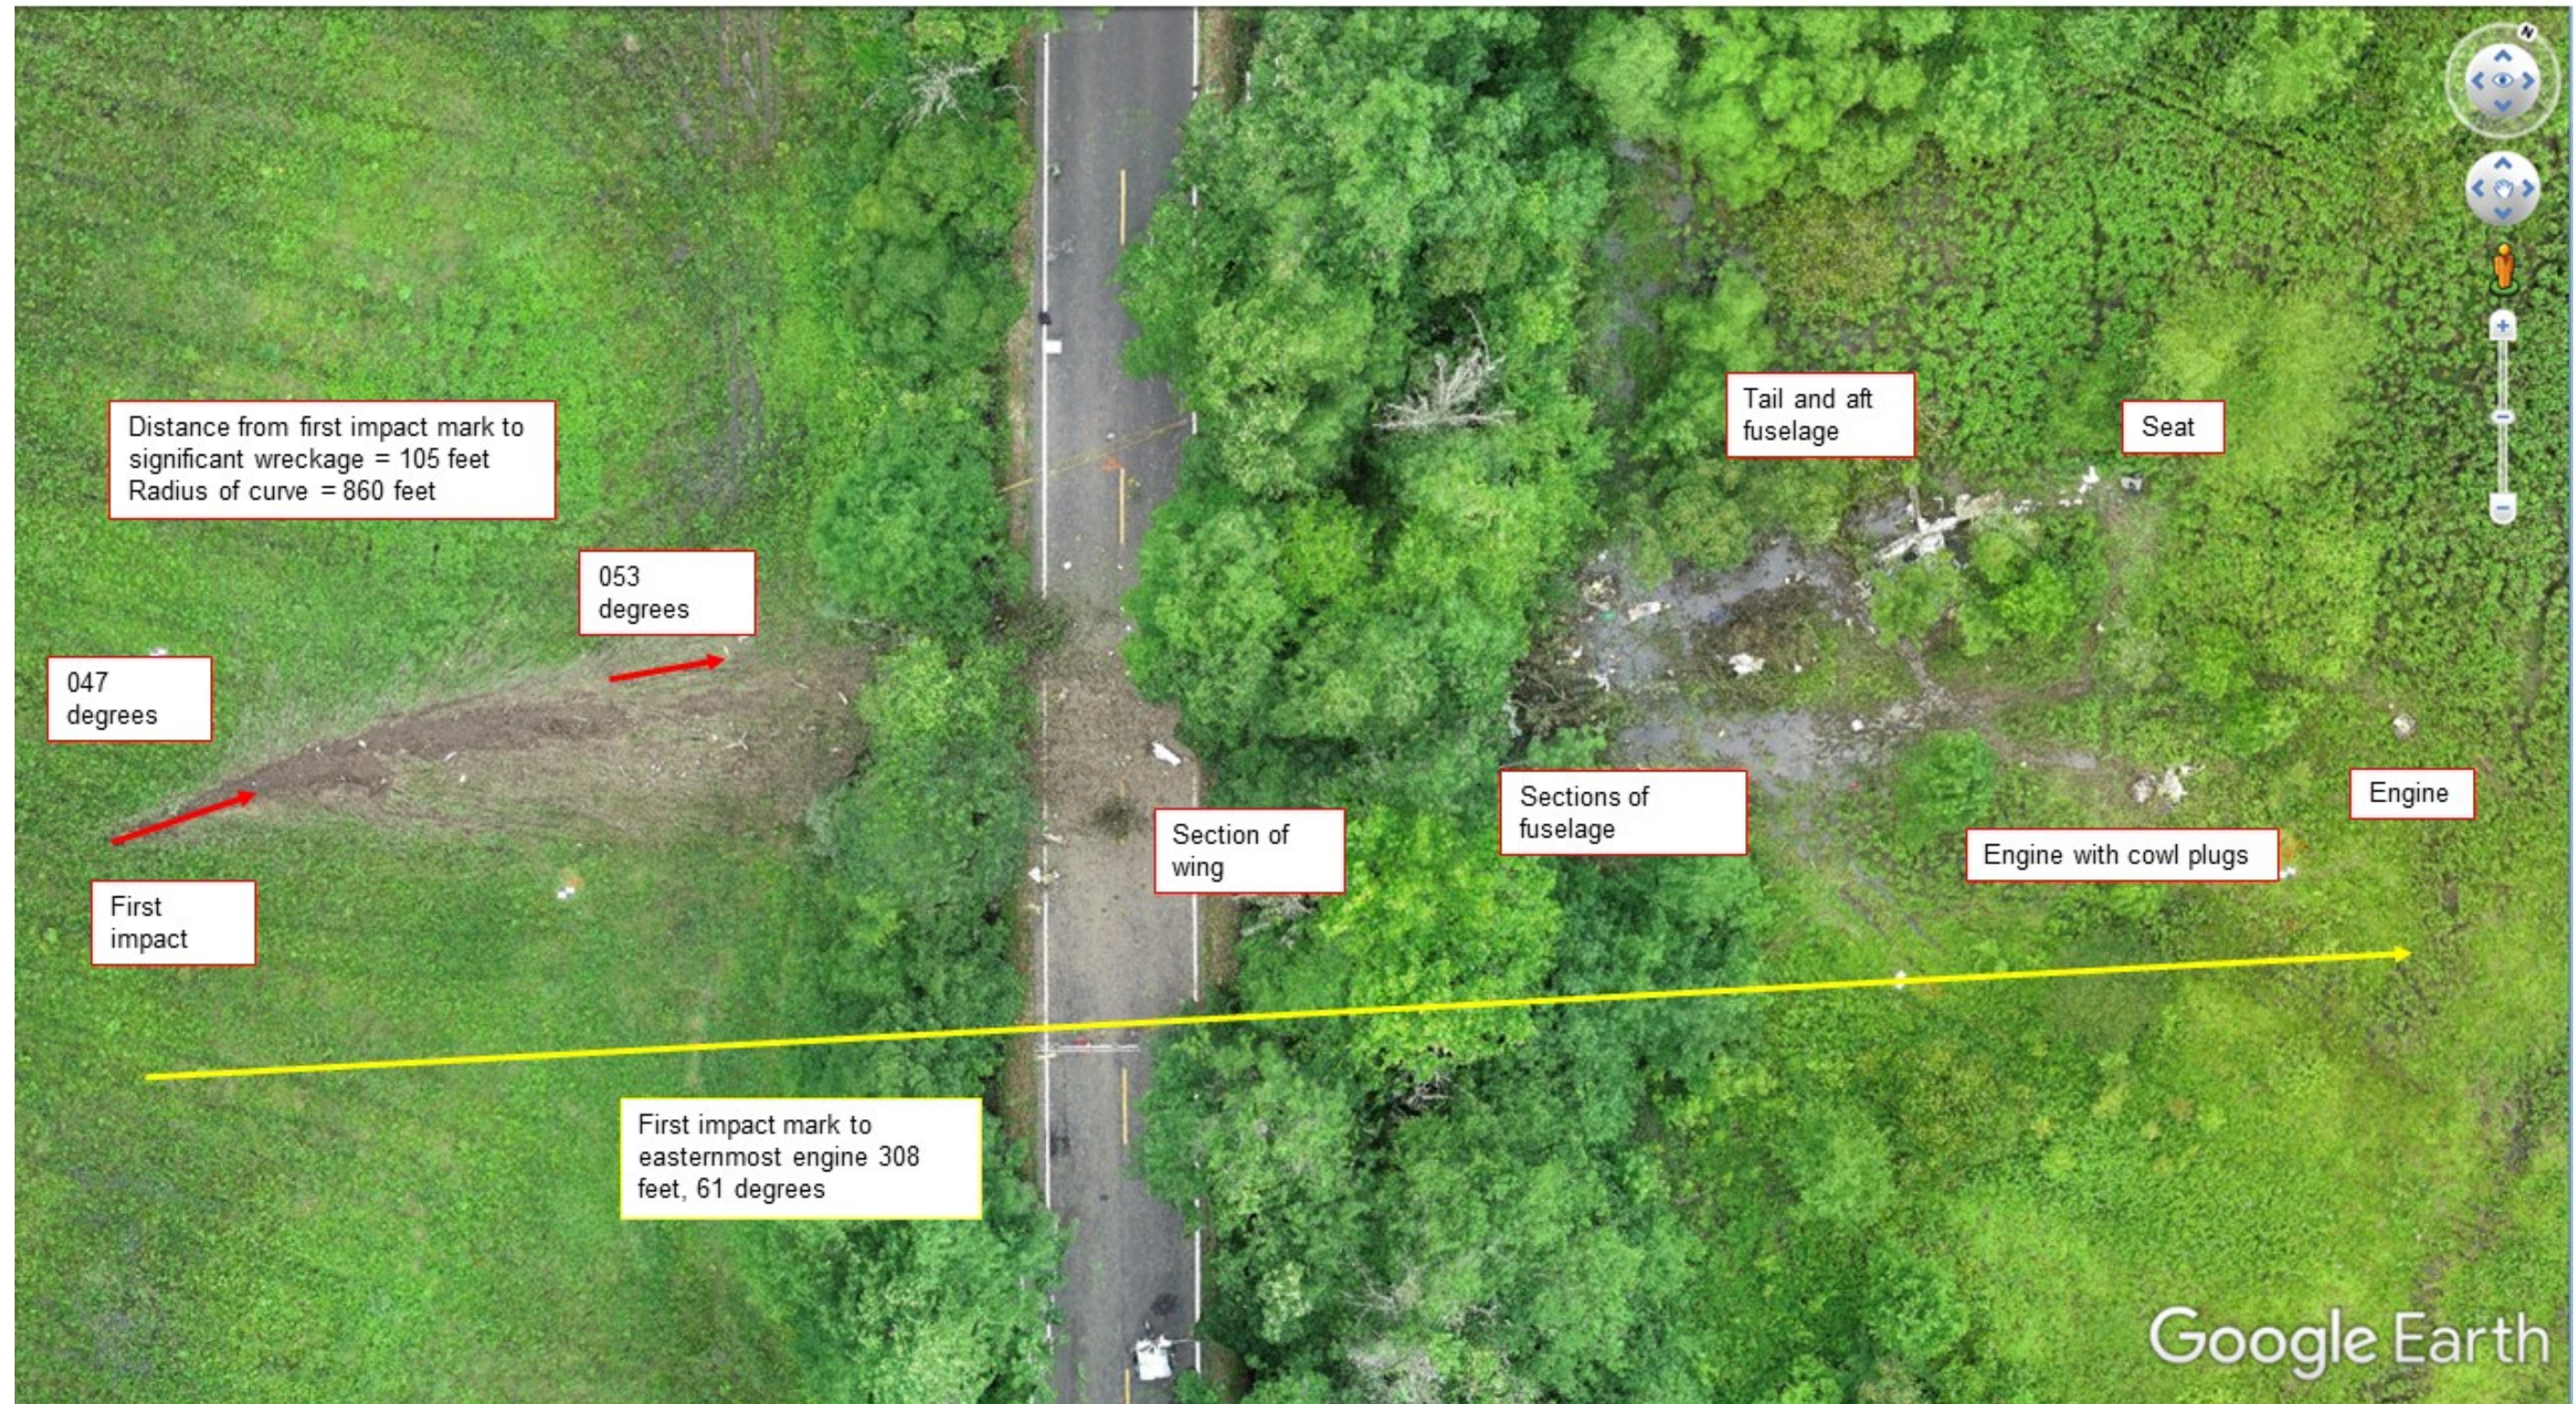
Figure 3 – Google Earth wreckage map

Figure 3 is a snapshot of a Google Earth overlay of the orthomosaic wreckage map (Attachment 2). Significant portions of wreckage, distances and directions are indicated. The Attachment 2 file can be opened in Google Earth and other measurements can be made.

Using the standard turn radius formula  $R = V^2/G \cdot \tan\theta$ , entering the 860 foot radius from figure 3, and bank angle of 29 degrees from figure 6, resulted in a ground speed of 73 knots. The source orthomosaic and point cloud are available in the docket for validation.

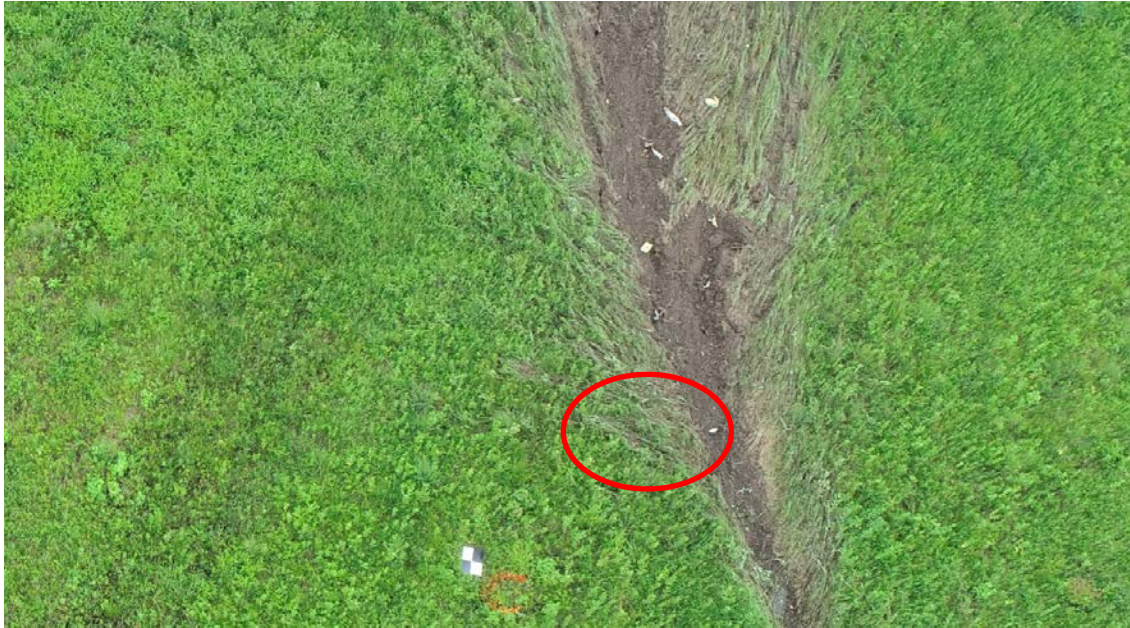
Figure 5 is a closeup of one of the source photos of the ground scar. The area circled indicates an area of ground that appeared to be solid enough to make a reasonable measurement of the angle of the side of scar consistent with the lower surface of the airplane's right wing, a piece of which is nearby. Much of the initial part of the scar was soft and muddy, or covered with long grass. The checkerboard is one of the DGPS ground control points.

Figure 5 – Closeup of sample photo of impact ground scar

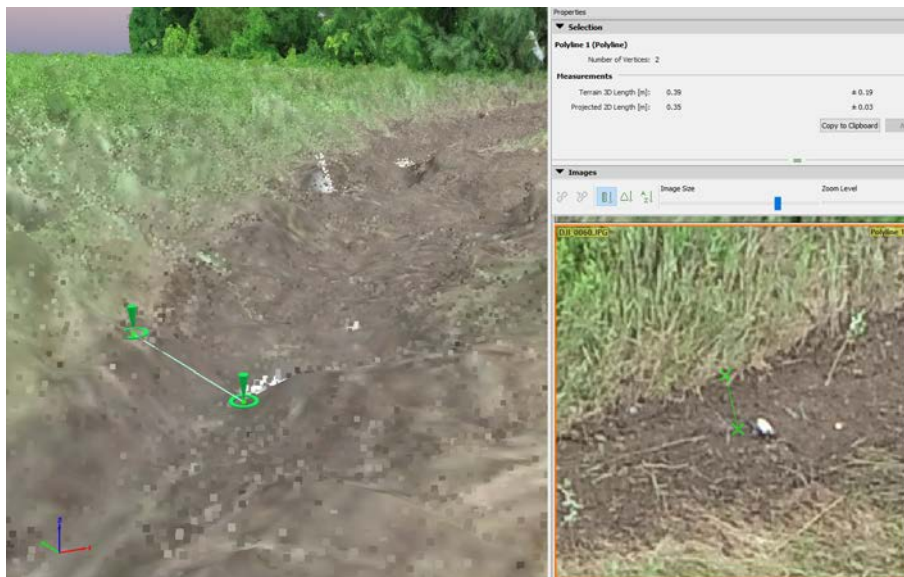
Figure 6 is a measurement between two selected points that appeared to be consistent with a stable area of ground accurately reflecting the bank angle at impact. The length of the line between the two points is 0.35 meters, the elevation difference is 0.17 meters, resulting in an angle of approximately 29 degrees. Note, this measurement is subject to the precision errors of the photogrammetry processing and should be taken as an estimate only.

Figure 6 – Point cloud measurement of impact mark angle

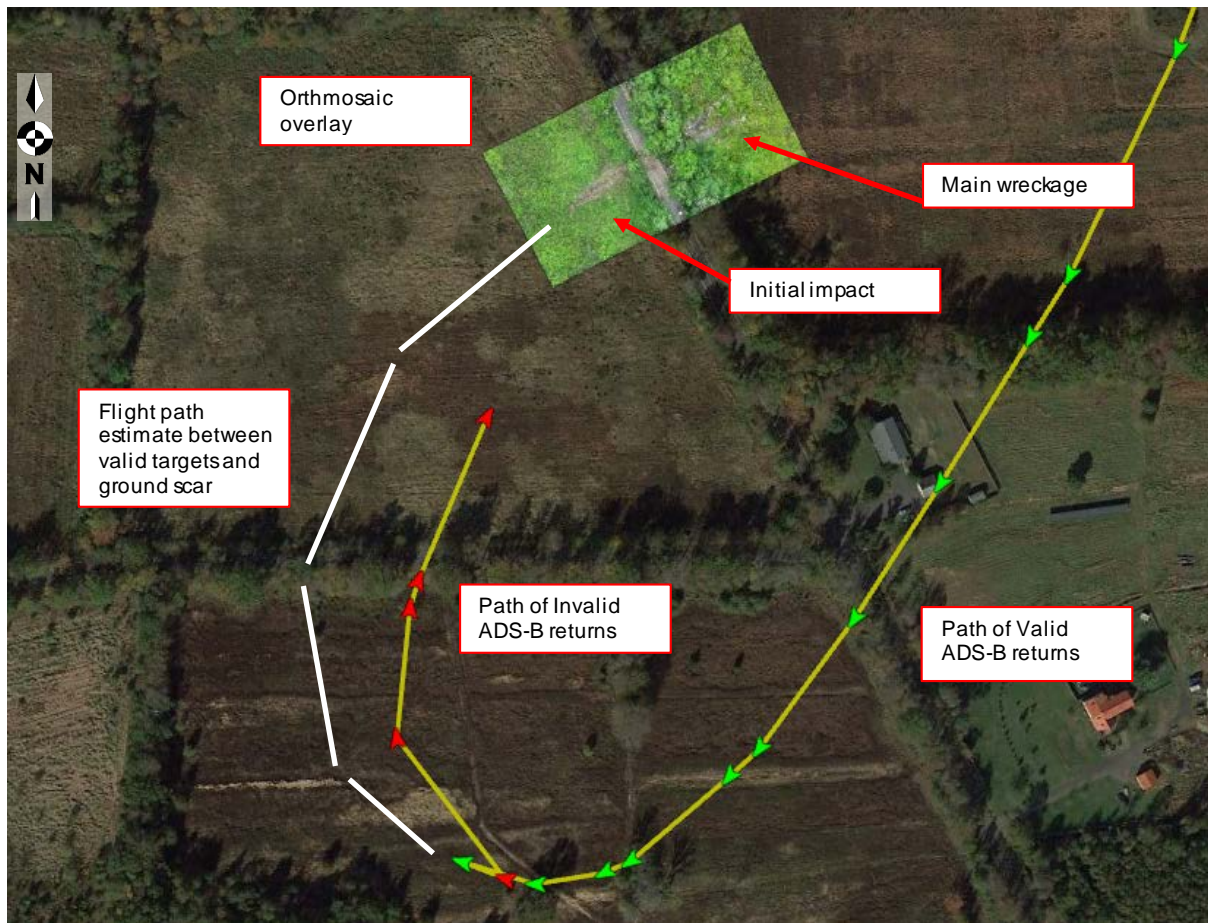
ADS-B surveillance data was obtained from the FAA and overlaid on a basemap along with the orthomosaic. Green symbols were tagged as valid data in the ADS-B file, red symbols were returns tagged as invalid. The white line is an estimation of the flight path based on aligning the ground scar, valid ADS-B returns, and an assumed fit around the invalid returns.

Figure 7 – Orthomosaic and ADS-B returns plotted on common basemap
