Examination and functional testing of UP 9708 horn sequencer and alerter

12/9/14

Participating: Mike Hiller, NTSB; Mike Flanigon, NTSB; James Carter, UP.

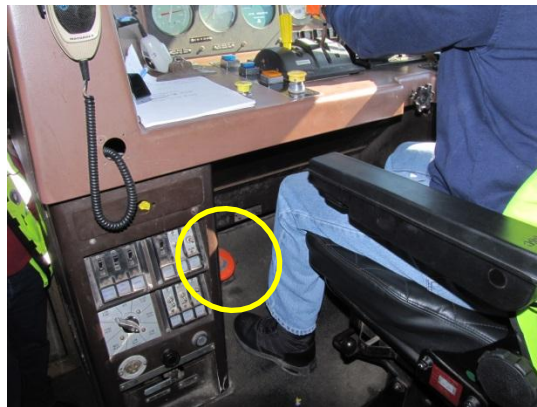
- The horn sequencer was activated by the sequencer foot pedal located under the engineer's control stand at various speeds under 70 mph. The sequencer sounded the standard crossing horn cadence (long, long, short, long) continuously until the sequencer foot pedal was again depressed, which stopped the horn cadence.

Figure 1-Horn Sequencer Pedal on UP 9708 (Circled in yellow)
