Submission of the

US Airline Pilots Association

National Transportation Safety Board

USAirways Flight 1549

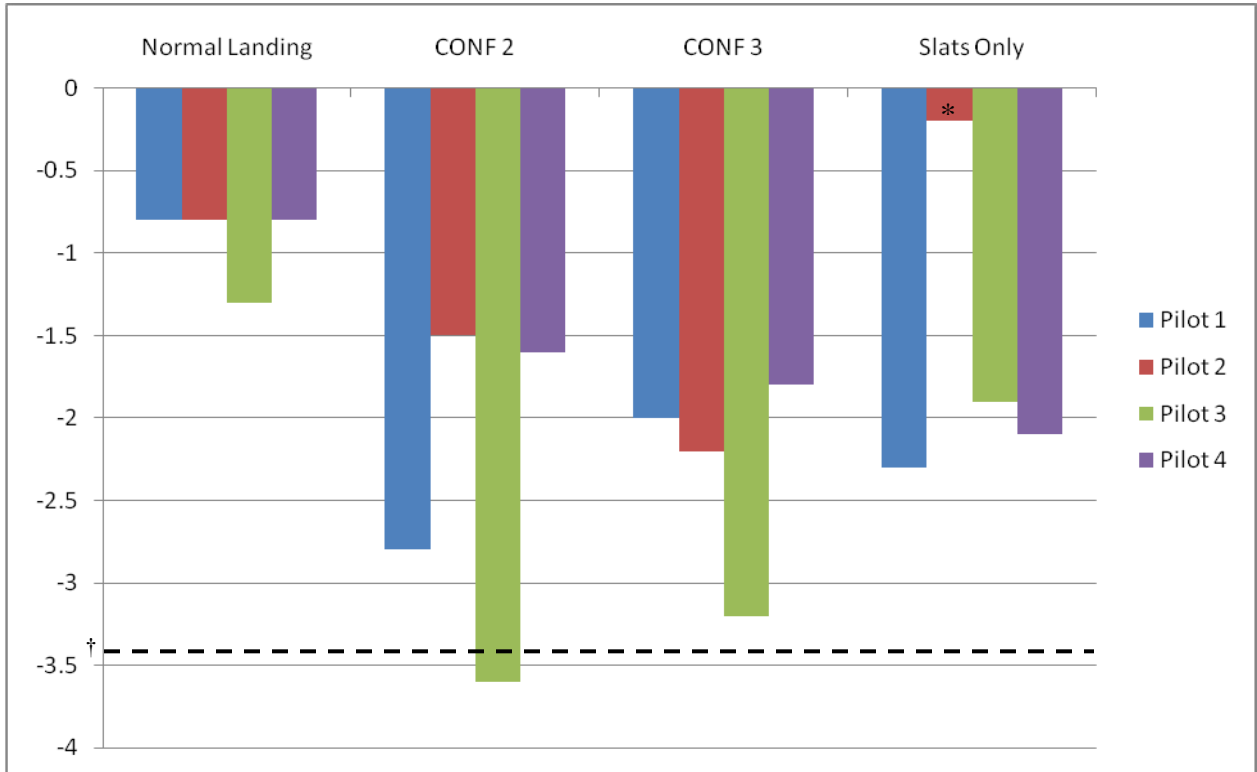
Figure 1. Flight path angles (in degrees) for a normal landing and different airplane configurations for ditching

Flight path angle calculated by “alpha - theta (deg)”; * Landing technique flown to achieve lowest vertical descent rate possible at touchdown; † Flight path angle (-3.4 degrees) of flight 1549

It should be highlighted that only one landing achieved the .5 degree (or less) glide path. This is in spite of the fact that this pilot was aware of the requirement and was attempting to achieve this flight path. Also noteworthy, is the fact that all of the normal landings, which were made to a runway at LGA with normal thrust and configuration, exceeded the .5 degree glide path immediately prior to touchdown. Regarding the descent rate, it is also not clear that the 3.5 feet per second is reasonable for ditching, especially with limited thrust available. Based on the simulator data mentioned above, it does not look reasonable whatsoever. Some of the considerations that occur in an actual ditching would include sea conditions and sight picture/depth perception issues. It only seems prudent to consider a design based on a more realistic “real world” descent rate and glide path.

In the case of flight 1549, we do not believe that these certification standards are reasonable, and attainable. We therefore favor a more realistic approach of using an achievable flight path in which to evaluate the structure. We, therefore, issue the following recommendations to Airbus, FAA, and EASA.

Convene an engineering evaluation board to review the certification standards for ditching the A-320 series aircraft. This should include a review of the .5 degree glide path and the 3.5 feet per minute decent rate. Should this prove to be unacceptable, amend the above parameters to ensure structural integrity following a ditching or forced landing on water.

Ensure that the assumptions of the aircraft certification procedures are incorporated into flight operations procedures for that aircraft. This will help to protect the structure following a ditching or forced landing on water.
