August 7, 1998

# Submissions Supplement USAir 737-300

Accident Near Pittsburgh  
9 September 1994

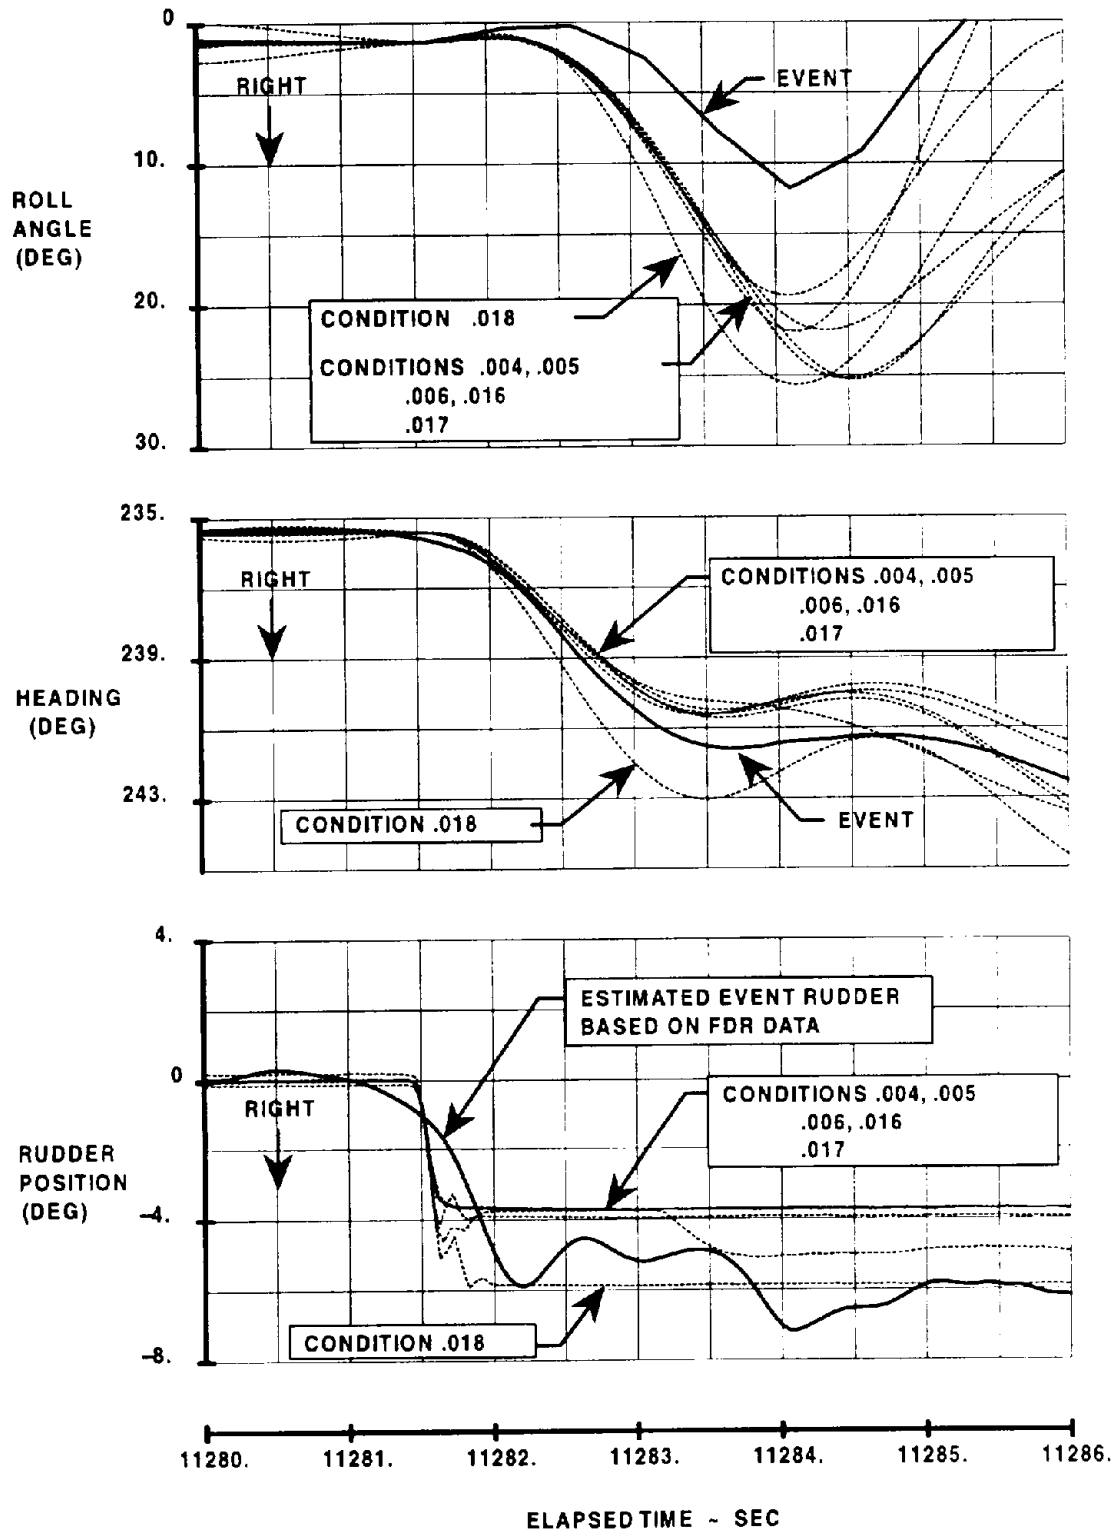
- The rudder deflection required to produce the recorded upset *could not have been generated by yaw damper activity alone*. This is apparent in Figure 2 (page 19), which shows the event data compared to several yaw damper hardover test conditions and a 6-degree rudder step. The event heading change is greater than the change recorded during the yaw damper hardovers. Note that the event bank angle is not consistent with the flight test data because of recovery wheel commands during the event. Correcting for the difference in bank angle between the event and flight test conditions would increase the heading change during the event.

**Comparison of Airplane Roll and Yaw Response for Eastwind Event Vs. Various Flight Test Rudder Steps**
