## **MARINE SAFETY ALERT**

Safety Alert 17-16

#### **MAN B&W Cooling Jacket Failures** **Using the correct bolts is essential!**

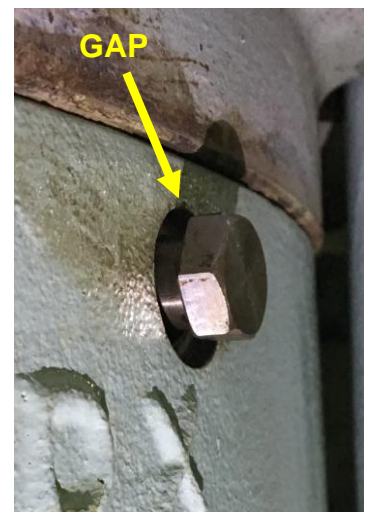
By design, the shoulders of these bolts are longer than the cooling jacket wall thickness. New replacement bolts will often have even longer shoulders. When the bolts are properly tightened there will likely be a gap between the bottom of the bolt head and the outside of the jacket cover. (Image A) The extra shoulder length allows the cooling jacket to position itself concentrically on the bottom of the cylinder cover and facilitate any movement or slight expansion of the o-rings. It also allows for some expansion of the cast iron cooling jacket. If the cooling jacket is slightly positioned non-concentrically on the cylinder cover, some of the bolt head's bottom surface areas may appear as if the bolt is fully tightened against the outside of the jacket cover.

*Image A: Properly secured cooling jacket bolt.*

- Owners, managers and operators ensure that their vessel engineering staffs have access to all available manufacturer service letters for propulsion, electrical generation, steering and other critical equipment; and
- Senior engineering personnel on vessels with MAN B&W MC-C and other similarly constructed engines using the same cooling jacket cover securing method *review* the applicable maintenance procedures and ensure that persons assembling these components know that the shoulder bolts may not butt up against the cooling jacket cover, as breakage may occur if forced, and that regular bolts with no shoulders should never be used.
