November 11, 2016

Senior Hazmat Accident Investigator
National Transportation Safety Board
490 L'Enfant Plaza East, SW
Washington, DC 20594

SUBJECT: Ultrasonic Inspection of AXLX1702 B-end stub sill pad weld termination

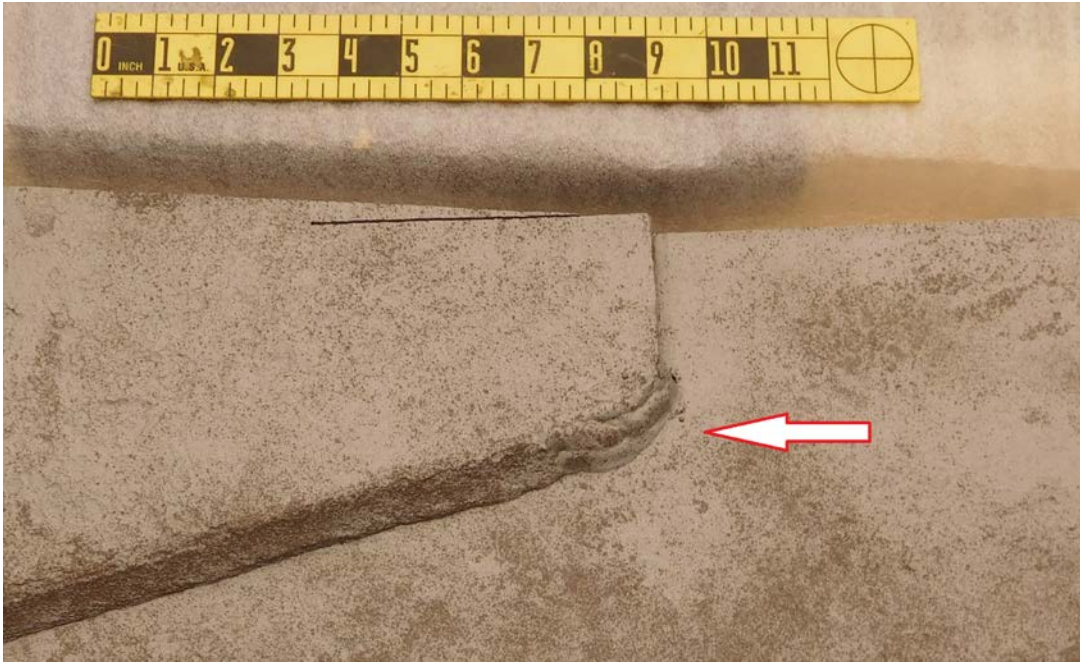
FIGURE #1

After distance and sensitivity calibration was completed the plate was scanned adjacent to the fillet weld termination for linear indications at the fillet weld to tank shell "toe" weld (see Figure 1). Surface condition of the scanned area was ground smooth with approximately 1" band of corrosion remaining adjacent to the weld. Scanning was performed in both the 1st and 2nd leg of the UT beam. An indication was observed at weld to tank toe in the 2nd leg of the UT beam. The indication height did not exceed the reference dB DAC curve and was approximately 80% of the DAC curve. The length was approximately .750" at a depth of about .100". It was determined that the indication was an undercut at the toe of the fillet weld to tank shell.

After scanning of the subject component, it was determined the indication observed by UT was the visual undercut at the toe of the fillet-to-tank-shell weld.

AXLX1702 B-end Stub Sill Pad Weld Termination UT Scan Area
