<h1>FRACAS</h1> <h2>Failure Analysis Report</h2>	DATE: November 11, 2015	
		FAR0211 Rev. A	Page 1 of 27
		PROGRAM: Phenom 300	
		TSN: - MFG DATE: 02/11	
		Customer: Embraer PO Number:

Customer P/N (Assy): -	Umbra P/N (Assy): 09762P000-03
Nomenclature: Gust Lock Actuator	Serial Number: 00075 (see photo 1)

**WORK TO BE CARRY OUT:**  
 Inspection required following an Accident/Incident Notification from NTSB (Figure 1).

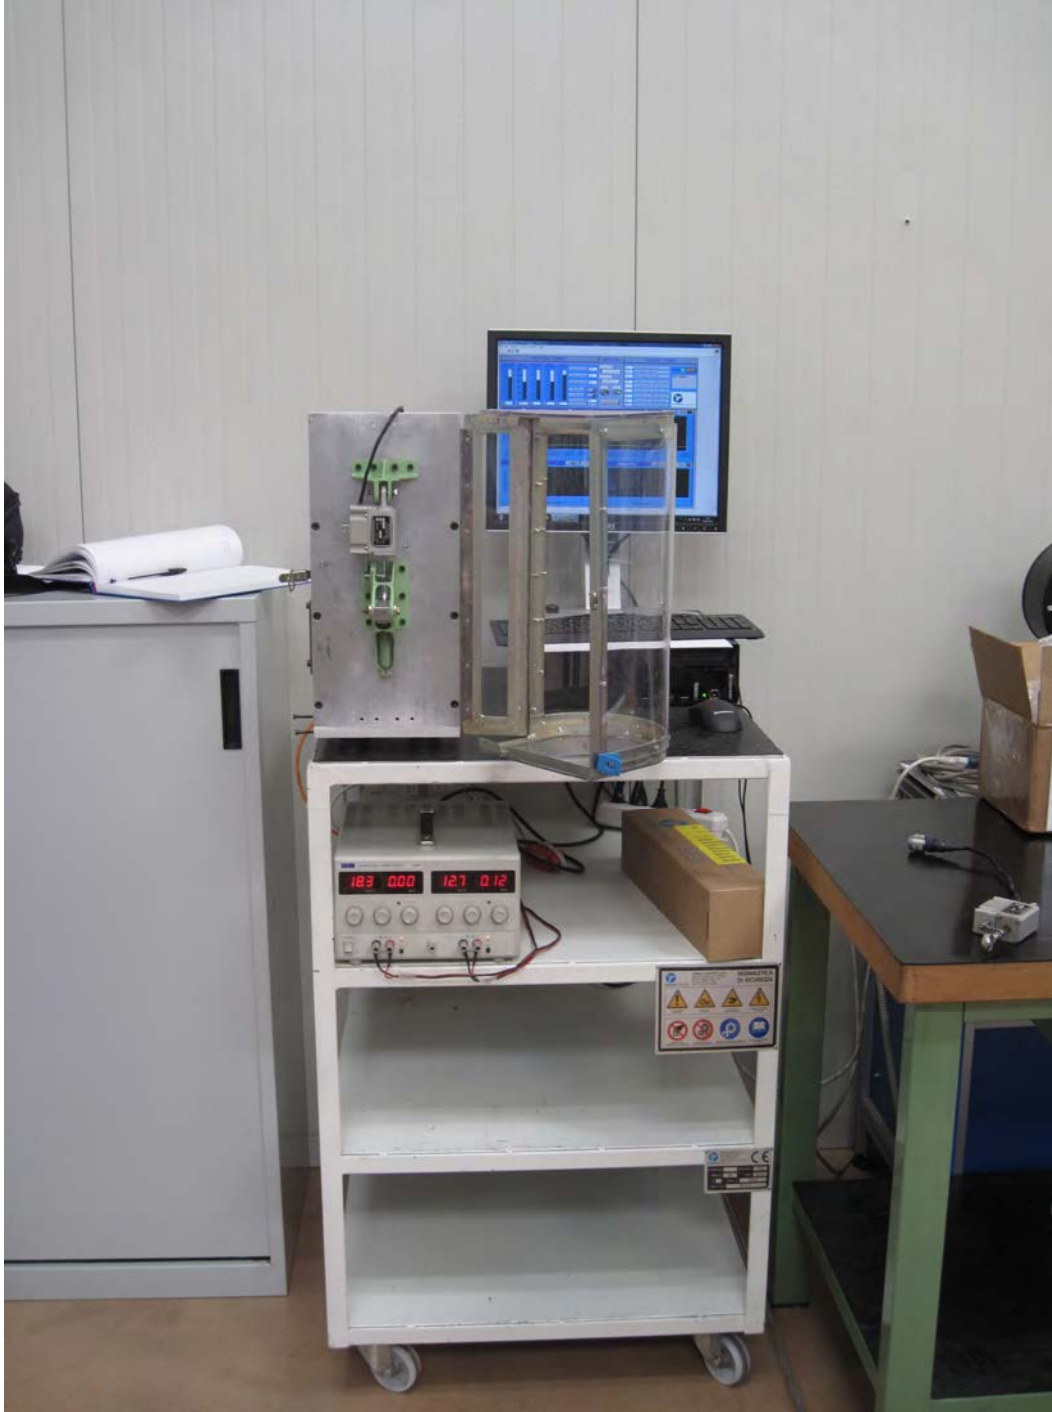
Photo 2 Gust Lock Test Rig  
(a new Actuator is installed)

<p><b>DIMENSIONAL CHECKS / VISUAL INSPECTION</b></p> <p><b>Check of pin to pin distance</b>  <b>Scope</b>  To verify if the Actuator is at its end stroke position or locked in an intermediate one.  <b>Check</b>  The Actuator has been installed in the test rig (see photo 2 and 3), which is tuned at the correct pin-to-pin distance, and it was not possible to insert the Pin 2 because the Actuator length is shorter than required. Measurements of the rod end in respect of the Actuator body confirm the pin-to-pin distance is shorter in respect of the full-extended position (i.e. 6.8 mm shorter, 29.2 vs. 22.4 mm, new and 00075 unit respectively). The minimum stroke is 25.4 mm. See photos 4, 5, 6 and 7.  <b>Result</b>  The Actuator is locked in a position closed to the extended one.</p>
---

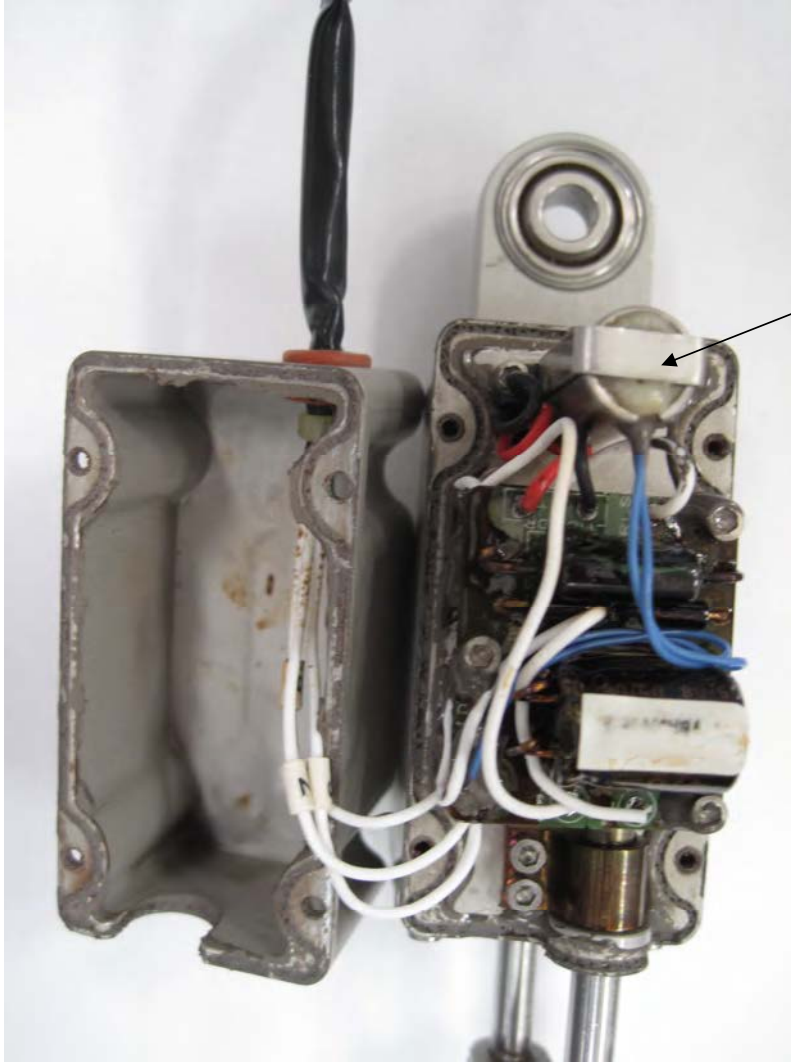
Photo 8

<p><b>DISASSEMBLY</b></p> <p><b>Disassembly</b>  <b>Scope</b>  To identify the cause of Actuator seizure.  <b>Check</b>  The Actuator was coupled to the test rig supply and management system and when operated did not move even if the max current at rated voltage was supplied.  The Actuator cover (see photo 8) was removed and then the solenoid/locking system. The electronic board was moved on side but kept connected. The cam, which actuates the microswitch, is closed to the microswitch actuating lever but does not operate it. See photo 9.  The solenoid was not disassembled. The solenoid/locking system is found locked at extended position or close by (i.e. the locking system engages the ballnut/screwshaft preventing the rod end to move). See photo 10 and a sketch of the solenoid section, figure 4. The reel function is to guide the Pin that, pushed by the solenoid spring, engages the ballnut and locks the screwshaft/rod in position. The Pin resulted to be sized inside the solenoid body, likely due to distortion of the plastic reel heated. The Pin position was closed to the full extension. Measurement of the exact position was prevented by pin misalignment due to distortion of the solenoid plastic reel. The functionality of the microswitches was checked with positive result. Even if with the solenoid/locking system removed the Actuator did not move electrically, even if the max. current at rate voltage was supplied, and manually as well (the load applied was not measured but a new unit would have moved under such load).  The cap was then removed and the ballscrew was moving freely. See photos 11, 12 and 13 and a section of the actuator section, figure 5. The Cap is the seat of a bearing, preloads the bearing, is the seat of the dynamic seal and closes the actuator body. The Cap did not show any sign of interference with closed items. The resistance of the three windings have been found between 4.3 and 7.3 ohm, it means that the windings are not short because such figures are acceptable for a new motor. The motor brushes were not checked. The rotor OD shows signs of possible interference with the stator. See photo 14. The part measurements in three axial positions revealed that the gap between rotor and stator is per drawing (i.e. about 1 mm); if any contact between the two parts occurred that happened when the motor was hot. Such signs, which are not measurable, could have been even caused during handling of the rotor.  The bearings were found operative with no axial play.  <b>Result</b>  The Solenoid/locking system was found sized at approximately the full extended position.</p>

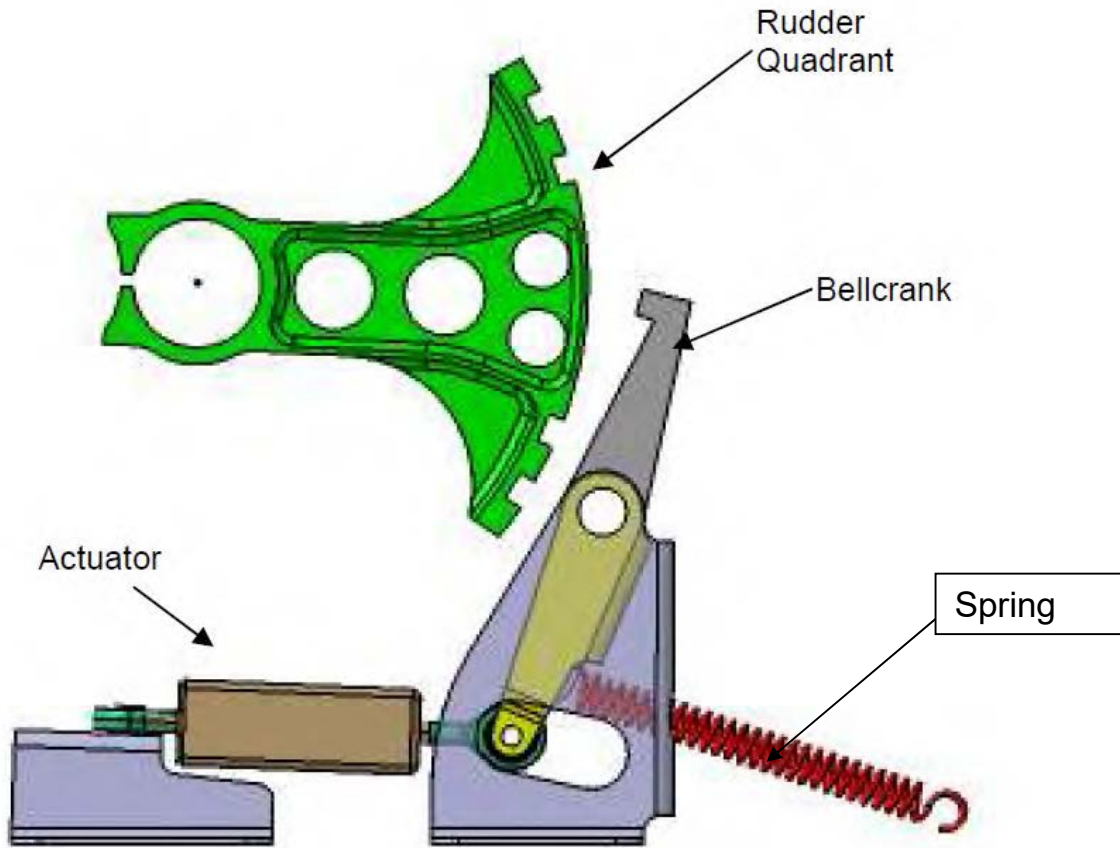
Figure 6

<p><b>ANALYSIS</b></p> <p>This investigation determined the following most likely failure scenario:</p> <ol style="list-style-type: none"> <li>The Actuator was commanded to retract and reached the retracted position but failed to keep such position under the load applied by the spring (see figure 6);</li> <li>The screwshaft/rod end extended under the load applied by the spring but, because the command to retract, the solenoid and the motor were supplied again until the retracted position was achieved over again;</li> <li>The sequence depicted in point a) and b) was repeated until the solenoid temperature reached a level such to deform the plastic reel and the winding failed open; the electric motor brushes failed as well;</li> <li>The screwshaft/rod end not locked by the solenoid/locking system and with the motor failed was pushed in the found position under the action of the spring;</li> <li>The high temperature reached by the solenoid, electric motor and other parts closed to those (i.e. bearings, antirotation rod), could have caused a misalignment of the screwshaft/rod and thickened lubricant; this fact can explain why the actuator did not move after the solenoid/locking system was removed but did it freely after the removal of the cap.</li> <li>From figure 38 of the report "<i>Embraer Phenom rudder gust lock actuator - CT factual report – final</i>" supplied by NTSB it seems that the solenoid/locking system is in a position such to engage the groove into the ballnut. It is likely that the locking system, under the force applied by its spring, reached such position while the actuator was cooling down.</li> </ol>

<p><b>COMMENTS</b></p> <ol style="list-style-type: none"> <li>The failed Actuator was found about 6.8 mm shorter – i.e. pin-to-pin distance - than a new Actuator in the extended position. Umbra is not in the position to determine if the bellcrank would be in contact with the quadrant in such Actuator condition (see figure 6). The personnel who assisted at disassembly of the Actuator from the A/C at PS Airport could confirm the respective position between the quadrant and the bellcrank. Embraer could answer to such question from design point of view.</li> <li>The Actuator design does not include any "unmistakable warning" of the engaged system. In rev. B (i.e. the latest) of Embraer's Technical Specification there is the requirement for an indication of the extended (i.e. engaged) position. A microswitch in the Gust Lock Actuator was provided to meet such requirement. Later (i.e. January 9th, 2009) Embraer requested Umbra to remove such microswitch. Dash number -03 was then generated and qualified. Dash number -03 is the only production actuator configuration provided by Umbra to Embraer. Umbra do not know if there are means in the whole gust lock system that provides unmistakable warning of the extended (i.e. engaged) position. Embraer could answer to such question.</li> <li>The solenoid and electric motor, according the technical specification, are not sized for a continuous duty cycle; the requirement is a cycle (extend and retract) per flight.</li> <li>There are no safety requirements for the Actuator: it is a single point failure item;</li> <li>The contact in flight of the bellcrank with rudder quadrant in the circumferential area within the indentures, due to a failure of the Actuator, cannot cause the lock in position of the rudder;</li> <li>During the meeting on June 16<sup>th</sup> 2015 in Foligno, Embraer, on the contrary of what is defined into the component technical specification, reported that the quadrant has two indentures instead of four and the indenture position can be reached during the flight if commanded by the pilot.</li> </ol>				
<table border="1"> <tr> <td> <b>Analysis:</b>  Marco Nardeschi  <b>Engineer</b> </td> <td> <b>Date:</b>  11/11/2015 </td> <td> <b>Approval:</b>  Luciano Pizzoni  <b>V.P. Engineering</b> </td> <td> <b>Date</b>  11/11/2015 </td> </tr> </table>	<b>Analysis:</b> Marco Nardeschi <b>Engineer</b>	<b>Date:</b> 11/11/2015	<b>Approval:</b> Luciano Pizzoni <b>V.P. Engineering</b>	<b>Date</b> 11/11/2015
<b>Analysis:</b> Marco Nardeschi <b>Engineer</b>	<b>Date:</b> 11/11/2015	<b>Approval:</b> Luciano Pizzoni <b>V.P. Engineering</b>	<b>Date</b> 11/11/2015

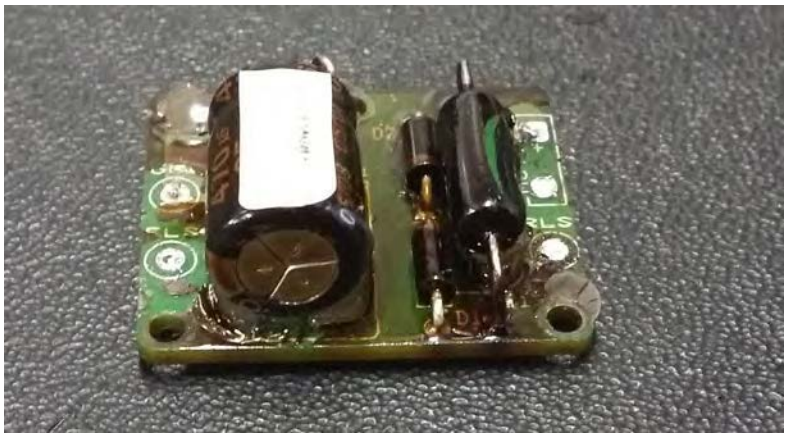
Photo 15

<b>WORK TO BE CARRY OUT:</b>
Inspection of the electronic board 09762P019-70 (see photo 15)

No evidence of mechanical failure on components and PCB. Surface coatings has been found damaged.

The electronic board 09762P019-70 works as expected.  
 No evidence of damage or failure has been noted.  
 The solenoid 09762P037-01 has been found with a high impedance at the coil terminal.

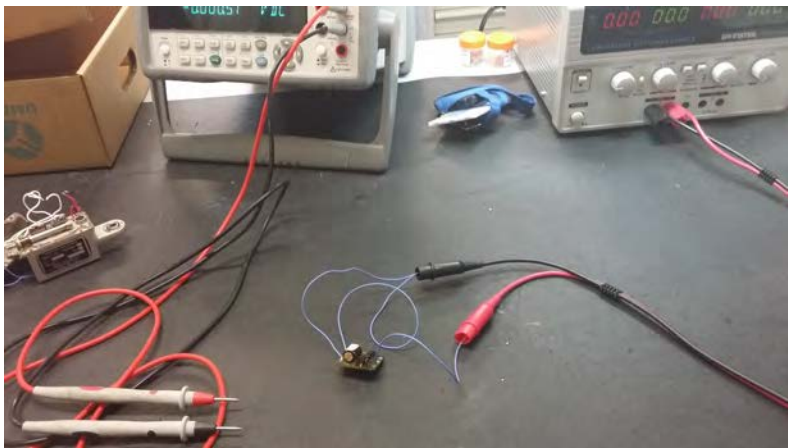
Photo 16

The test was performed according the test set-up below. See Photo 16.

Test #	Type of test	Test Condition	Expected results	Test results
Test #1	To retract configuration test	ELS → +12Vdc RLS → 0Vdc GND → 0Vdc	Voltage of 12Vdc at: • Solenoid terminals • Motor terminals	Passed
Test #2	To extend configuration test	ELS → 0Vdc RLS → +12Vdc GND → 0Vdc	Voltage of 12Vdc at: • Solenoid terminals • Motor terminals	Passed
