UNDERWATER INSPECTION AND EVALUATION REPORT

**PIER 1-B
ST. GEORGE FERRY TERMINAL
MAINTENANCE FACILITY
STATEN ISLAND, NEW YORK**

December 2003

Prepared by:
Atlantic Engineering, LLC
170 Kinnelon Road, Suite 21
Kinnelon, NJ 07405

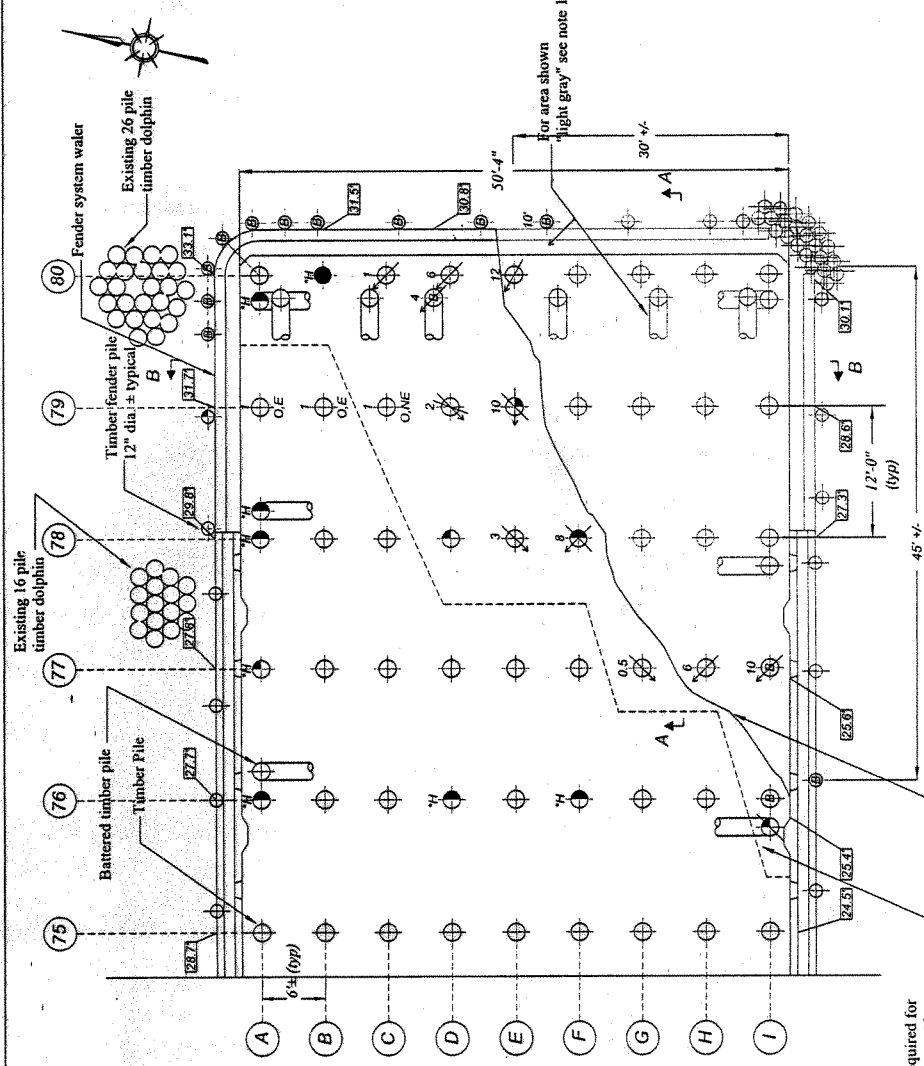
PILE/DECK DEFICIENCY PLAN
 Scale 1"=10'

Limits of deck removal required for repair of timber sub-structure. Note, additional slab may need to be demolished for deck reinforcing splice

Approximate location of broken concrete deck with entire SE corner section "hanging" from reinforcing

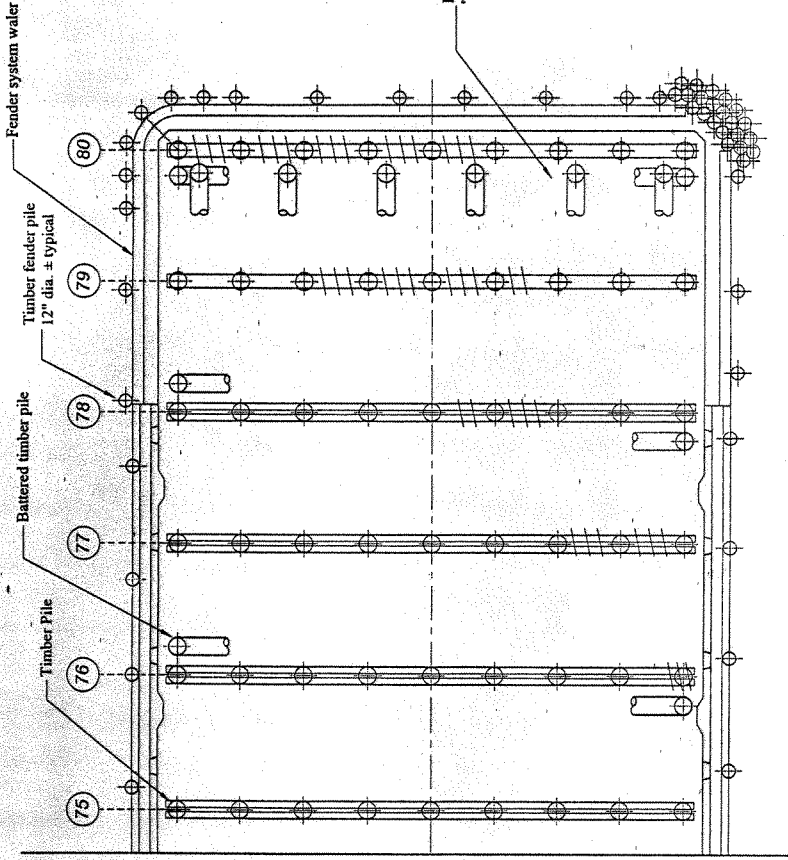
TIMBER PILE CAP DEFICIENCY PLAN

1. Some of the destroyed timber caps, piles, and bracing could not be safely inspected due to remnants of concrete deck above. Large concrete slab is "hanging" by deck reinforcing. Demolition and removal poses local stability issues. All elements broken.

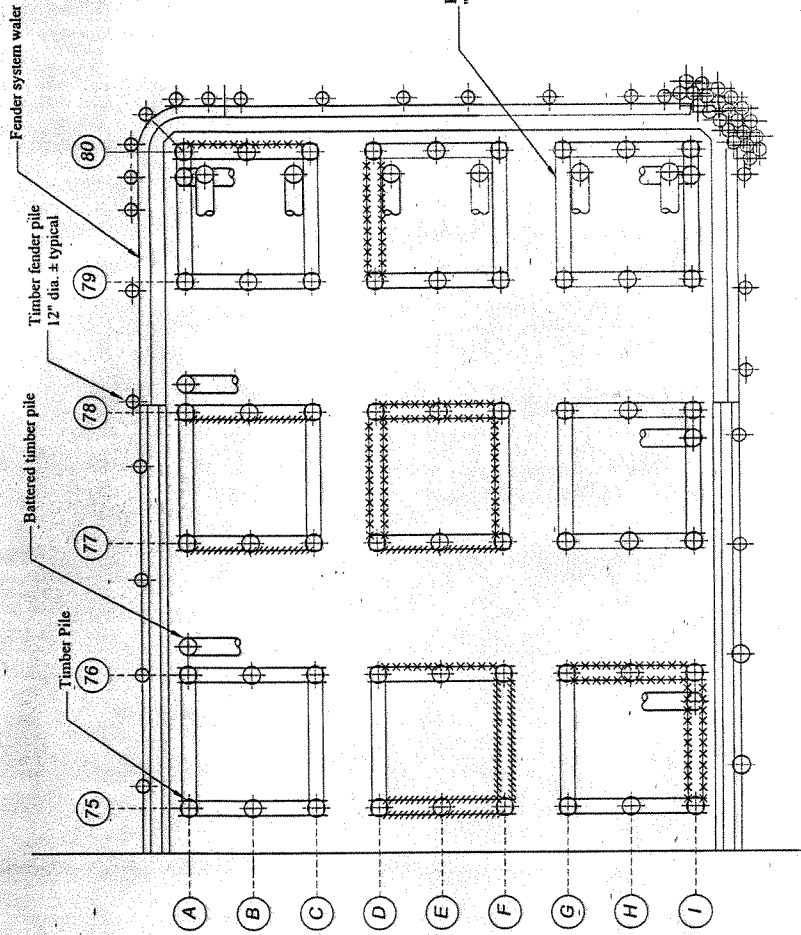
Diagonal Bracing Deficiency Plan
 Scale 1"=10'

1. Some of the destroyed timber caps, piles, and bracing could not be safely inspected due to remnants of concrete deck above. Large concrete slab is "hanging" by deck reinforcing. Demolition and removal poses local stability issues. All elements below are considered to be broken.

2. Lower bracing and lower end of diagonal bracing typically exhibits minor deterioration with rot, marine borer activity and moderate corrosion of the hardware.

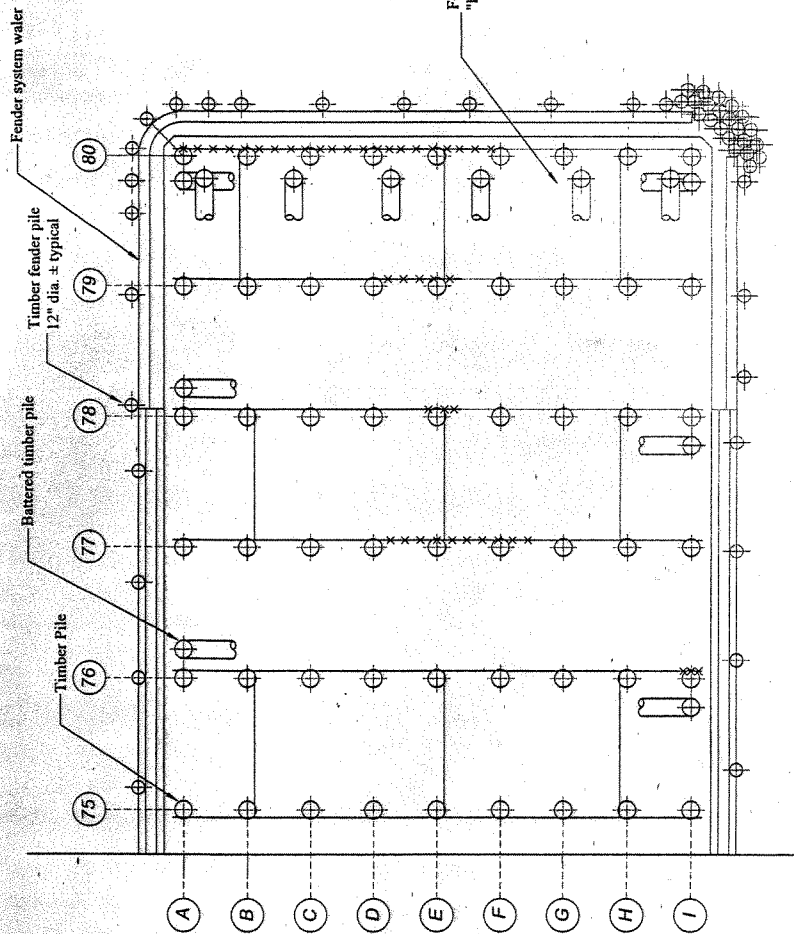
LOWER BRACING DEFICIENCY PLAN
 Scale 1"=10'

1. Some of the destroyed timber caps, piles, and bracing could not be safely inspected due to remnants of concrete deck above. Large concrete slab is "hanging" by deck reinforcing. Demolition and removal poses local stability issues. All elements below are considered to be broken.
2. Lower bracing and lower end of diagonal bracing typically exhibits minor deterioration with rot, marine borer activity and moderate corrosion of the hardware.

4 x 8 Horizontal lower timber bracing, see "Lower Bracing Deficiency Plan" for locations	4 x 8 Horizontal bracing is missing and assumed destroyed below the collapsed concrete deck.	Locate, remove, and replace 4 x 8 horizontal timber bracing.
4 x 8 Horizontal lower timber bracing, see "Lower Bracing Deficiency Plan" for locations	4 x 8 Horizontal bracing is broken due to impact damage.	Remove, and replace 4 x 8 horizontal timber bracing.
4 x 8 Diagonal timber bracing, see "Diagonal Bracing Deficiency Plan" for locations	4 x 8 Diagonal bracing is broken, <u>not</u> due to impact damage.	Remove, and replace 4 x 8 diagonal timber bracing.
4 x 8 Horizontal lower timber bracing, see "Lower Bracing Deficiency Plan" for locations	4 x 8 Horizontal bracing is broken, <u>not</u> due to impact damage.	Remove, and replace 4 x 8 horizontal timber bracing.

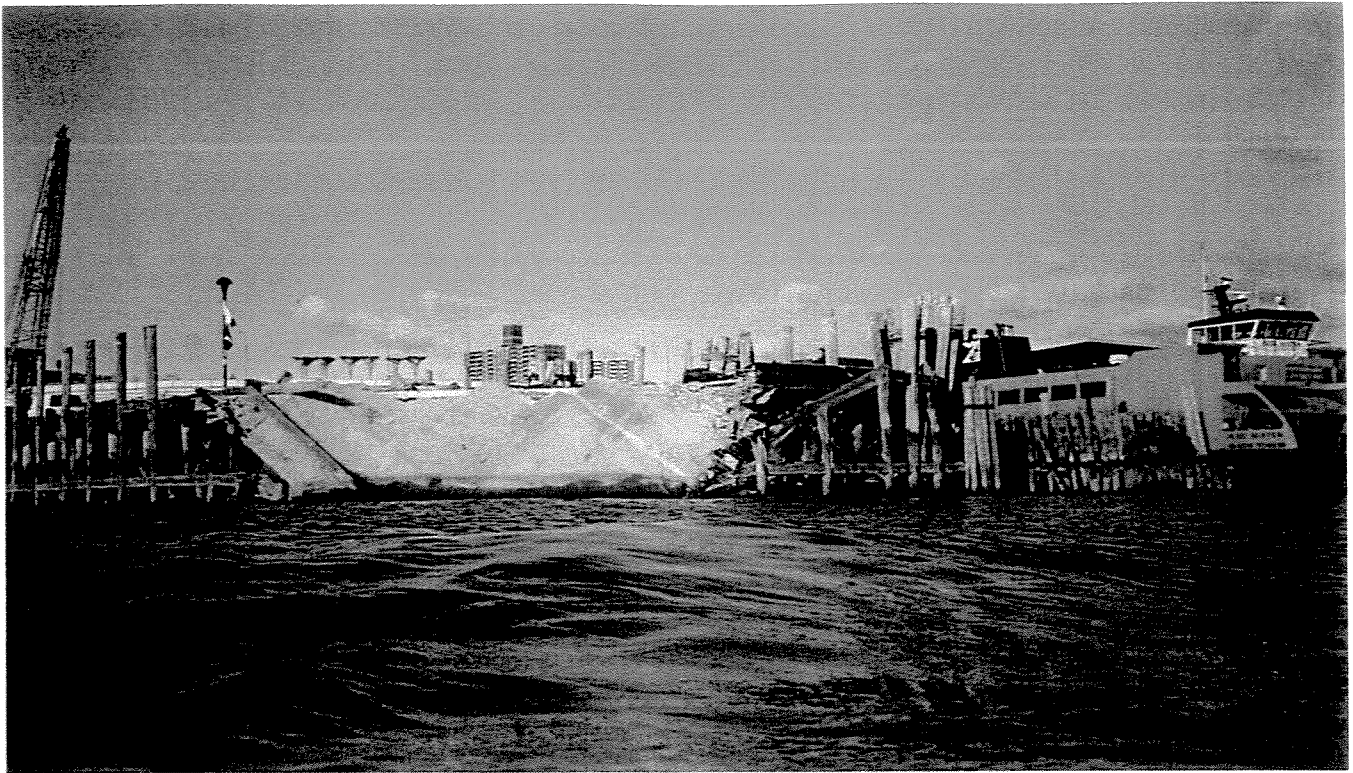
PHOTO 1 - General view of pier with collapsed SE corner, looking NW.

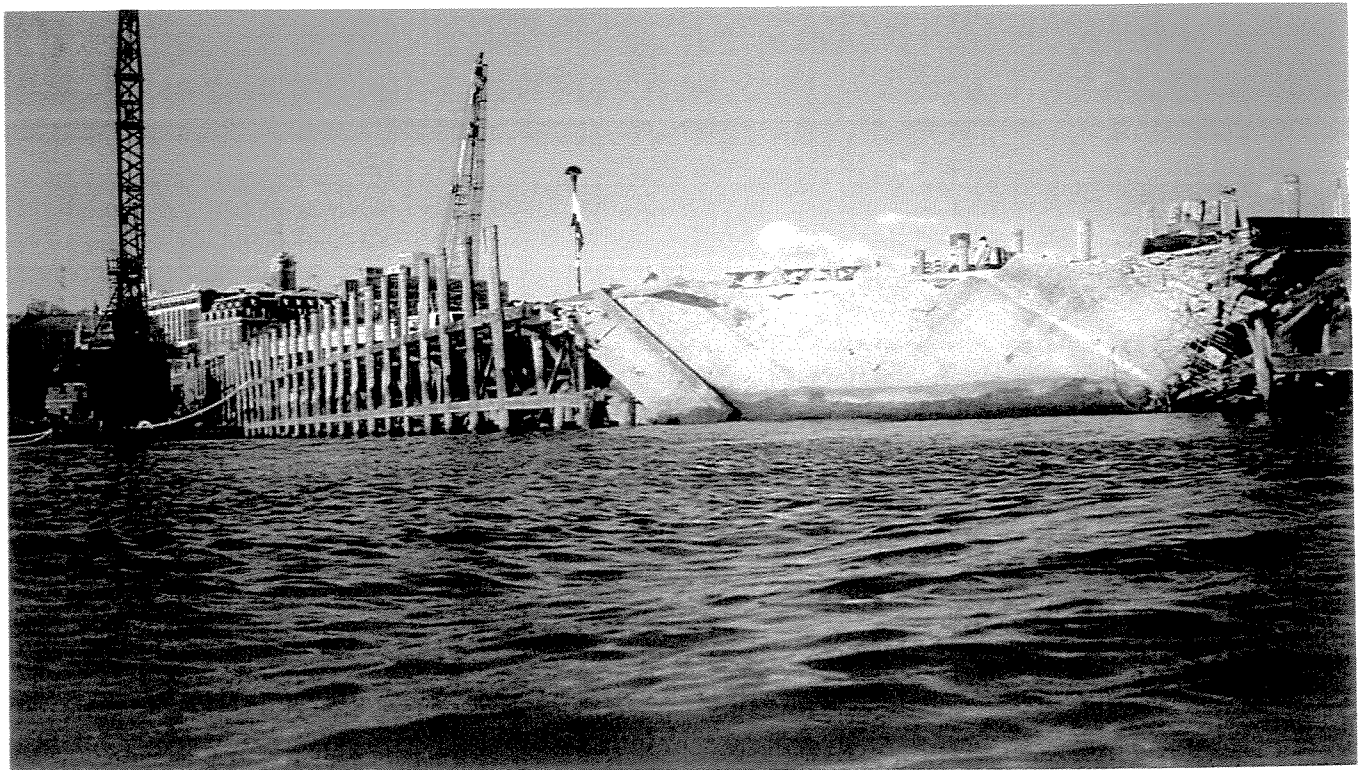
PHOTO 2 - General view of pier with collapsed SE corner, looking west.

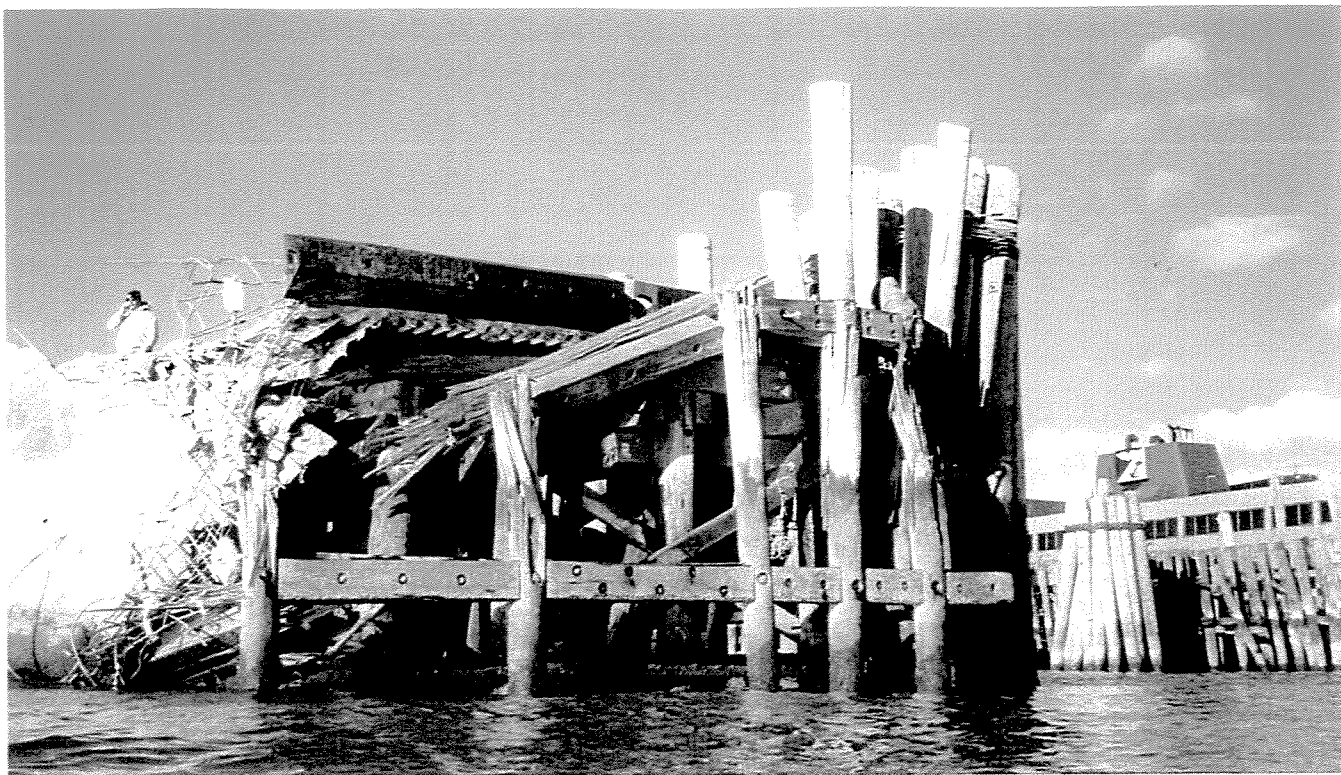
PHOTO 3 - East end of pier, approximately 20' along the east face remains erect at north end.

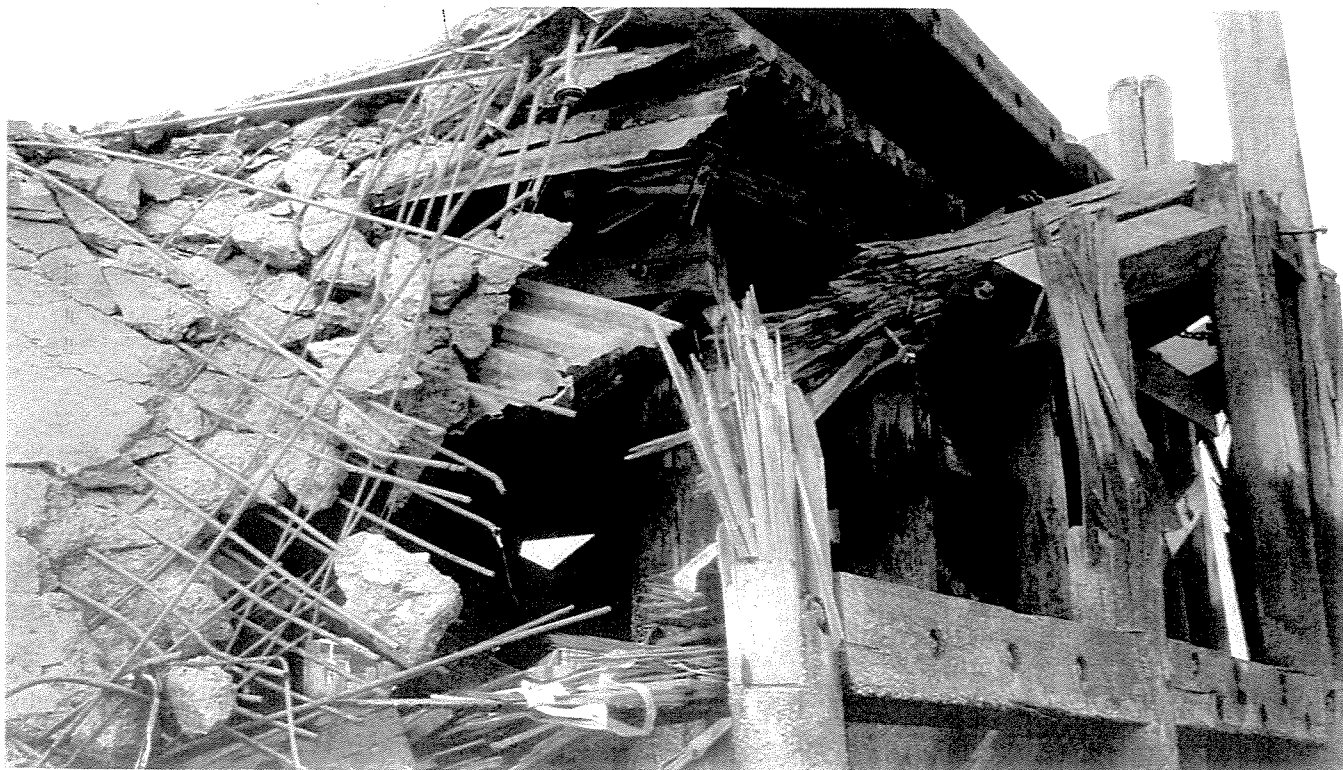
PHOTO 4 - East end of pier close-up view collapsed/erect interface, 20' south of the NE corner, looking NW.

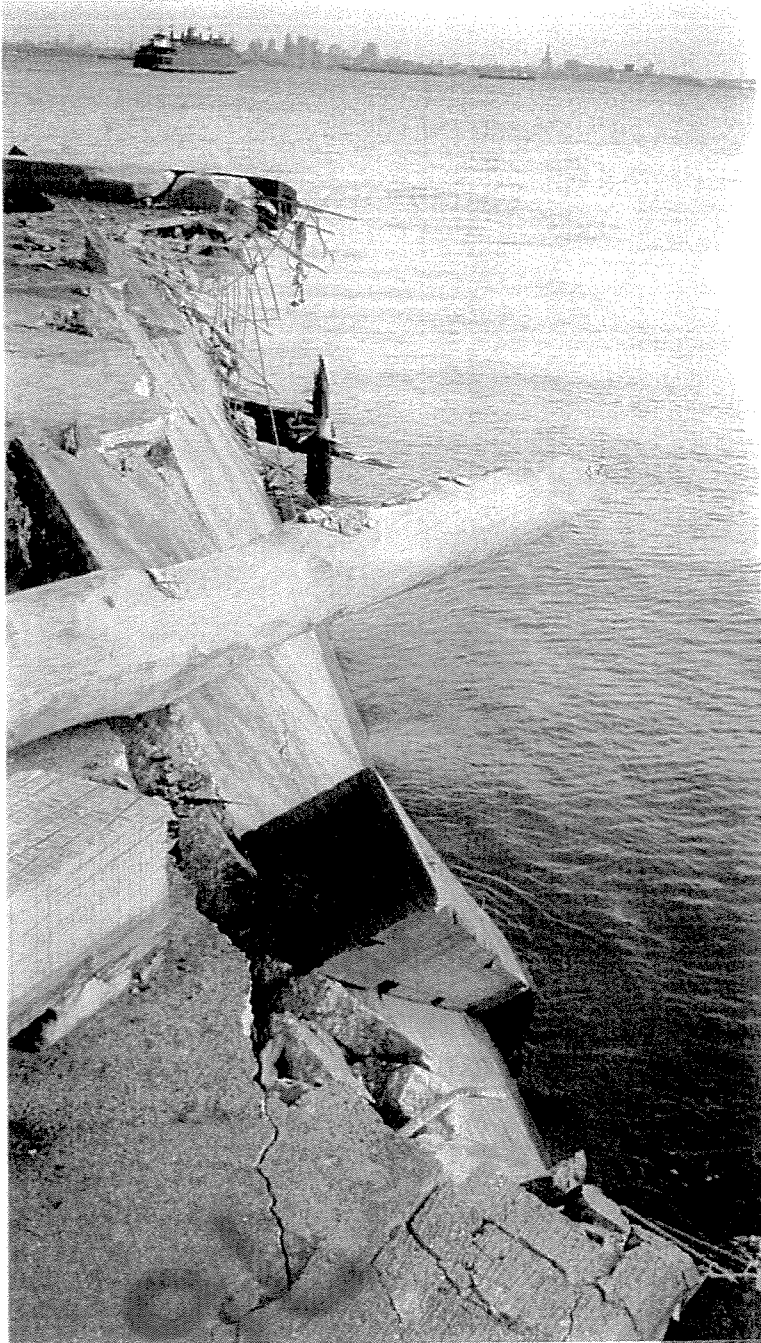
PHOTO 5 - Top side view of collapsed SE corner of the pier looking NE.

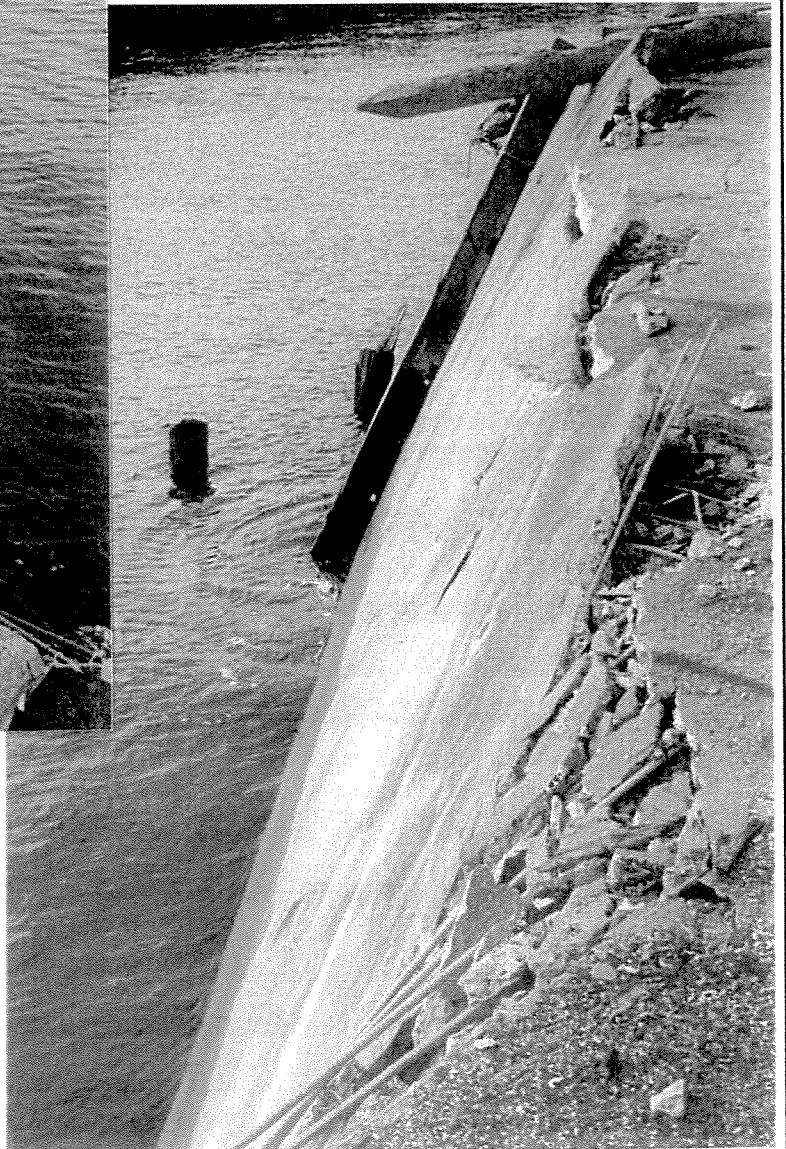
PHOTO 6 - Top side view of collapsed SE corner of the pier looking SW.

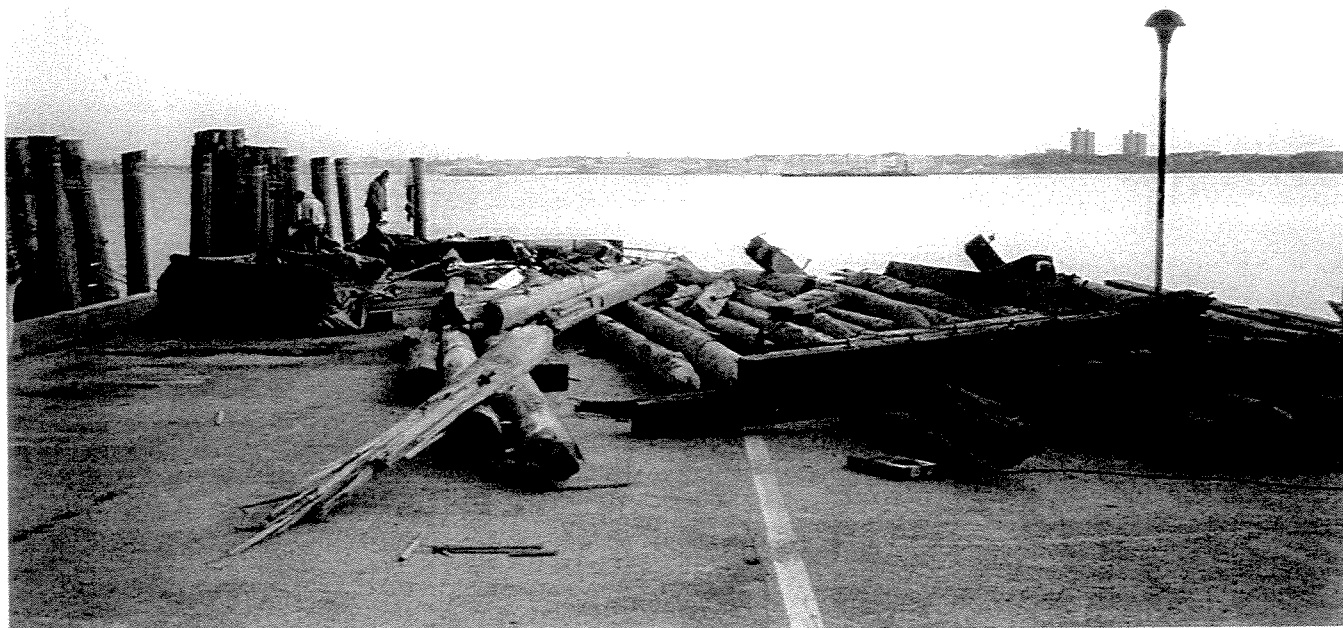
PHOTO 7 - Top side view with pulled fender system piles on top of the pier, looking east.

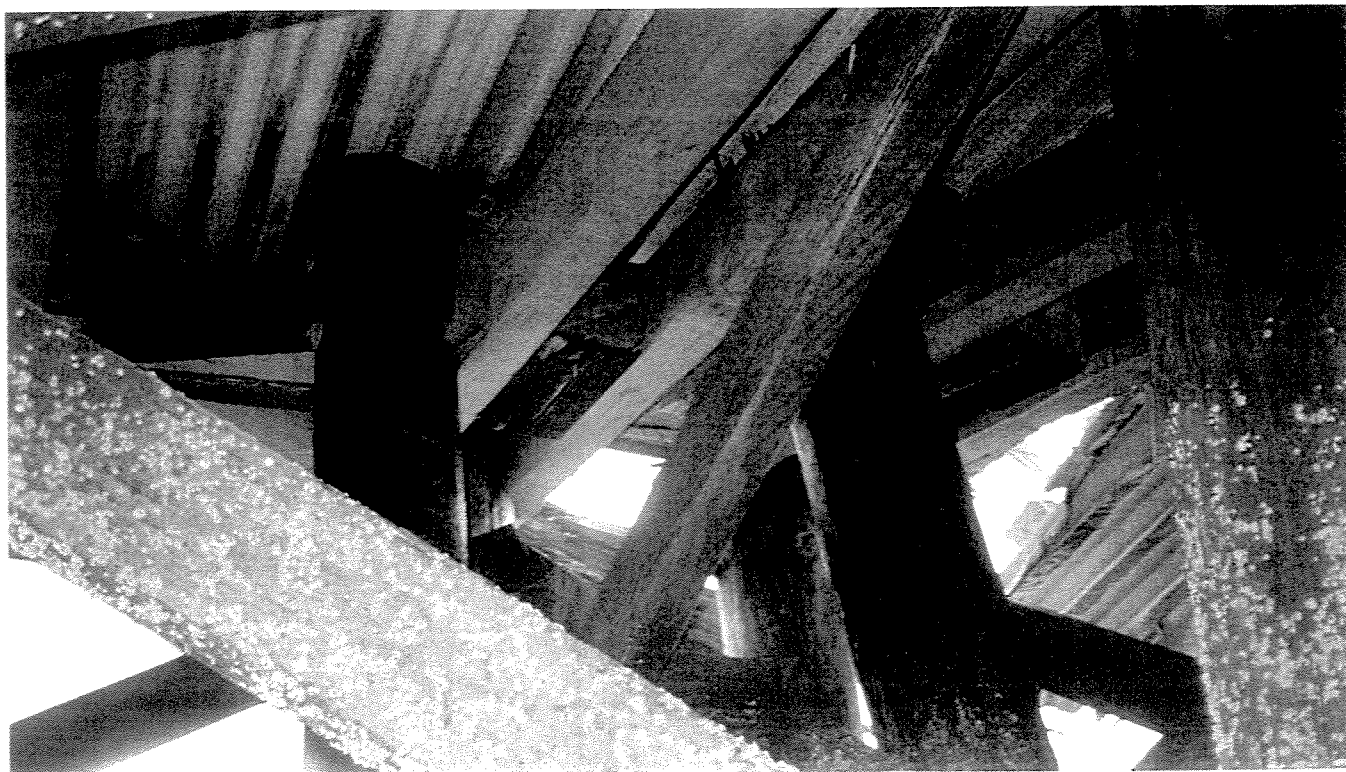
PHOTO 8 - Bent 80, piles "C" and "D" with "C-batter" and "D-batter" showing general configuration and construction. Note, top horizontal 6 x 12 bracing provides connection of battered piles to bent 80 and 79 vertical pile, looking SE.

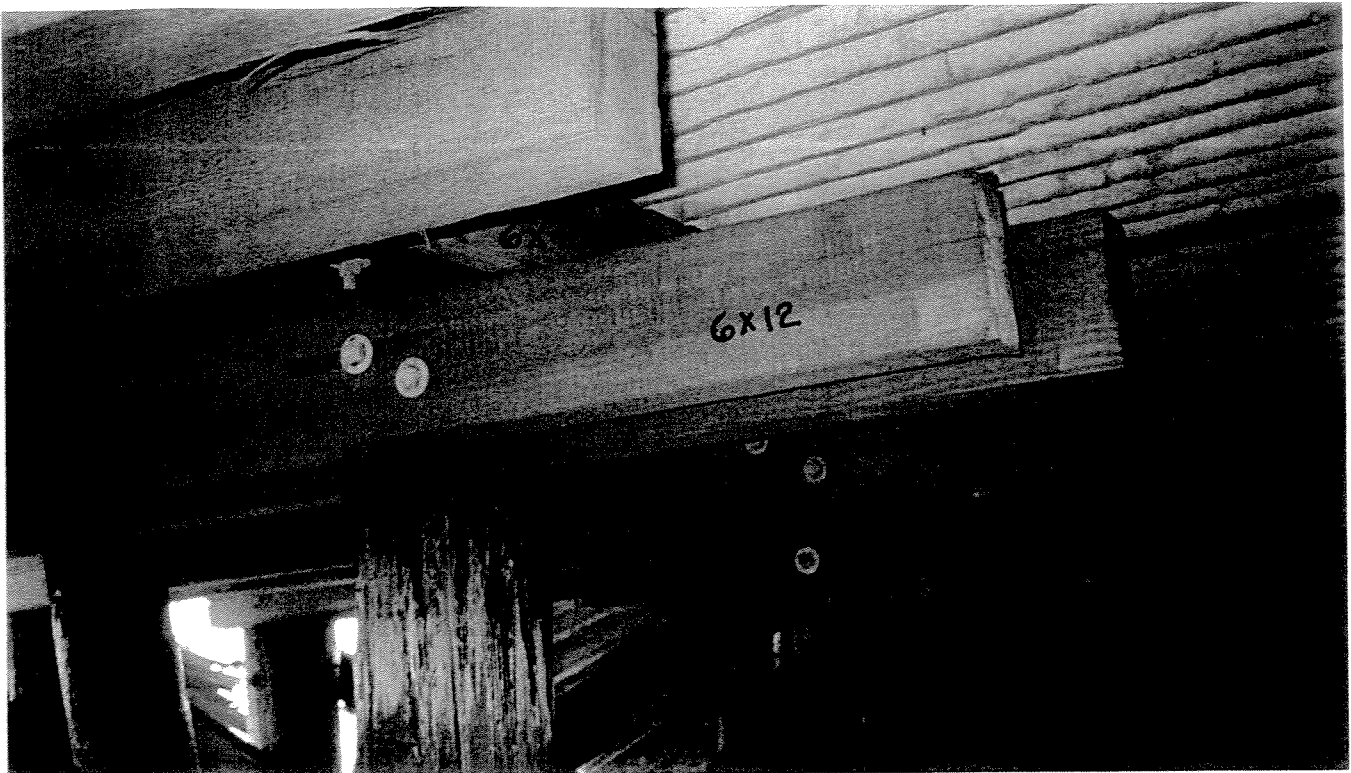
PHOTO 9 - Pile bent 79, pile "B" showing general configuration and construction. Note 6x 10 timber "sistered" to 12 x 12 cap acting as a ledger to support the corrugated steel deck form. Transverse 6 x 12 horizontal timbers serve as bracing and provide connection of battered piles at bent 80 (see photo 8) , looking SE.

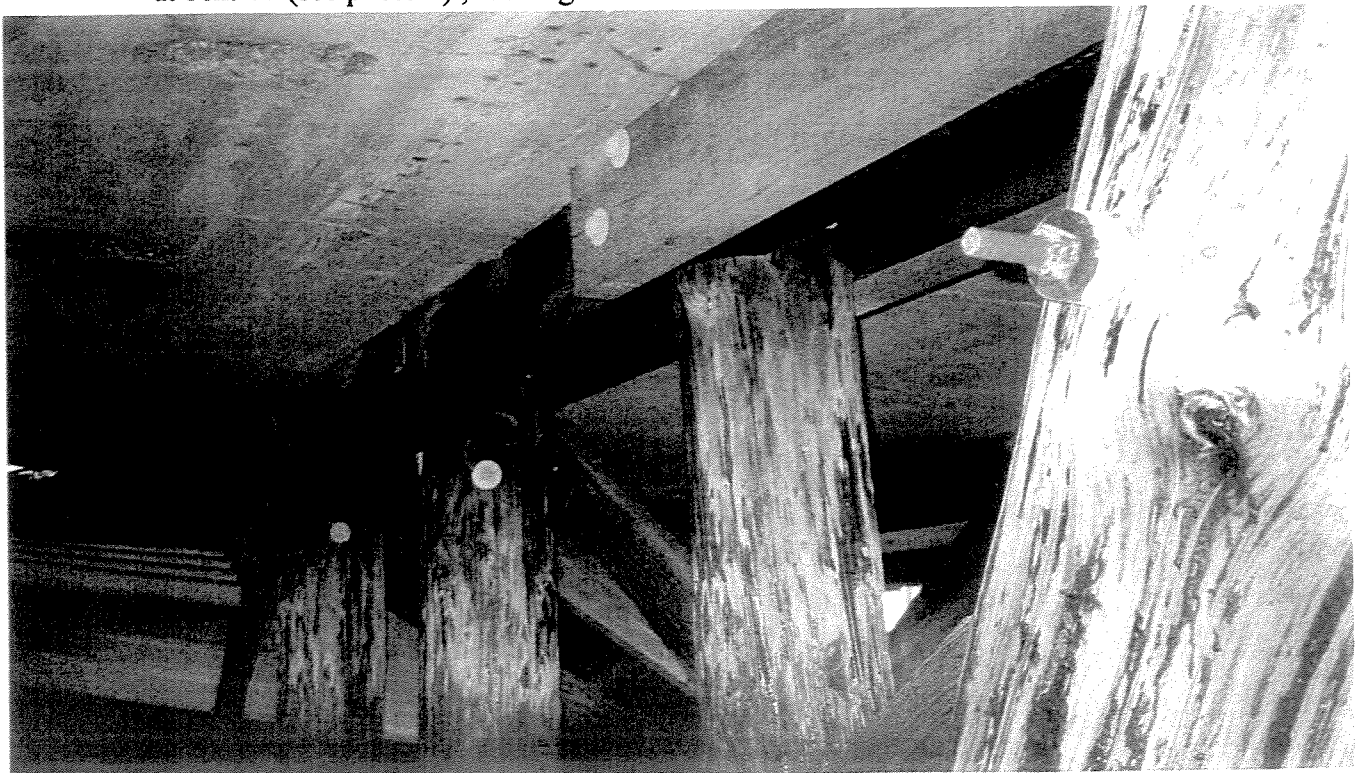
PHOTO 10 – Bent 78, piles "A-batter," to "D." Bent numbers 78 and lower have a dual 6 x 12 timber cap with a "sistered" 6 x12 from piles "B" to "A" and "H" to "I" providing a 2' long cantilever on the outside perimeter of the pier for support of the concrete deck above, looking SW. Refer to section.

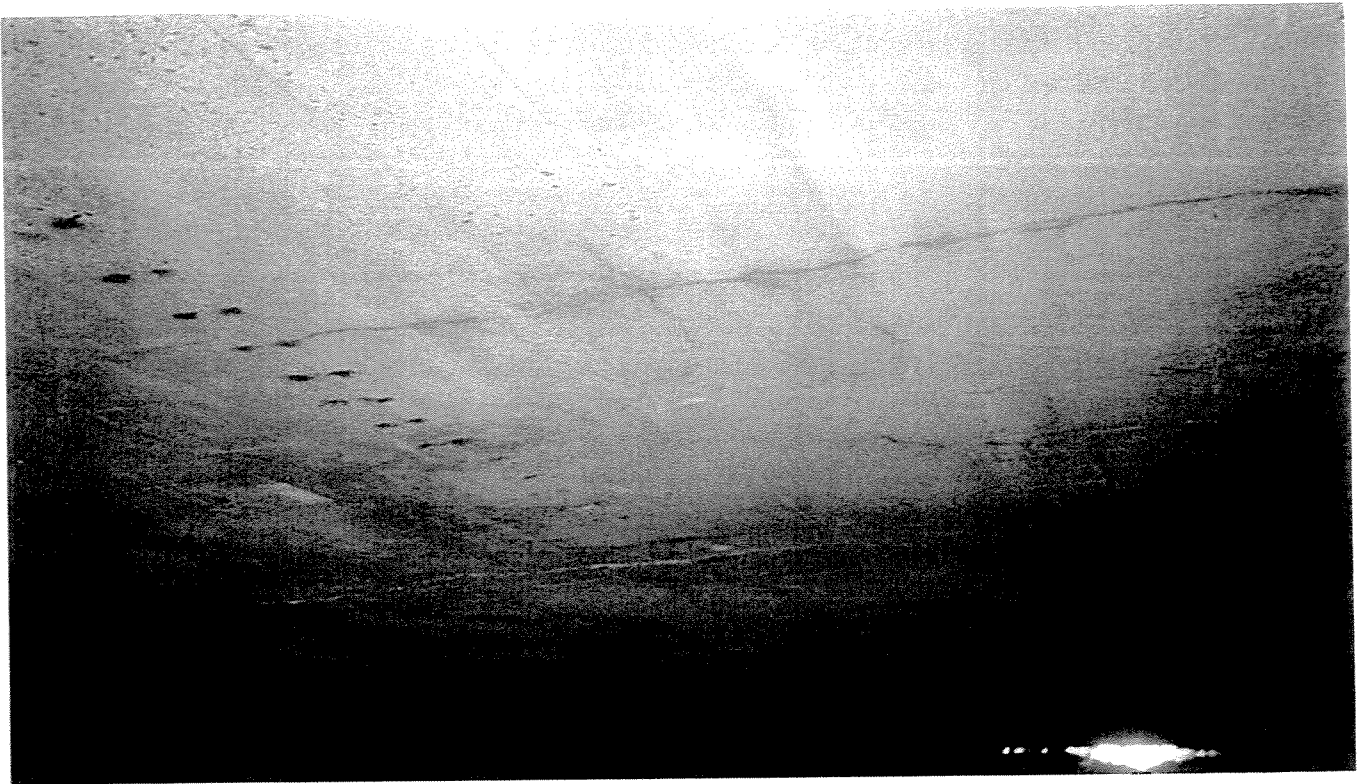
PHOTO 11 - Between pile bents 78 and 77 at north side of pier. General view of typical underside of concrete deck in satisfactory condition with several longitudinal cracks, looking SE.

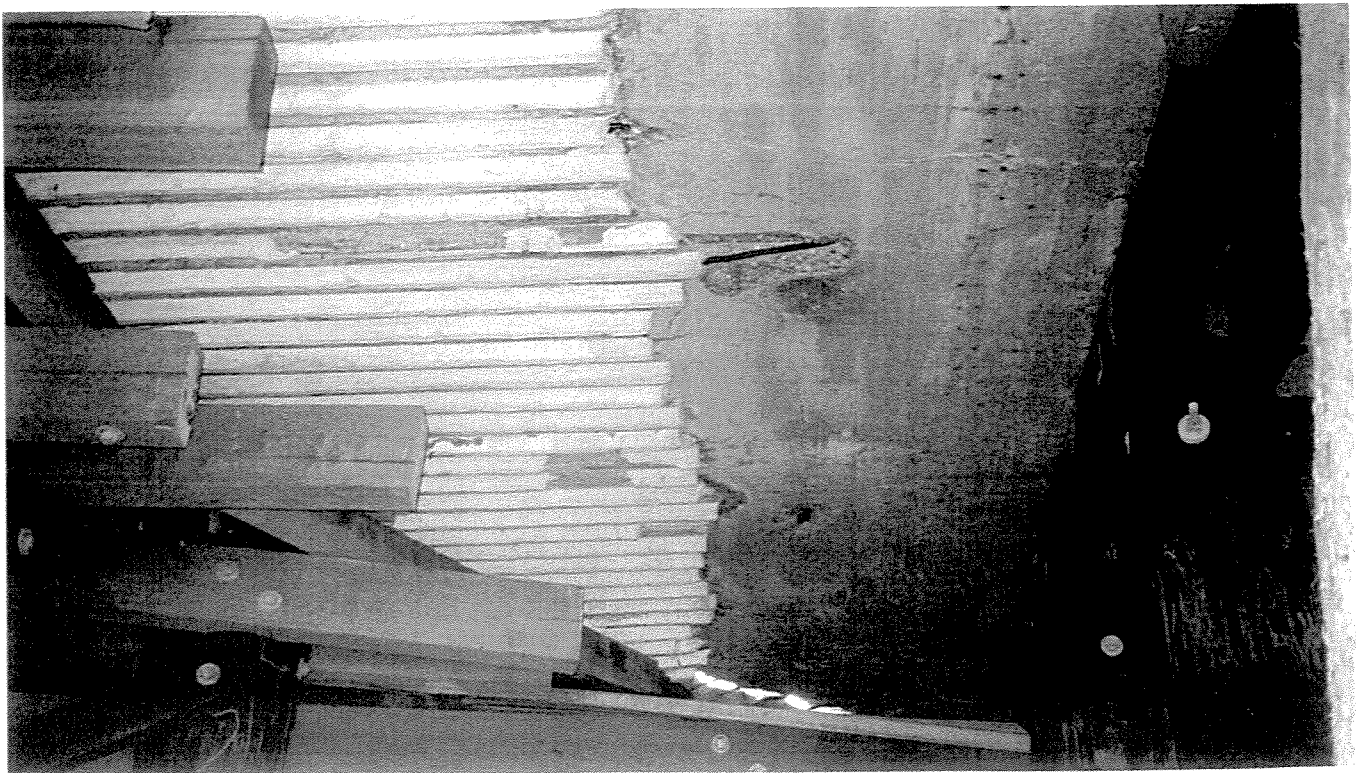
PHOTO 12 - Between pile bents 79 & 78, north side of pier. East side (left) formed with steel corrugated metal decking (gone). Note, deck flutes were packed with a foam filler still in place. West side (right) typical cast in place concrete deck with a few small spalls with exposed steel reinforcing, looking south.

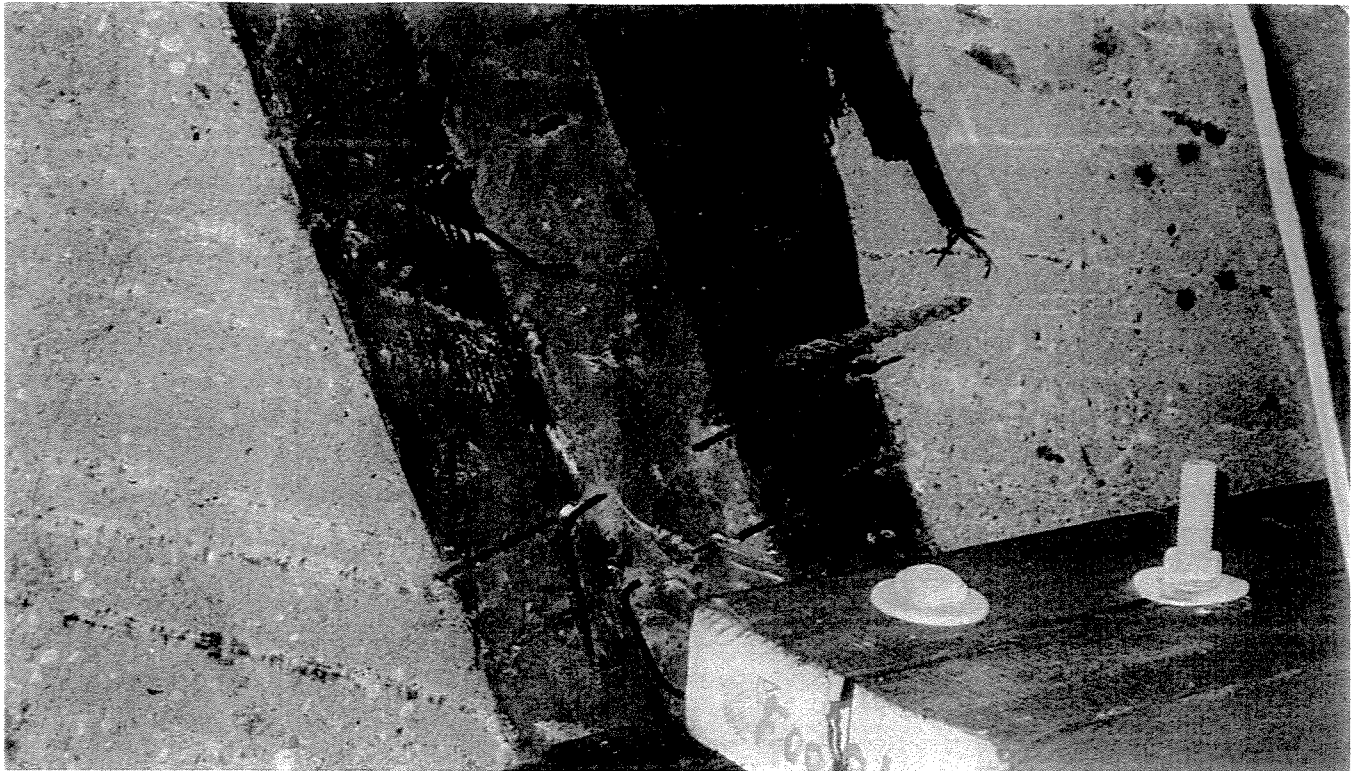
PHOTO 13 - Pile bent 78, close-up of collapsed deck showing 1/4" diameter steel "ties," sets of four (4) at 12" spacing. Steel ties assumed to have provided connection between concrete deck and timber pile cap, looking south.

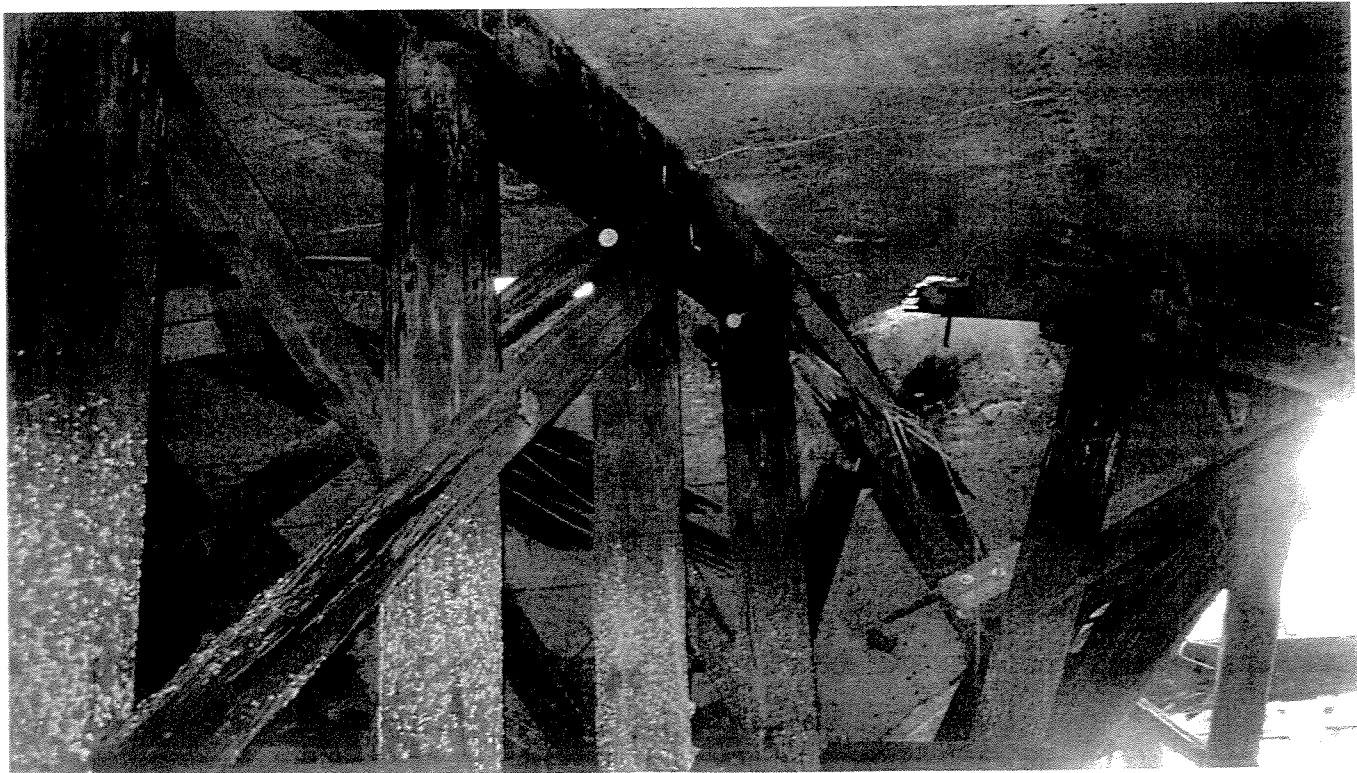
PHOTO 14 - Pile bent 77, general view of impact damaged, collapsed underside of pier. Piles "D" thru "I," timber cap beam broken south of "G" pile with severe displacement of "H" and "T" piles, looking SE.

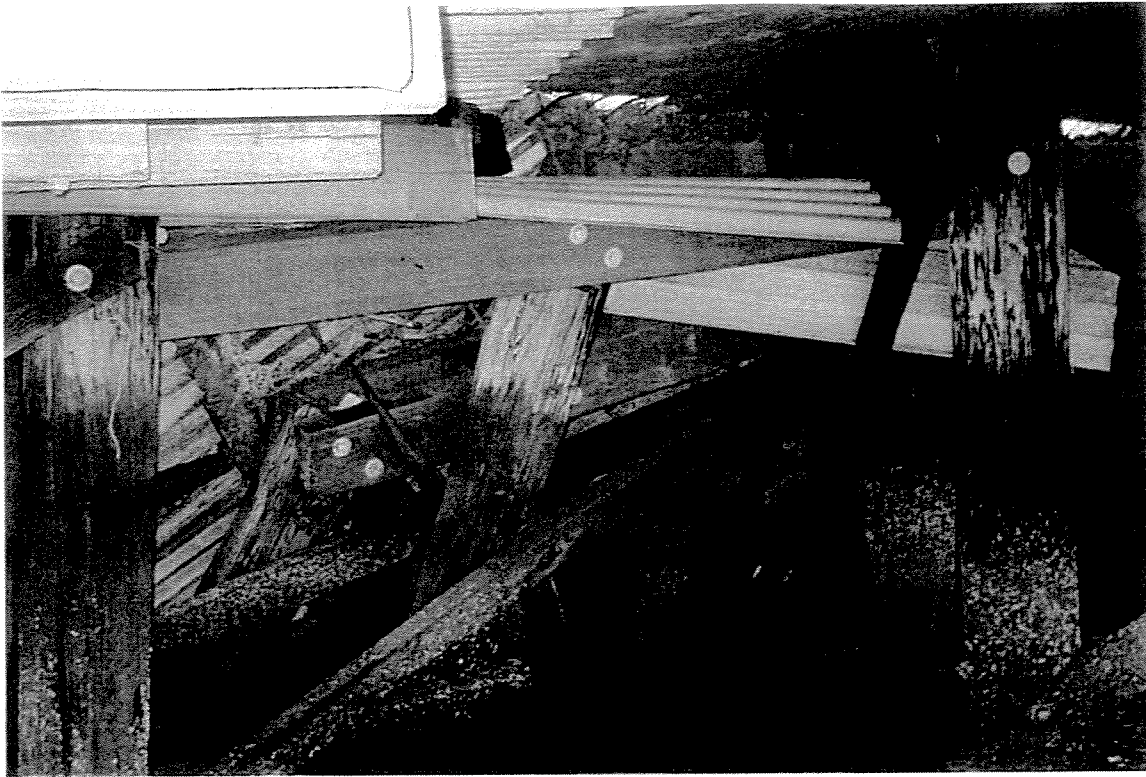
PHOTO 15 - Between pile bents 79 and 78 at the north side of pier. General view of collapsed area with severely displaced piles, looking south.

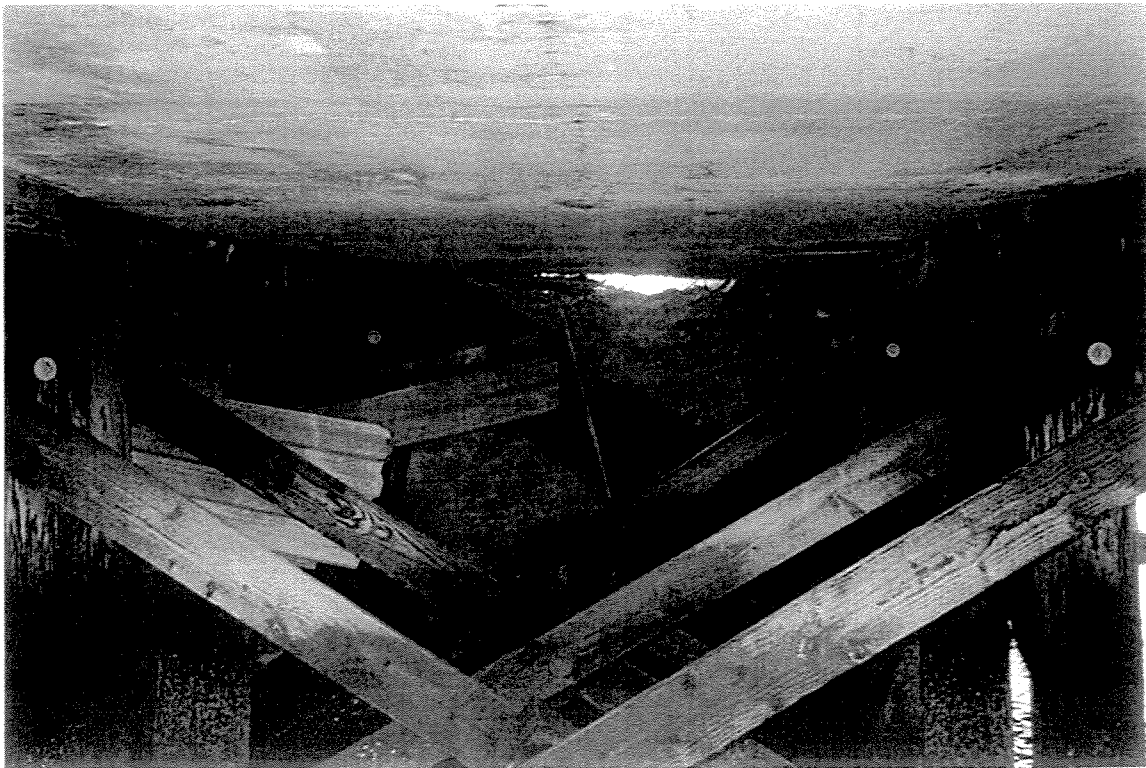
PHOTO 16 - Between pile bents 78 and 77 at the north side of the pier. General view of collapsed area with severely displaced piles and broken timber caps, looking south.

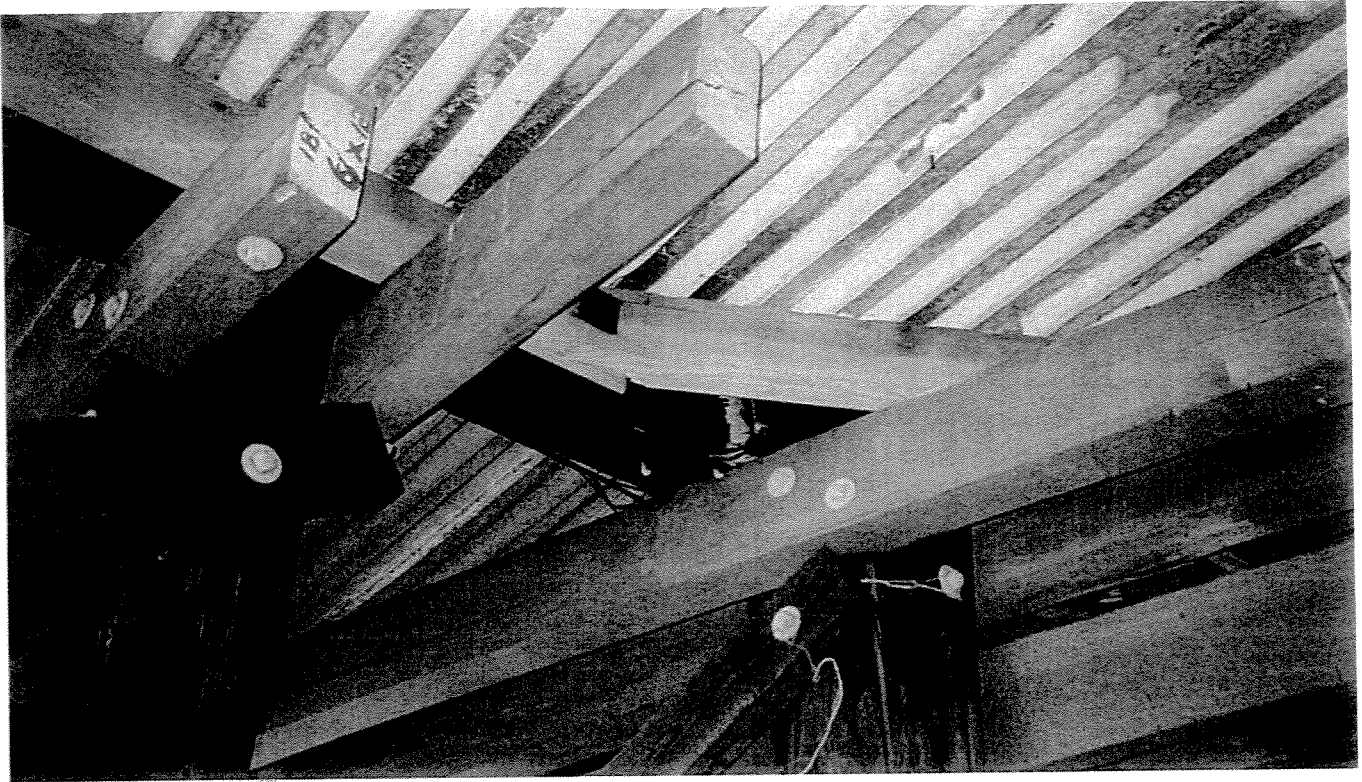
PHOTO 17 - Bent 79, pile "C" and "D." Note break in timber cap at "D" with split pile and rotation of 6 x 12 horizontal timber bracing, looking SE.

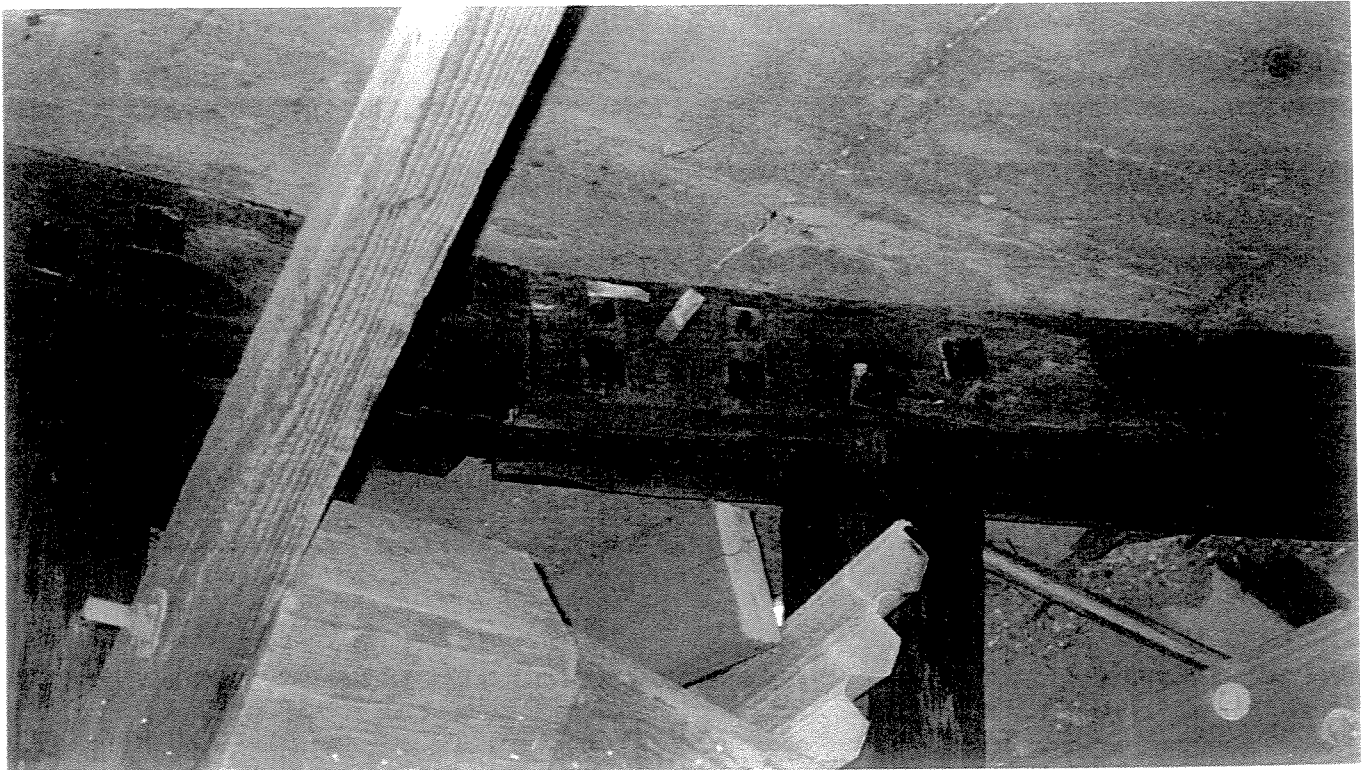
PHOTO 18 - Bent 78 piles "D" and "E," splice in timber pile cap beam with displaced "E" pile and broken cap. Timber cap to the north of the splice is satisfactory, looking SE.

Structural Element/ Location	Description	Recommendation
Dual 6 x 12 Timber Cap Beam Bent 78, "D" pile to "I" pile	(2) 6 x 12 Timber cap beam is broken or split due to impact damage.	Remove and replace timber cap utilizing existing splice at "D" pile.
Dual 6 x 12 Timber Cap Beam Bent 77, "D" pile to "I" pile	(2) 6 x 12 Timber cap beam is broken or split due to impact damage.	Remove and replace timber cap. Splice to good 6x 12 cap at "G" pile.
Dual 6 x 12 Timber Cap Beam Bent 76, 3 LF at "I" pile	(2) 6 x 12 Timber cap beam is broken or split due to impact damage.	Remove and replace timber cap. Splice to good 6x 12 cap at "H" pile.
4 x 8 Diagonal timber bracing, see "Diagonal Bracing Deficiency Plan" for locations	4 x 8 Diagonal bracing is missing and assumed destroyed below the collapsed concrete deck.	Locate, remove, and replace 4 x 8 diagonal timber bracing.
4 x 8 Diagonal timber bracing, see "Diagonal Bracing Deficiency Plan" for locations	4 x 8 Diagonal bracing is broken due to impact damage.	Remove, and replace 4 x 8 diagonal timber bracing.
