UNDERWATER INSPECTION AND EVALUATION REPORT

**PIER 1-B
ST. GEORGE FERRY TERMINAL
MAINTENANCE FACILITY
STATEN ISLAND, NEW YORK**

December 2003

Prepared by:
Atlantic Engineering, LLC
170 Kinnelon Road, Suite 21
Kinnelon, NJ 07405

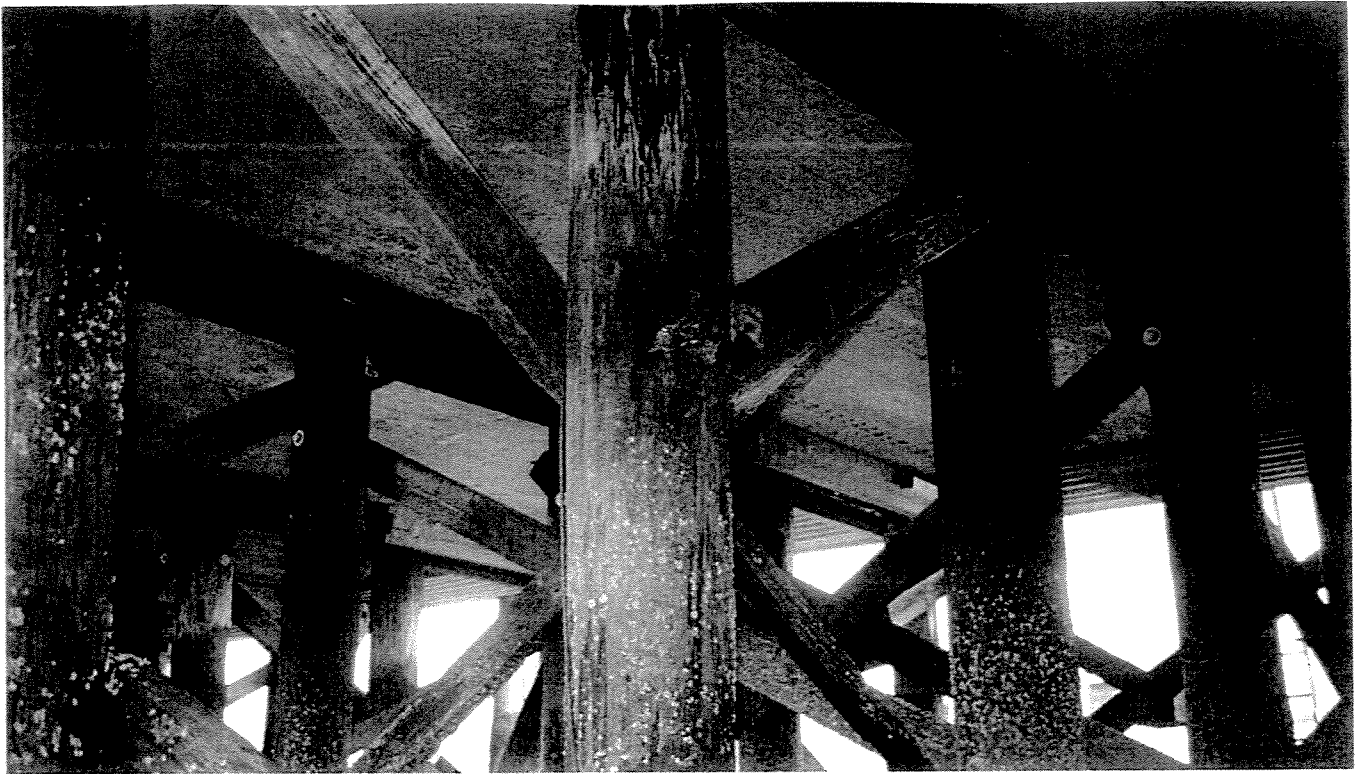
PHOTO 19 - Bent 76, "E" pile, diagonal 4 x 8 timber brace broken. Deficiency does not appear to be the result of impact damage.

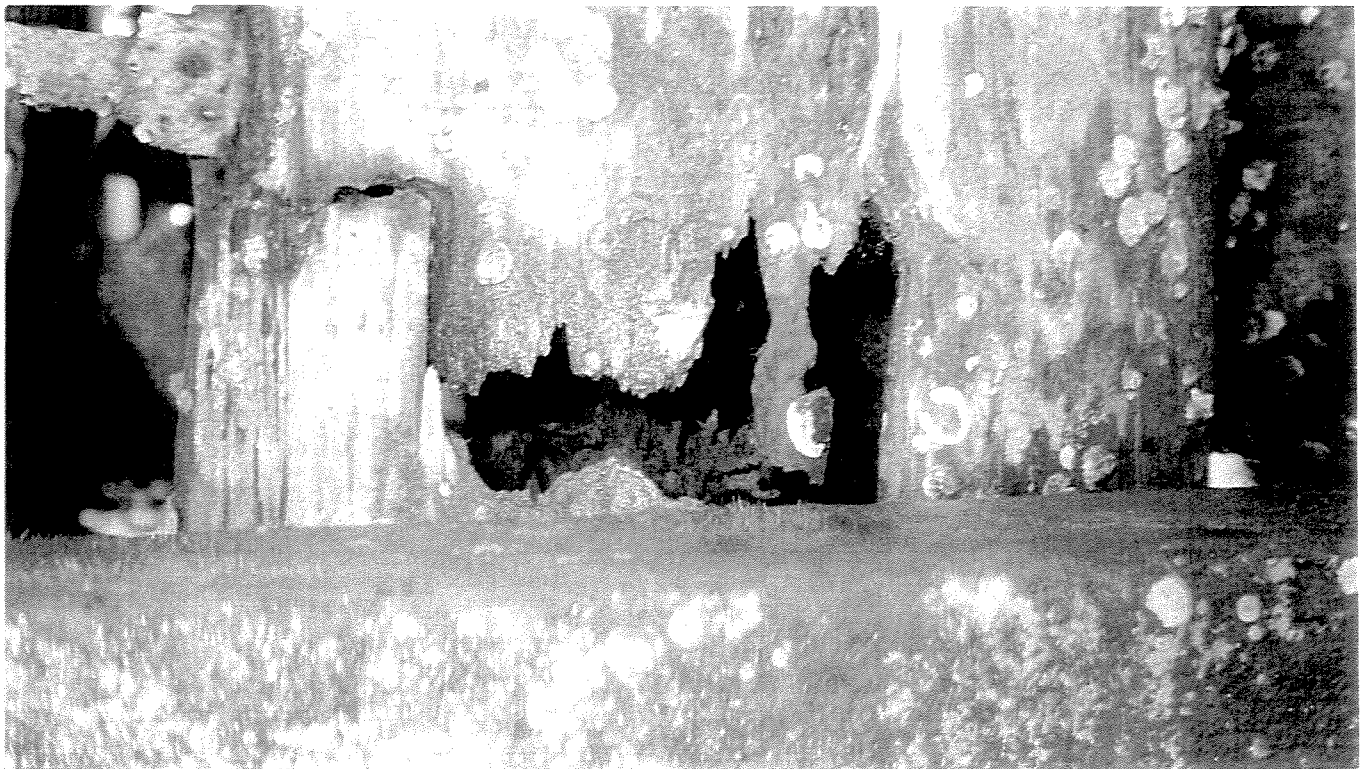
PHOTO 20 - Bent 80, "B" pile, close-up view of hole in pile, 2" above the lower horizontal brace. Note, pile exhibits hollowing with 95% loss of cross-sectional area and heavy marine borer activity.

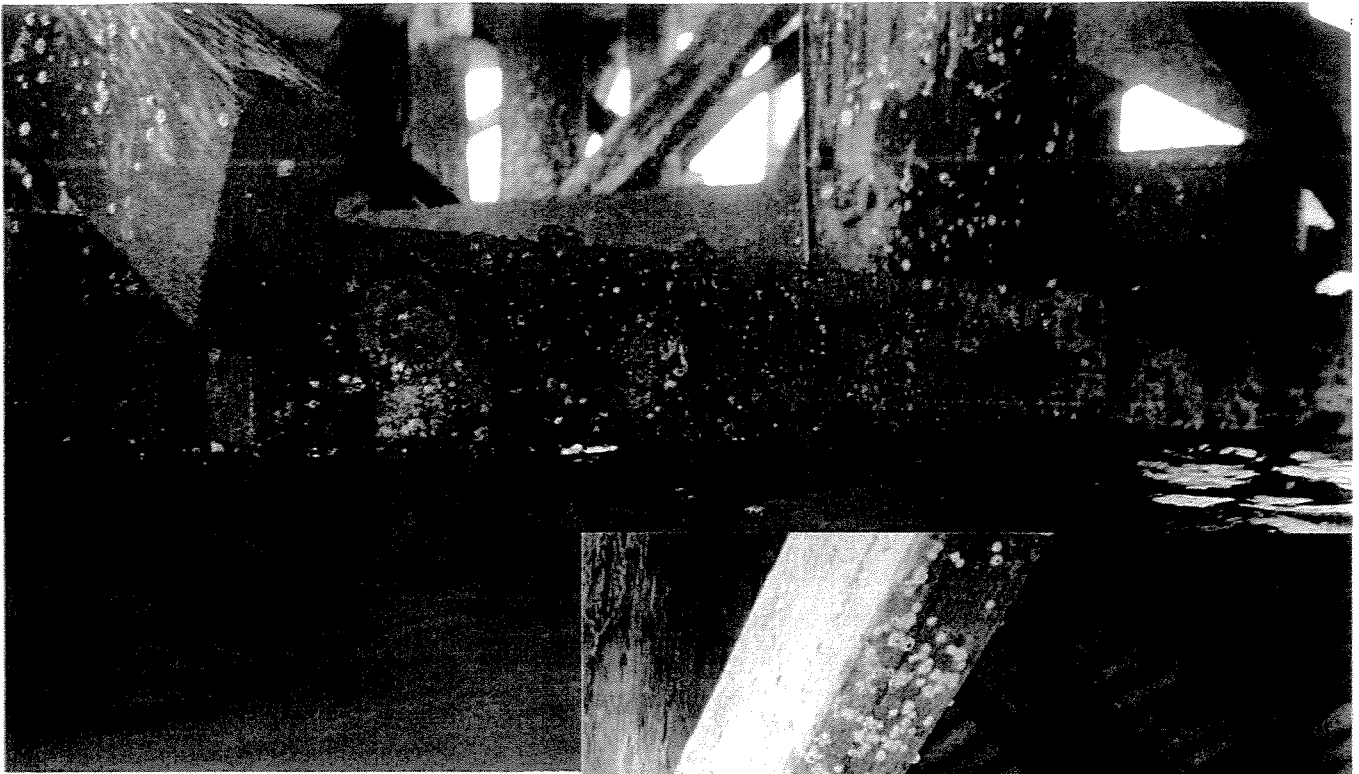
PHOTO 21 - Bent 76, "E" pile with typical splice of lower timber bracing between piles "E" and "F," looking NW.

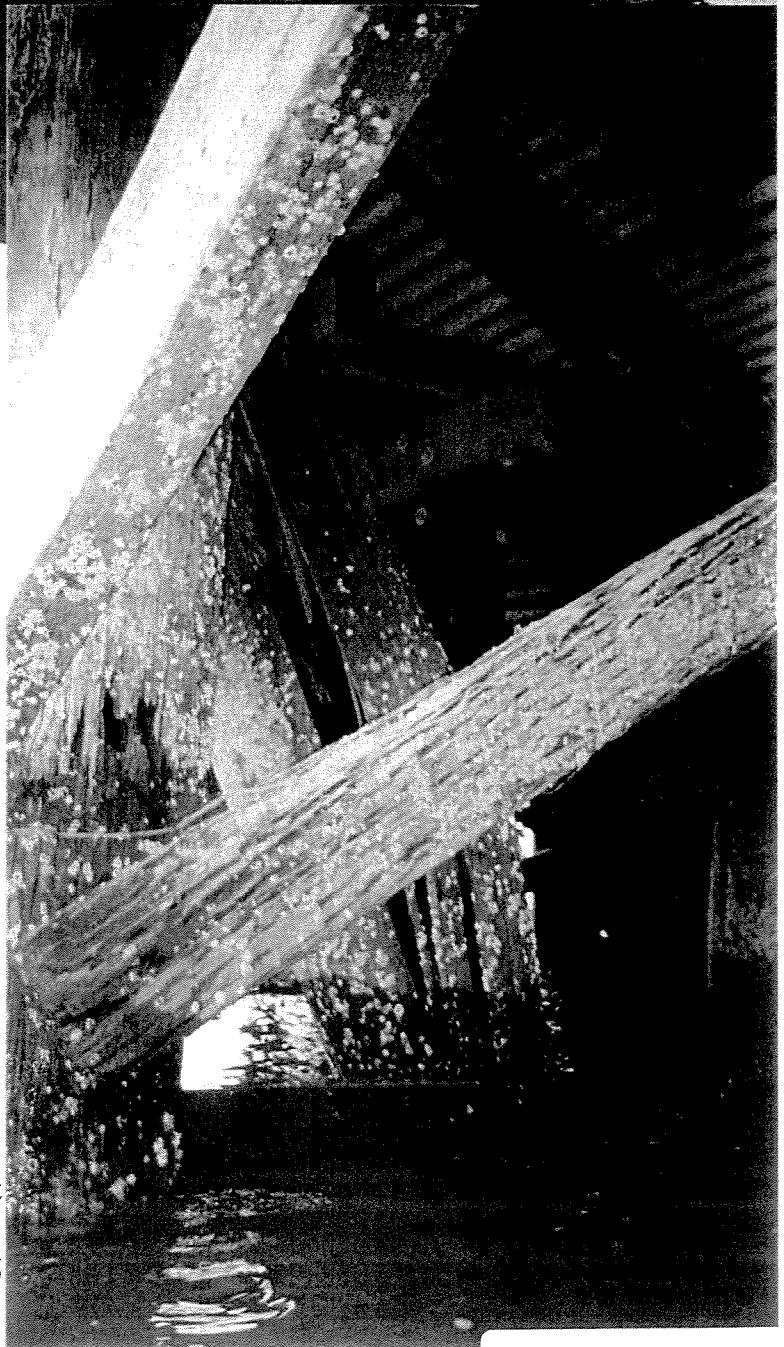
PHOTO 22 - Bent 78, "A" pile with "A-batter" beyond. Both piles exhibit 25% to 50% loss of cross-sectional area due to rot in the tidal zone with heavy marine borer activity, looking SE.

Timber Piles 78A, 78A-bat, 77A, 76A, 76D, 76F	Timber piles exhibit excessive loss of cross-sectional area due to rot and/or marine borer activity.	Replace poor section of pile with 12 x 12 timber post repair.
12 x12 Timber Cap Beam Bent 80	12 x 12 Timber cap beam is broken or split due to impact damage.	Remove and replace timber cap.
12 x12 Timber Cap Beam Bent 79, "D" pile to "I" pile	12 x 12 Timber cap beam is broken or split due to impact damage.	Remove and replace timber cap. Splice to good 12 x12 cap at "C" pile.

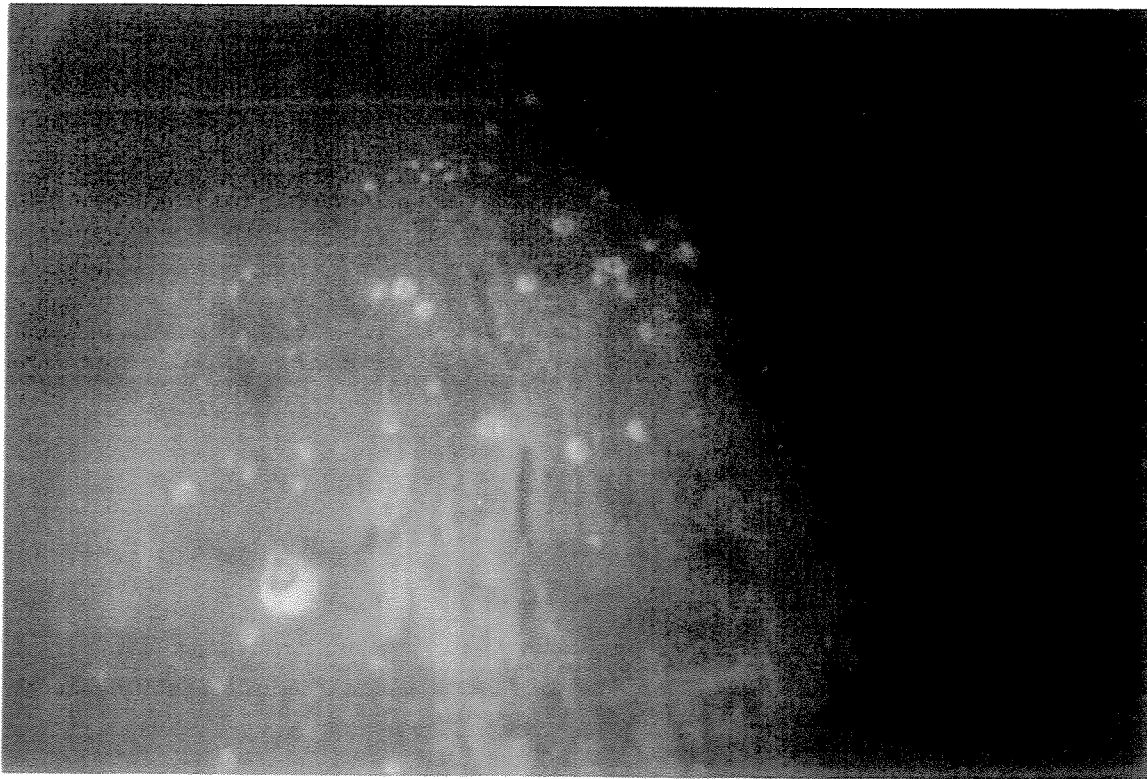
PHOTO 24 - Pile 75 "B," 5' above the mudline. Typical pile with minor marine borer activity. Note the vertical 1/4" diameter "tracks" indicative of the Teredo marine borer, looking NE.
