UNDERWATER INSPECTION AND EVALUATION REPORT

**PIER 1-A & 1-B BENTS 28 to 74
ST. GEORGE FERRY TERMINAL
MAINTENANCE FACILITY
STATEN ISLAND, NEW YORK**

February 2004

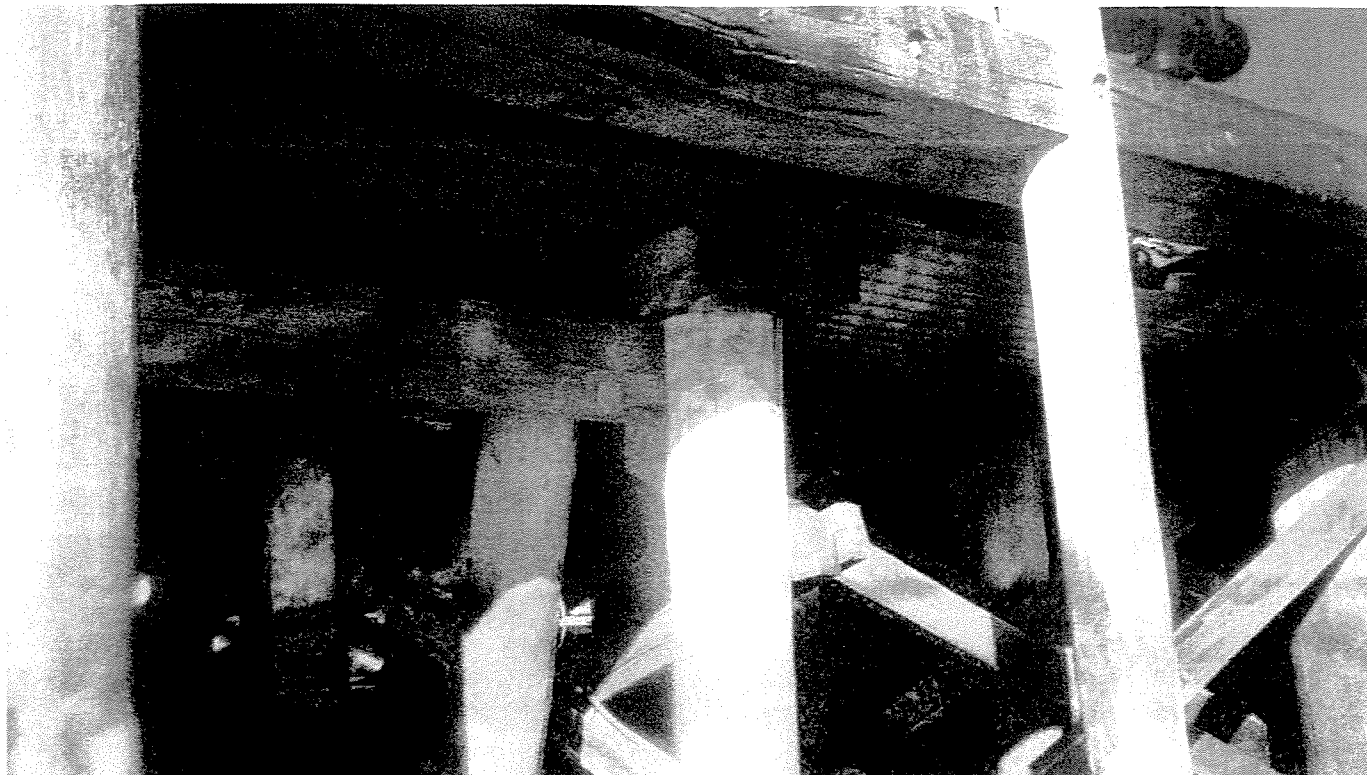
PHOTO 1 - Bent 38, "T" pile. Typical configuration and underside of deck in good condition looking NE.

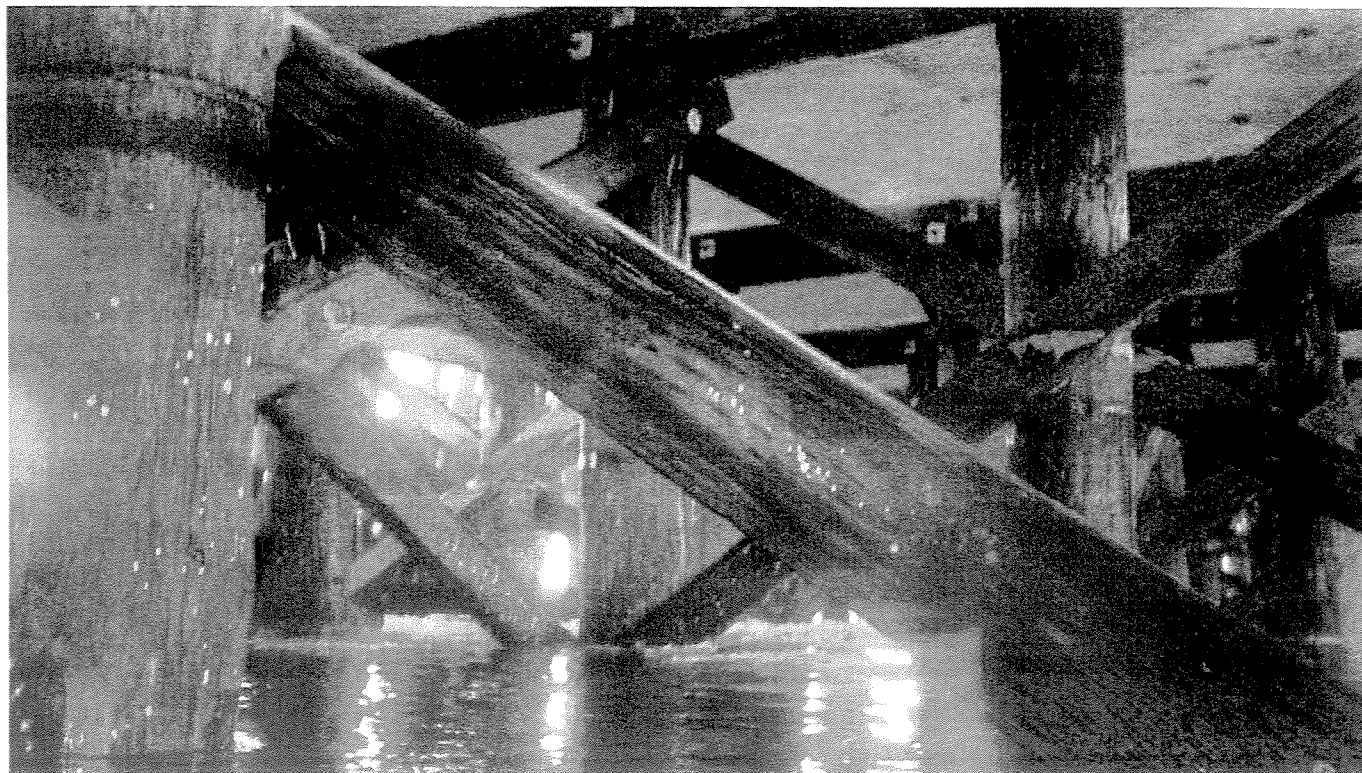
PHOTO 2 – Bent 66 between piles "E" and "F." Brace exhibits rot in the tidal zone with 50% loss of cross-sectional area looking east.

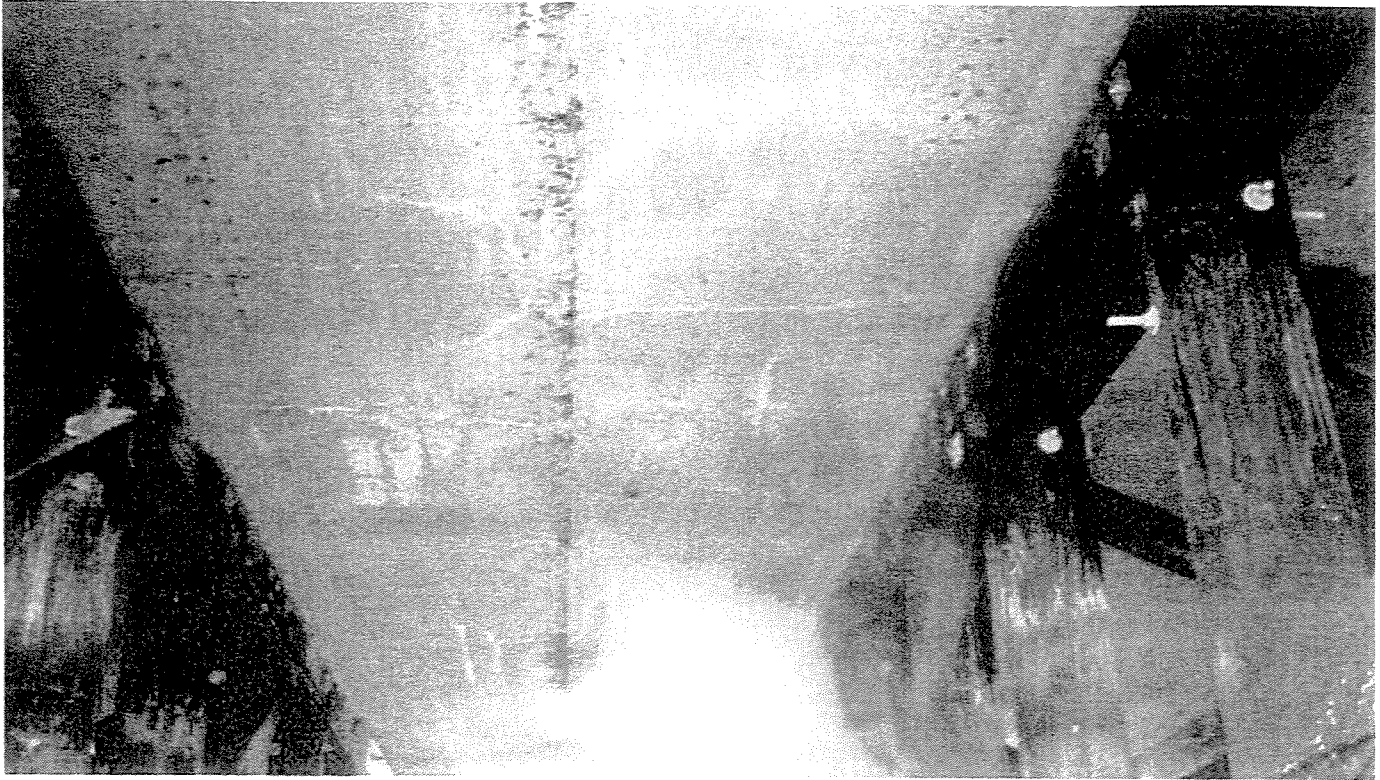
PHOTO 3 - Bent 68/69, typical underside of concrete deck exhibits hair line cracking with efflorescence looking north.

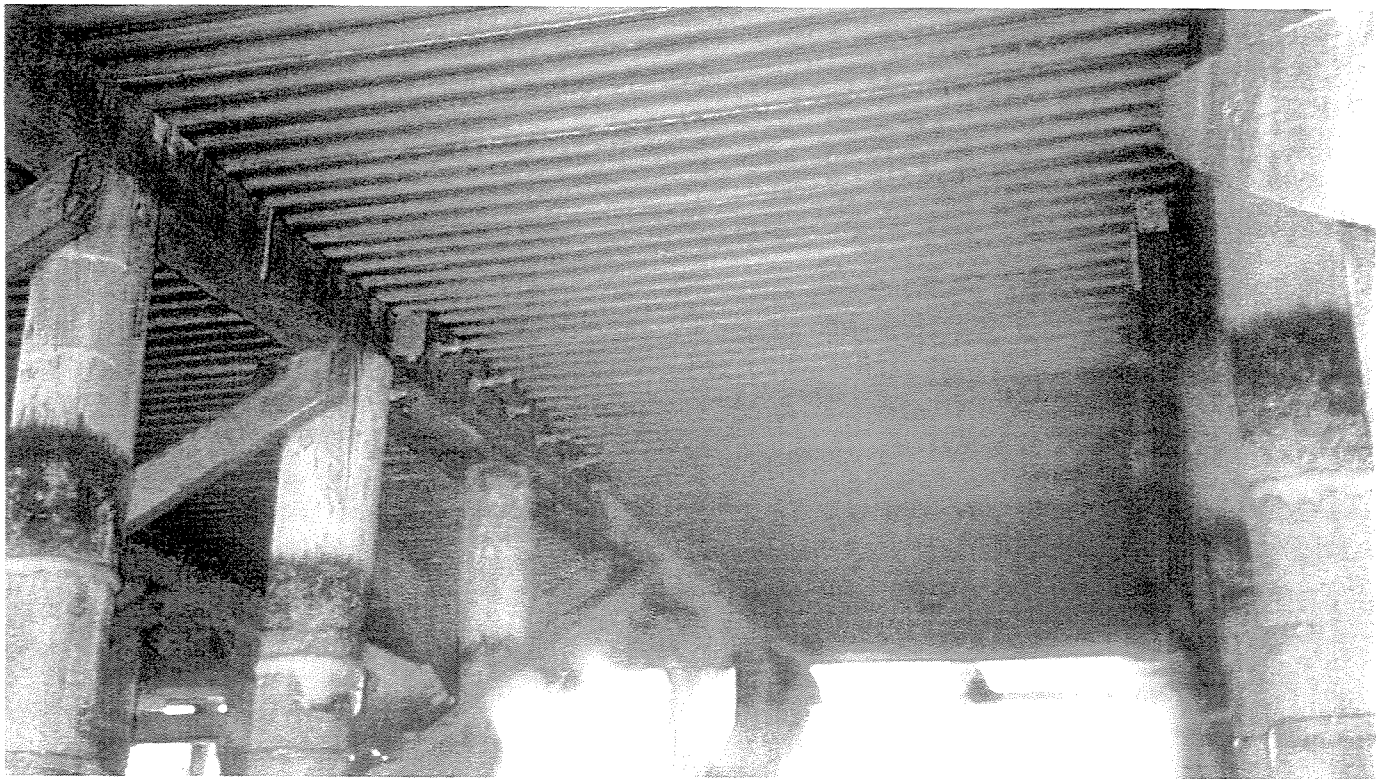
PHOTO 4 - Bent 58/59, typical underside of deck in good condition with corrugated galvanized steel stay-in-place forms looking north.

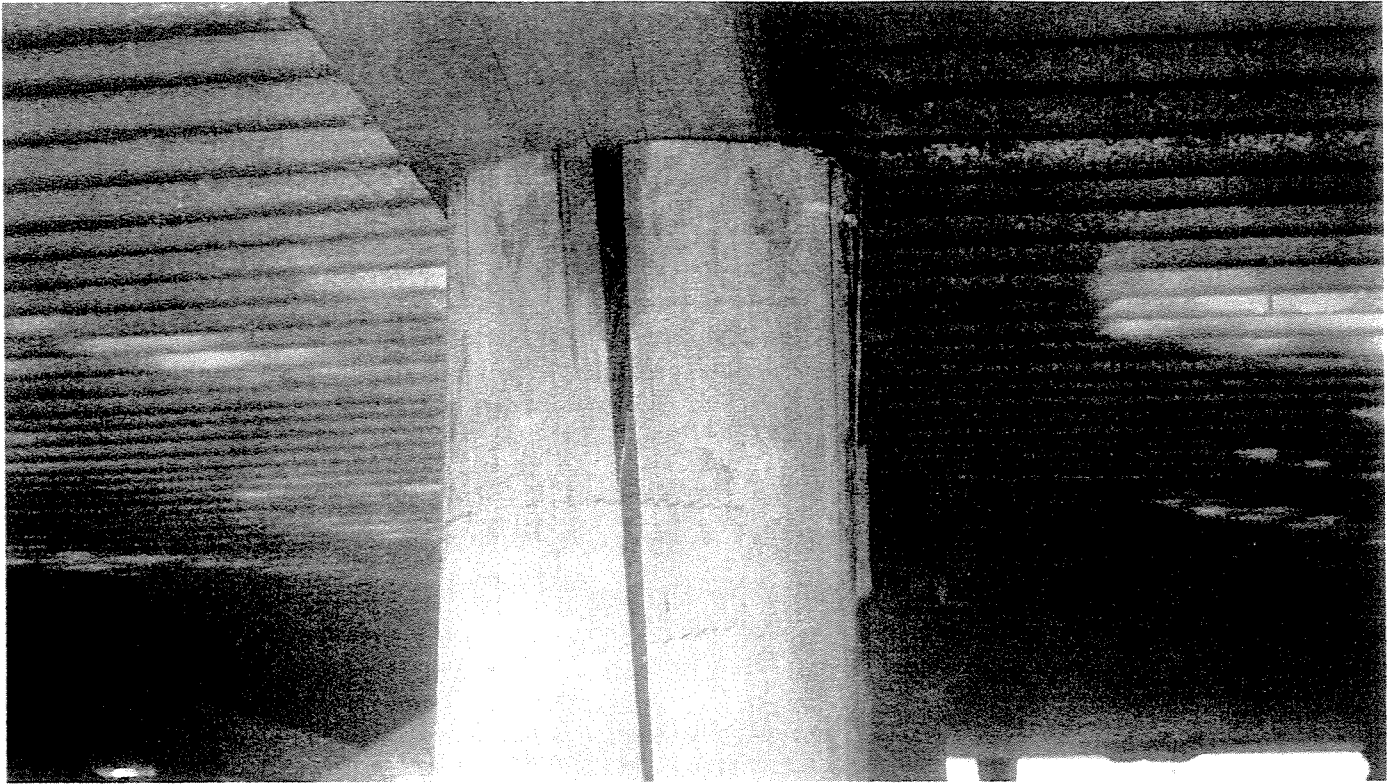
PHOTO 5 - Pile 38 H, split at top looking north.

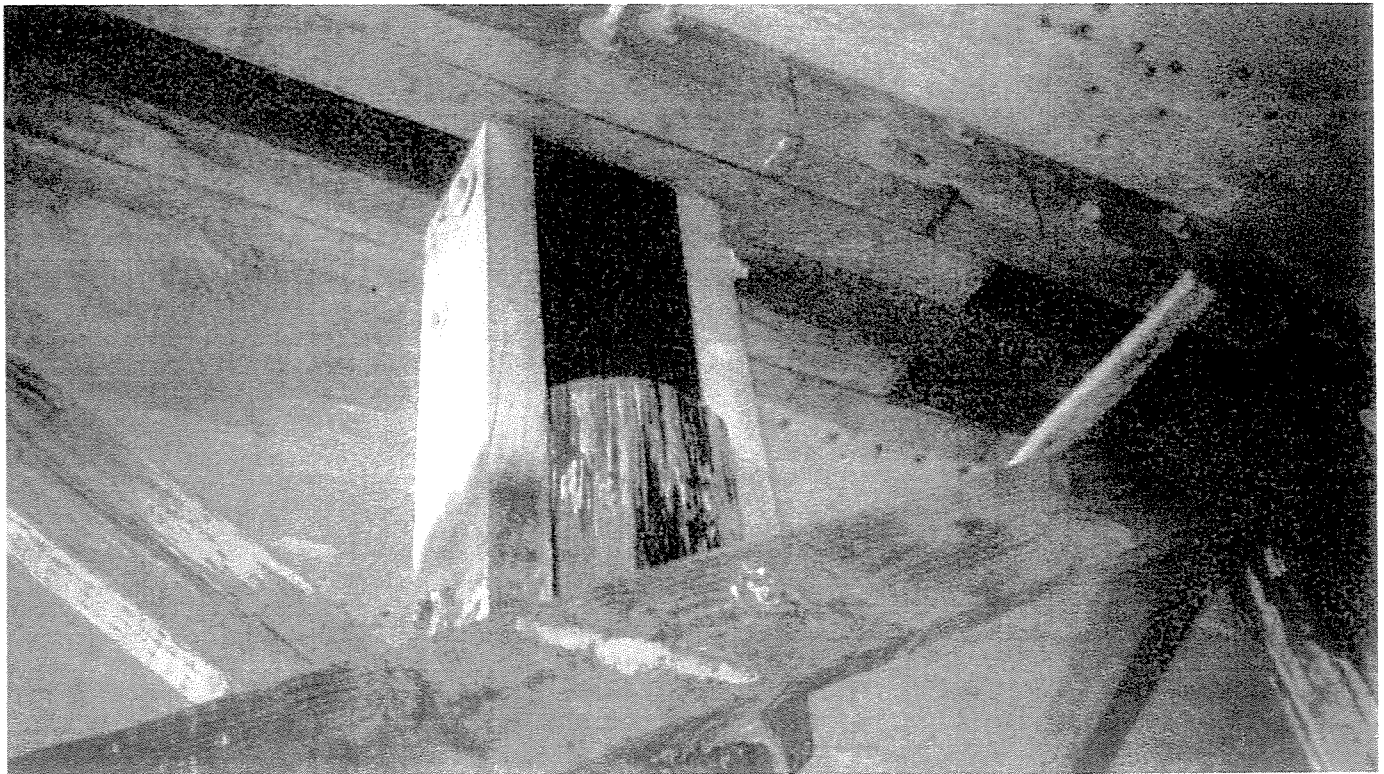
PHOTO 6 – Pile 69 B, 2' post repair looking SE.

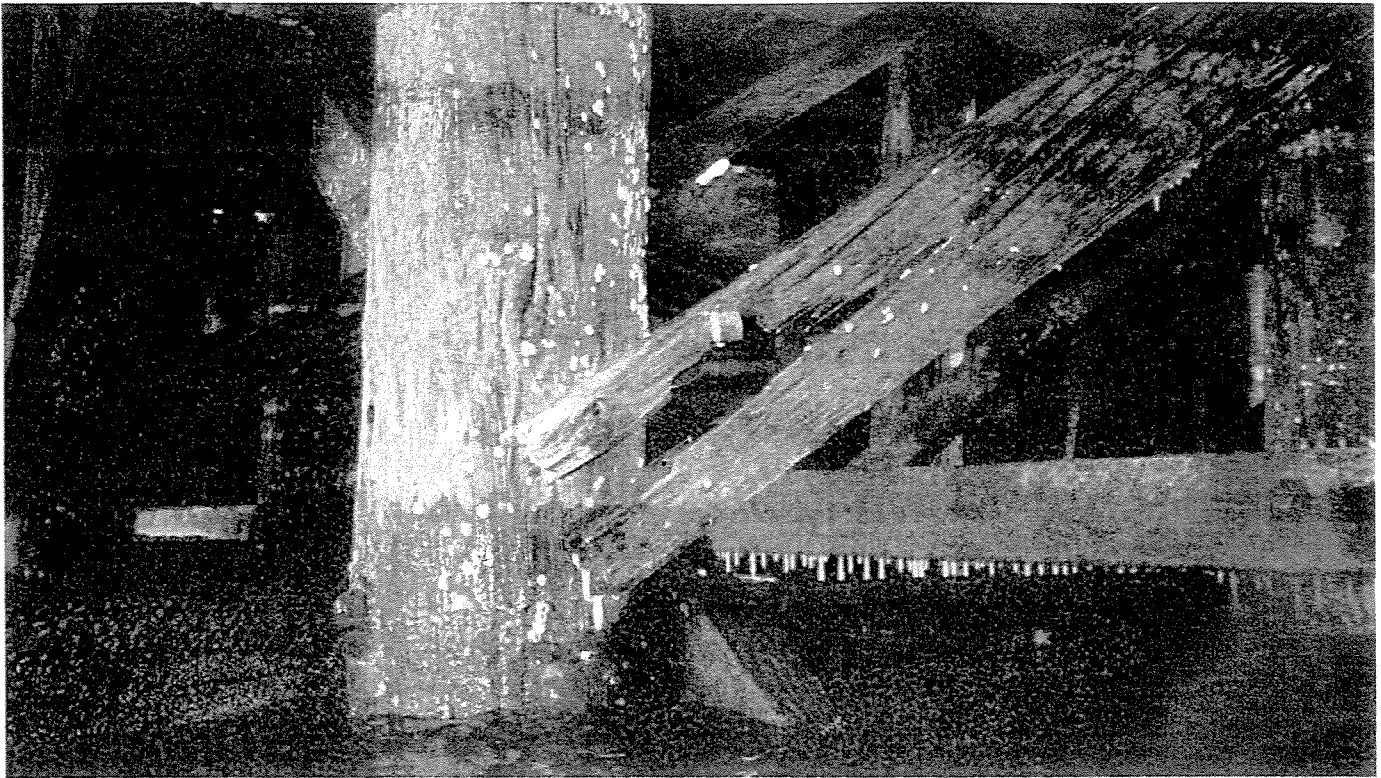
PHOTO 7 - Pile 74 A, E/W diagonal brace is broken and loose looking SE.

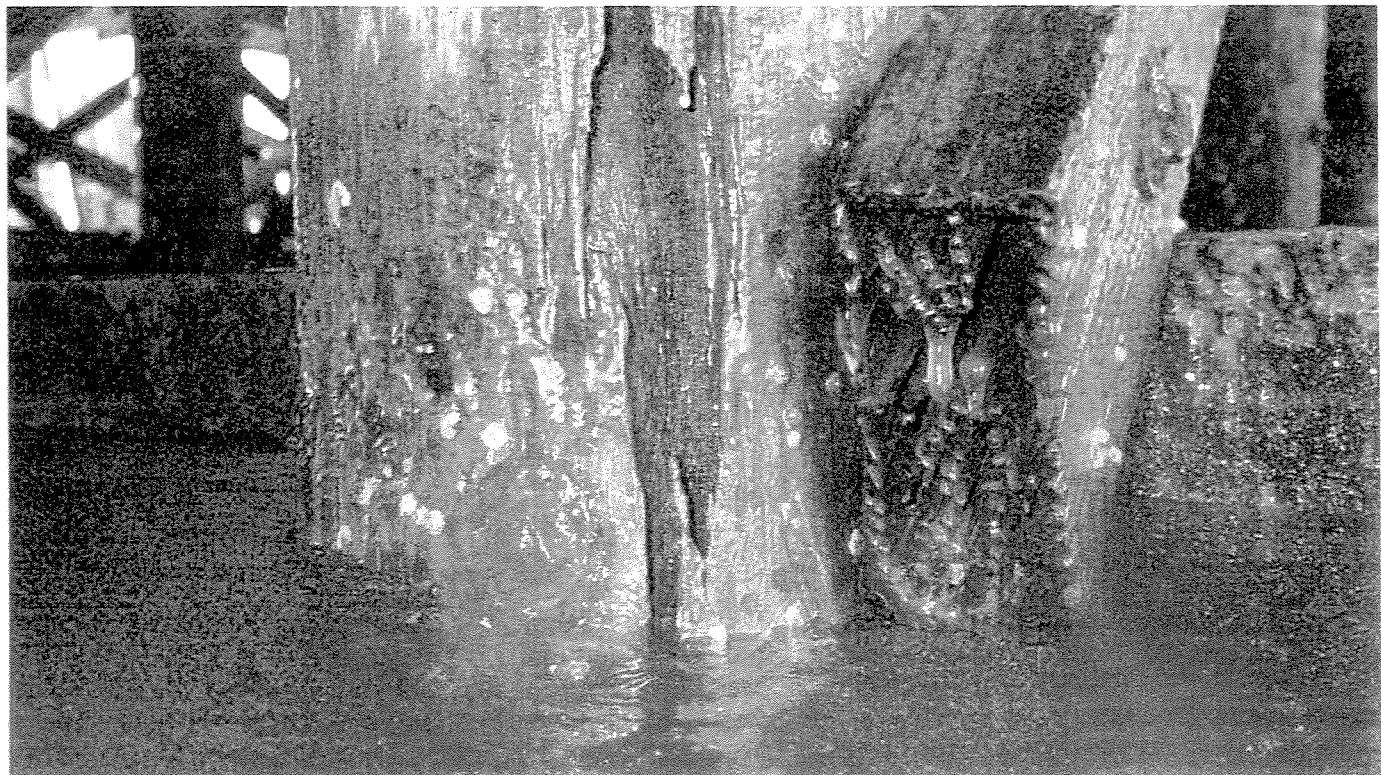
PHOTO 8 - Pile 73 G exhibits 25% loss with Limnoria marine borer activity looking NE.

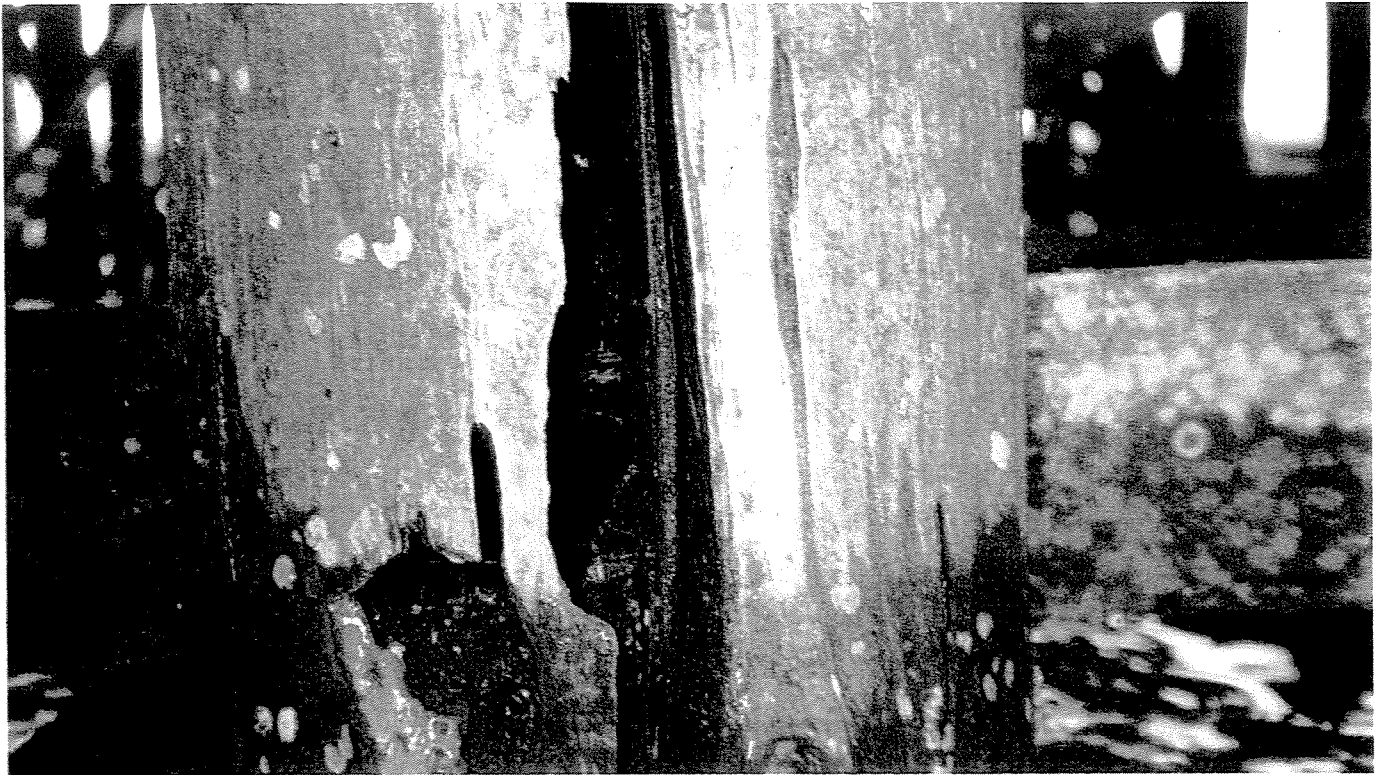
PHOTO 9 - Pile 72 B exhibits 90% loss of cross-sectional area with "hollowing." Outer annulus conceals extent of deterioration, typical of hollowing at creosote treated timber pile, looking south.

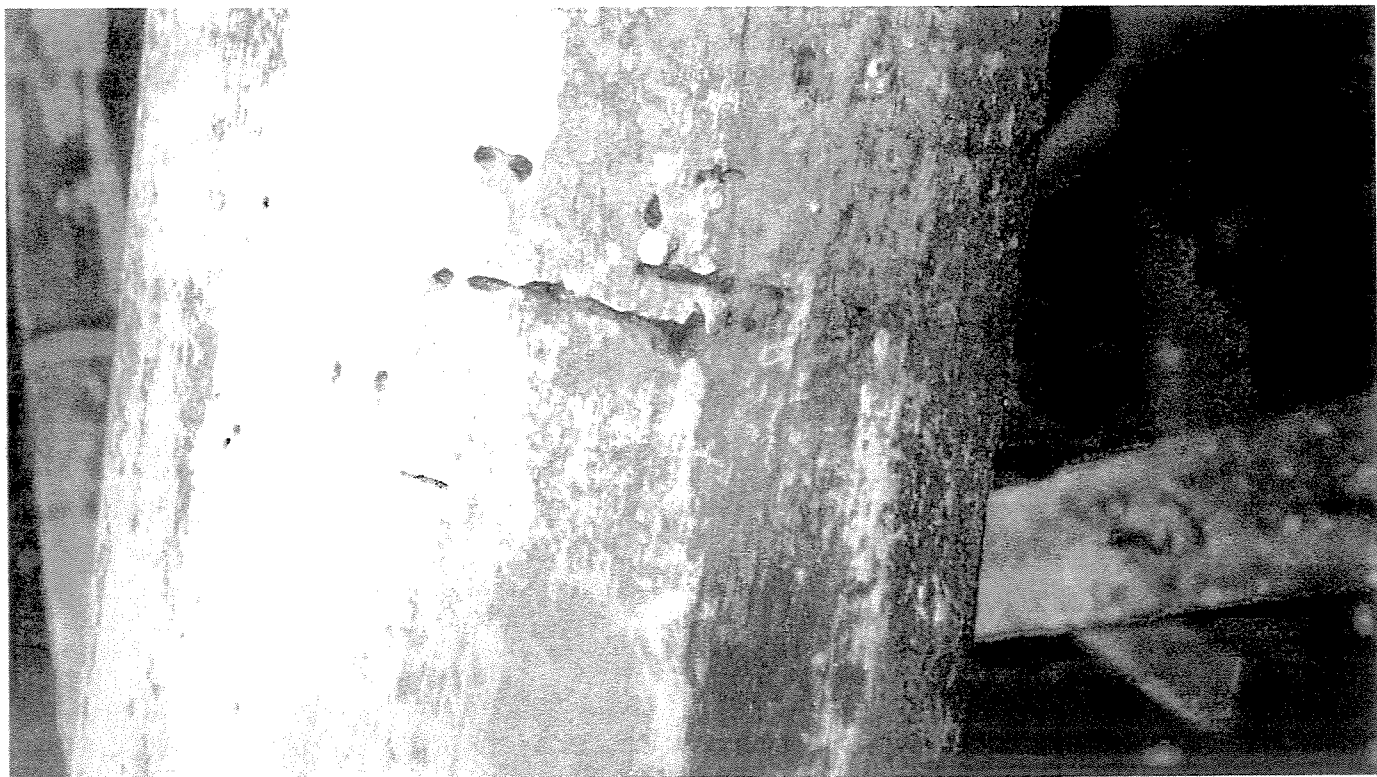
PHOTO 10 – Pile 61 I (batter). Moderate localized Teredo marine borer activity on outer annulus of the greenheart pile, looking NW.

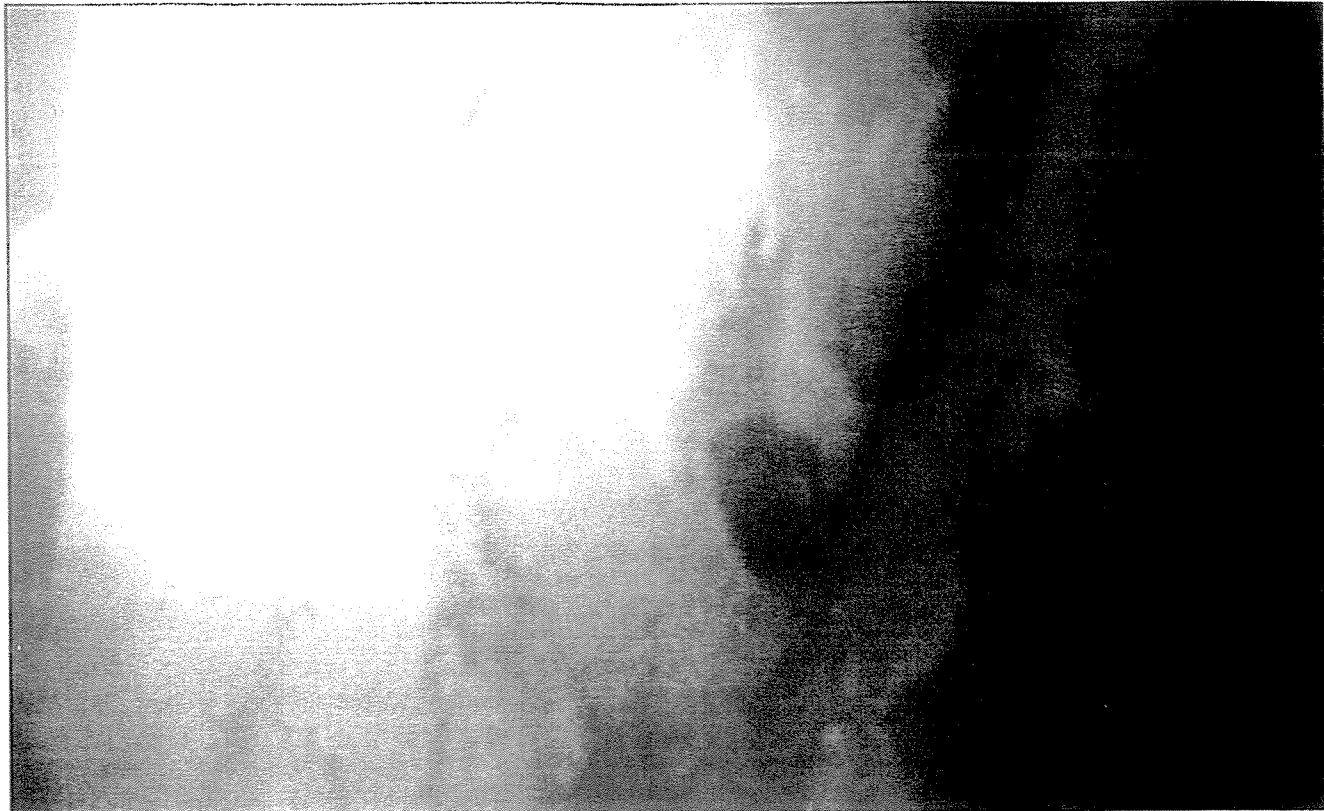
PHOTO 11 - Pile 71 I at the mudline. Several tracks from the Teredo marine borer on the outer annulus looking NW.

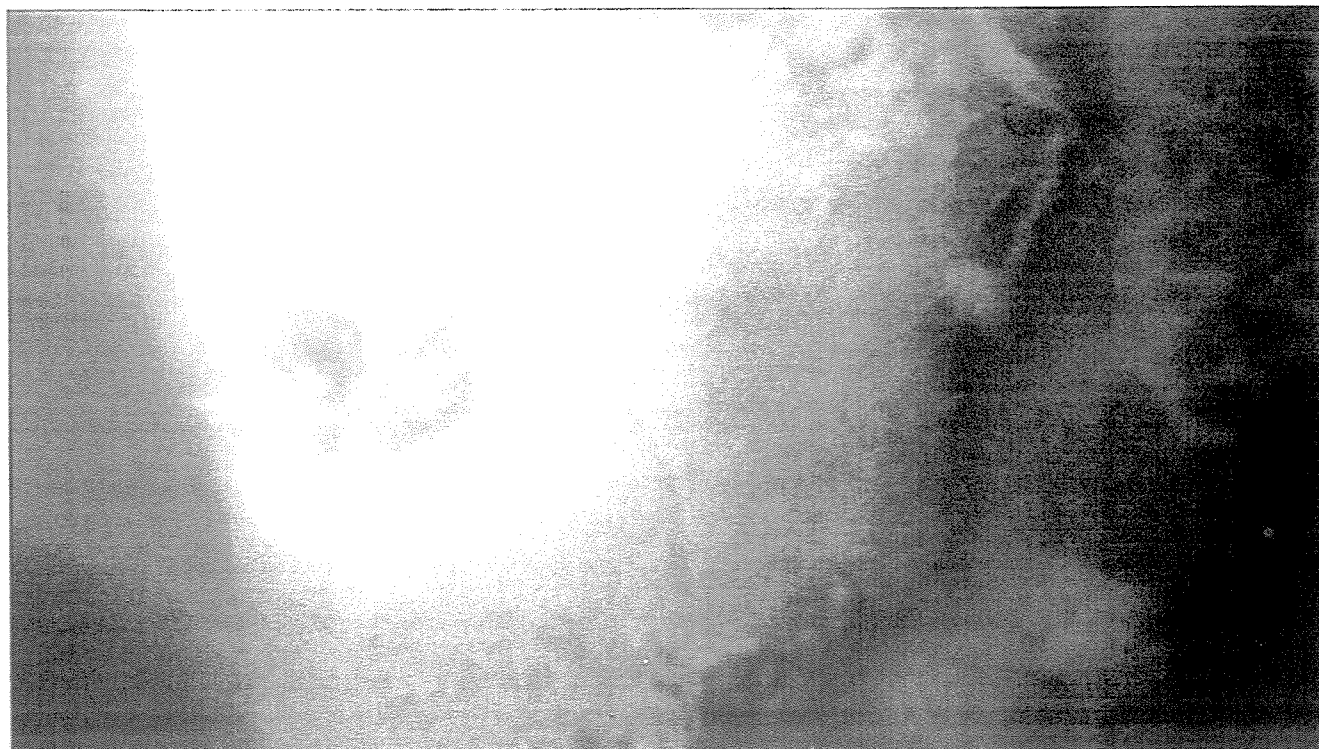
PHOTO 12 - Pile 67 A, 10 above the mudline. Several tracks from the Teredo marine borer on the outer annulus looking east.

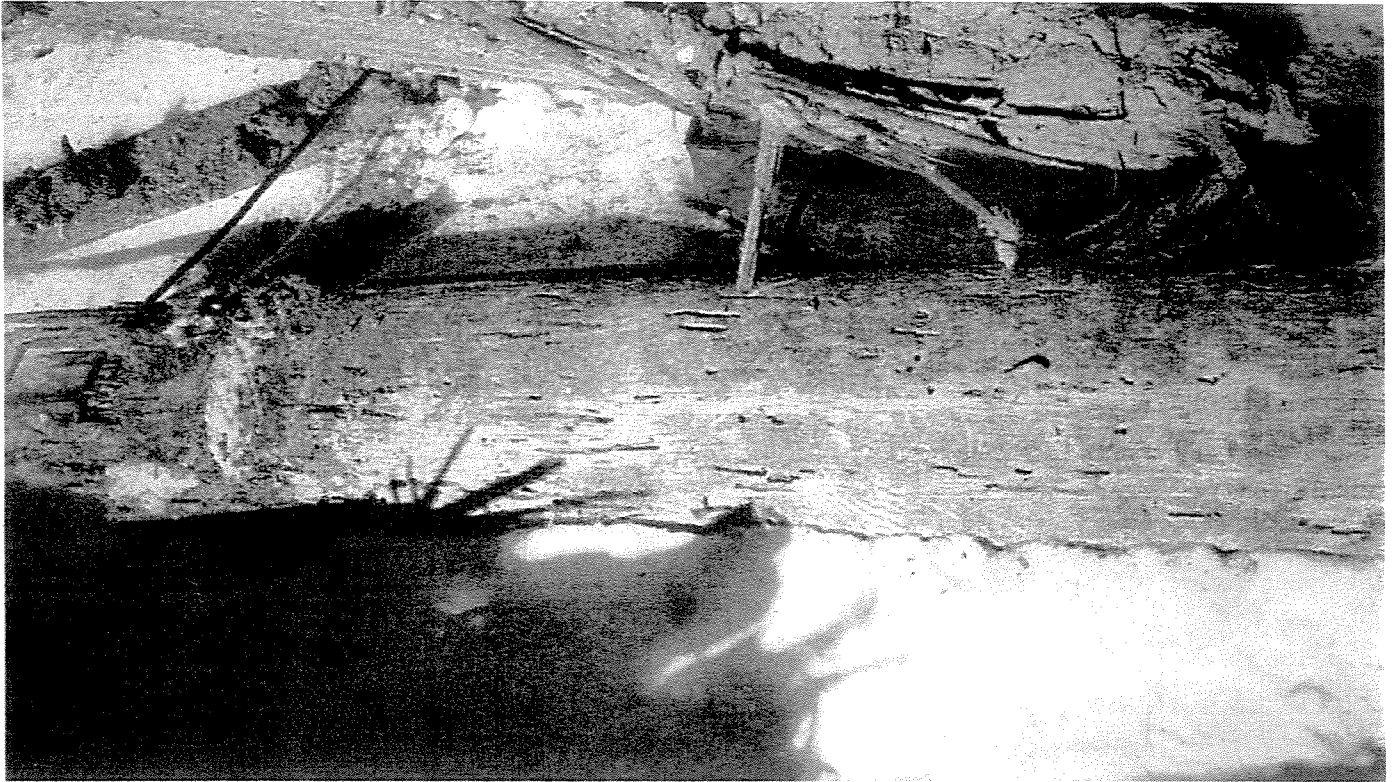
PHOTO 13 - Greenheart pile on top of the deck ("pulled" from the mud). Typical of view of moderate Teredo activity observed below water at various greenheart piles from mean-low-water to the mudline.

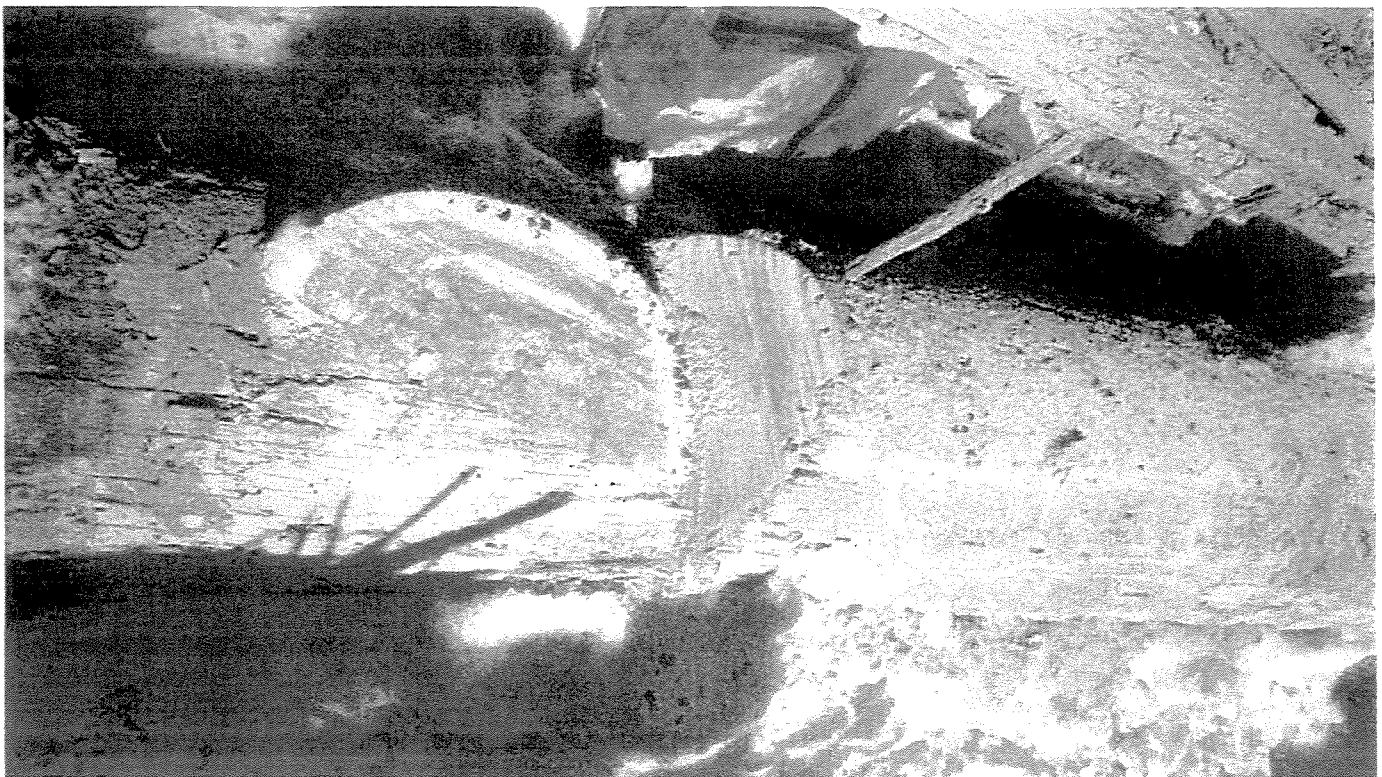
PHOTO 14 - The above referenced pile was sectioned with a saw revealing a solid inner core. Damage is limited to the outer annuls with no significant loss of cross-sectional area.

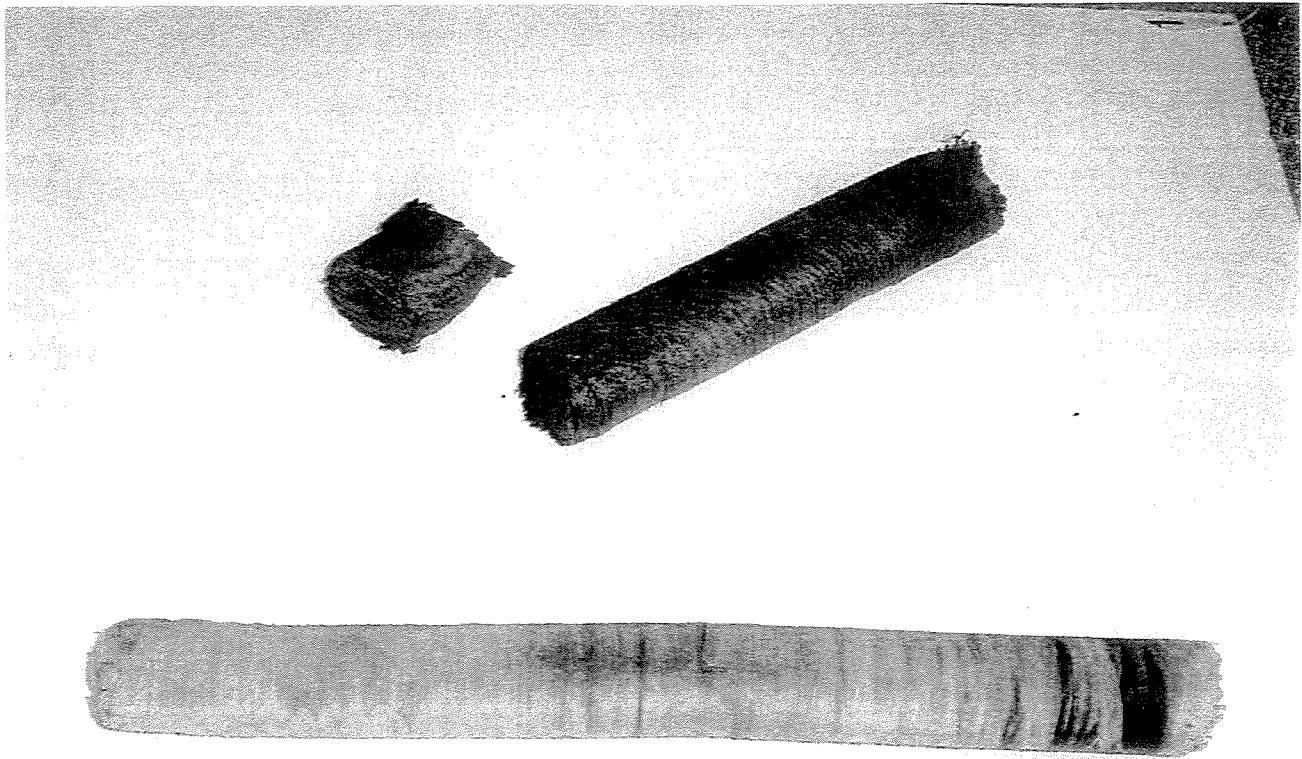
PHOTO 15 - Core Sample from a creosote treated pile (top) and a greenheart pile (bottom). Both cores reveal activity is limited to the exposed "outside" of the pile. Creosote pile is well treated throughout. Live *Limnoria* borers were observed on the outside of the creosote core sample.

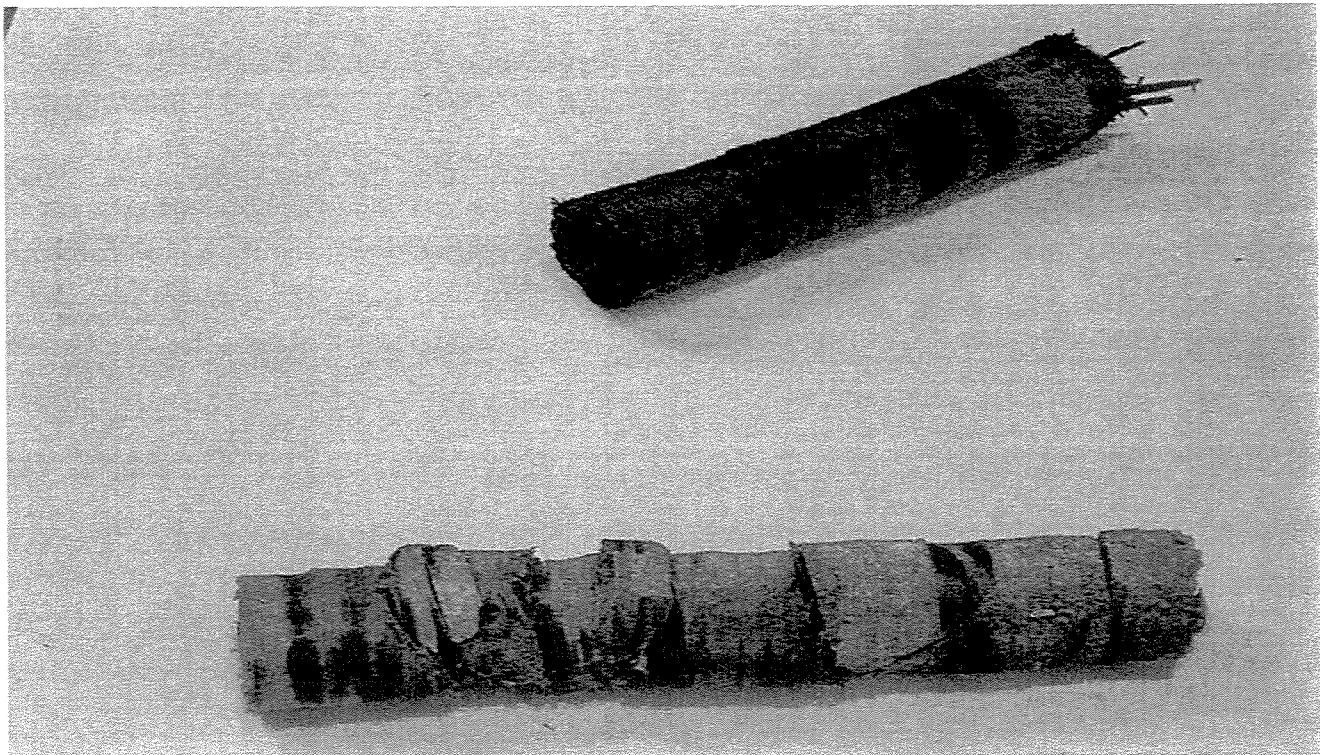
PHOTO 16 - Core Sample from a creosote treated pile (top) and a greenheart pile (bottom). Both cores reveal activity is limited to the "outside" of the pile. Creosote pile is well treated throughout. The Creosote piles sampled exhibited loss of section and hollowing at the core
