VEHICLE FACTORS ATTACHMENT

Navistar Vehicle Recall G-04507

HWY18MH003

SUBJECT: SAFETY RECALL (U.S., EXPORT)
Kelsey-Hayes (Lucas Varity or TRW) Anti-Lock Brake (ABS) Electronic Control Unit on 3400, 3800, RE, FE, and CE bus models built 2/28/1999 thru 4/5/2004

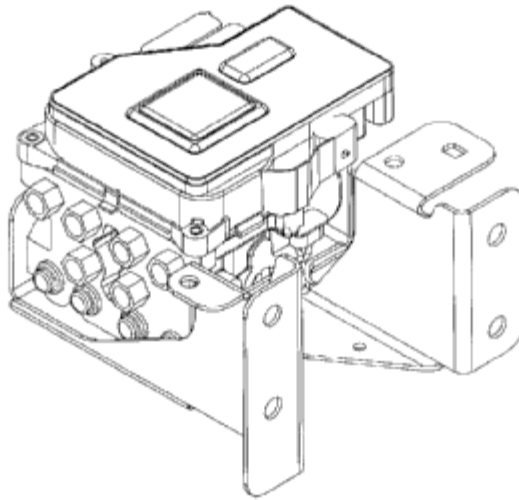
Figure 1

1. Disconnect the negative battery terminal.
2. Locate the EHCU assembly on the driver's side frame rail.

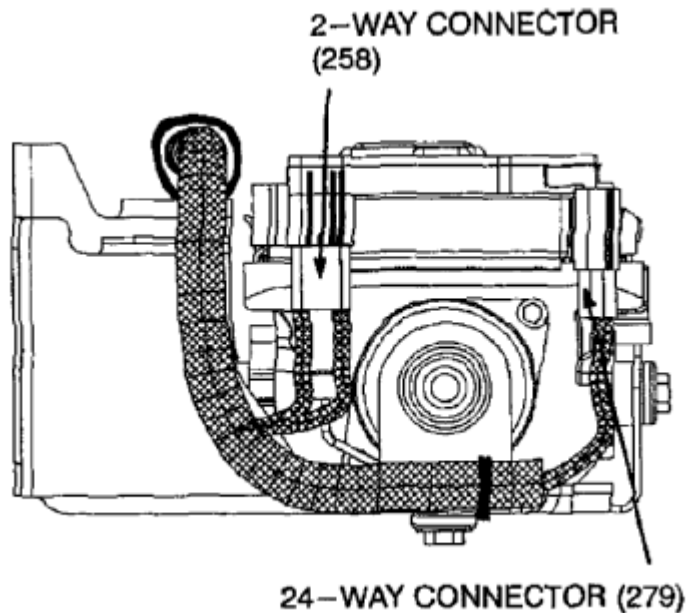
Figure 2 -- View from Rear of Vehicle

3. Remove dirt from the EHCU assembly with a dry soft brush or cloth. Blow loose particles and dust away with low-pressure shop air. **Do not use water or chemical cleaners.**
4. Disconnect the 2-way and 24-way connectors from the ECU.

IMPORTANT: *Avoid touching the pins of the electrical connectors on the ECU. Damage could occur, due to electrostatic discharge.*

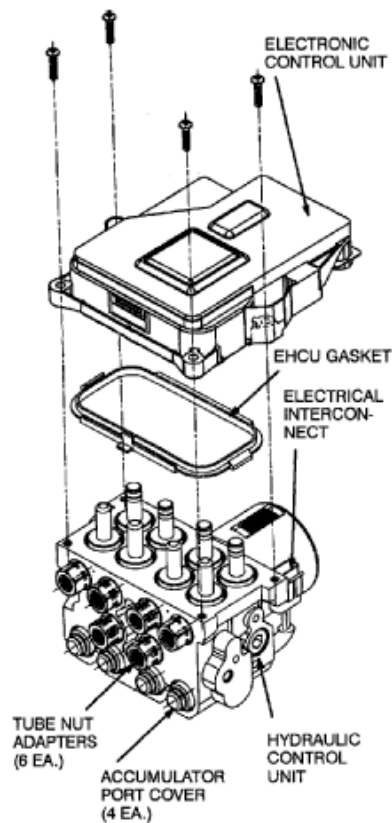
Figure 3

5. Disconnect the 2-way connector from the electrical interconnect between the ECU and HCU (it is located on the side of the EHCU that was next to the frame rail).
6. With a small hammer, lightly tap the four T-25 Torx® bolts which fasten the ECU to the HCU. Remove the bolts cautiously, so as to ensure they are not broken during removal.
 - a. If bolts cannot be removed due to corrosion, or stripped heads, or if they become broken off, replace entire EHCU assembly. This is the only condition in which EHCU assembly replacement will be necessary.
 - Refer to Master Service Manual for proper EHCU removal and re-installation instructions.

IMPORTANT: *Do not pry on the ECU or HCU with a mechanical aid. Excessive force will cause damage to the units.*
