**VEHICLE FACTORS GROUP CHAIRMAN'S
FACTUAL REPORT**

**Vehicle Attachment – MCI Steering Gear Examination Report From ZF-TRW
Commercial Steering**

HWY17MH005

Accident Gear Inspection MCI Bus – 23FEB 2017

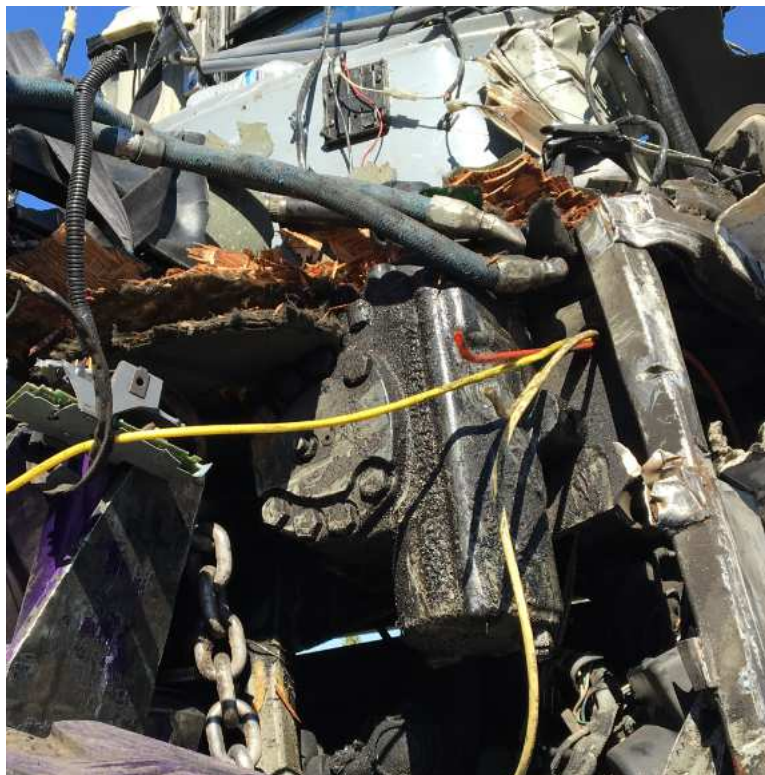
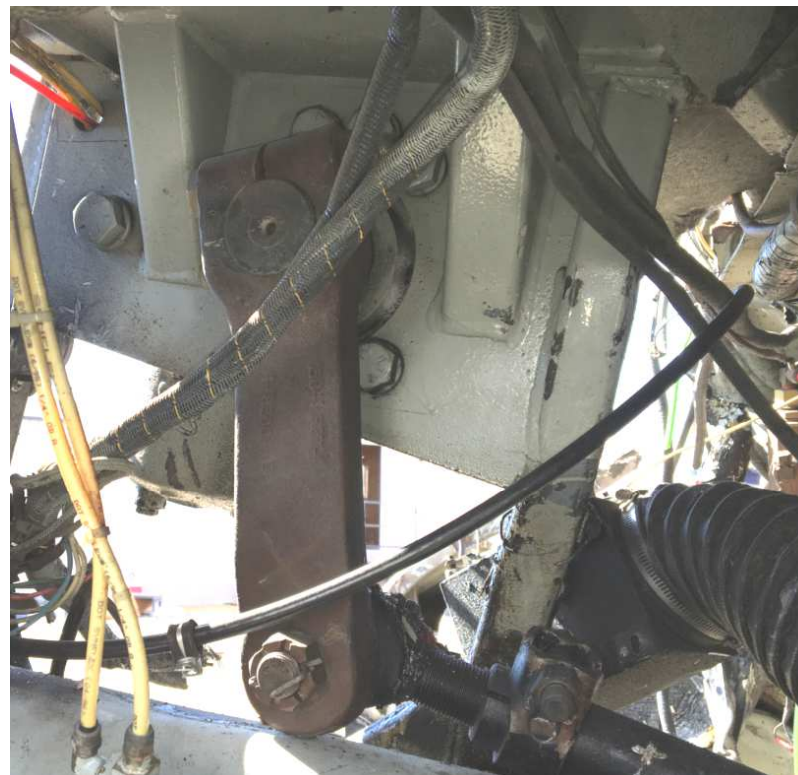
Gear on vehicle post accident
(photos courtesy of NTSB)

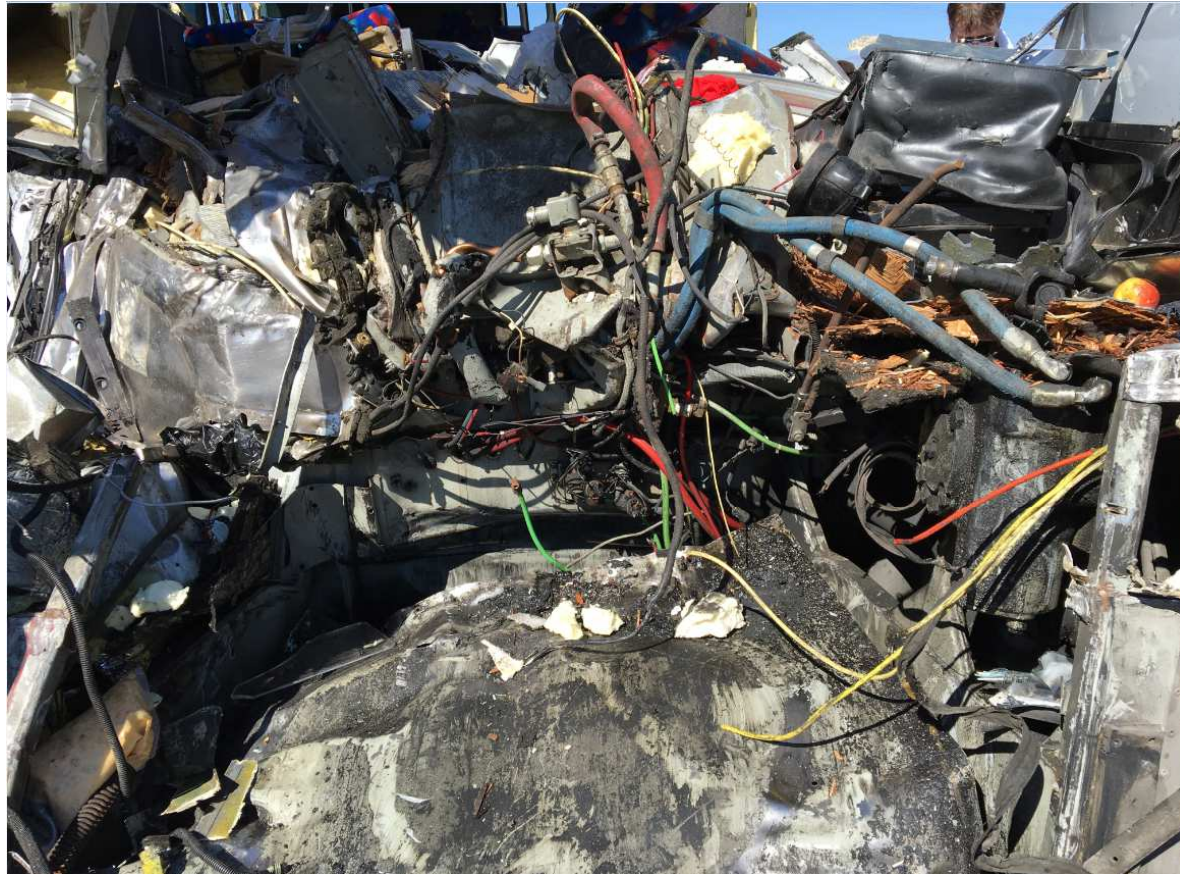
Vehicle post accident
(photo courtesy of NTSB)

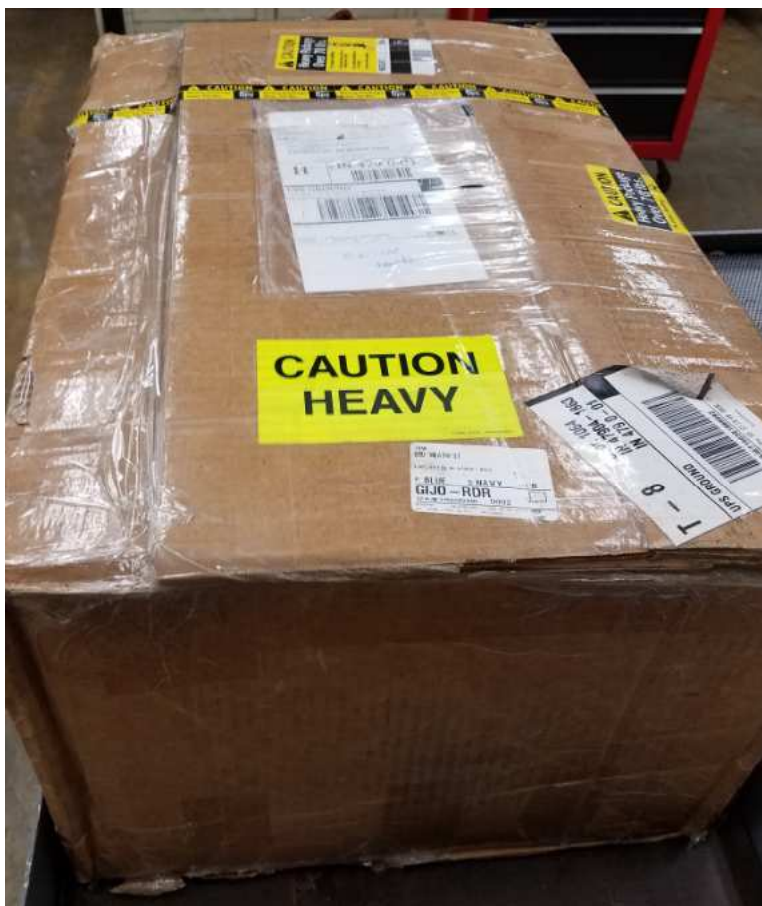
Steering Gear – As received at TRW

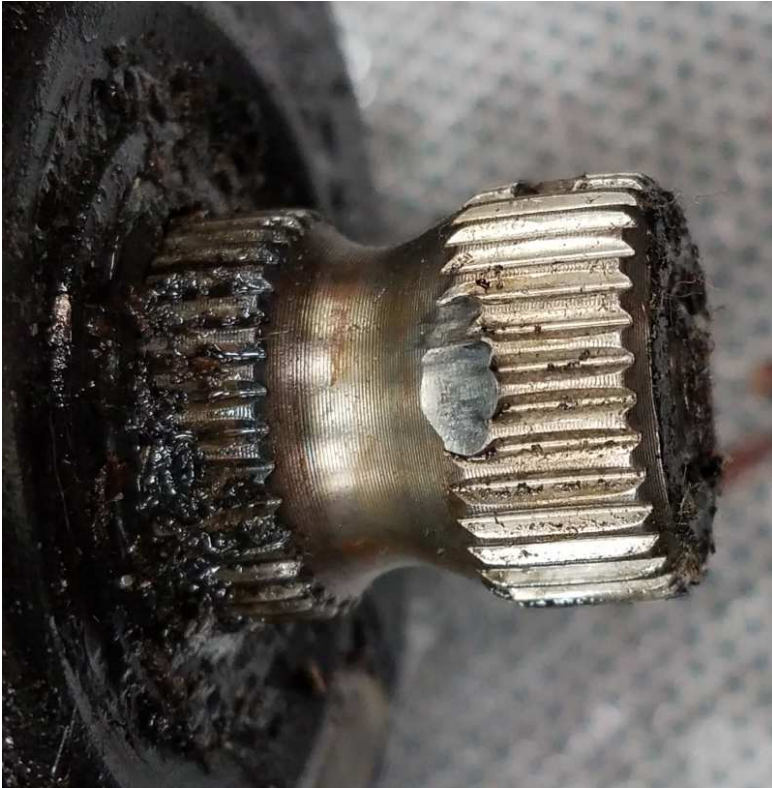
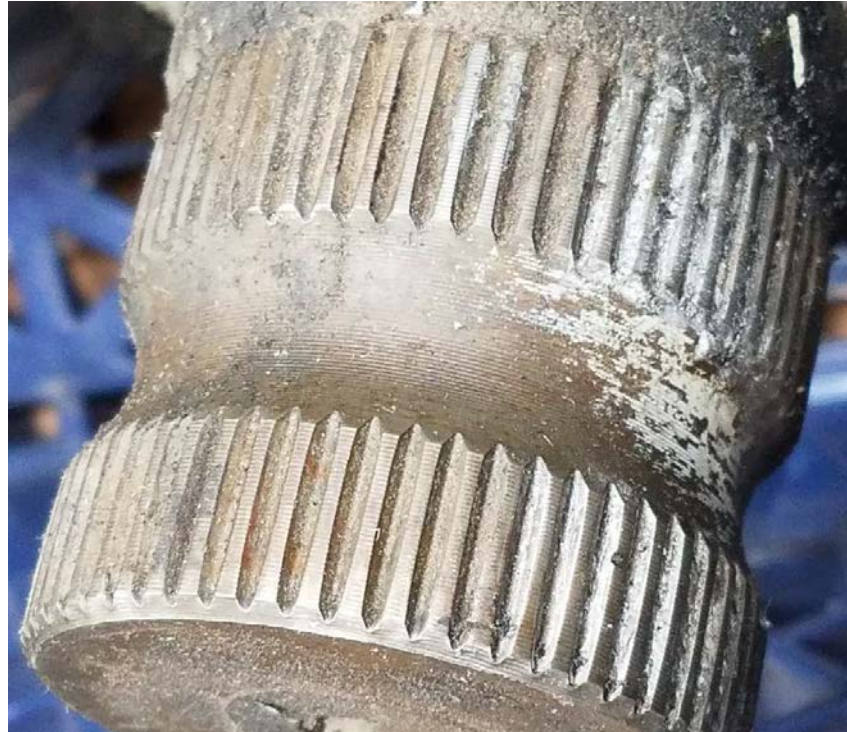
Input Shaft Splines intact but damaged from tensile load forcing u-joint pinch bolt against groove during accident Output Shaft Splines are undamaged and in good condition.

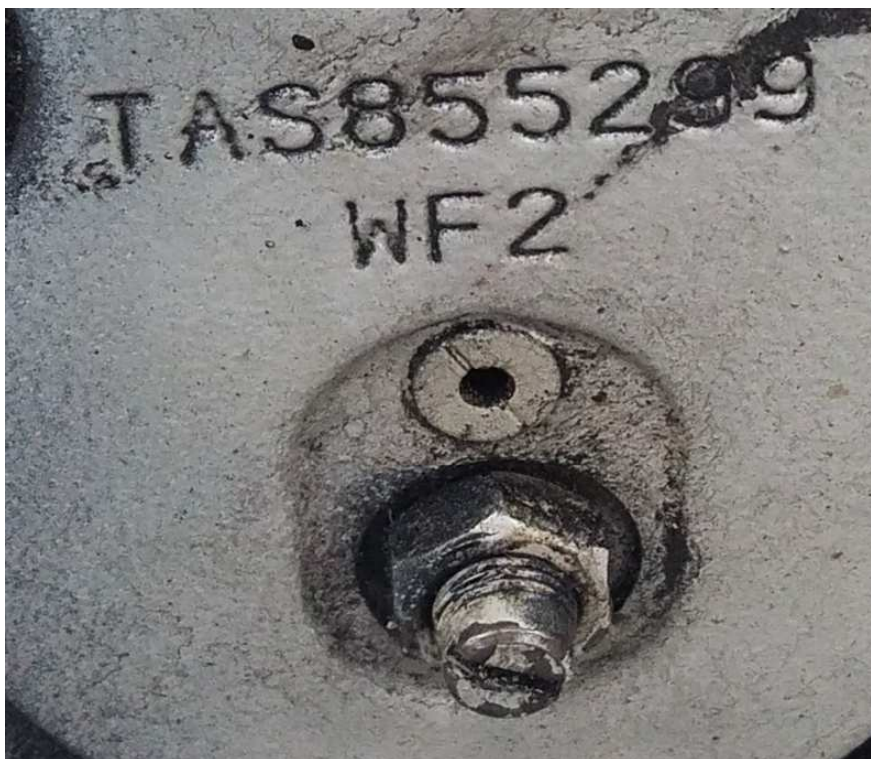
Adjuster nut shows no signs of broken paint indicating no servicing of the lash adjuster.

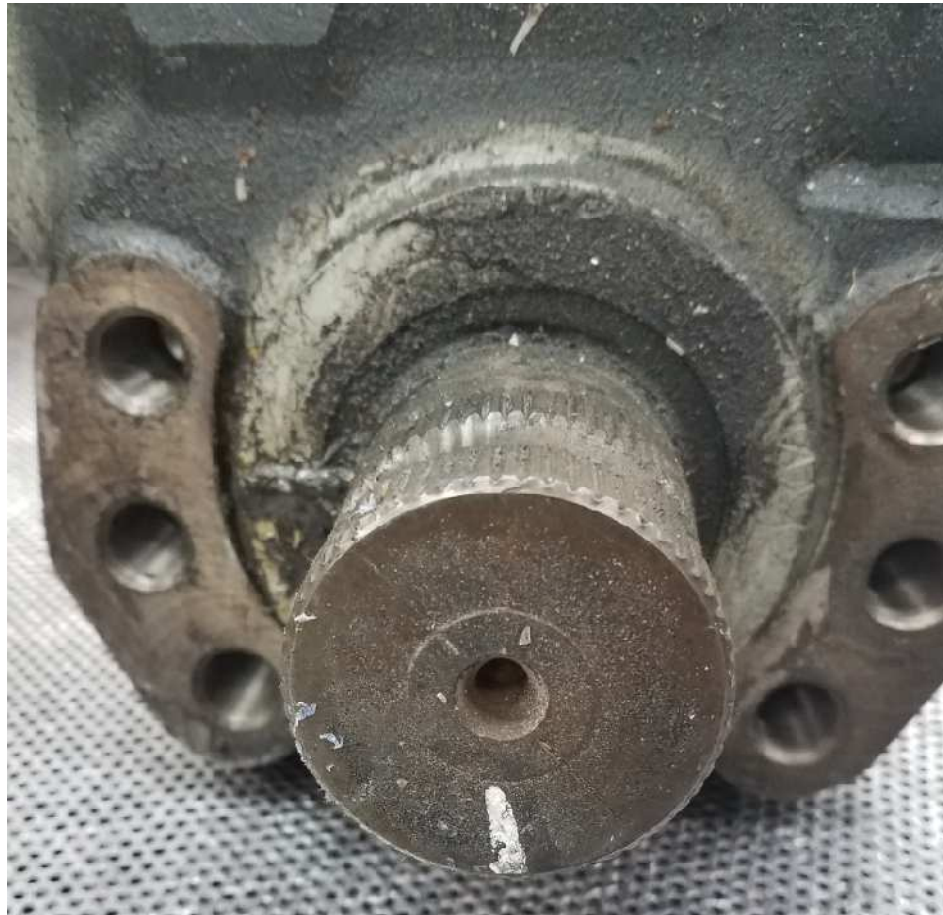
As received the gear output shaft was in about 35 degrees right turn position.

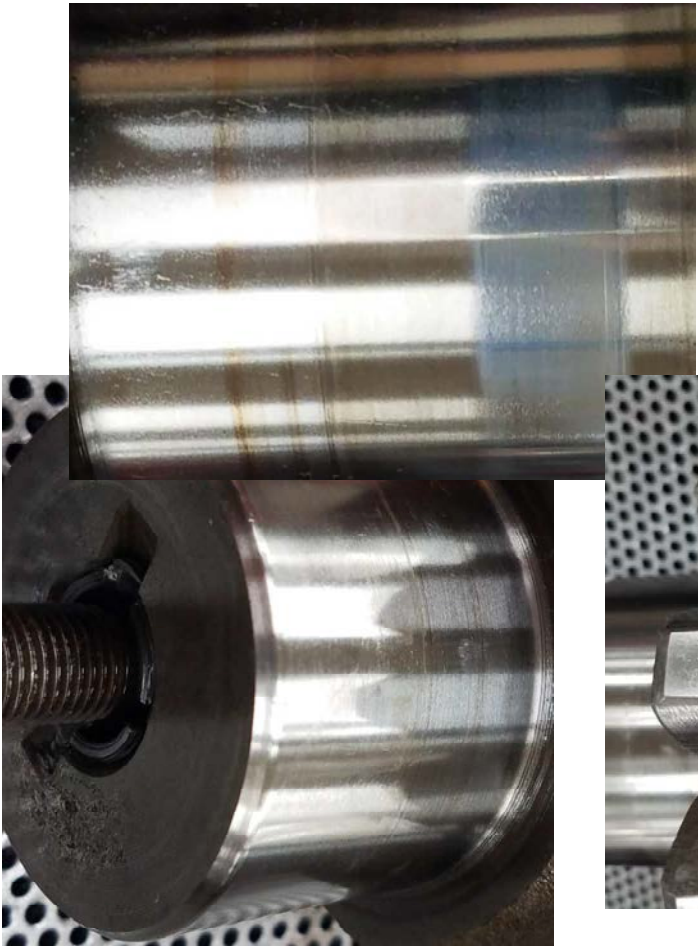
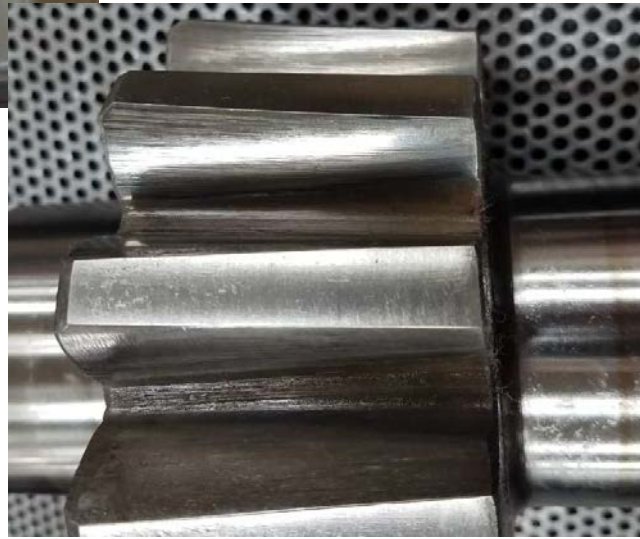
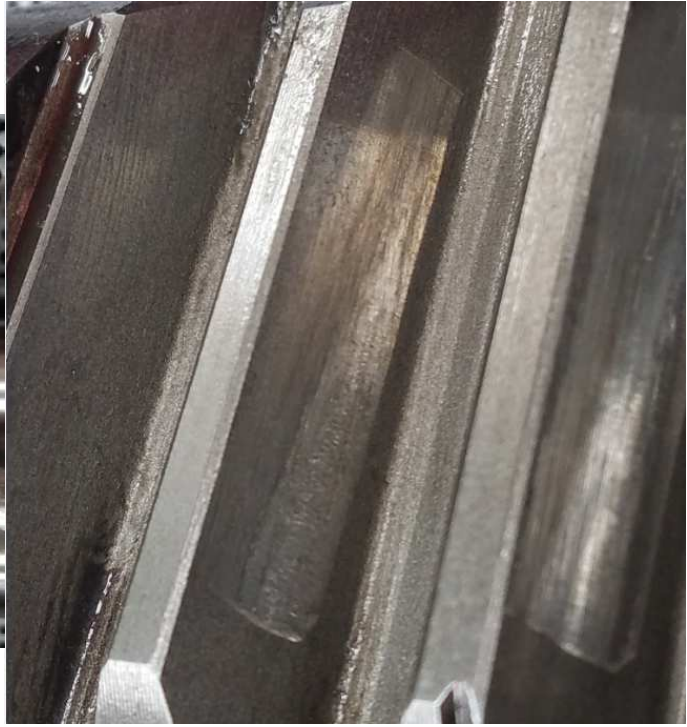
The sector teeth were intact and no brinell marks noted on the trunnion surface. This indicates no impact load into the output shaft.

The rack teeth were intact.

No brinell impact marks to sector trunnion. Trunnion bearing contact exhibits normal wear. Sector and rack piston teeth intact.

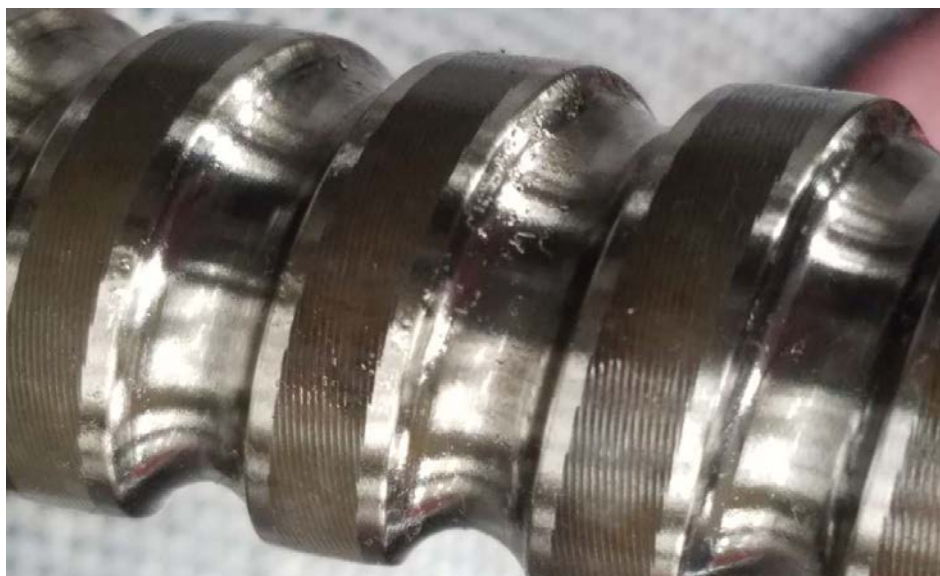
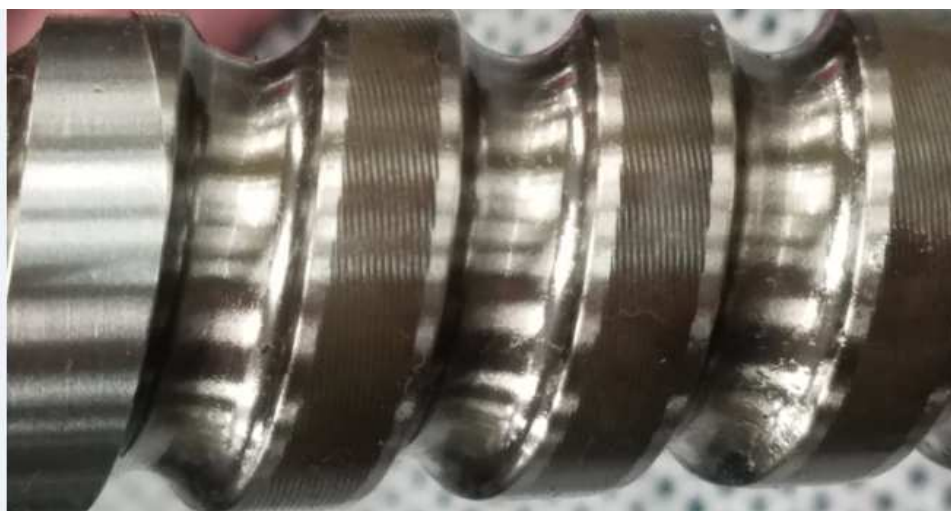
The recirculating ball bearings did not generate brinell marks (indents) on the worm helix indicating no impact driving the rack piston against the worm.

No brinell impact marks from the balls to the worm.

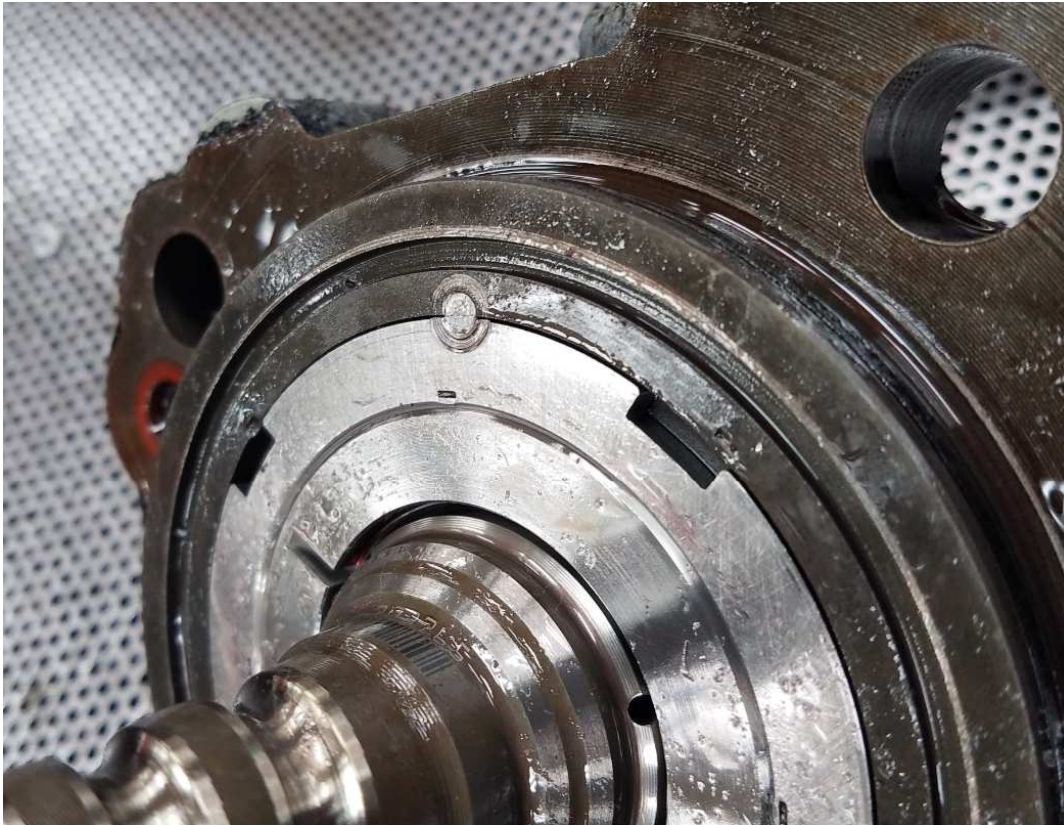
Valve housing adjustment intact with no damage.

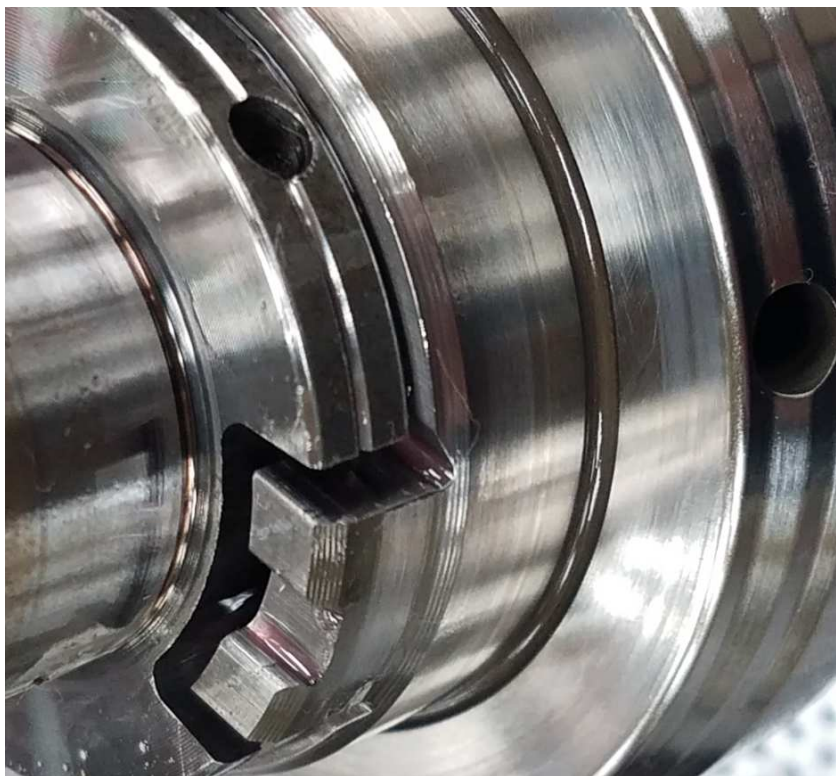
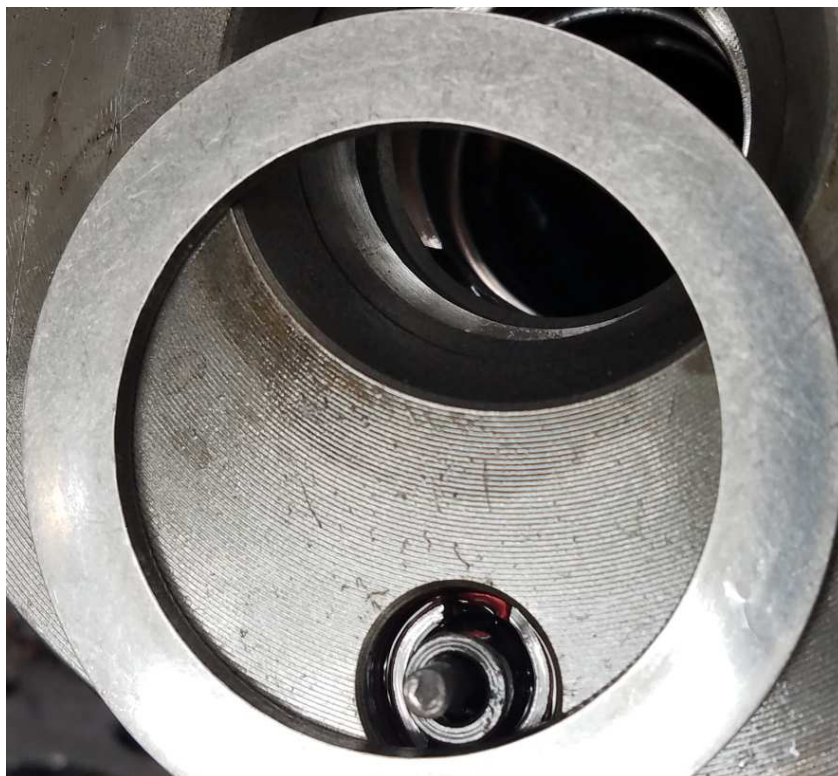
No damage to valve housing thrust bearings. Wear appears normal age.
