**VEHICLE FACTORS GROUP CHAIRMAN'S
FACTUAL REPORT**

Vehicle Attachment – MCI Vehicle Reports

Palm Springs, California

HWY17MH005

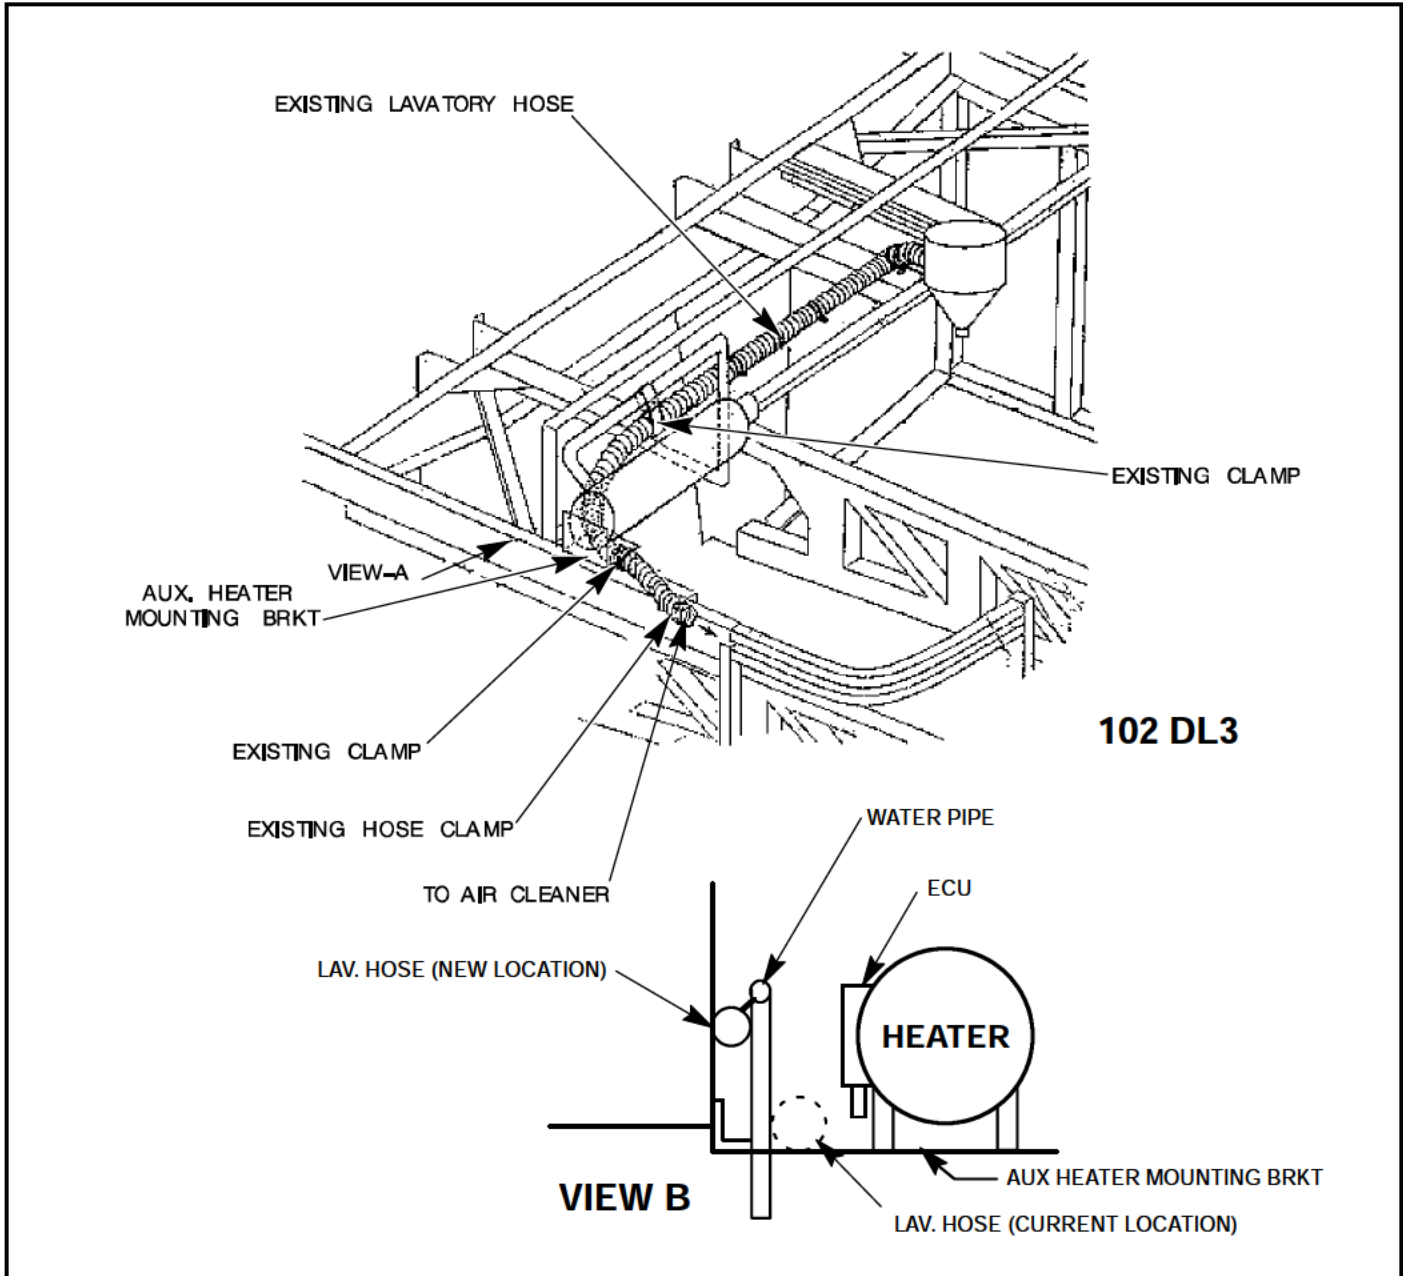
Figure 1: DL3 Routing and Connection Details

Effective with units [REDACTED] reroute the lavatory exhaust hose to avoid contact with the auxiliary heater ECU, per the following procedure. Contact with the auxiliary heater ECU can cause premature hose wear.

1. Loosen the hose clamp and remove the lavatory hose from the air cleaner (Figure 1).
2. Remove the two securing clamps from the auxiliary heater mounting brackets (Figure 1).
3. Inspect the lavatory hose and auxiliary heater harness for damage. Replace these if necessary. The part numbers are 7L-12-1219 for the harness and 17L-4-2 for the hose.

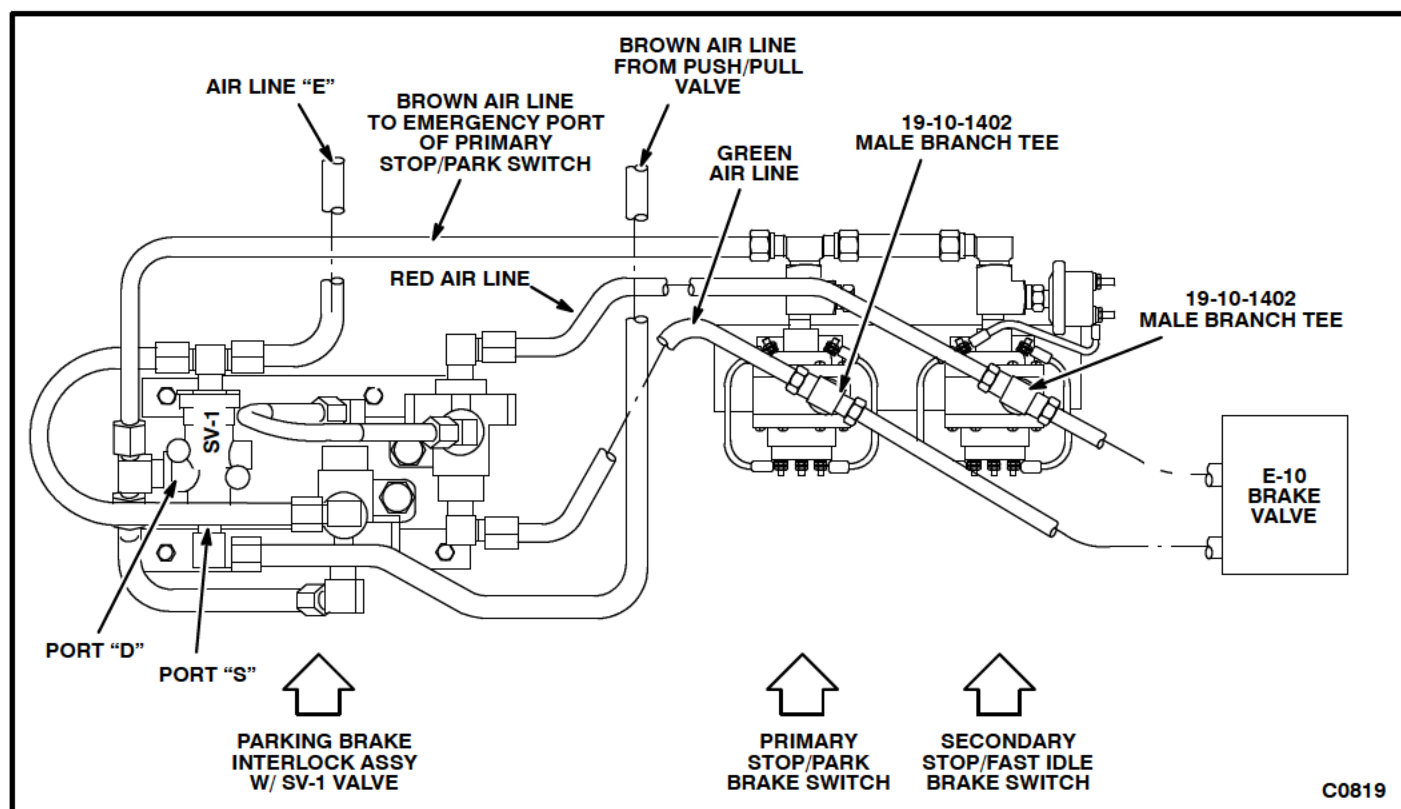
Figure 1. Brake System With E-10 Brake Valve and Parking Brake Interlock.

Effective with unit 48127*, MCI redesigned the braking system on 102D3 and 102DL3 coaches by removing the interlock between the parking brake and service brakes.

2. Open the front bumper and remove the spare tire from the tire compartment.
3. a) On coaches having an E-10 brake valve, disconnect the air lines to the 19-10-1402 male branch tees on the primary stop/park switch assembly and the secondary stop/fast idle switch assembly (see Figure 1). Replace the tees with 19-10-1336 male elbows (see Figure 3). Reconnect the red and green airlines running between the switches and the E-10 brake valve (see Figure 3).

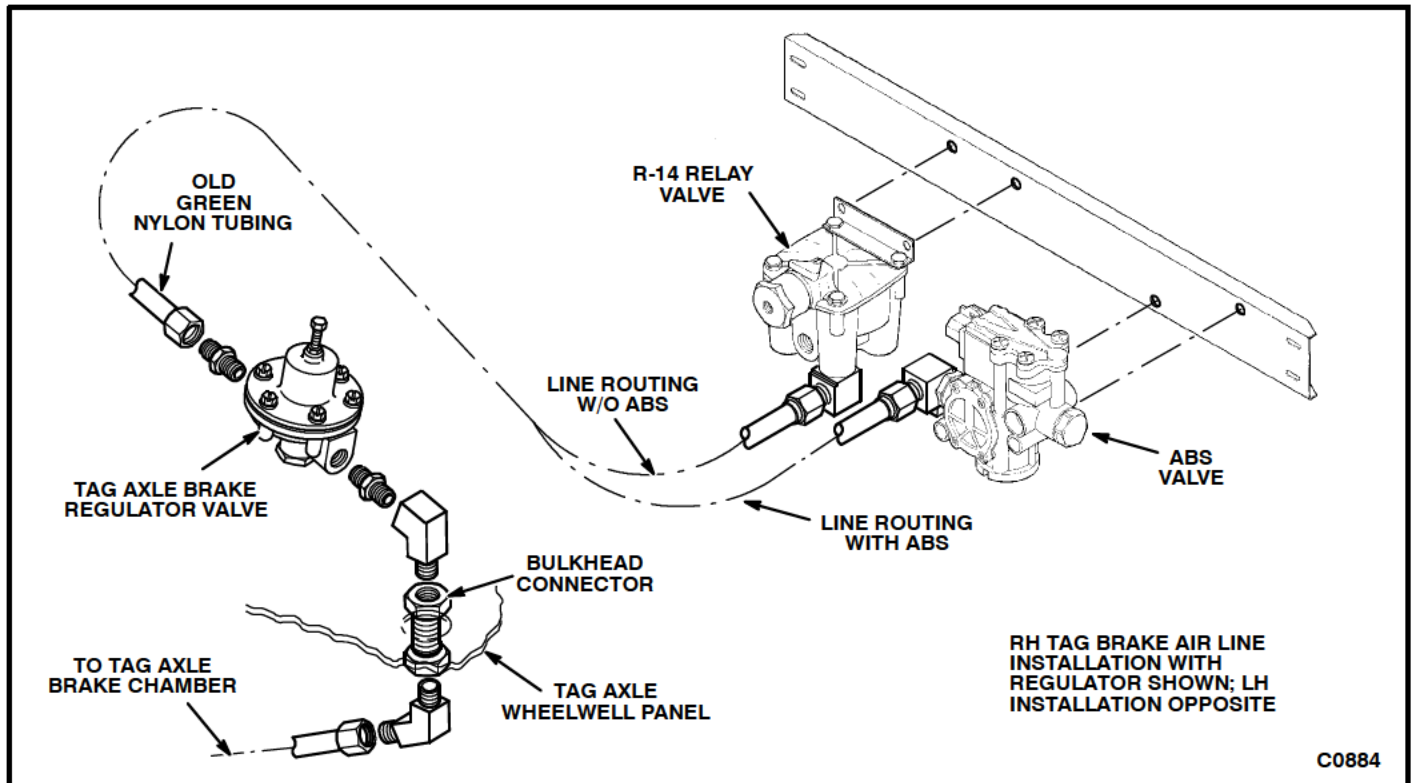
Figure 5. Old Tag Axle Brake Line Installation With Regulator Valve.

On some 102D3 coaches, removal of the parking brake interlock results in noise from the tag axle brake regulator valve. DOT braking performance standards are not impaired by removing the tag axle brake regulator valves from 102D3 coaches. As a result, the tag axle regulator valve was removed from 102D3 production coaches effective with unit 48107*.

1. Turn the main battery switch to "OFF," apply the parking brake and chock the coach wheels.
2. Remove and discard the 1/2" green nylon airlines connecting the the R-14 valve to the 28 psi tag axle brake regulator valves. See Figure 5.
3. Remove both regulator valve assemblies complete with all fittings from the wheel well bulkhead connectors. Do not remove the bulkhead connector. See Figure 5.

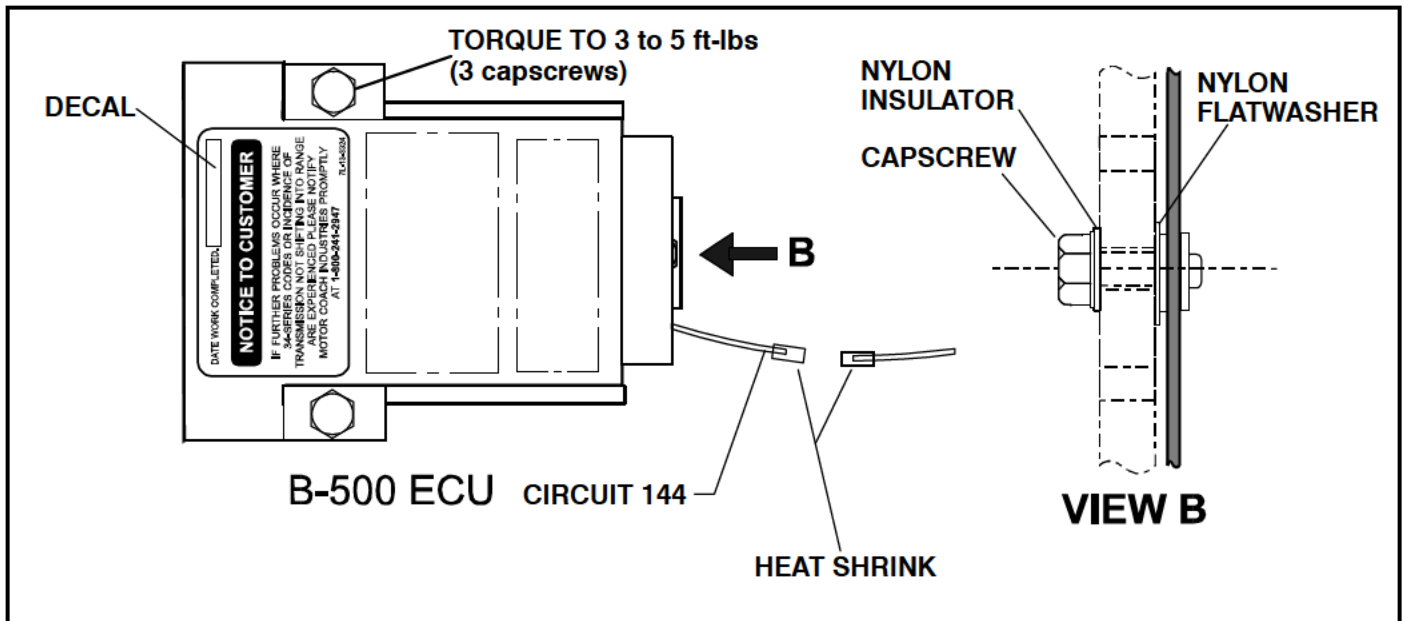
Figure 4: ECU Isolation Details

Note: Do not over-tighten the bolts. This will extrude the nylon insulators and washers, and compromise the electrical isolation.

8. Reinstall the ECU, using the existing capscrews and the nylon insulators and washers supplied as shown in Figure 4. Torque the capscrews to 3 to 5 ft-lbs torque.
