**VEHICLE FACTORS GROUP CHAIRMAN'S  
FACTUAL REPORT**

**Vehicle Attachment - NTSB MCI Brake Pedal and Linkage Inspection Report**

**HWY17MH005**

MATERIALS LABORATORY FACTUAL REPORT

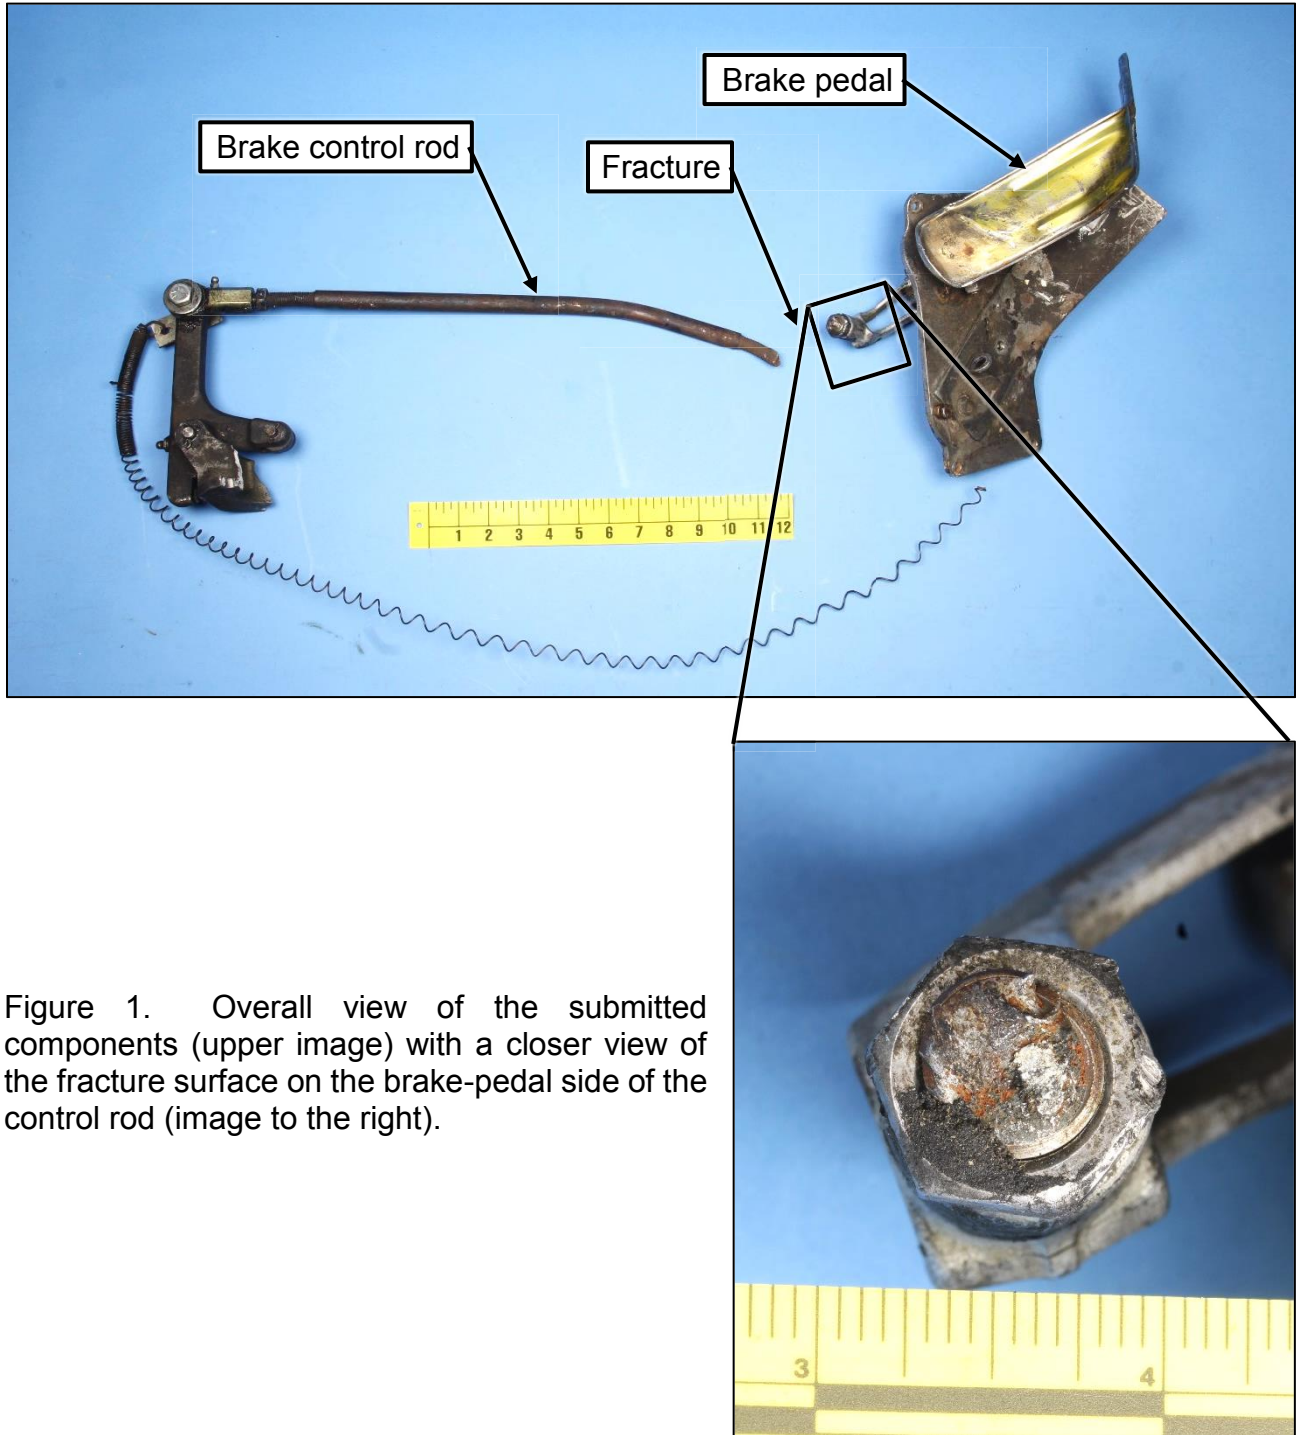
An overall view of the submitted brake components is shown in the upper image in figure 1. The brake control rod was fractured in the threaded region adjacent to the nut at the end closer to the brake pedal as indicated in figure 1. The brake control rod was bent in the threaded region adjacent to the fracture in the smooth portion of the rod approximately 4.5 inches from the fracture. The linkage between the control rod and the brake pedal was also bent.

A closer view of the fracture surface on the brake pedal side of the fracture is shown in the lower image in figure 1. The fracture surface had rough matte gray features and overall deformation consistent with ductile overstress fracture. Portions of the fracture were obliterated by post-fracture contact. Orange oxides consistent with post-fracture oxidation of the fracture surface was also observed. No evidence of a preexisting crack was observed.

Figure 1. Overall view of the submitted components (upper image) with a closer view of the fracture surface on the brake-pedal side of the control rod (image to the right).
