**VEHICLE FACTORS GROUP CHAIRMAN'S
FACTUAL REPORT**

Vehicle Attachment 1 - 2015 IC school bus RH Sheppard Steering Gear Examination Report

HWY17MH007

Subject: Steering gear inspection removed from a 2015 Navistar CE school bus involved in an accident.

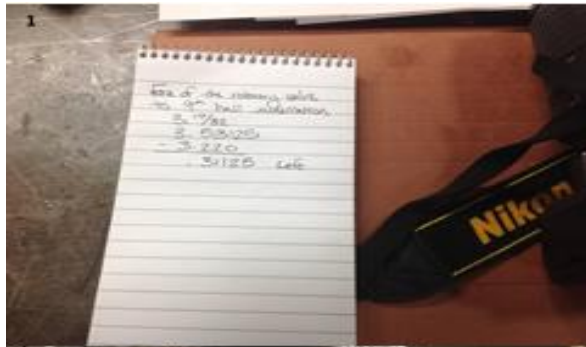
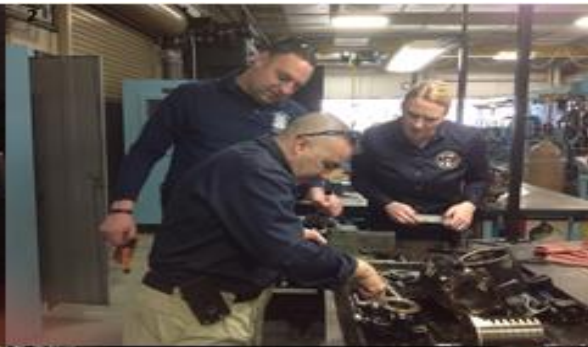
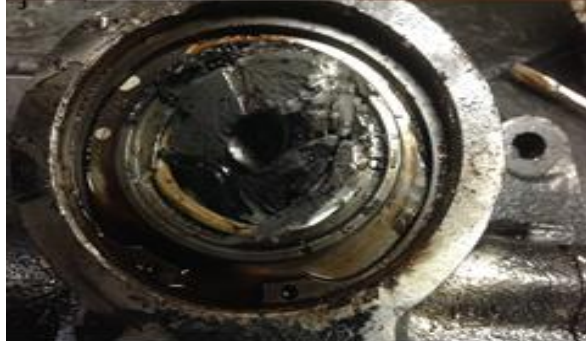
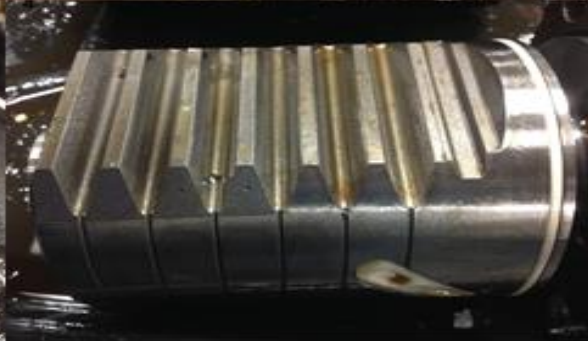
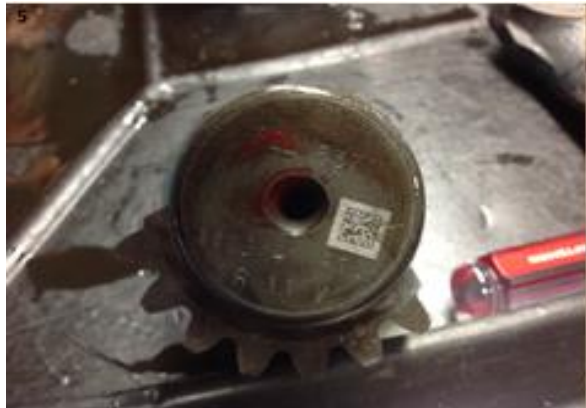
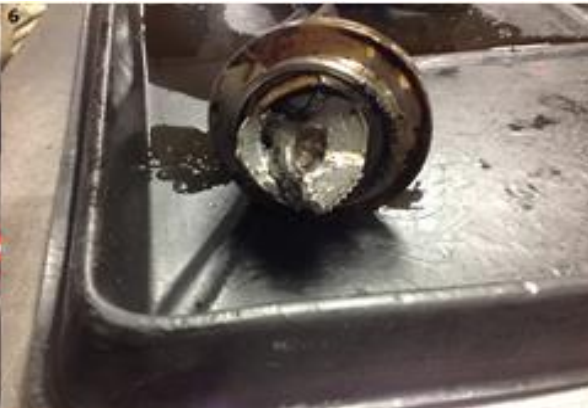
The incident resulted in a failure of the steering gear in which the sector was sheared between the pitman arm and the gear. Mr. Pereira requested a tear down and inspection of the steering gear to determine when the steering gear failed and the position of the wheels at impact. The steering gear was hand delivered to the R. H. Sheppard Co. by Ms. Morrison and Mr. Pereira. Photographs and documentation of the teardown inspection were collected by Ms. Morrison , Mr. Pereira and Mr. Bender.(Photo 2)The following is a report based on my observations and inspection of the parts.

Steering Gear Inspection: The subject steering gear was placed on a clean work bench where disassembly was made. The gear was a Sheppard model M100PMT3 with serial number 13J14475. Initial inspection showed the sector was sheared between the pitman arm and the sector cover. (Photos 3,6 and 7)The pitman arm remained attached to the broken end of the sector shaft. The pitman arm retainer was still in its lock position and the tab locks on the retainer were marked with seal lock such as the unit left the manufacturer. The remaining part of the fractured sector shaft was removed from the steering gear and examined. The sector teeth were in good condition with no signs of damage from the impact. The heat codes from the sector were recorded and verified with the original build records.(Photo 5)

The piston and bearing cap assembly was removed next. The piston teeth were inspected for damage which none was present. The heat code from the piston was recorded and verified with the original build sheet. The piston seal ring was in good operational condition (Photo 4). The rotary valve assembly was then removed from the piston. Inspection of the internal ball thread of the piston showed steel recirculating ball imprints on the thread. The bearing cap cover was removed from the bearing cap and inspected.

Inspection of the thrust washers showed single steel needle roller indents on both washers. This results when the rotary valve receives a single impact load. The steering gear had the required 24 steel recirculating balls present and the ball tube retainer O-ring was in good operational condition. Inspection of the rotary valve ball thread showed 15 steel ball indents on the shaft. The 15 ball indents were marked and the center of the ball indents was also marked. A measurement from the bottom of the rotary valve where the thrust bearing is located to the center line of the steel ball indents was measured at 3.53125 inches. This measurement provides the position of the pitman arm at the time the steering gear failed. Ball indentation of this type only occurs when the steering gear is subjected to an impact load in excess of three times the output torque of the steering gear. When the steering gear is in its center of travel (straight ahead) the distance from the bottom of the rotary center to it center line is measured at 3.220 inches. The piston/pitman arm moves .0315 inches per degree of travel. With these numbers, the position of the pitman arm at time of impact to the steering gear occurred approximately 10 degrees forward into a left steer or .31125 to the left on the steering wheel based on an 18.9:1 steering gear ratio. (Photo 1) The impact into the drag link/arm was driving the pitman arm toward the rear of the vehicle.
