**VEHICLE FACTORS GROUP CHAIRMAN'S
FACTUAL REPORT**

Vehicle Attachment 2 - 2005 Ford – Engine Visual Inspection Report from Navistar, Inc.

HWY15MH006

6.0L DIT ESN 6367159

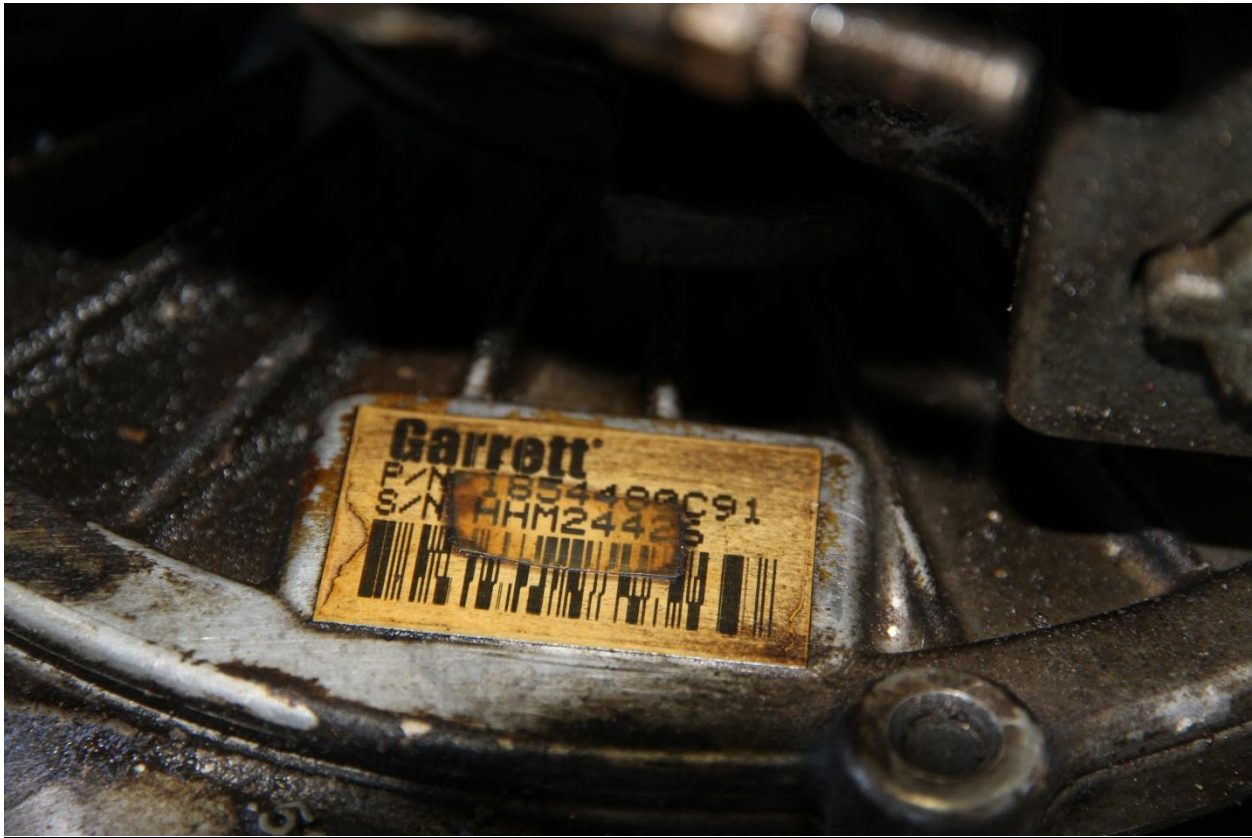
The turbo was not attached to the engine on arrival. Earlier pictures indicated it was still attached after the initial impact. Turbo p/n & s/n are shown in figure 1 in appendix – turbo serial number is the same as original build. Turbo was in good condition. Compressor and turbine wheels were still attached to the shaft and spun freely. Oil was present in the center housing oil cavity.

Figure 1 – turbo p/n and s/n

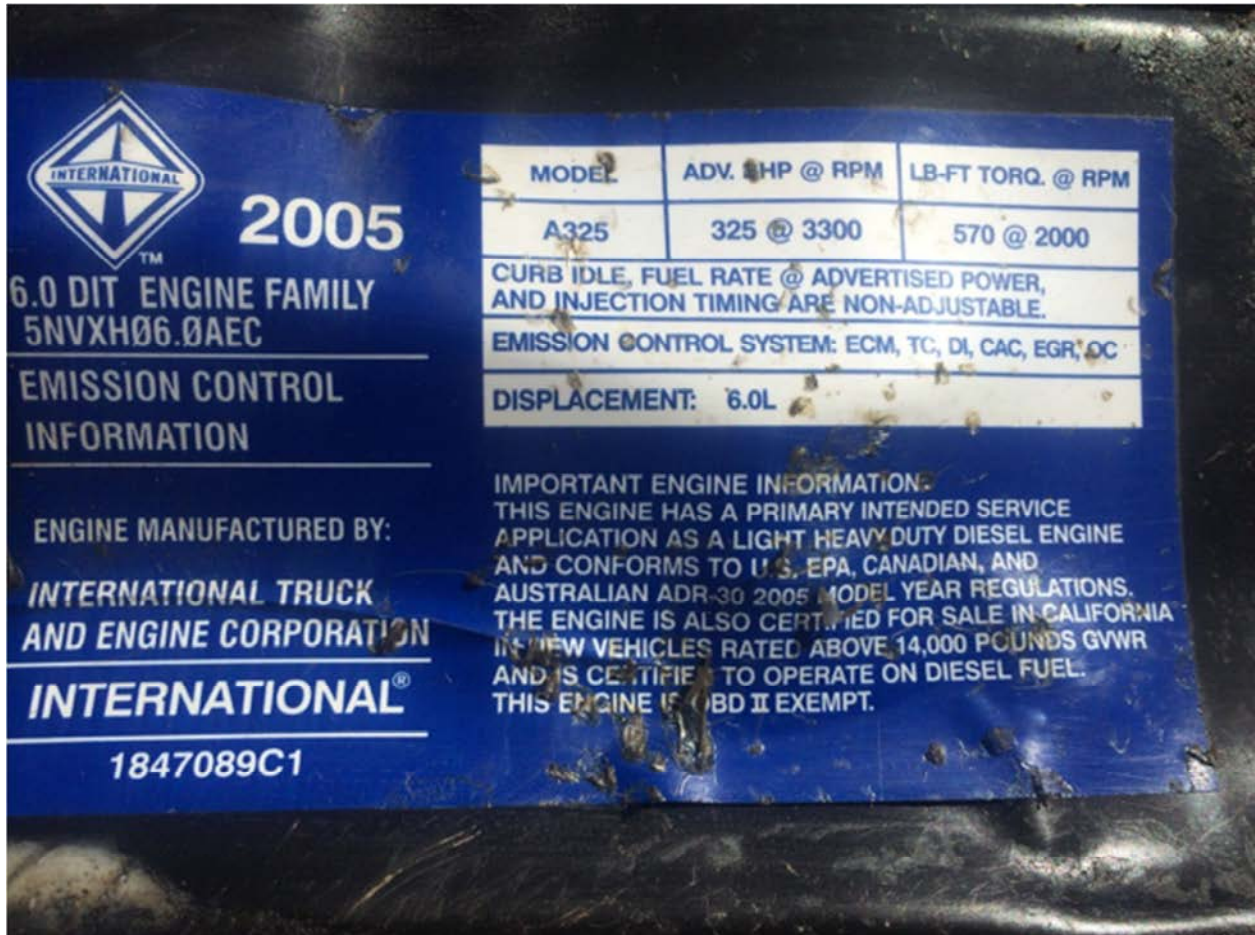
Passenger side valve cover was removed first. Picture of emissions label is in figure 2 in appendix. MY 2005 engine start of production was 6/30/2004.

Figure 2 - valve cover and emission label

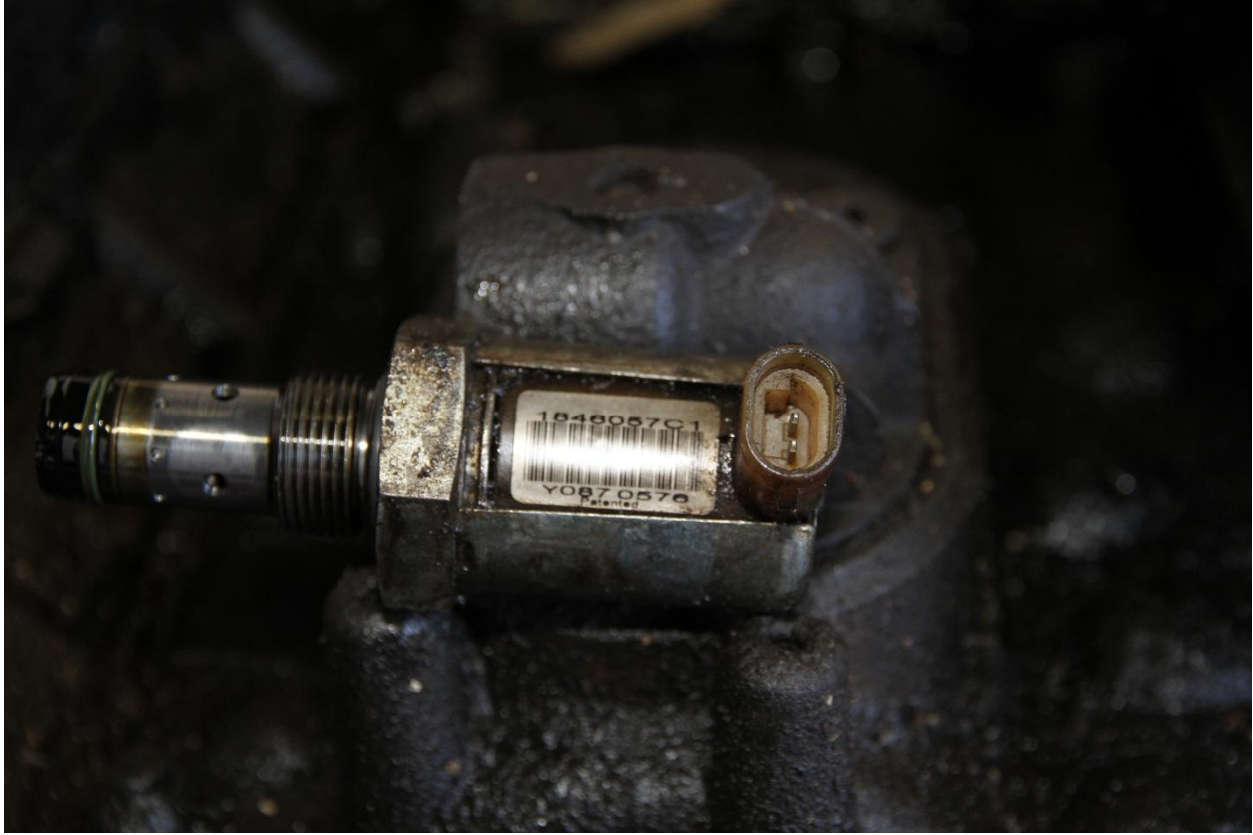
A schematic of the high pressure oil system is included in figure 3 in the appendix. IPR (injection pressure regulator) valve was removed from pump. The end screen was intact and in good condition. O-rings were intact and in good condition – see figure 4. Snap to connect fitting at pump was connected and in good external condition. Fitting was disconnected and reviewed - sealing surfaces were in good condition. O-rings between snap to connect fitting and branch tube were intact and showed no evidence of leakage. High pressure oil pump was removed and inspected. Pump gear was undamaged and pump turned freely. Mating crank gear showed no evidence of damage and teeth were in good condition. Oil supply cavity to high pressure pump was unobstructed. Oil reservoir in front valley of engine was full and screen was intact.

Figure 4 – IPR Valve

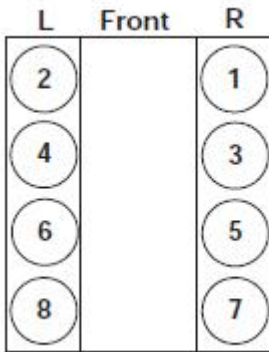
Passenger side exhaust manifold was cracked and showed signs of a large impact with broken bolts at cylinder 1 & 3 – see appendix figure 5 for cylinder naming convention. Driver side exhaust manifold was intact. Exhaust tubes were inspected and had no evidence of any obstruction prior to the impact damage. Up pipe assembly showed evidence of wire braiding failure over the bellows but no evidence of bellows cracking and no loss of function.

Figure 5 – Cylinder naming convention

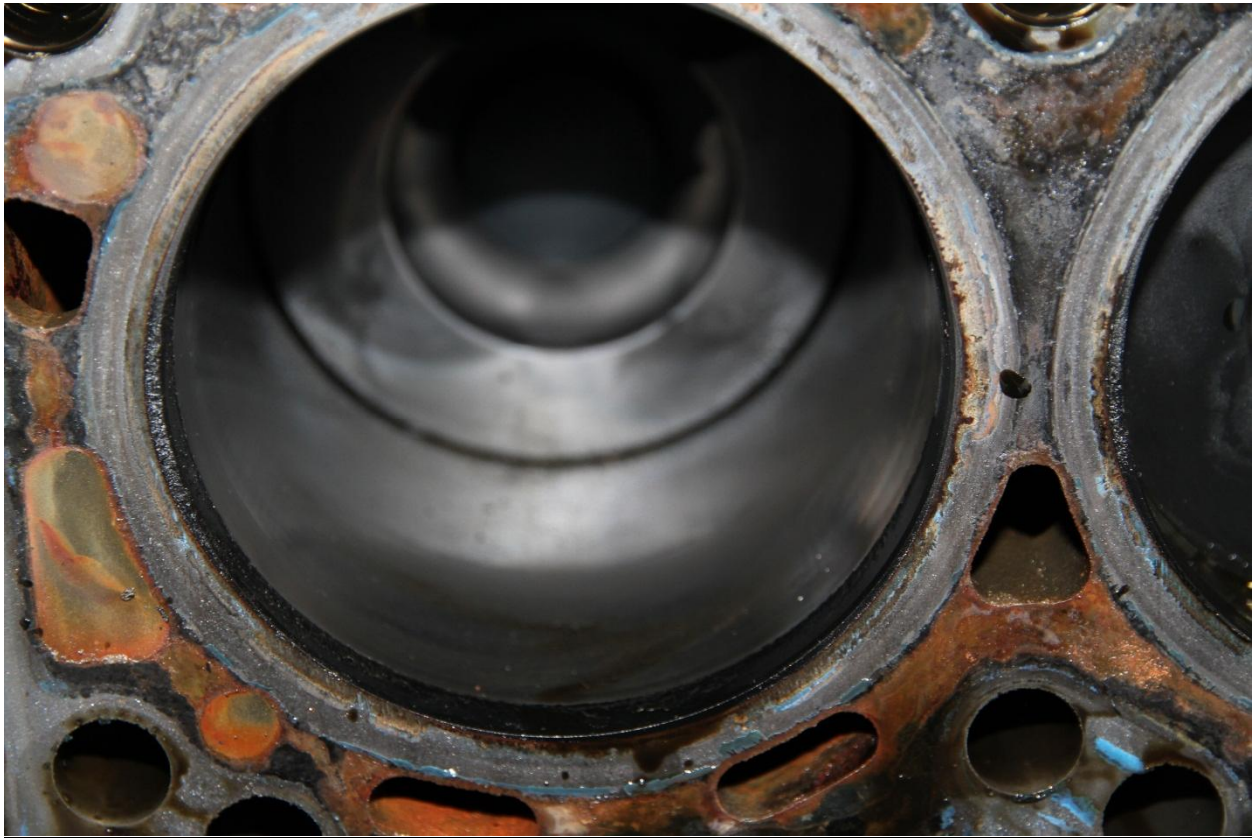
Cylinder block was in good condition. Cylinder bore wear was typical for an aged engine – cross hatch hone pattern was visible in all bores except at the top ring turnaround area – which is typical. See figure 6 for a typical example. There was no evidence of any bore scratches or scuffing. All piston cooling tubes were intact and undamaged. Bedplate bolts were tight and intact.

Figure 6 – Example of cylinder bore

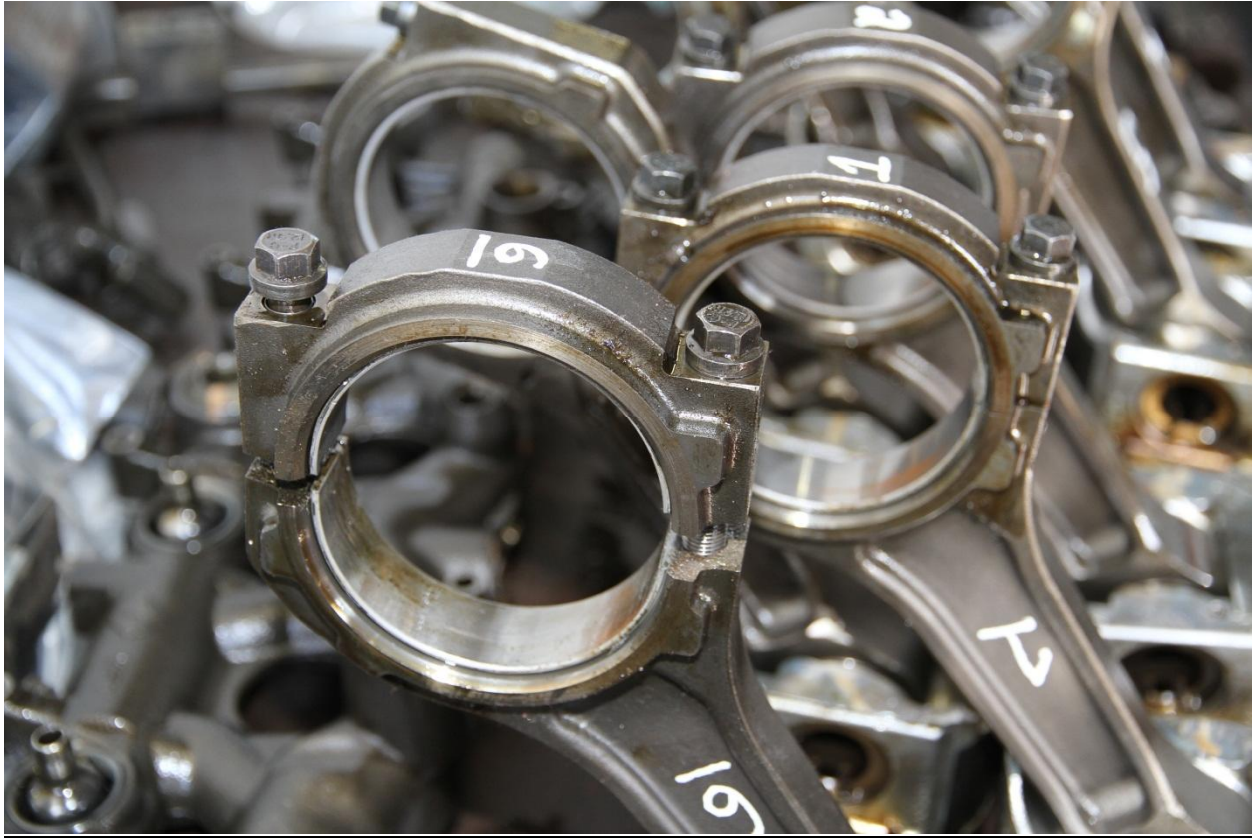
Connecting rod caps were removed and bearings inspected. Upper and lower rod bearings were in very good condition – there were no indications of excessive wear, no ‘copper’ was visible, minimal signs of debris scratches – see figure 7 for typical example. Rods all appeared straight with no signs of bending or twisting.

Figure 7 – Typical rod bearing
