**VEHICLE FACTORS GROUP CHAIRMAN'S
FACTUAL REPORT**

Vehicle Attachment – Recalls, Owners Letters, and Warranty Claims

Chattanooga, Tennessee

HWY17MH009

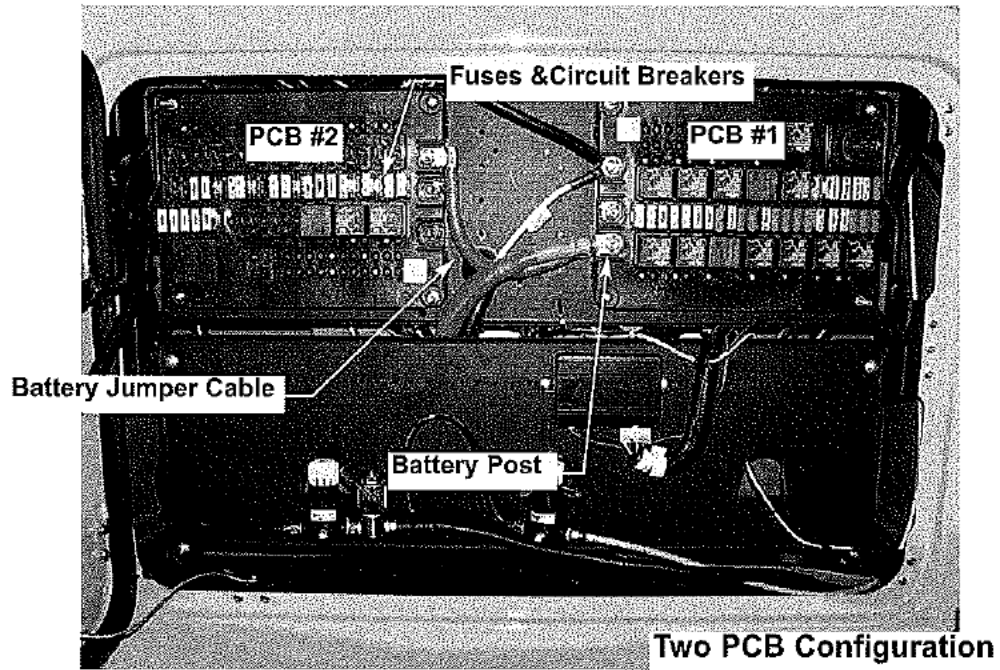
Figure 1

The defect involves the Type II auto reset circuit breakers. The Type II auto reset circuit breaker temperatures may exceed the rating of the Tyco PC board causing the board to melt potentially resulting in a vehicle fire. A vehicle fire may result in a crash.

This document replaces all the printed circuit board mounted auto-reset circuit breakers with either fuses or manual reset circuit breakers and replaces the printed circuit board battery power supply jumper cable for either the two or three Printed Circuit Board configuration.

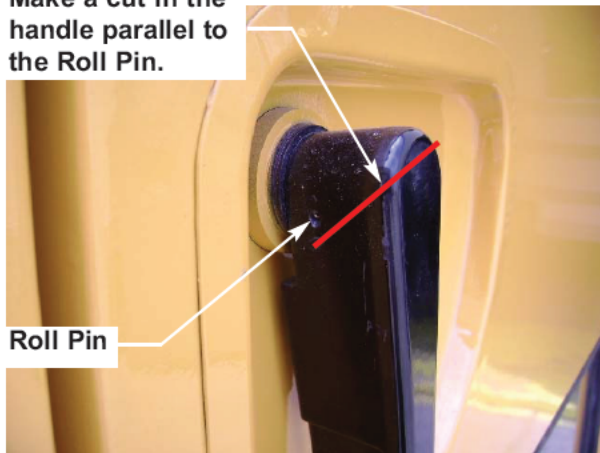
Figure 1

The defect involves the exterior handle. The exterior handle could begin corroding around the securing roll pin and square drive mechanism causing the protective finish to chip and flake. Continued corrosion and pitting weakens the handle. Handles weakened by corrosion over time may break while trying to open the door from the exterior. In the event of an emergency, a person on the outside of the bus may break the door handle trying to open the emergency exit potentially delaying evacuation and increasing the risk of personal injury to the vehicle's occupants.

1. Cut off the existing door handle to break it loose from the square shaft it is attached to. **(Figure 1)** Retain nylon washer and rubber washer to be reinstalled.
 - 1.1 Make cut in the direction pictured approximately 1/2" deep and then use a mallet / pry bar to remove handle.
 - 1.2 Be careful not to damage the square shaft. **Figure 2**
 - 1.3 Discard the existing pin and handle.

Make a cut in the handle parallel to the Roll Pin.
