**VEHICLE FACTORS GROUP CHAIRMAN'S
FACTUAL REPORT**

TRW Steering Gear Inspection Report

**MULTIPLE VEHICLE ACCIDENT
Chattanooga, TN**

HWY15MH009

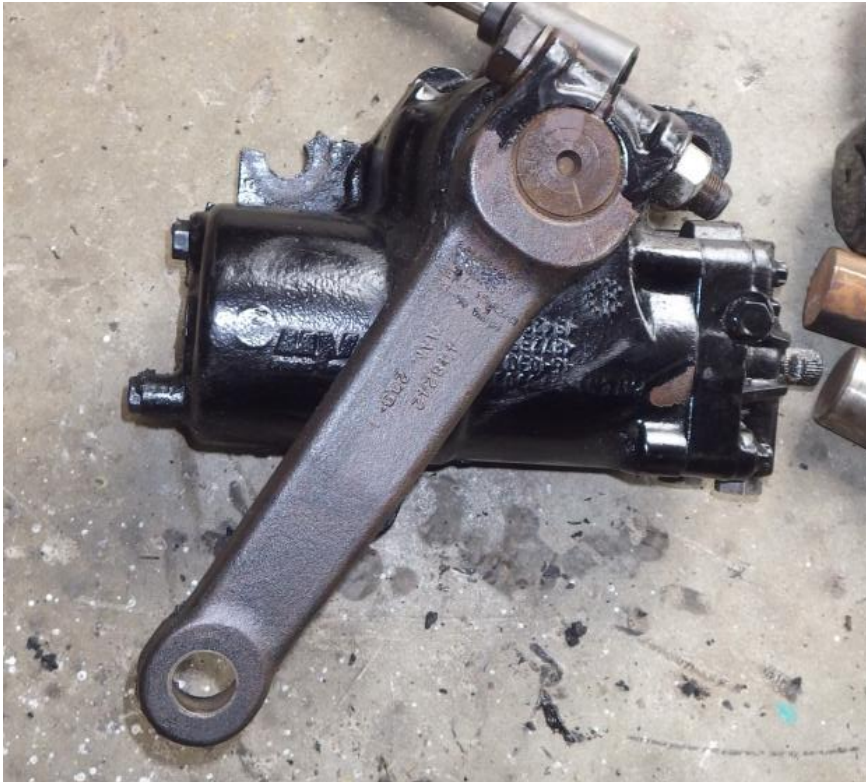
Gear as received

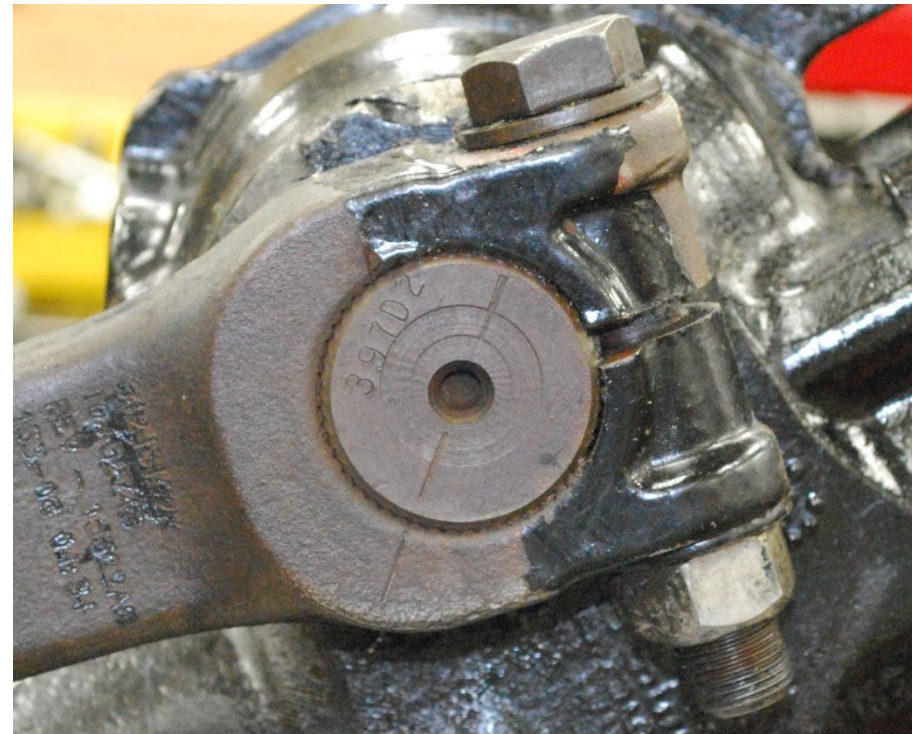
Pitman Arm was tight and aligned with timing mark

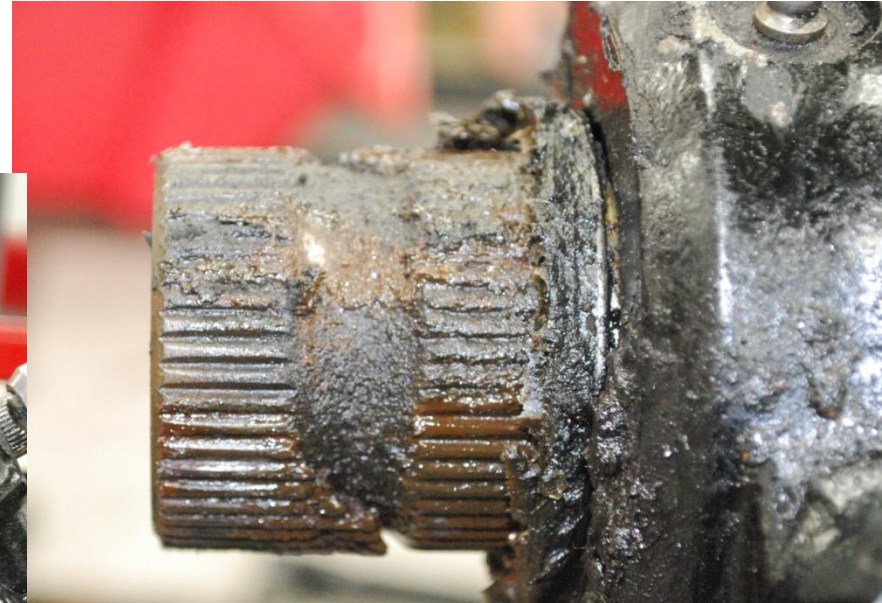
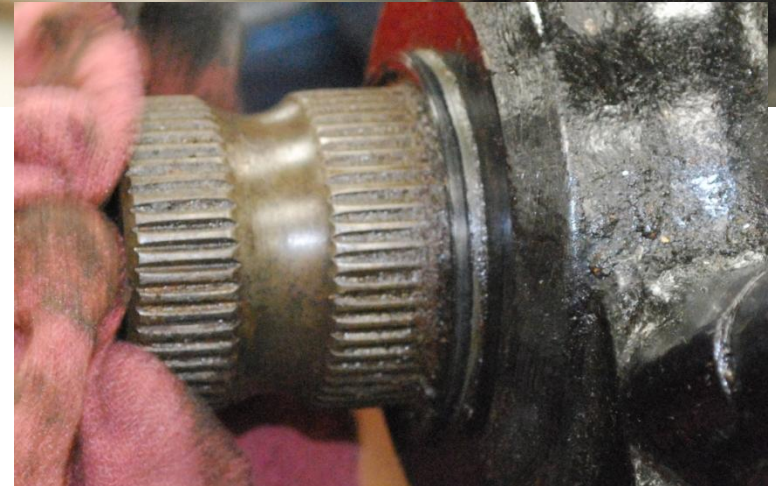
Output shaft very greasy and dirty, but splines in good condition

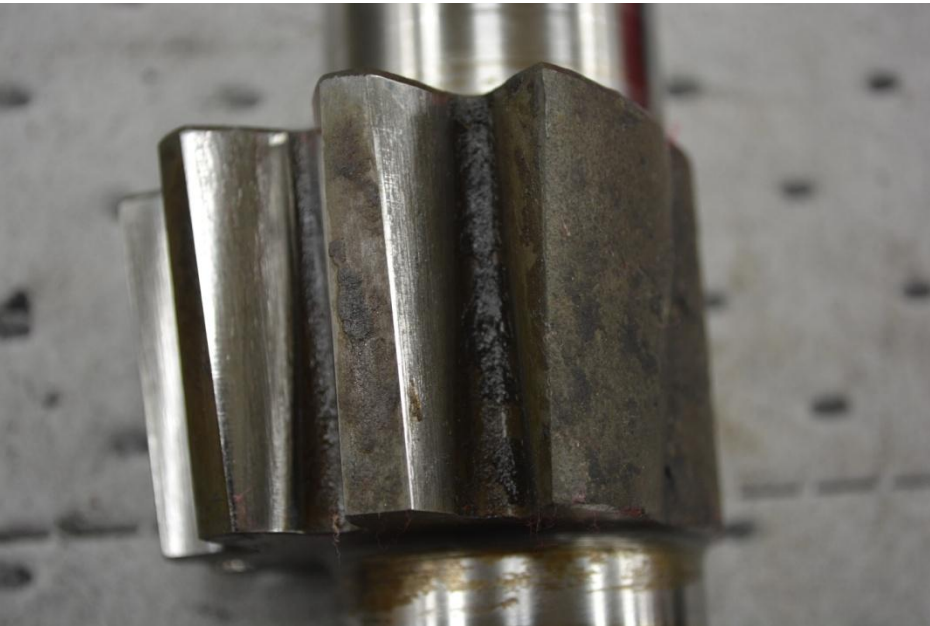
Sector teeth, dirty but no damage

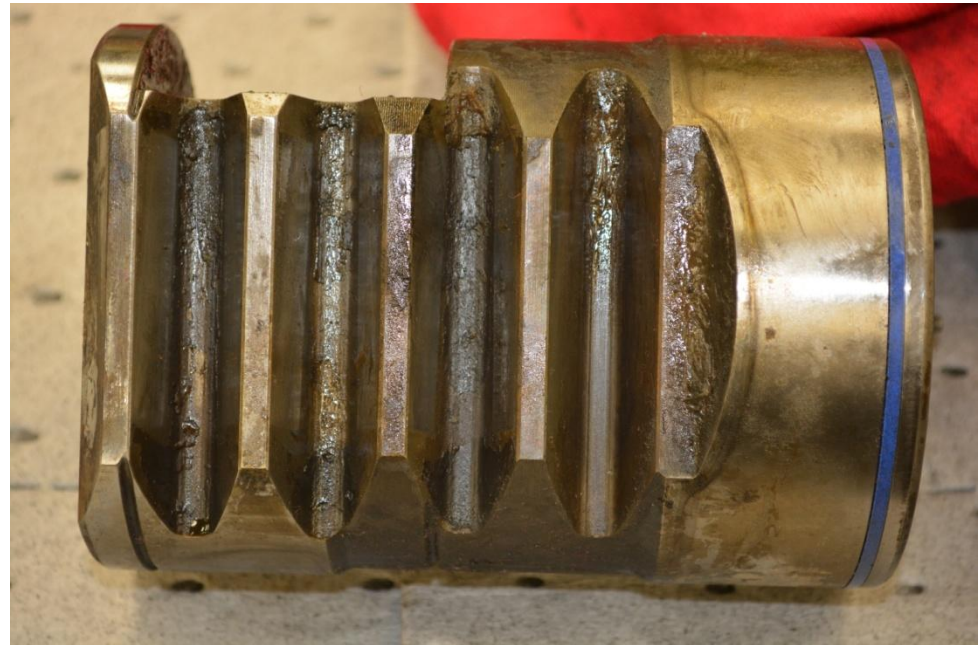
Rack Piston, dirty, but no damage
