**VEHICLE FACTORS GROUP CHAIRMAN'S
FACTUAL REPORT**

TRW Steering Gear Inspection Report

**MULTIPLE VEHICLE ACCIDENT
Chattanooga, TN**

HWY15MH009

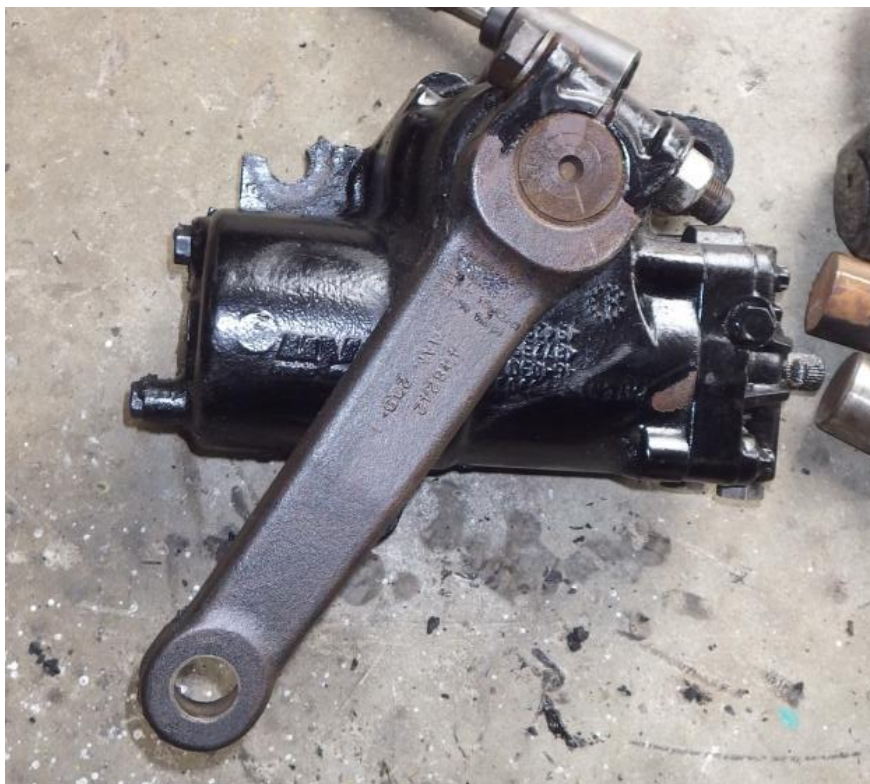
Gear as received

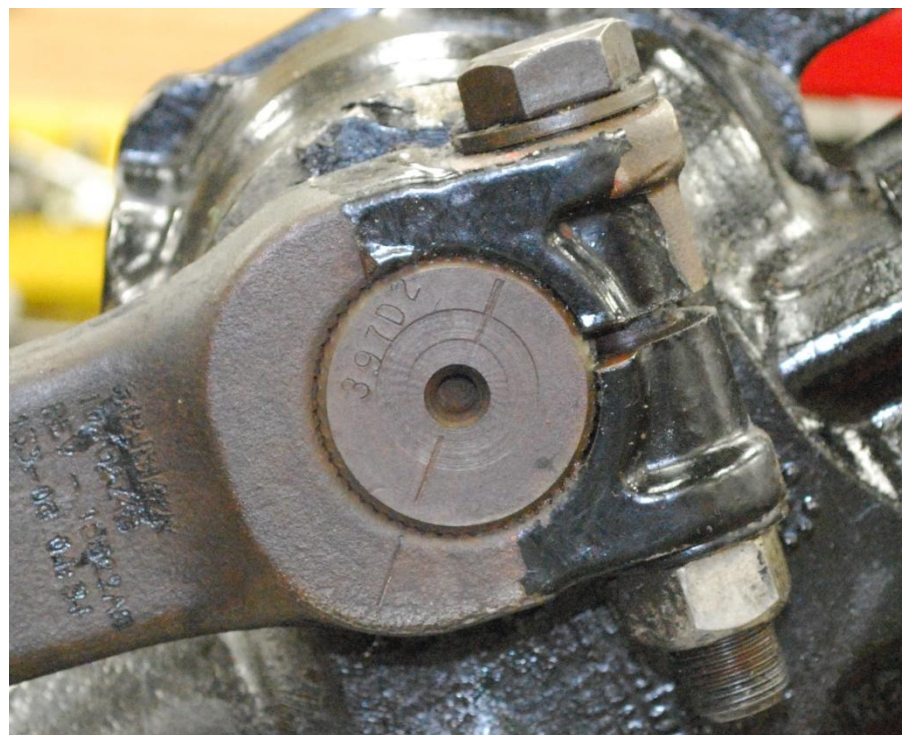
Pitman Arm was tight and aligned with timing mark

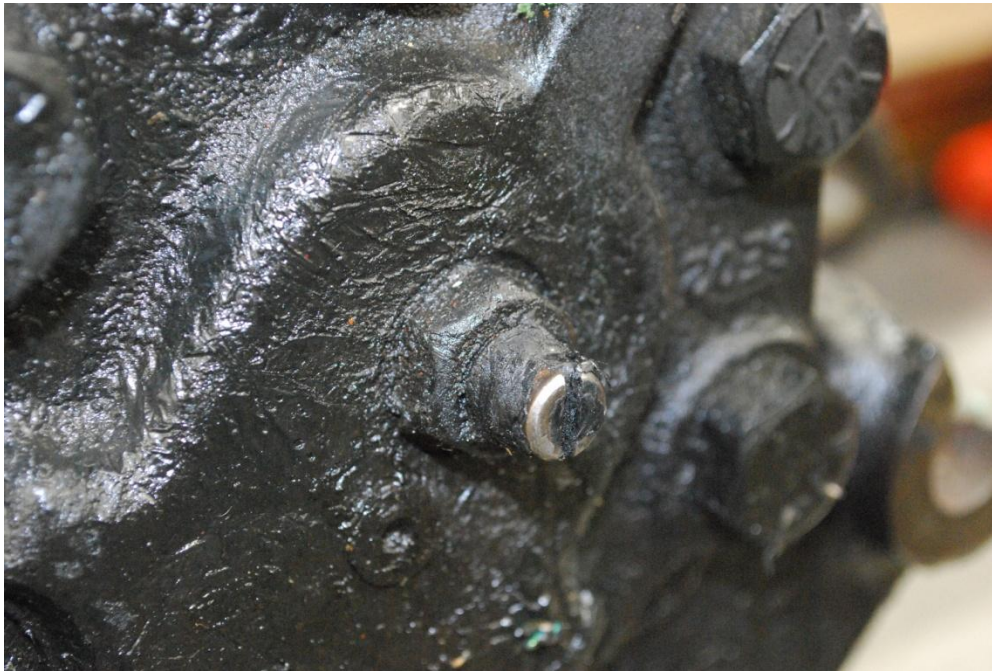
No signs of recent adjustment

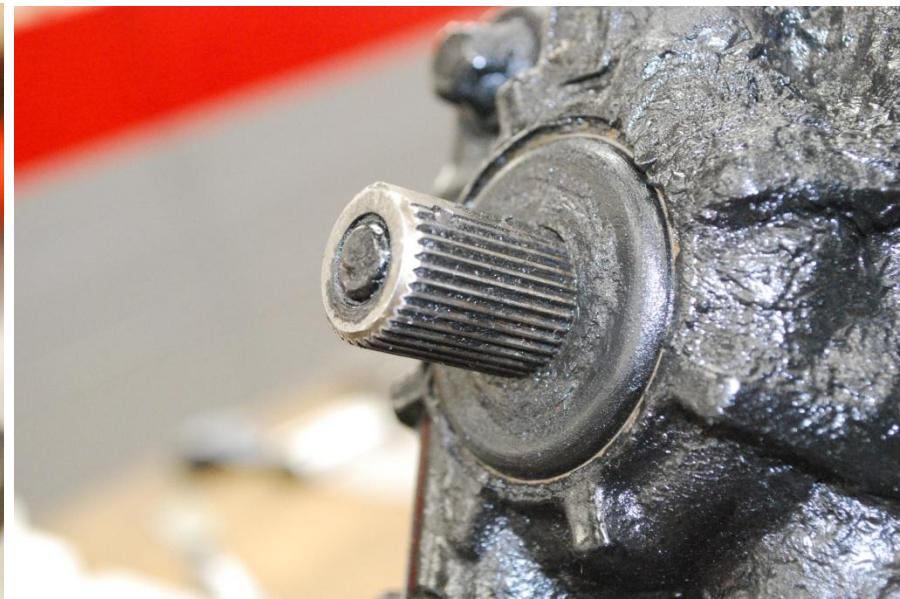
Input shaft splines in good condition

The input shaft and splines were in good condition. The steering gear output shaft turns when the input shaft is rotated indicating a correct mechanical connection of the internal components.

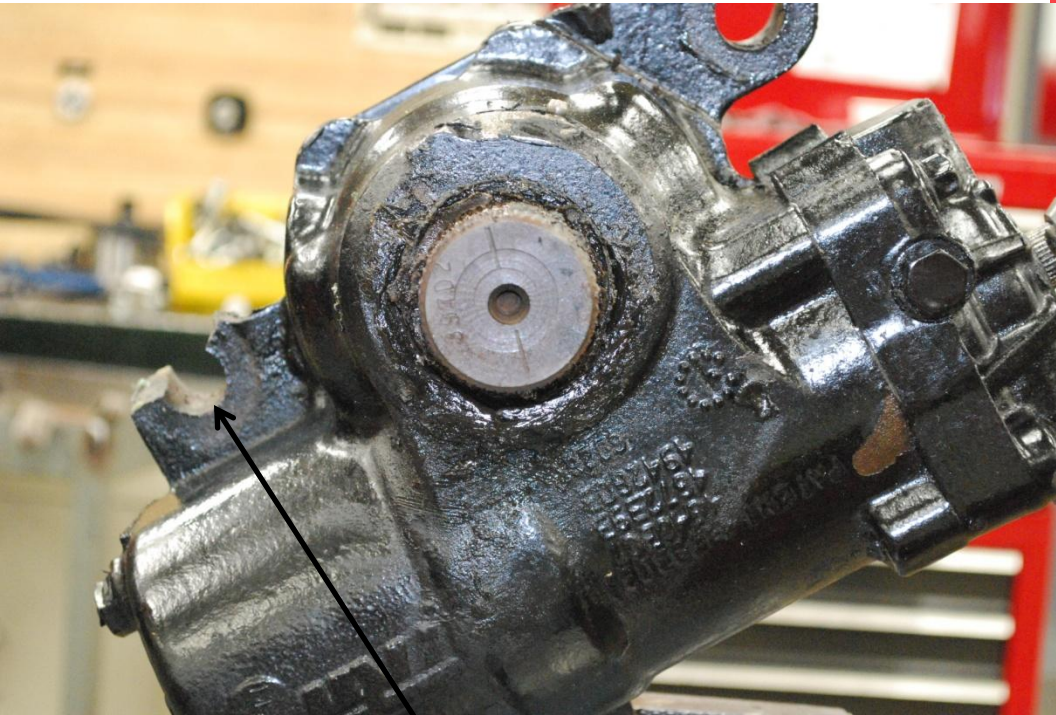
CONCLUSION: The steering gear was still mechanically functional as received. There were clear signs of impact since the mounting bosses showed fracture and damage. The output shaft showed brinell imprints from the needle bearings and the worm screw showed brinell imprints from the recirculating ball bearings. The position of the ball bearings indicate the steering gear was near straight ahead at the time of impact.

Gear was very greasy and dirty, broken mounting boss shown.

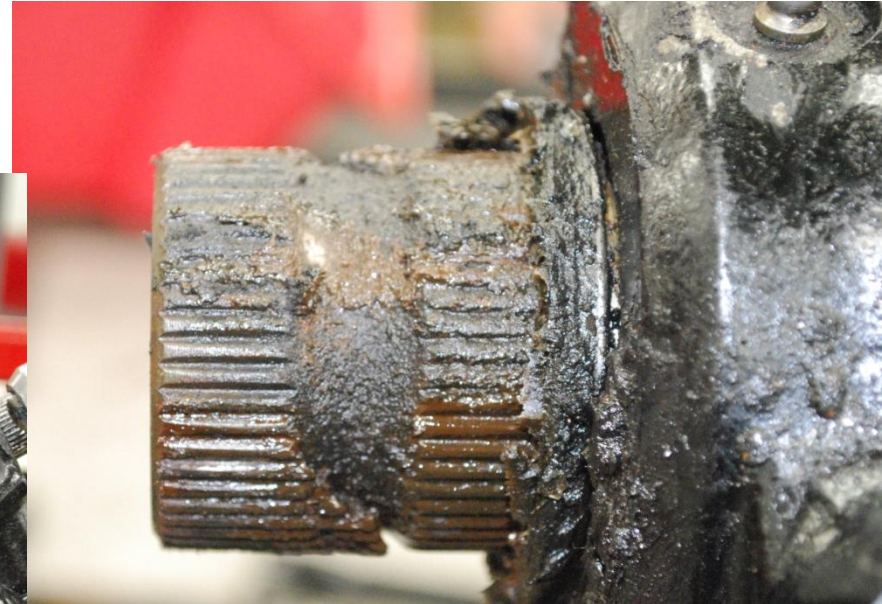
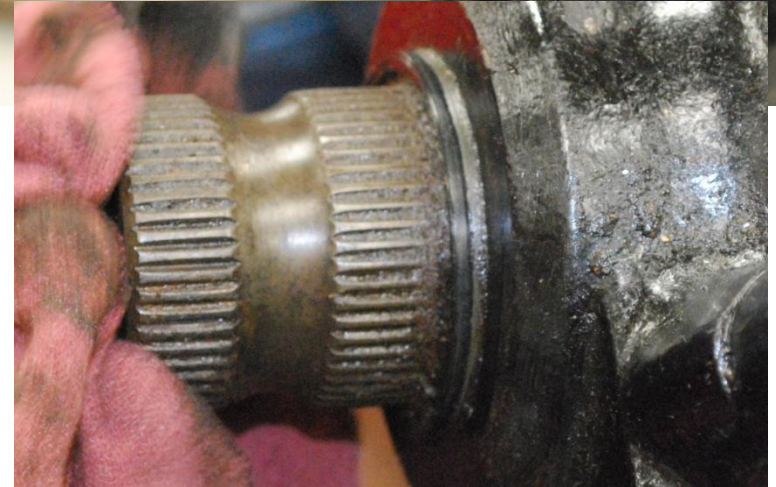
Output shaft very greasy and dirty, but splines in good condition

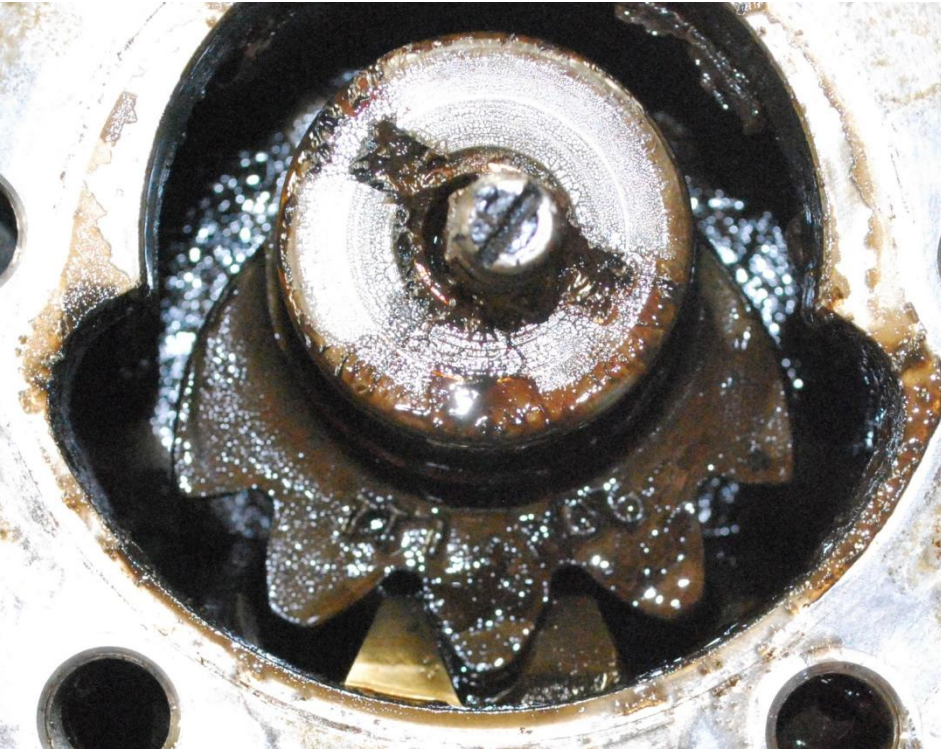
Gear teeth engaged, no damage evident.

The gear teeth on the rack piston and sector shaft showed signs of use, but were not broken or fractured.

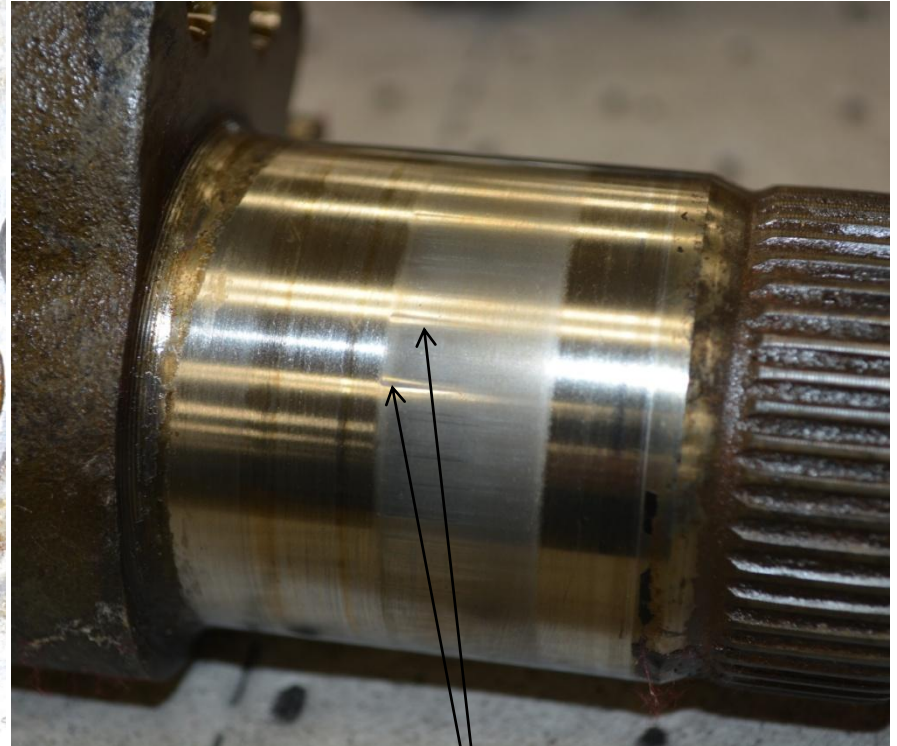
Output shaft showing brinell marks from needle bearing due to impact.

The output shaft was in good condition with evidence of impact load coming through the pitman arm and reacted from the shaft into the needle bearing. Brinell marks are evident on a portion of the output shaft. The splines are in good condition.

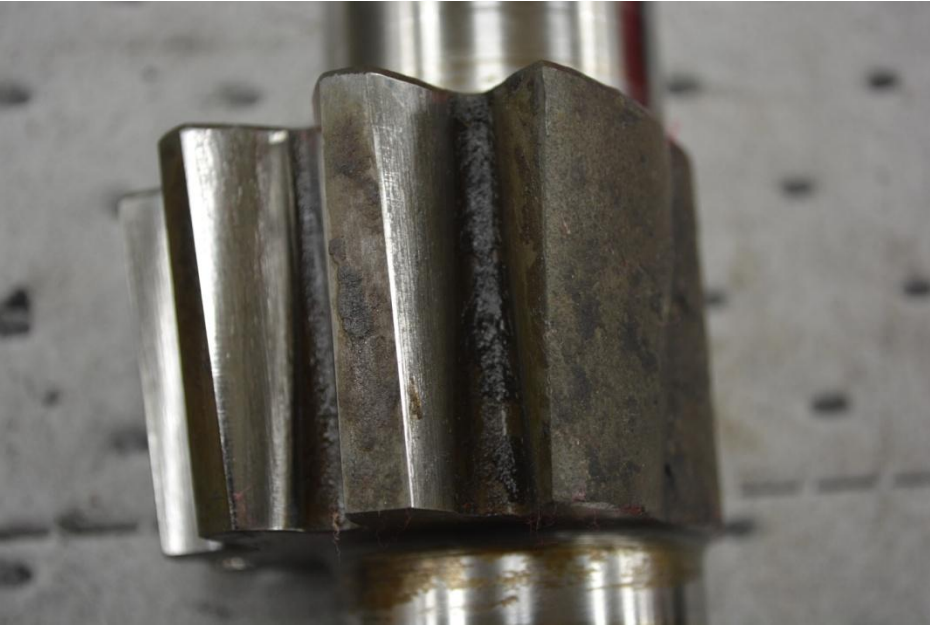
Sector teeth, dirty but no damage

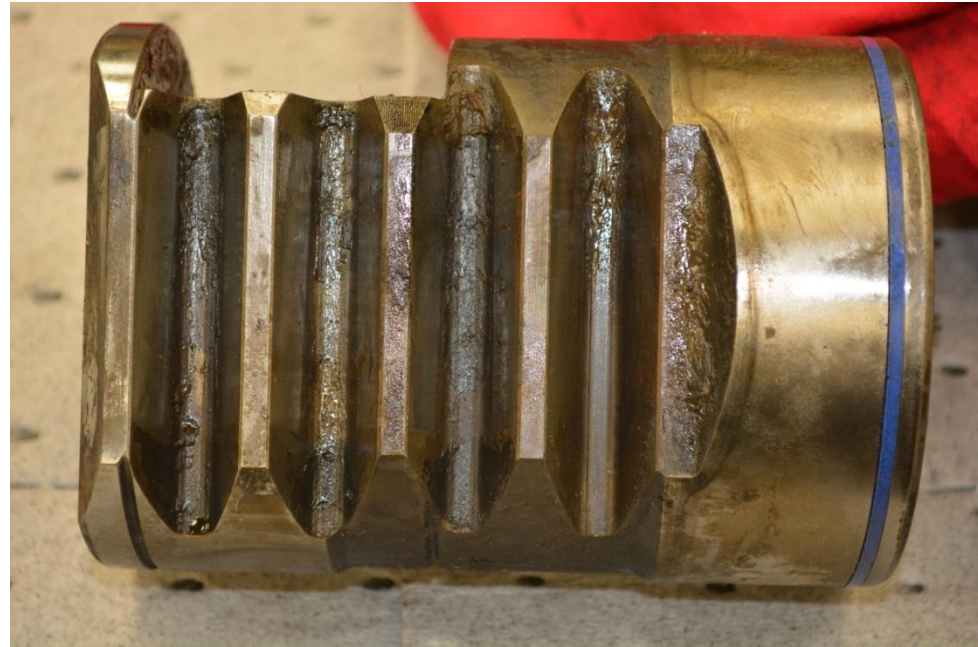
Rack Piston, dirty, but no damage

All of the recirculating ball bearings (32) were present and still within the rack piston assembly.

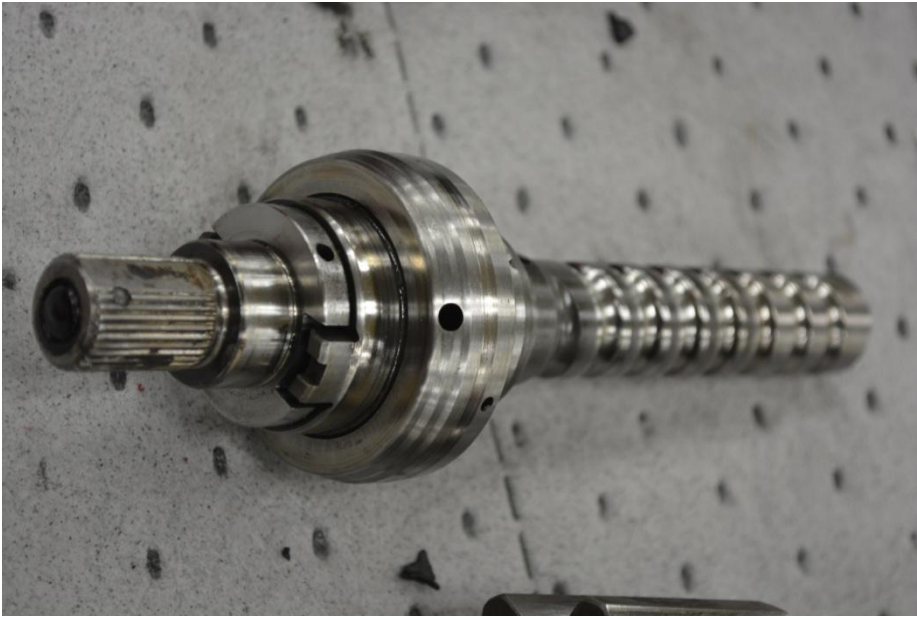
Worm and Valve assembly, no
apparent damage

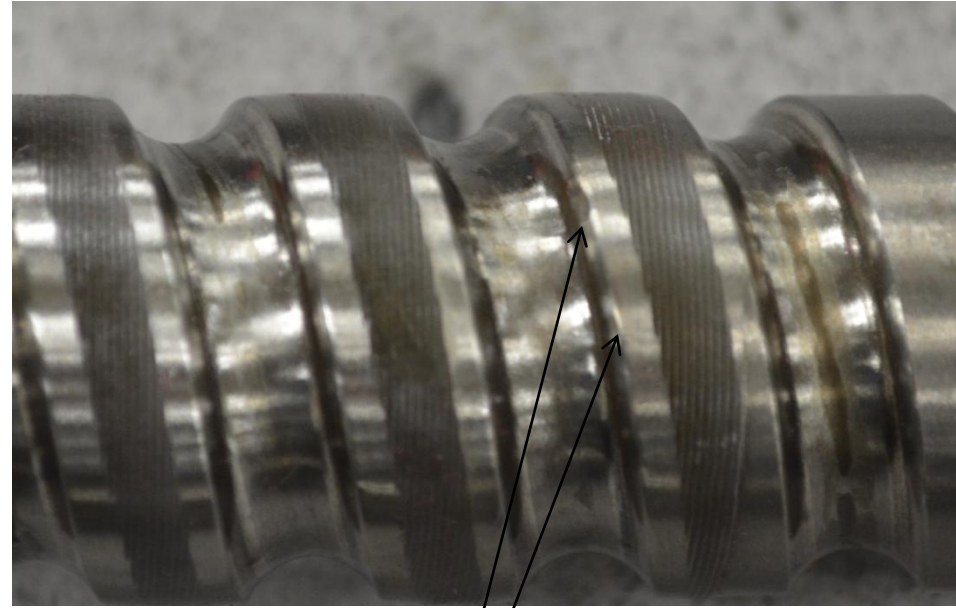
Worm showing light brinell impacts
from recirculating ball bearings

The recirculating ball bearings generated brinell marks (indents) on the worm helix indicating the rack piston was being driven toward the bottom of the gear, putting the worm in tension. The worm helix exhibits brinell marks matching a singular ball position indicating a single gear position during the impact. The brinell marks were not severe and the impact load was not severe enough to cause a fracture within the steering gear.

The recirculating ball impact locations are concentrated near the center of the worm shaft helix. This indicates the output shaft was near center, and thus the steering was near straight ahead.
